SUBJECT: Case H00153 - Application for De-Registration of 78 Shore Road
(a municipal heritage property) Dartmouth

5.2 H00153 - Application for Deregistration of 78 Shore Road, Dartmouth

G.F. DUFFUS & COMPANY LTD.
ARCHITECTS

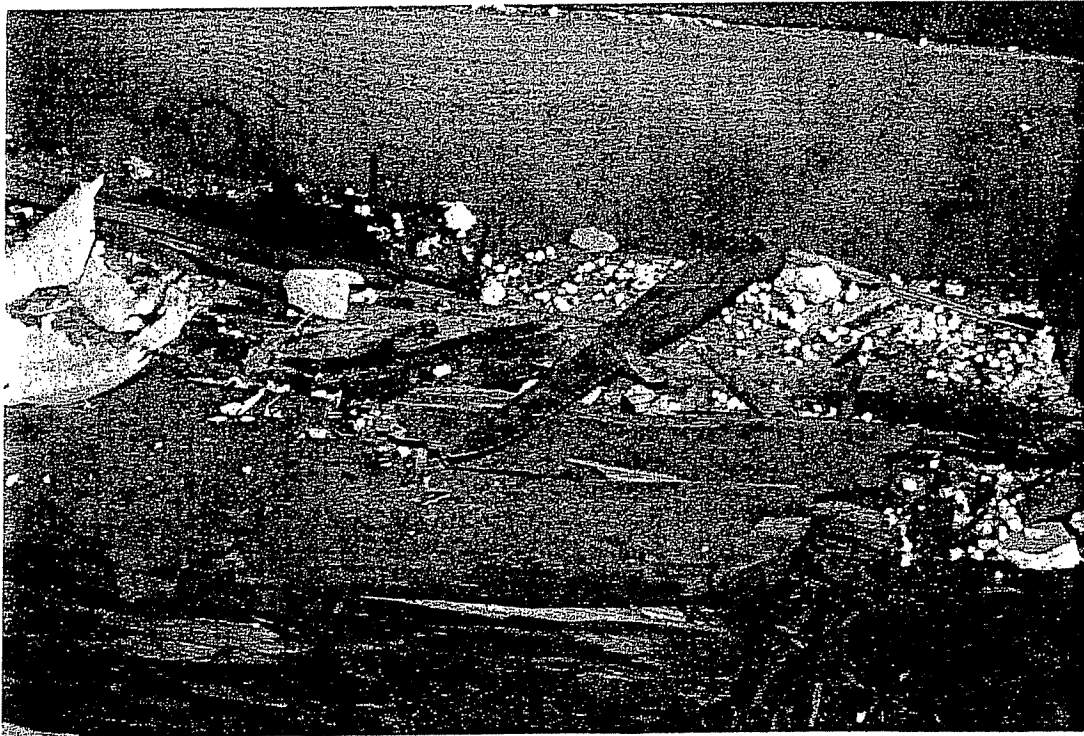
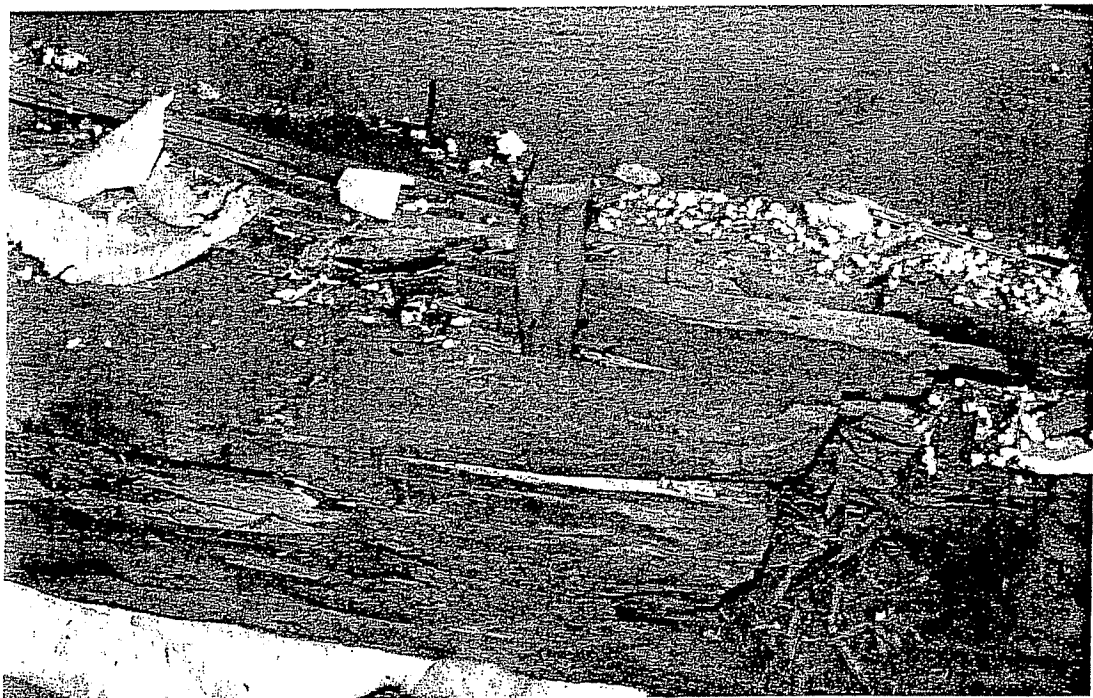
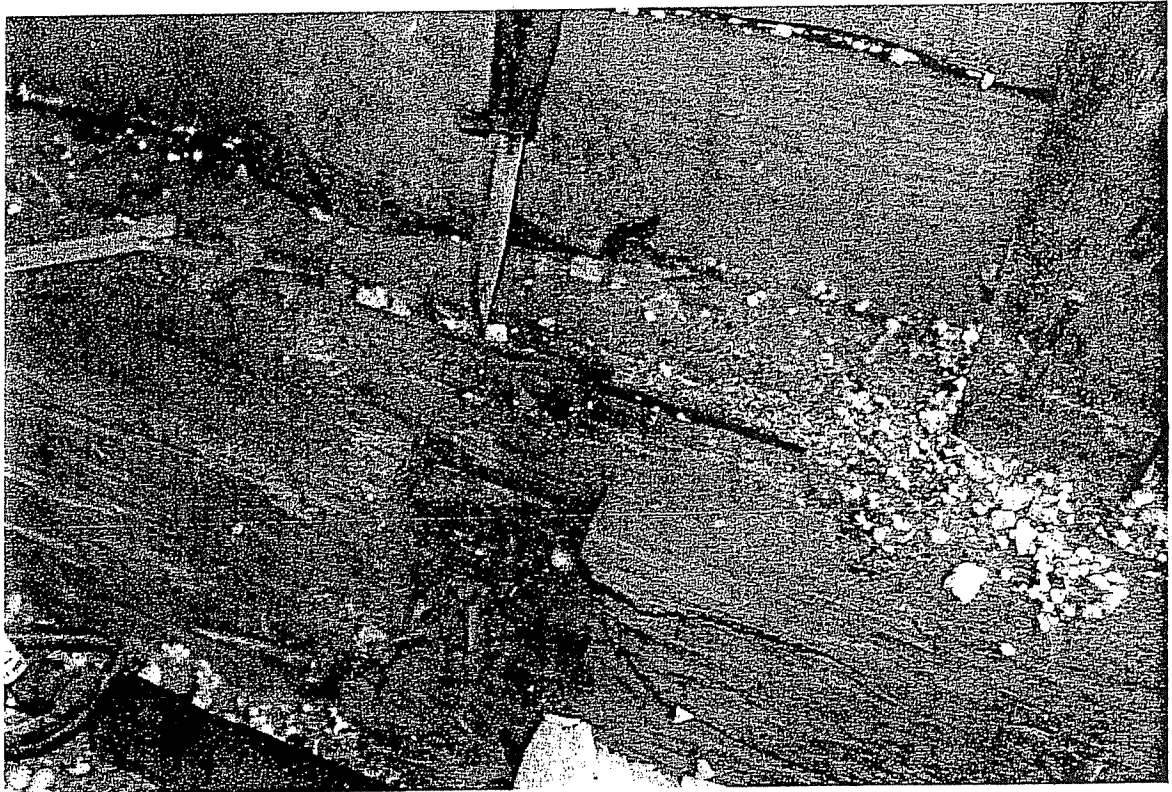
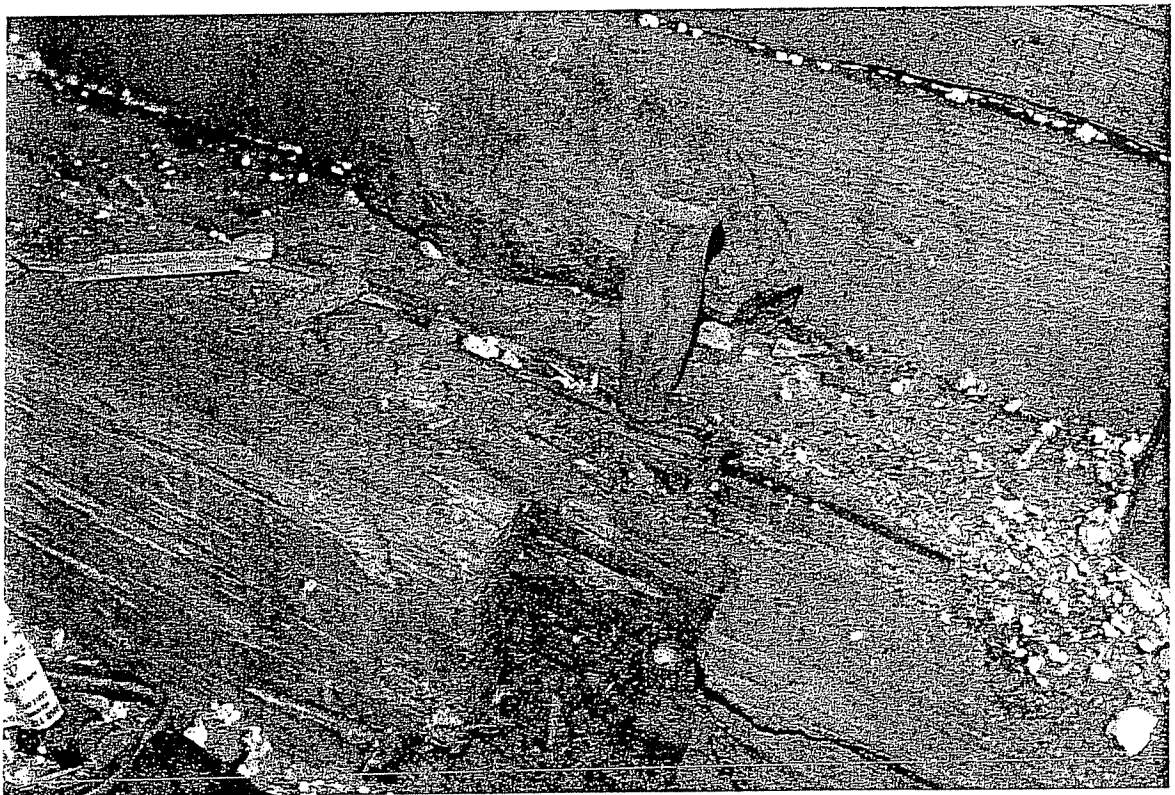
The next pictures are of the sills. We have taken the pictures of a knife with a 5 inch blade before and after it has been inserted into the rotten sill in various locations.

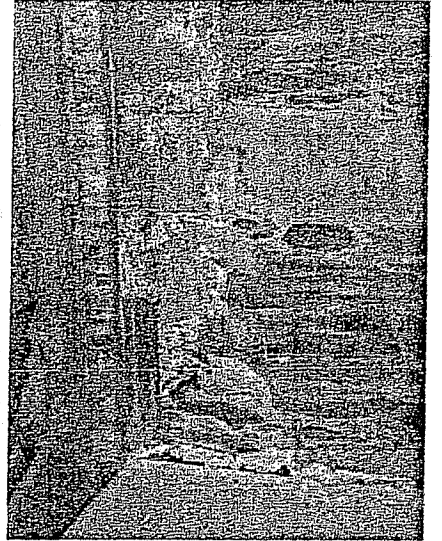
CHIMNEY

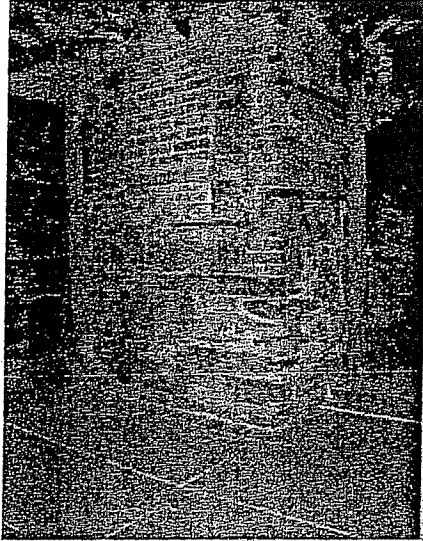
CHIMNEY

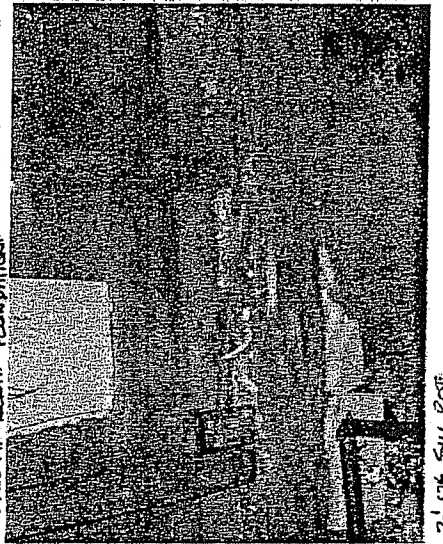
SILL AT WEST FOUNDATION

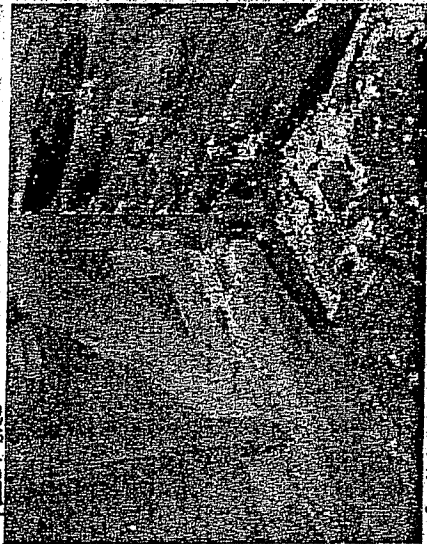
FRONT SILL

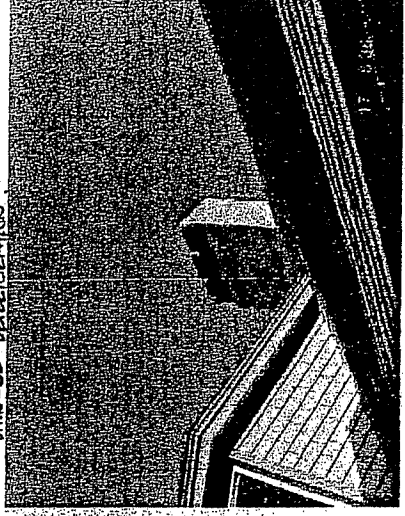
CHIMNEY FLASHING - POEMISE

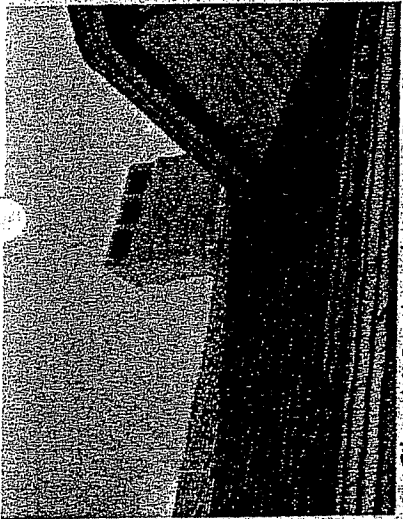
CHIMNEY FLASHING / SHINGLES - ROOF DRAIN

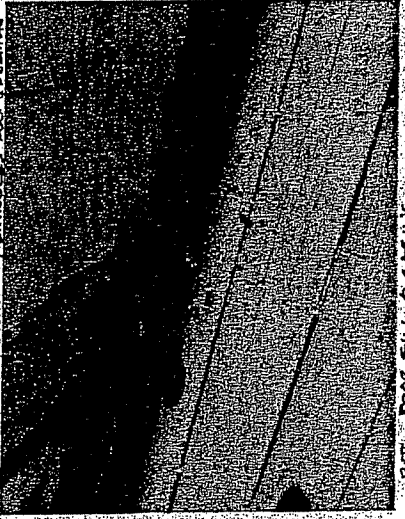
ROOF EDGE SILL & FLASHING

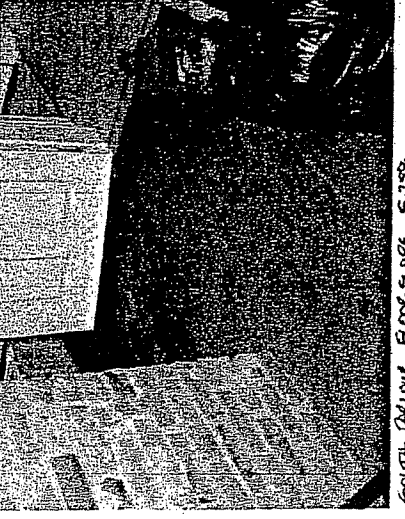
SOUTH FRONT ROOF SLOPE 5/27/8

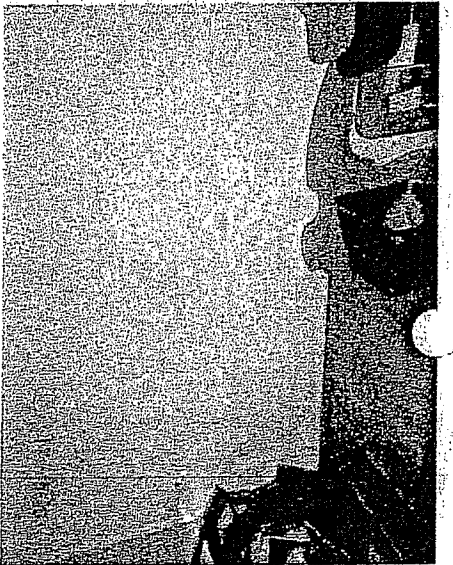
CRACK @ CHIMNEY

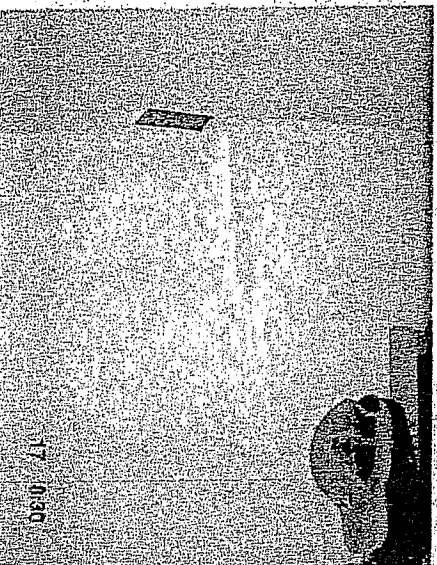
CRACK PLASTER @ CHIMNEY

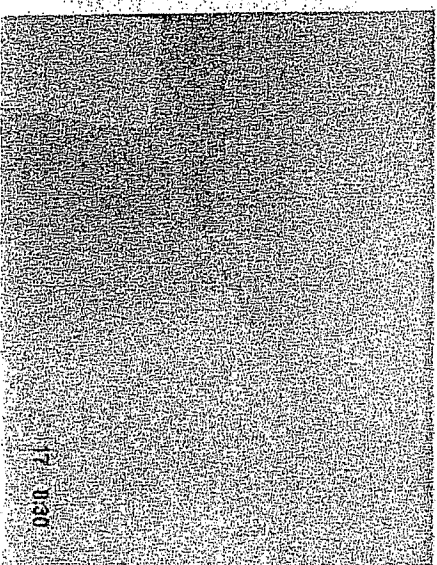
WHITE STAIN CEILING.

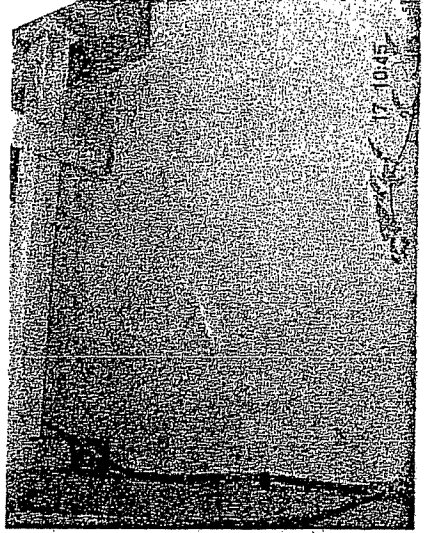
CRACK IN PLASTER - SOUTH WALL

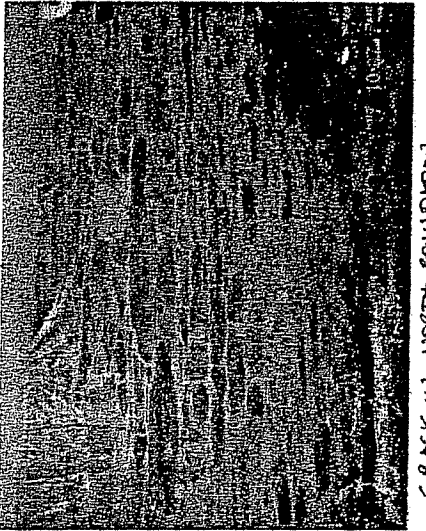
CRACK IN NORTH FOUNDATION

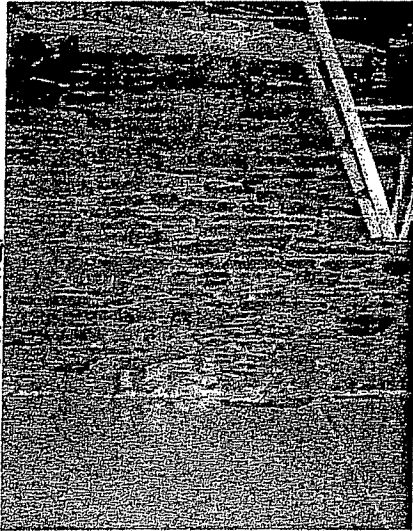
CRACK IN SOUTH FOUNDATION

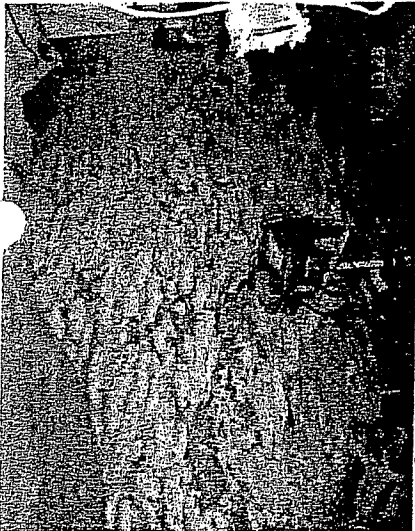
CRACK BOWED WALL

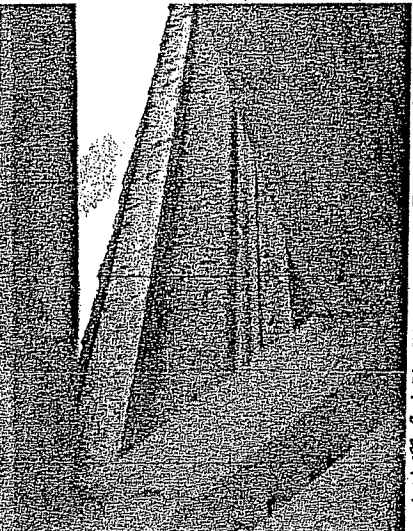
INAPPROPRIATE TRIM - RESULT OF REPAIR

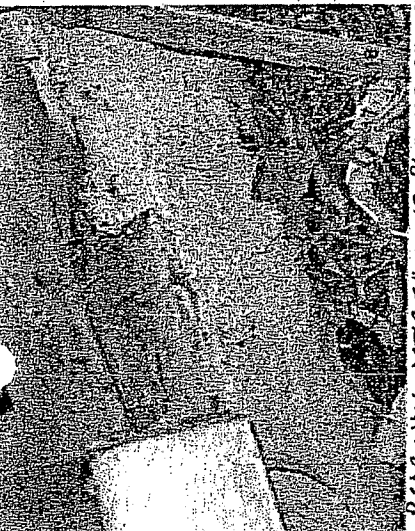
REPAIR WHERE METAL STRIPS BEHIND SILCO
