## Item No. 11.1.5 Halifax Regional Council December 9, 2014

то:	Mayor Savage and Members of Halifax Regional Council
SUBMITTED BY:	Original signed by Richard Butts, Chief Administrative Officer Original Signed by
	Mike Labrecque, Deputy Chief Administrative Officer
DATE:	November 17, 2014
SUBJECT:	Cherry Brook Community Centre

Capital Management Engineering Limited (CMEL) was retained by the Planning and Infrastructure Department of the Halifax Regional Municipality to complete a building condition assessment, and twenty-five year capital plan for the property known as Cherrybrook Community Hall located at 220 Lake Loon Road, Lake Loon, Nova Scotia.

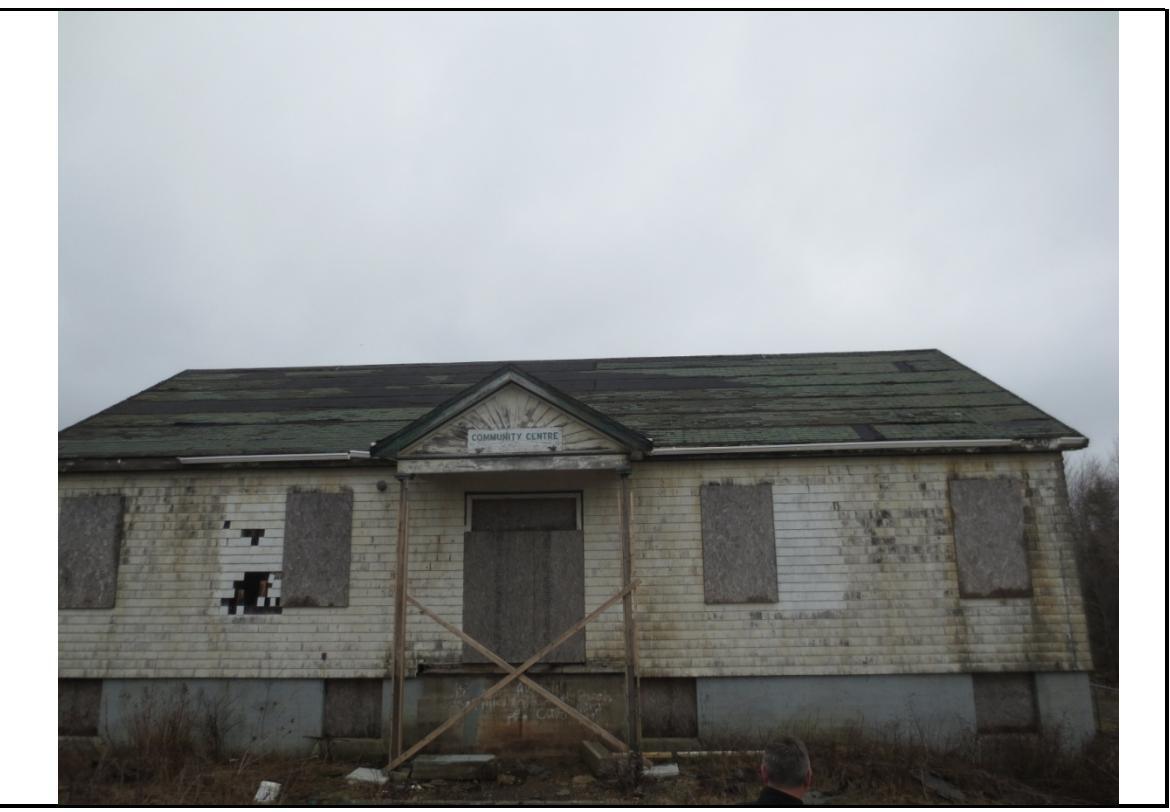
**Photo 1:** Front Elevation.

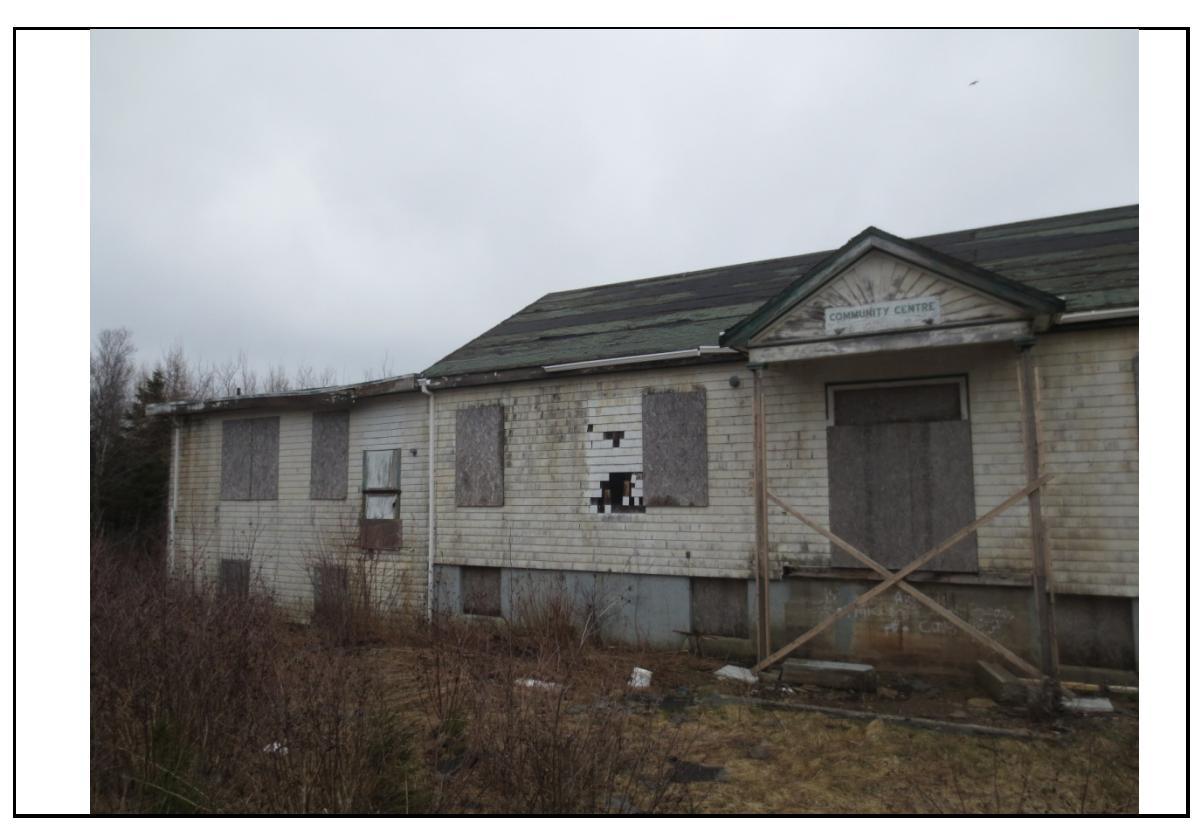
Photo 2: Cedar shingle cladding with significant areas of rotted wood and missing shingles.

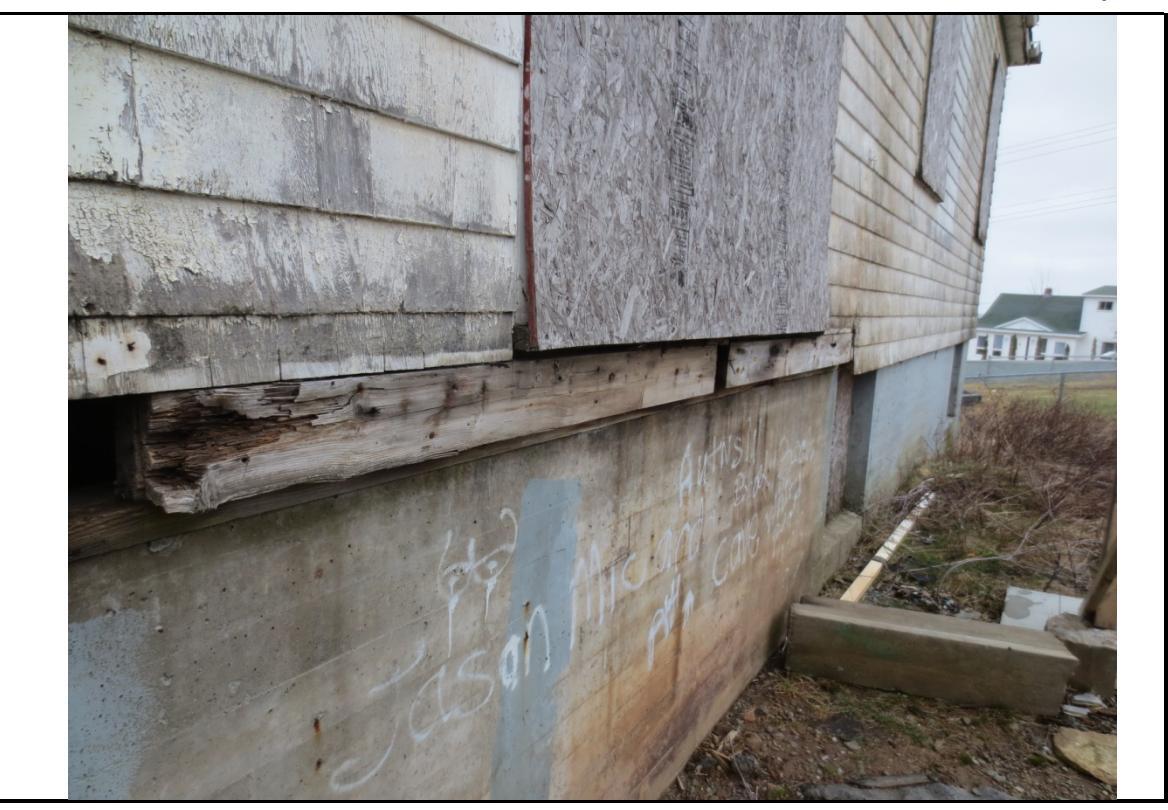
Photo 3: Concrete foundation. No cracks or other visible damage.

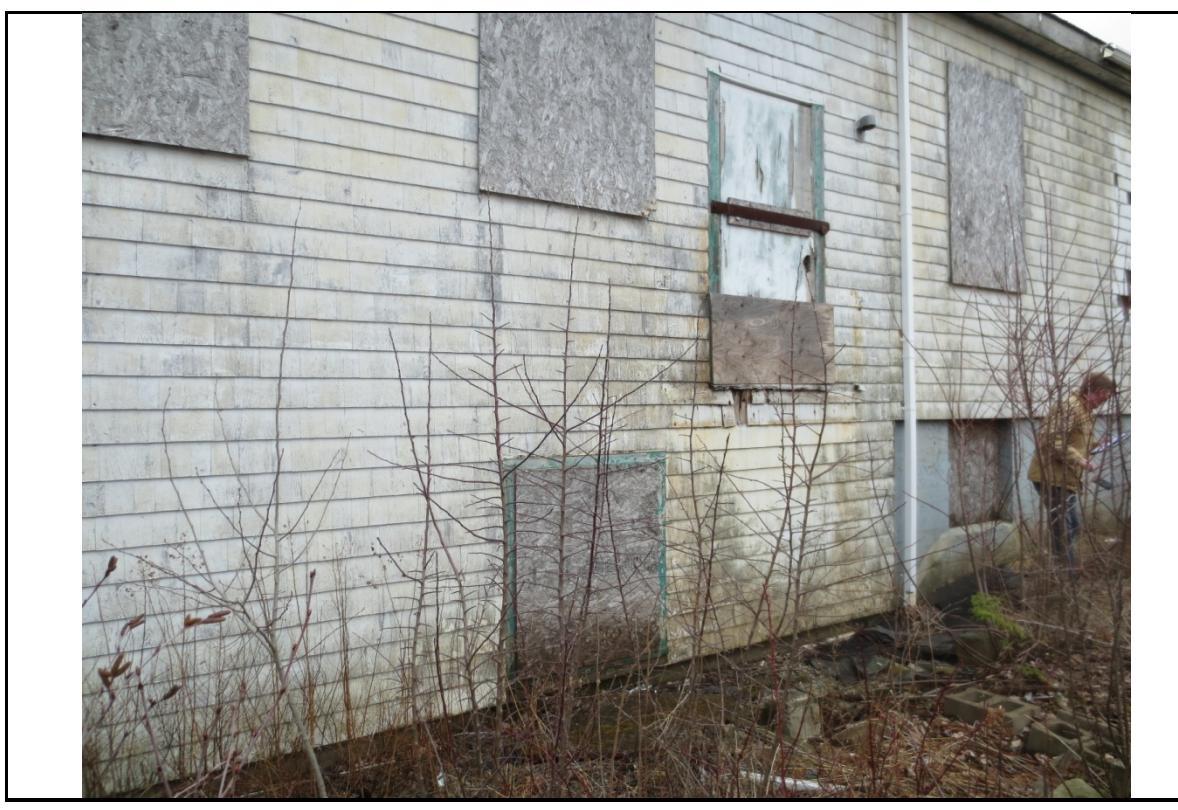
**Photo 4:** Windows and doors covered with plywood sheets. Most glass panes broken or missing. Wood stairs and decks removed from building.

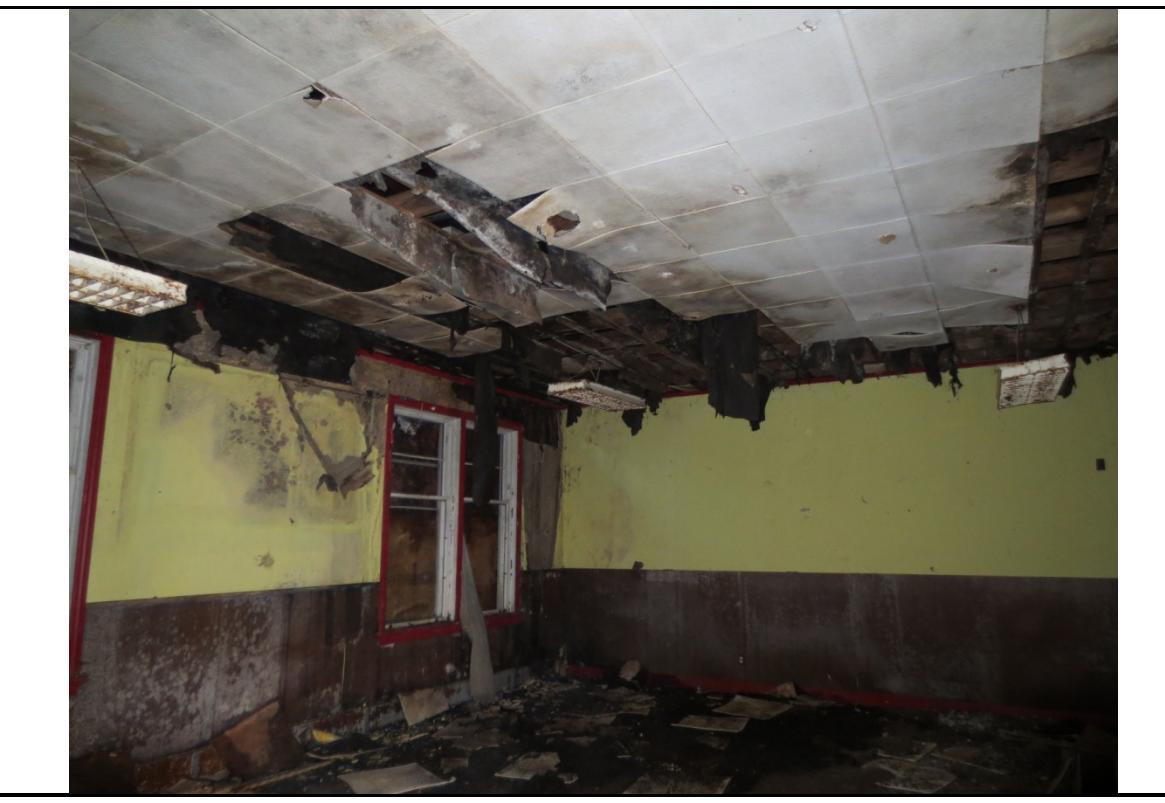
**Photo 5:** Ceiling with significant water and mold damage.

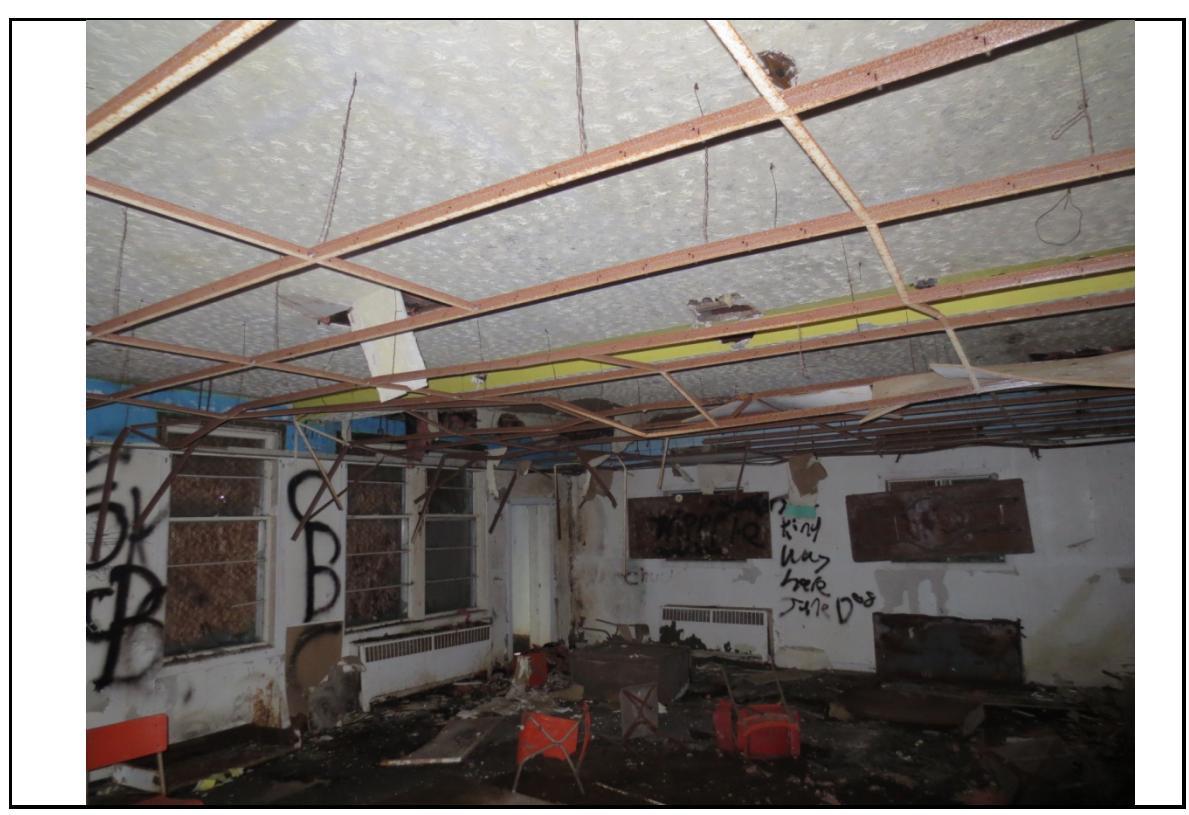
Photo 6: Interior finishes destroyed by water damage, animal inhabitancies, and vandalism.

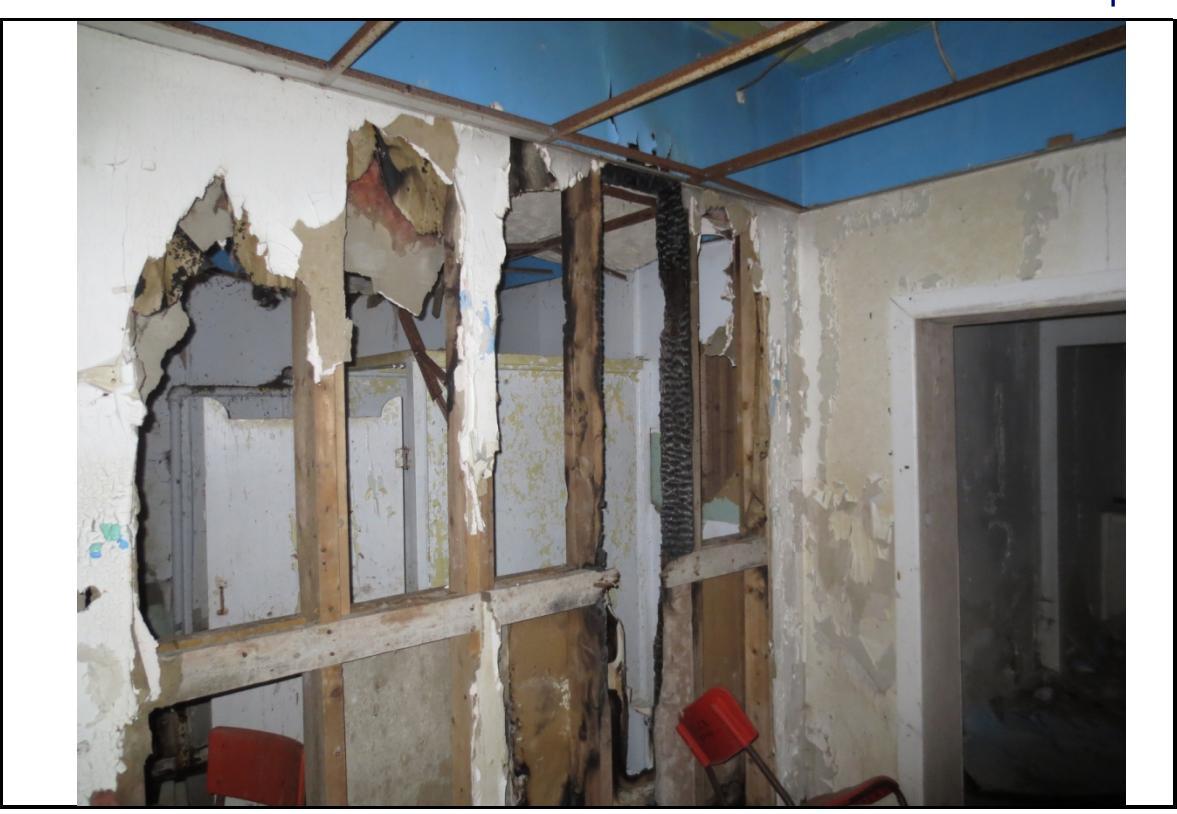
Photo 7: Damaged and missing drywall.

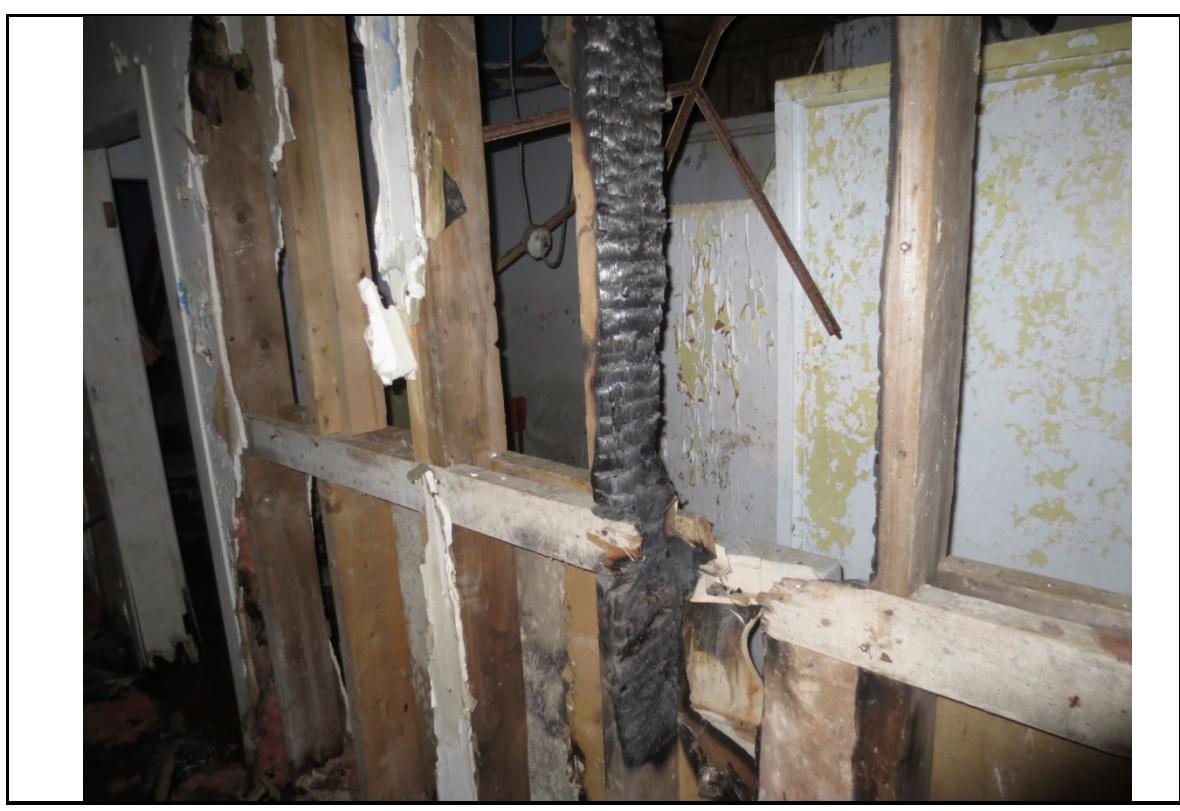
Photo 8: Missing dry wall with burned wooden partition

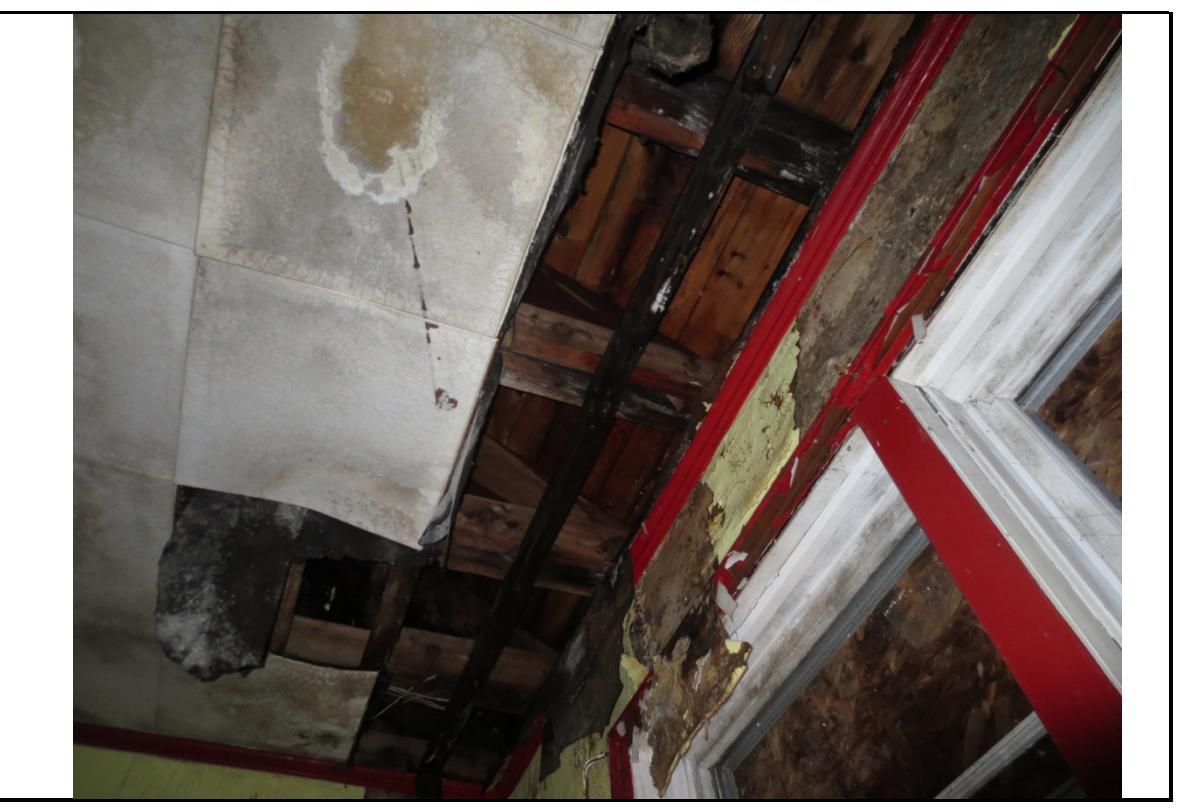
**Photo 9:** Exposed roof deck with significant mold and rot damage.

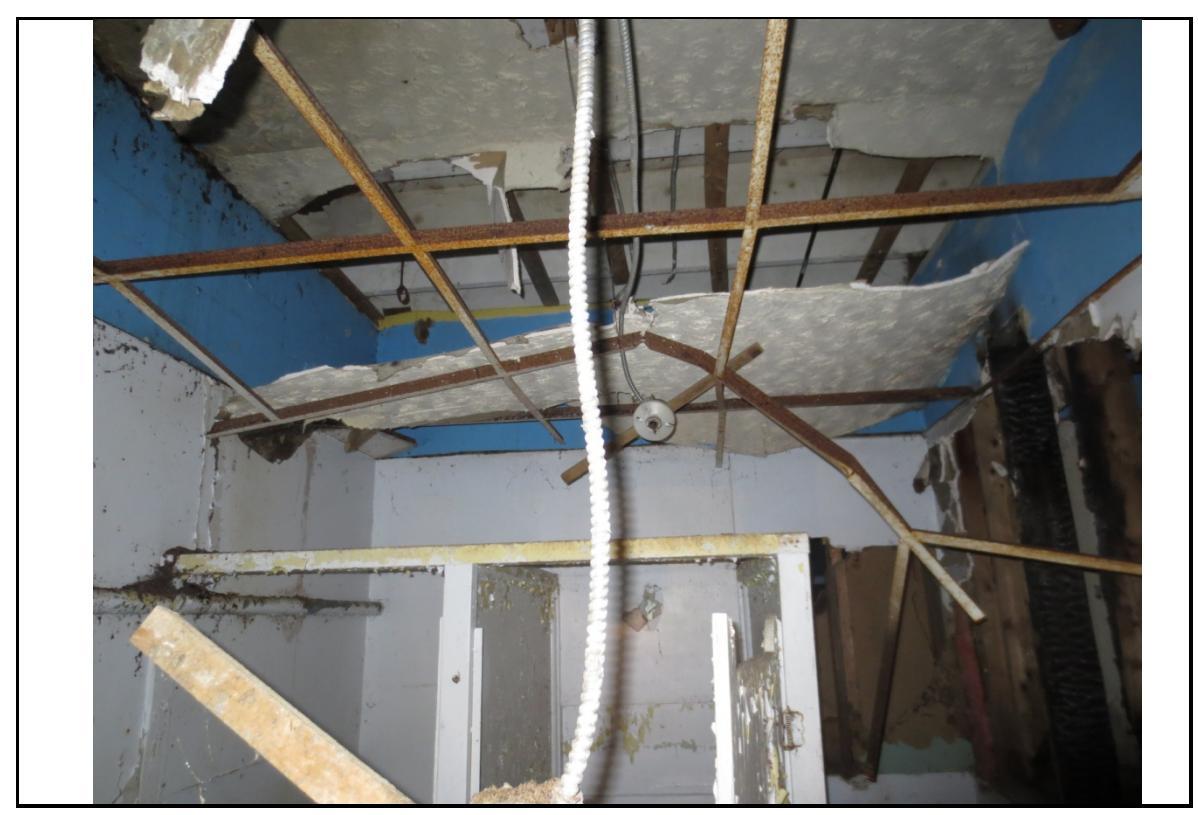
Photo 10: Suspended ceiling broken and detached.

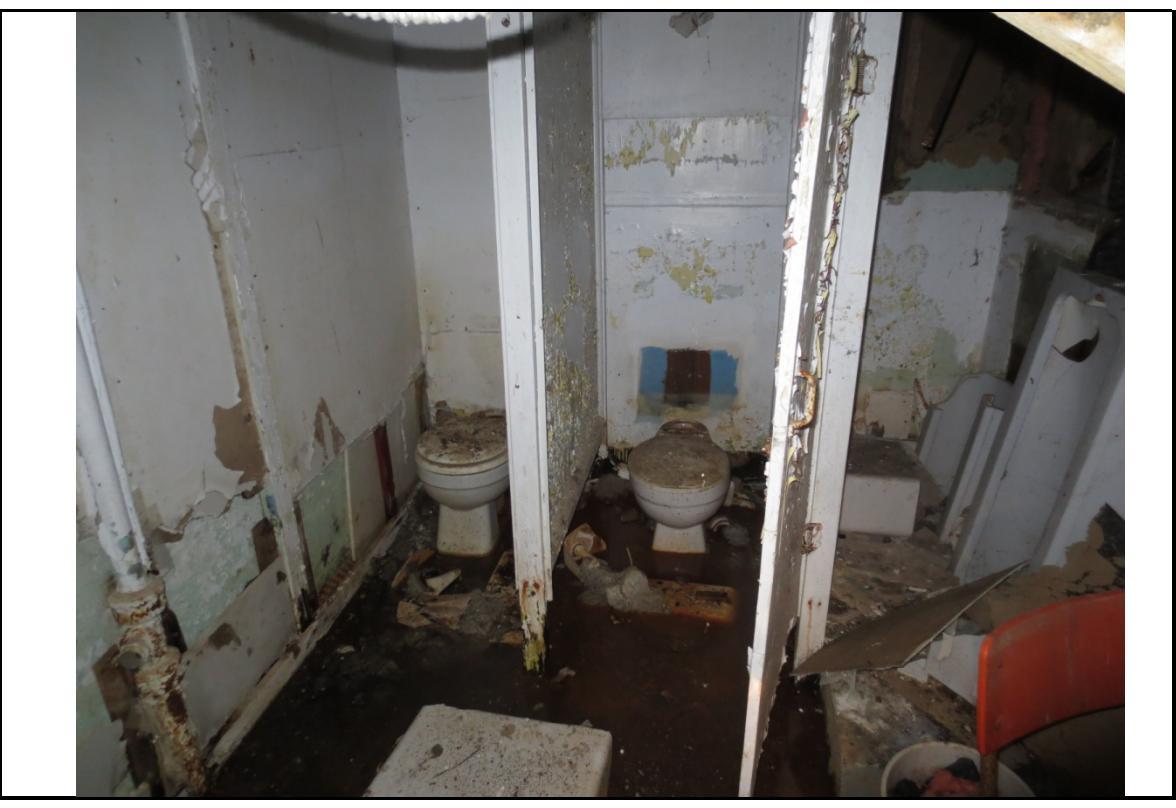
Photo 11: Bathroom stalls with disconnected water closets and urinal.

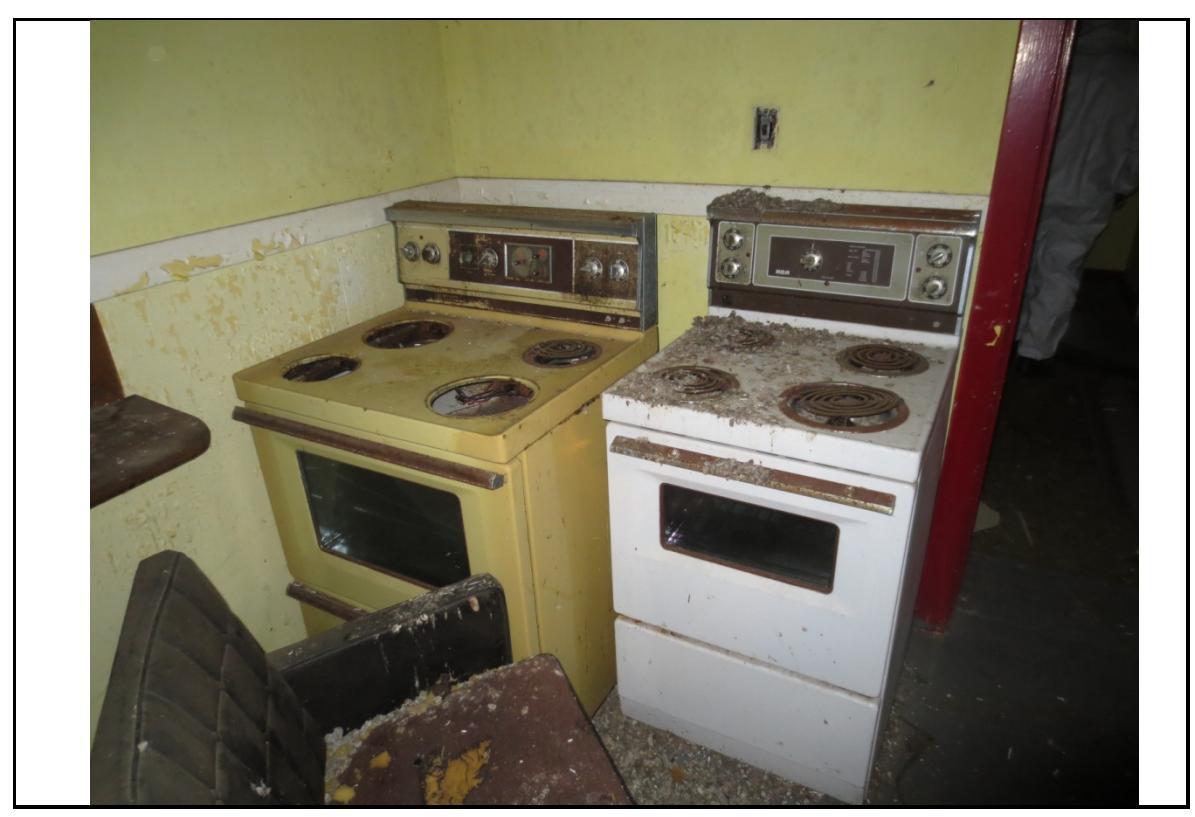
Photo 12: Existing kitchen stoves

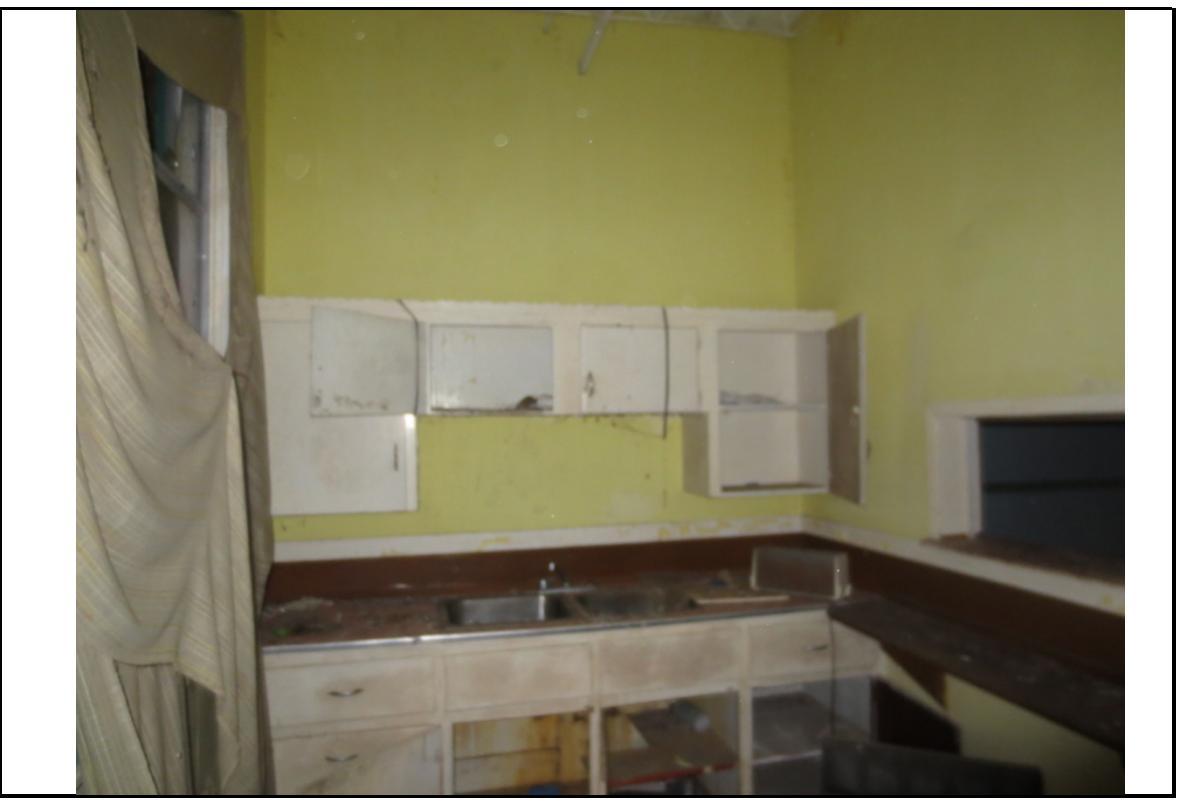
**Photo 13:** Kitchen cupboards including sink in kitchen space.

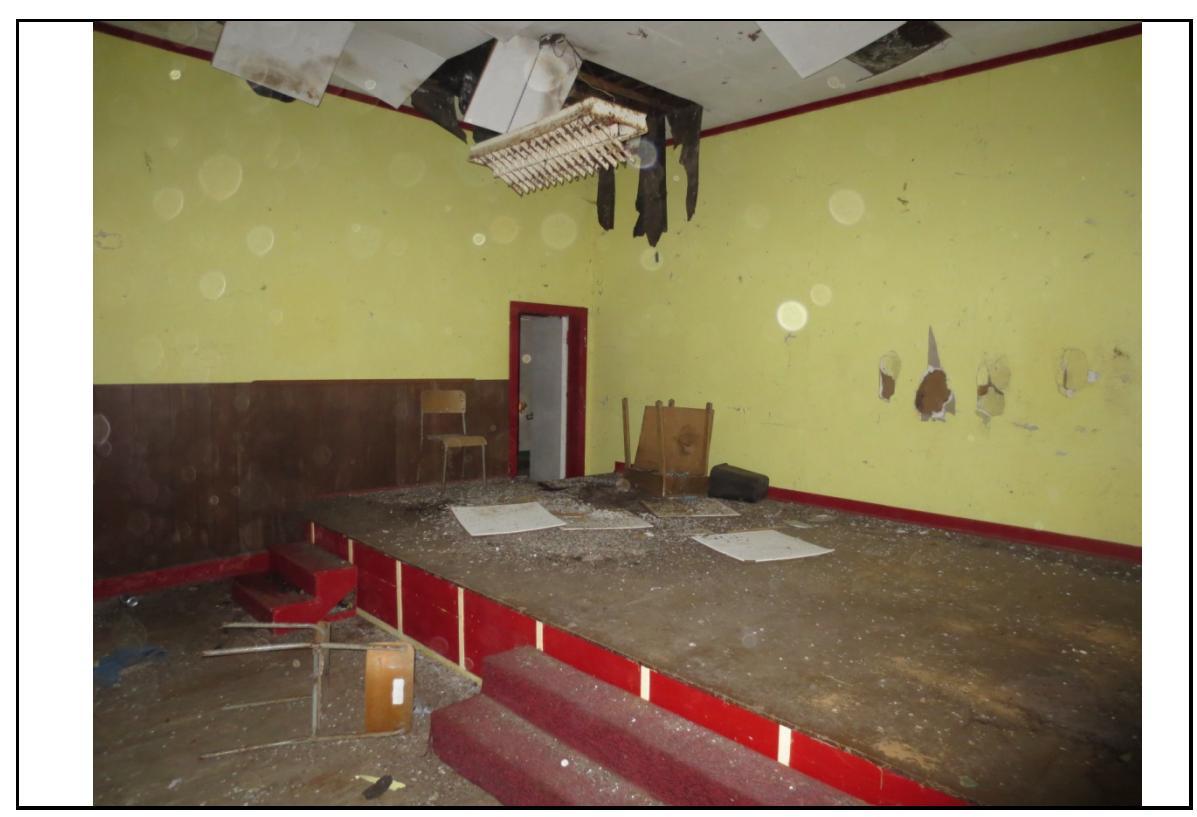
Photo 14: Stage area, visible damage to ceiling and dry wall.

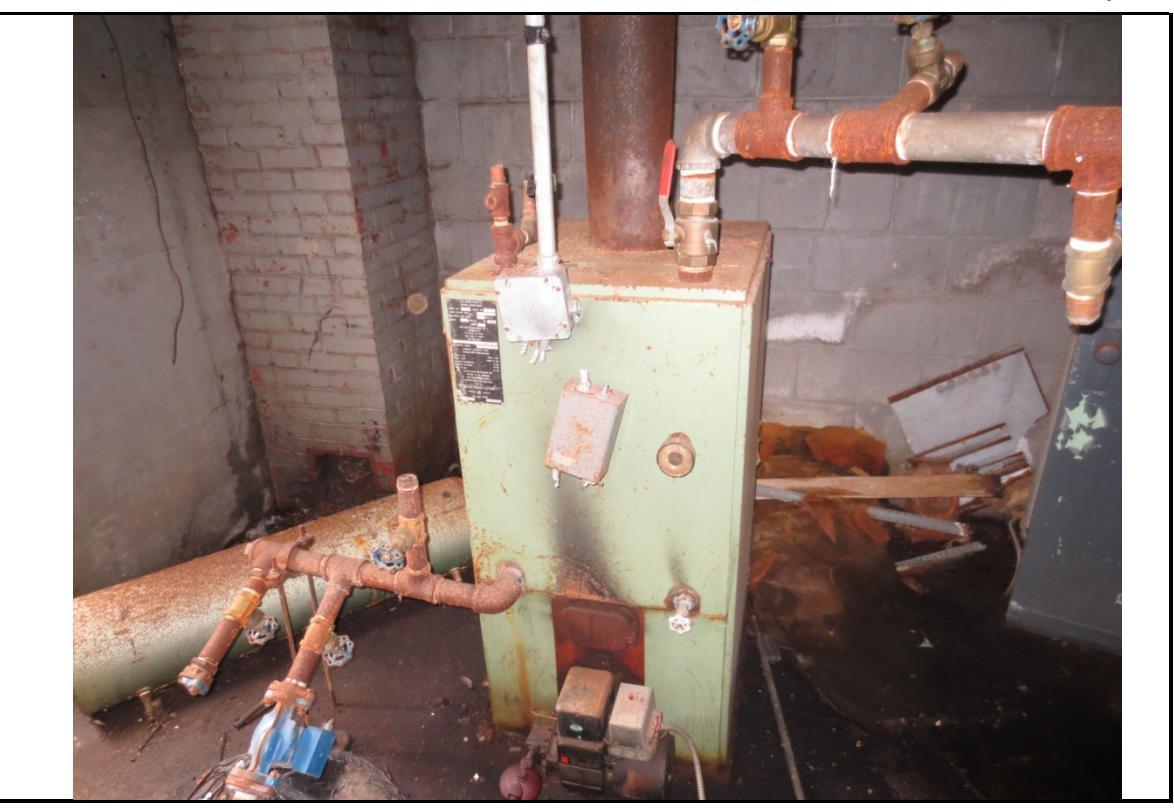
Photo 15: Disconnected Oil Fired Hot Water Boiler

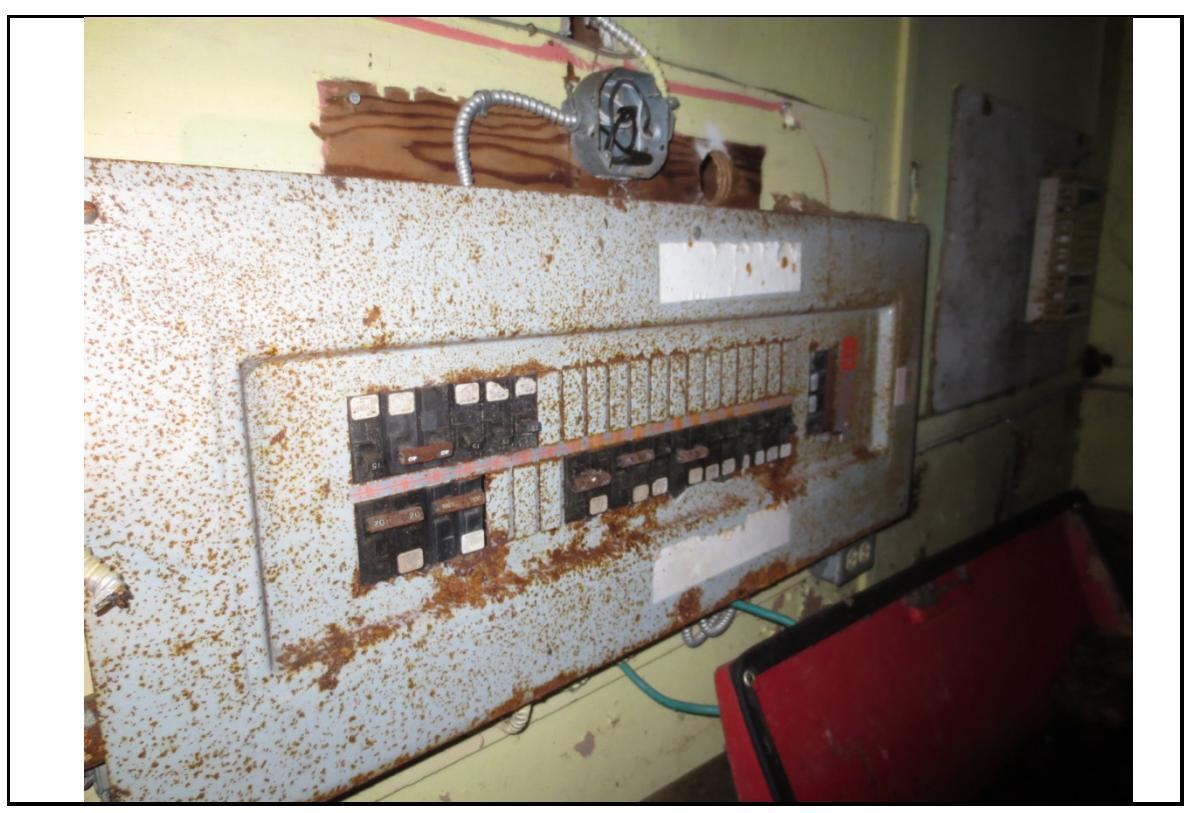
Photo 16: Electrical panel heavy rusting, no longer hooked to power utility.

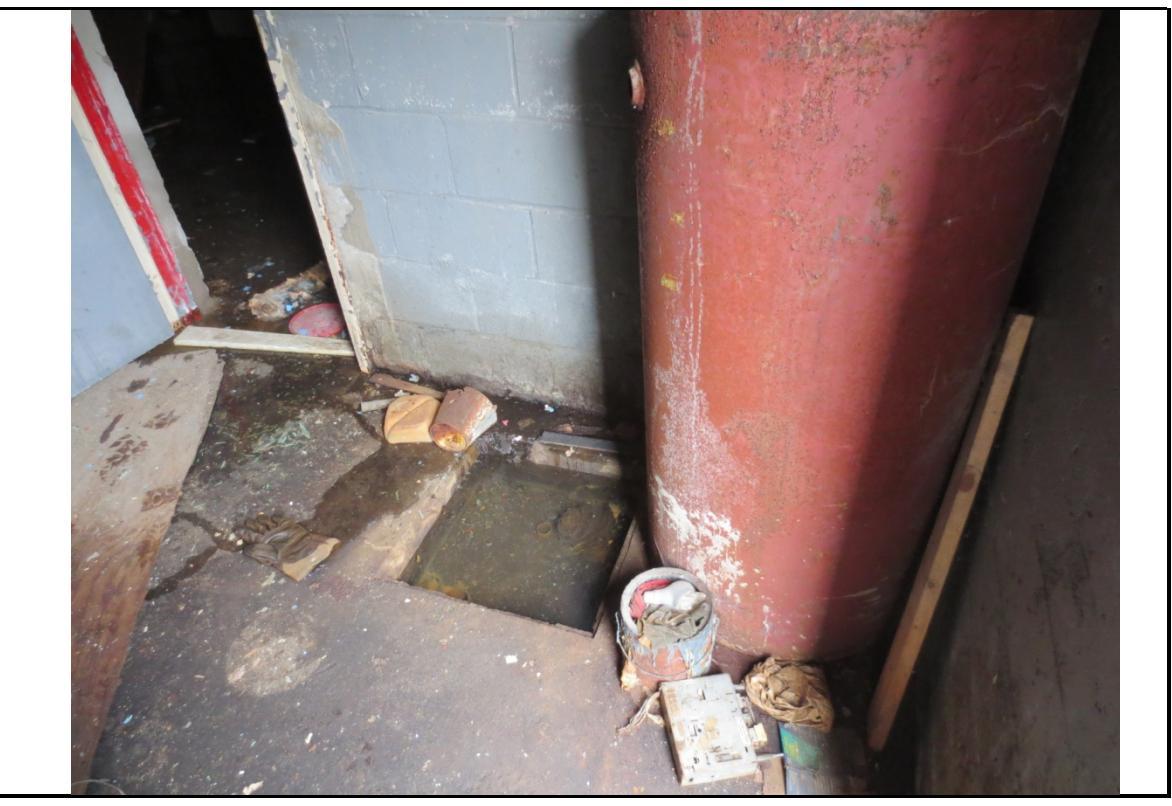
**Photo 17:** Sump and Expansion Tank.

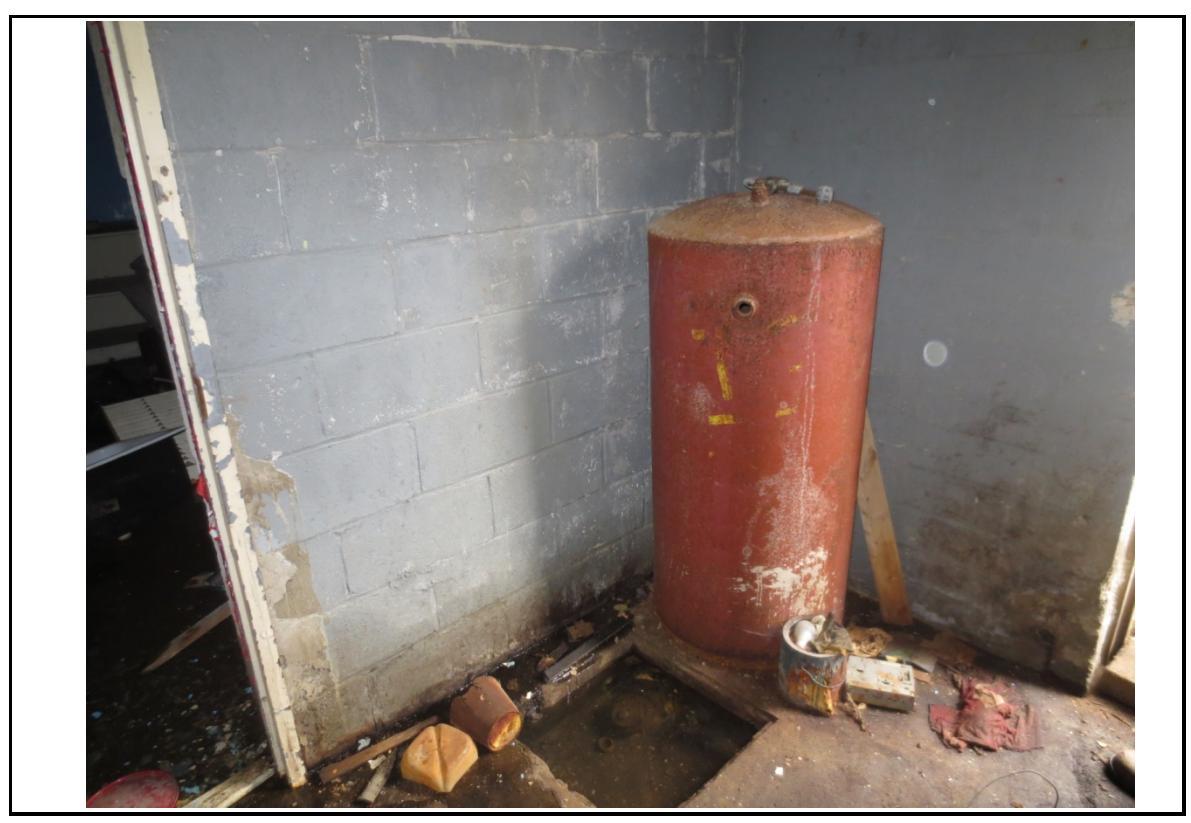
Photo 18: Expansion tank in Boiler room

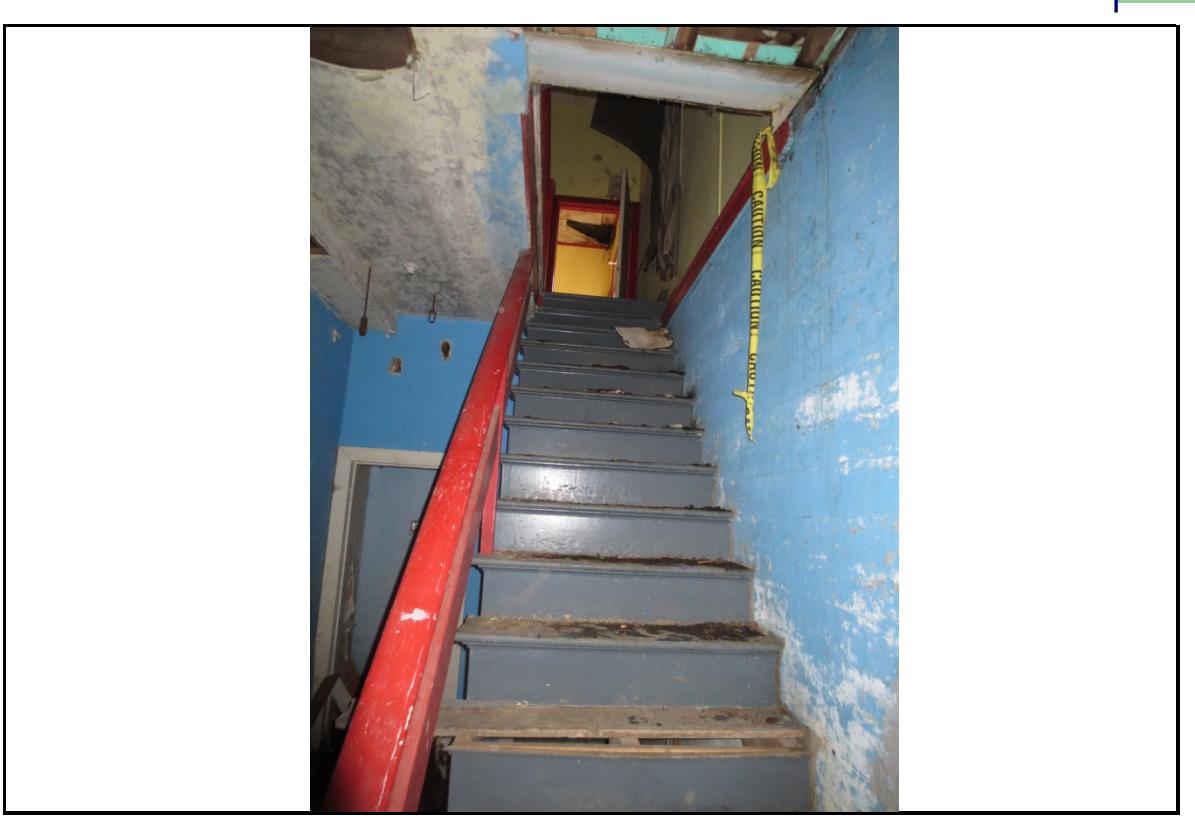
Photo 19: Interior staircase to basement missing treads.

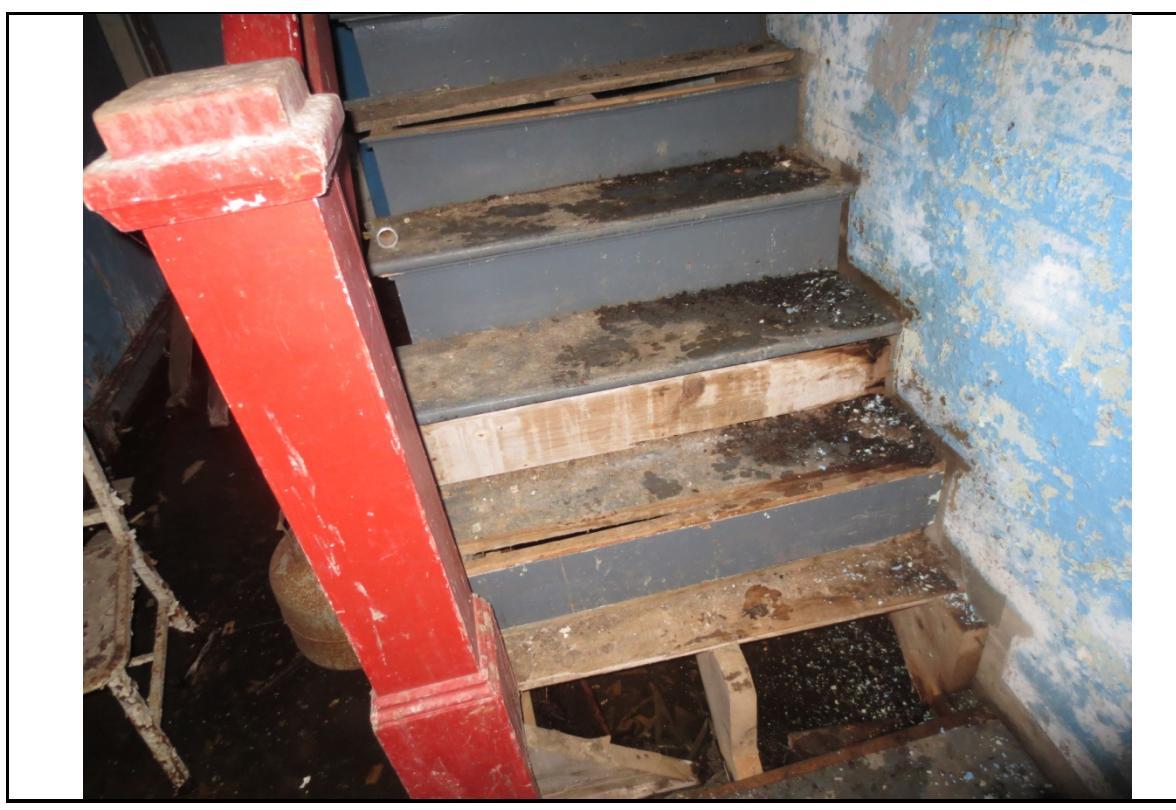
Photo 20: Missing treads on Stairs

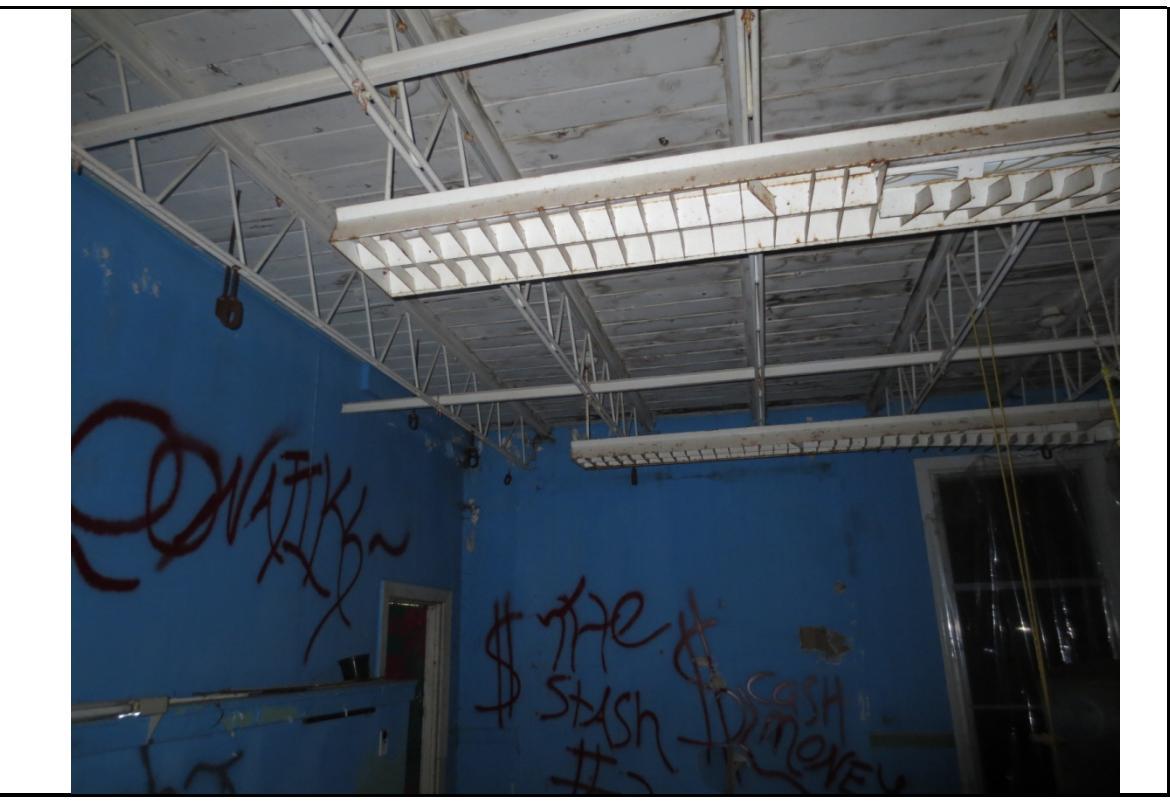
Photo 21: Main floor OWSJ in addition

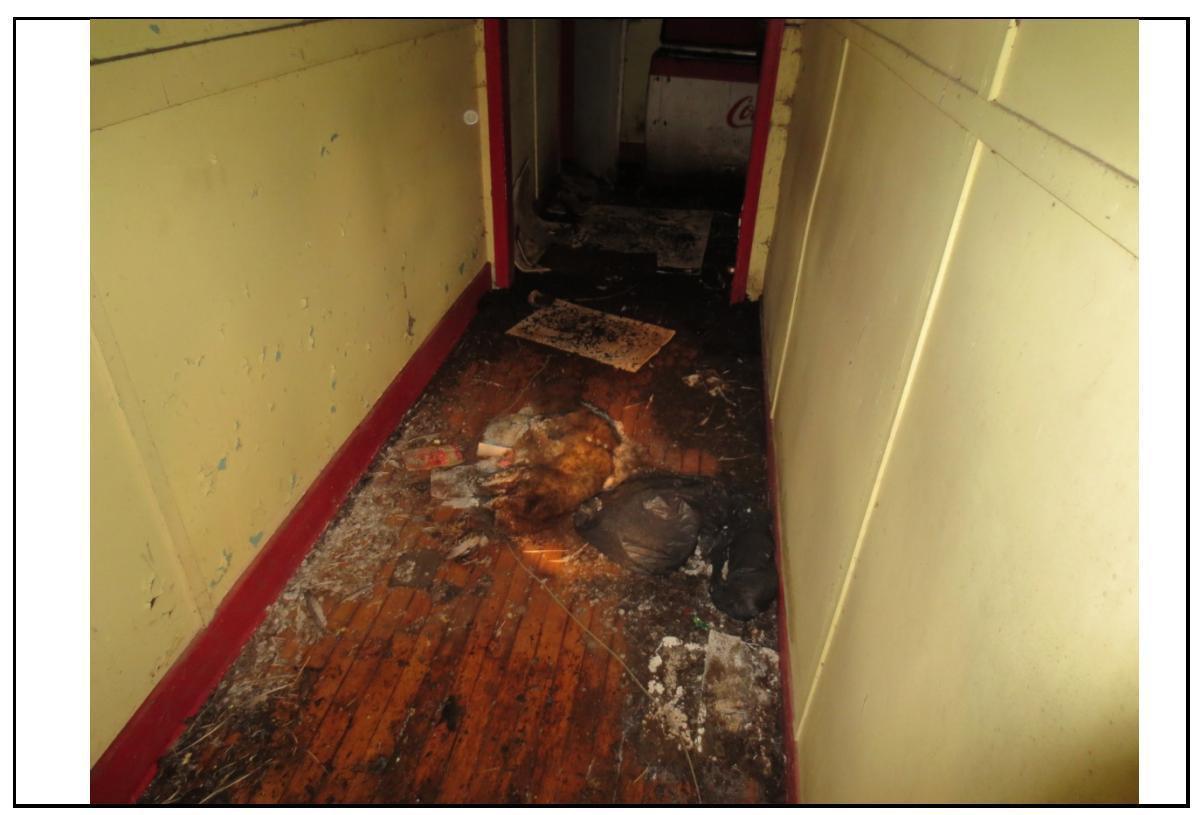
Photo 22: Animal carcass and feces.

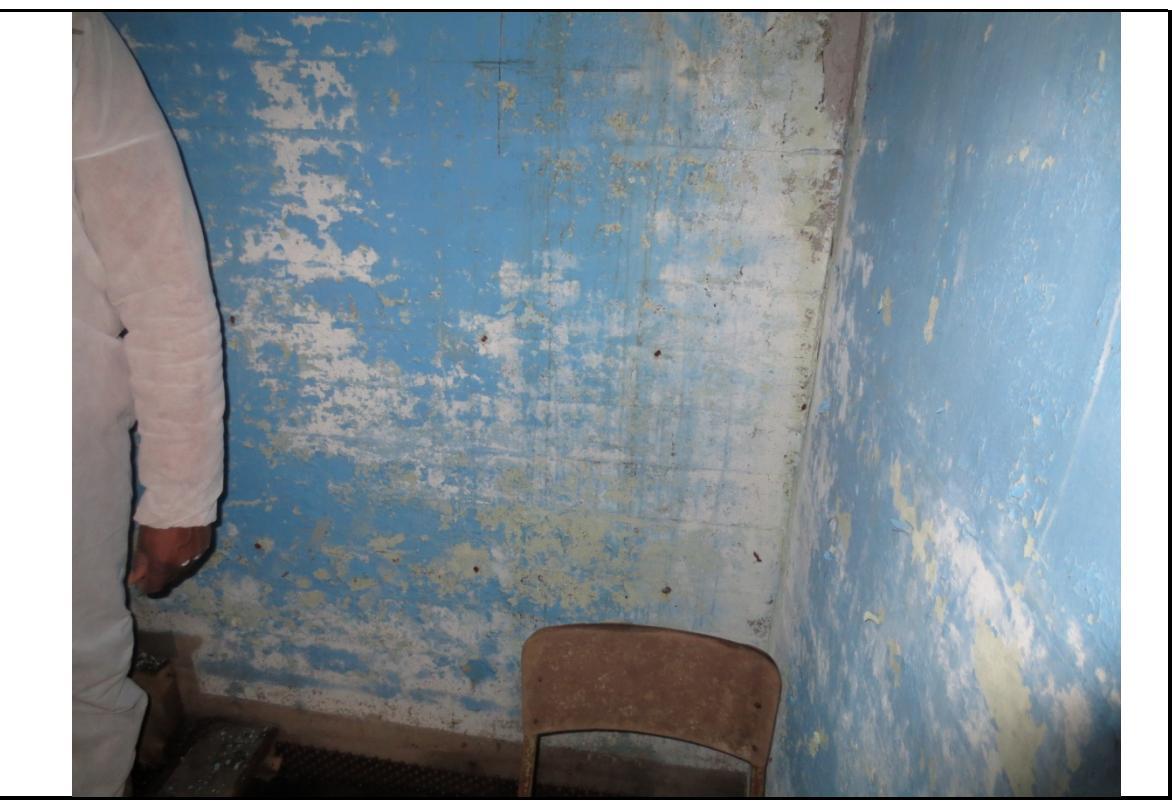
Photo 23: Concrete walls in basement.
