## Item No. 11.1.5 Halifax Regional Council December 9, 2014

то:	Mayor Savage and Members of Halifax Regional Council
SUBMITTED BY:	Original signed by Richard Butts, Chief Administrative Officer Original Signed by
	Mike Labrecque, Deputy Chief Administrative Officer
DATE:	November 17, 2014
SUBJECT:	Cherry Brook Community Centre

Capital Management Engineering Limited (CMEL) was retained by the Planning and Infrastructure Department of the Halifax Regional Municipality to complete a building condition assessment, and twenty-five year capital plan for the property known as Cherrybrook Community Hall located at 220 Lake Loon Road, Lake Loon, Nova Scotia.

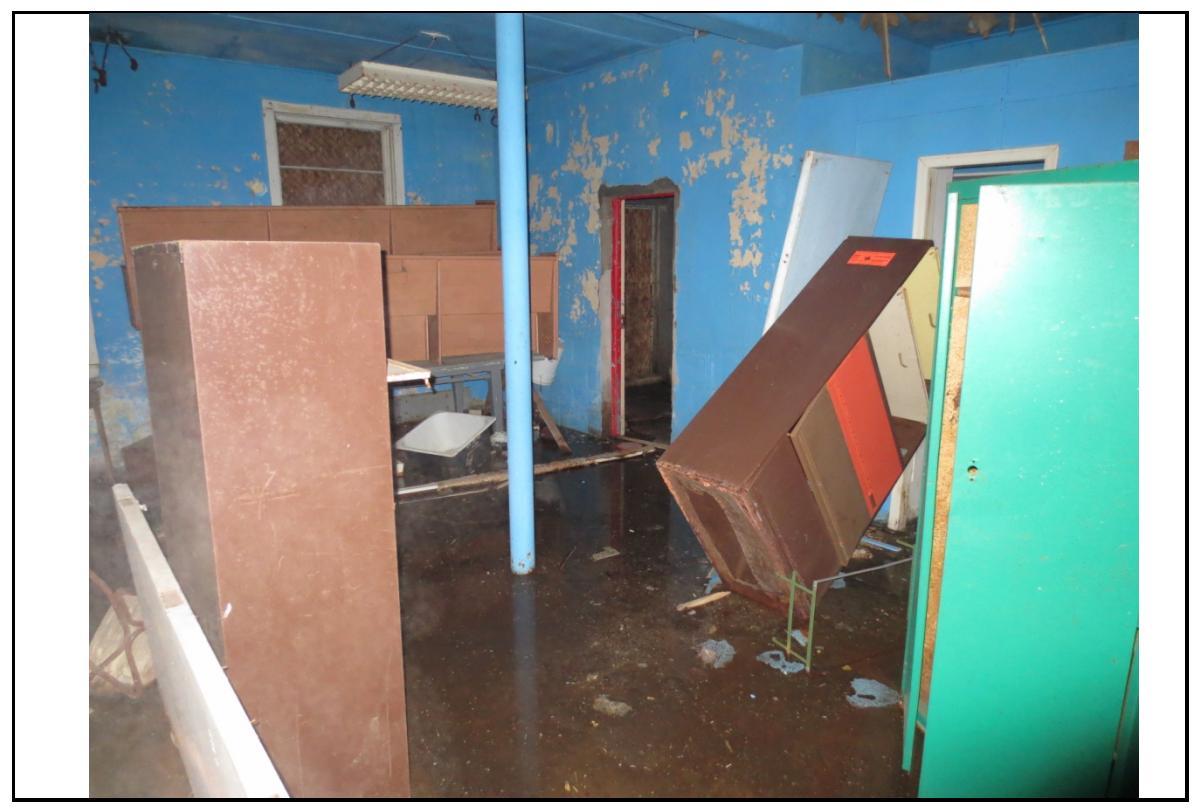
Photo 24: Standing water in basement

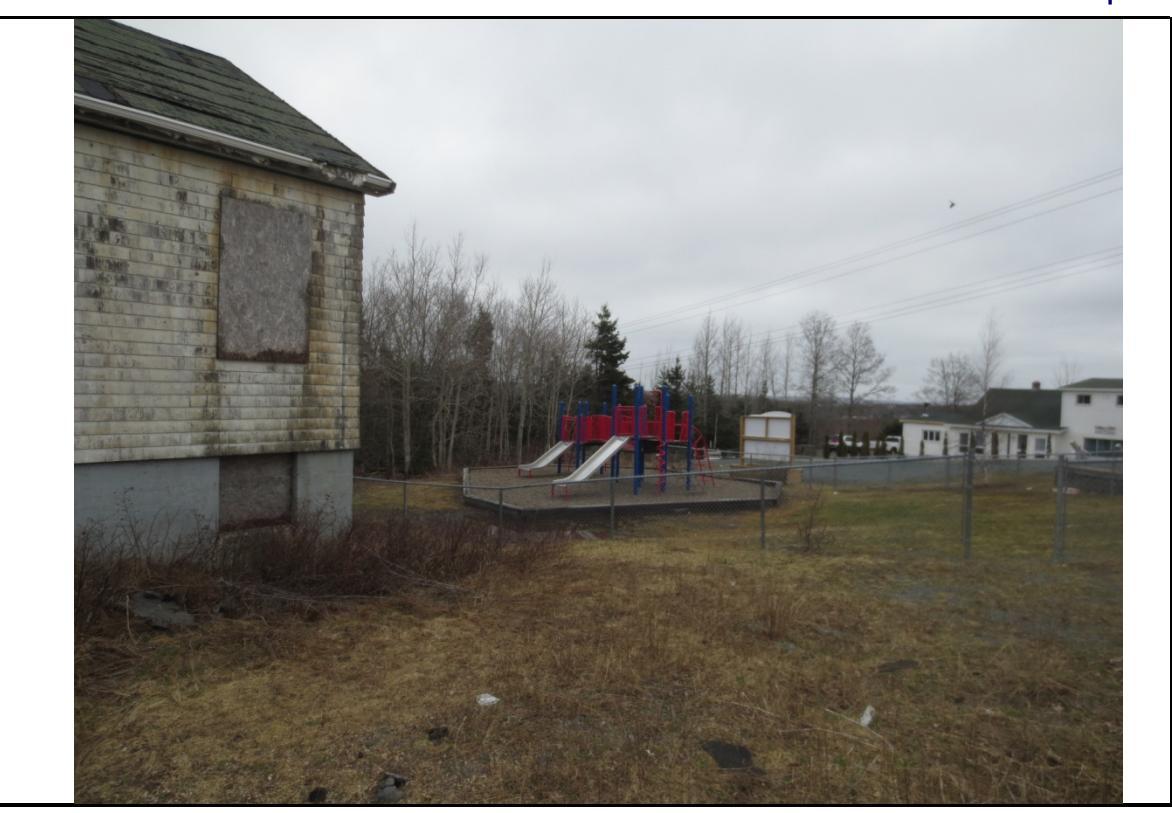
In addition to safety concerns related to the building structure, there are additional concerns related to its close proximity to a playground structure. With the playground structure adjacent to the vacant building, there is increased risk that young children could access the building. While the building has been boarded and is not accessible, HRM has received calls related to the boards being removed and people in the building. As a result, the building currently poses significant risk to the community and increased liability for HRM.

Photo 25: Playground adjacent to site.

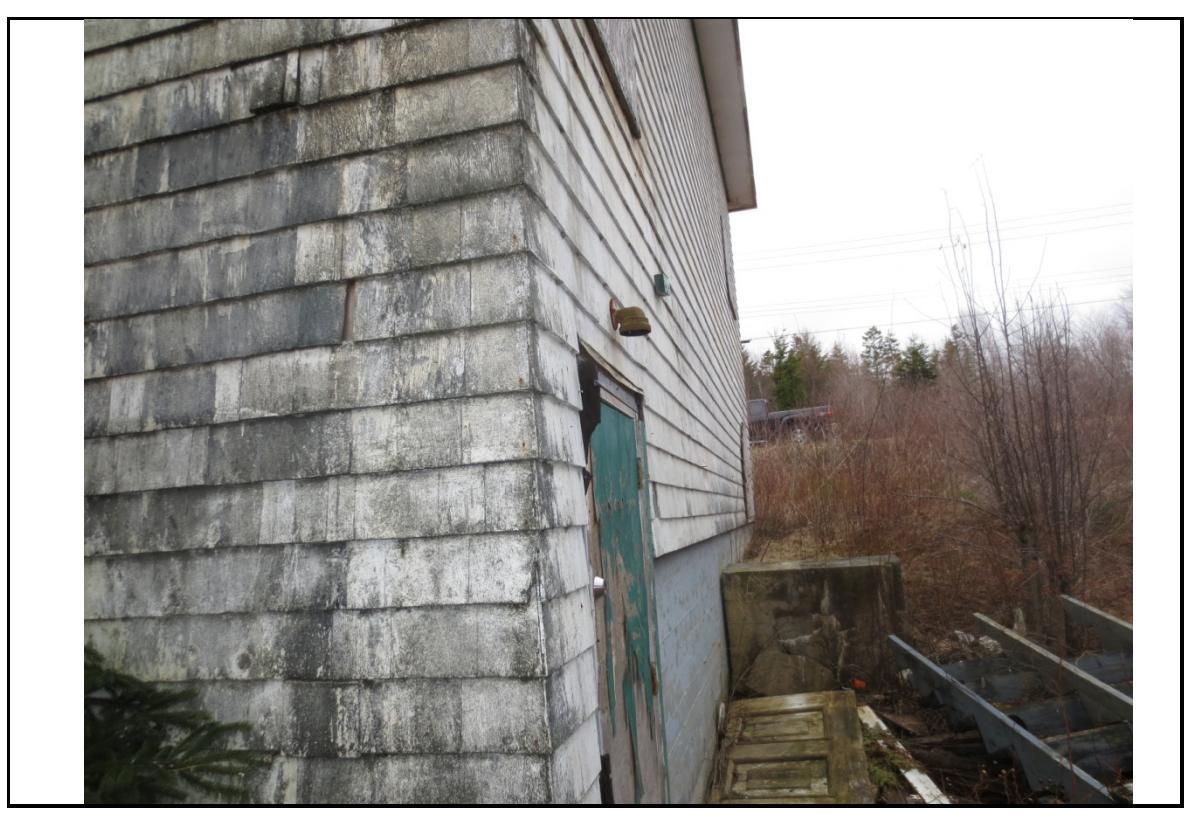
Photo 26: Exterior wall with door leading to basement.

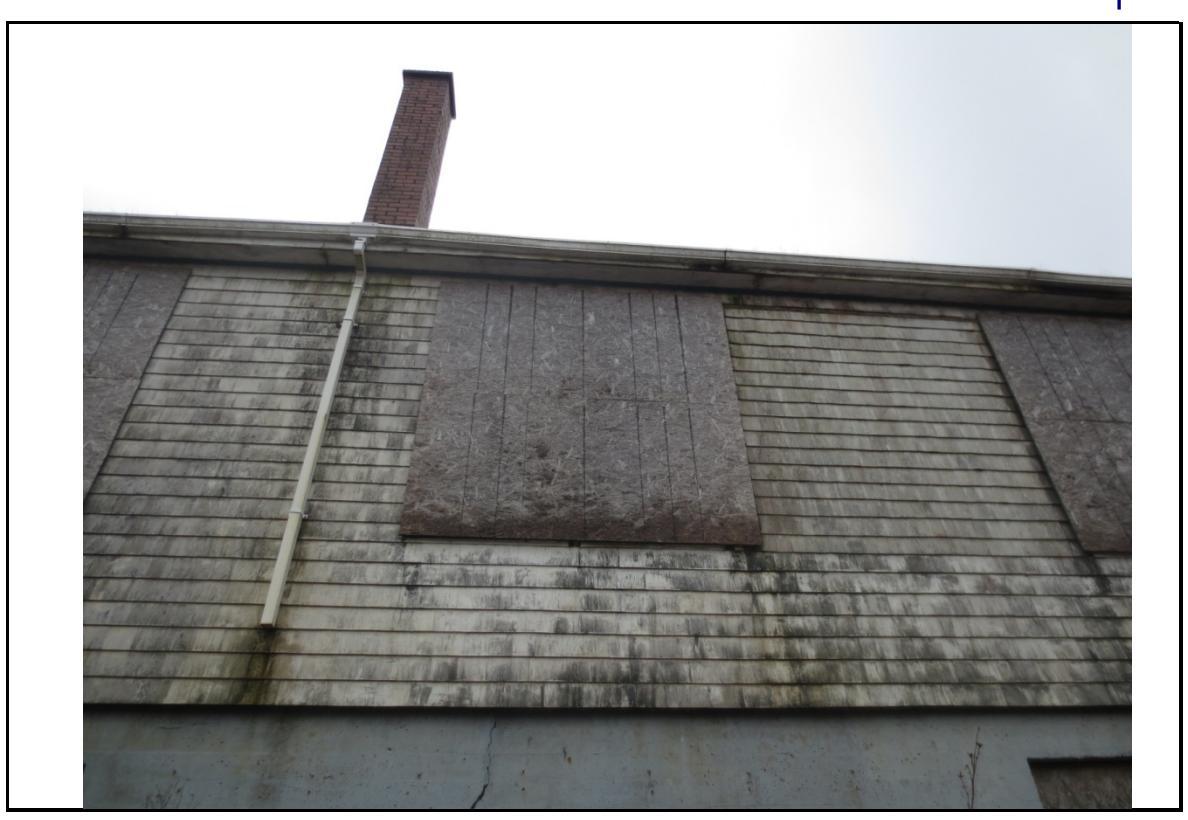
Photo 27: Eavestroughs and downspouts with pieces missing.

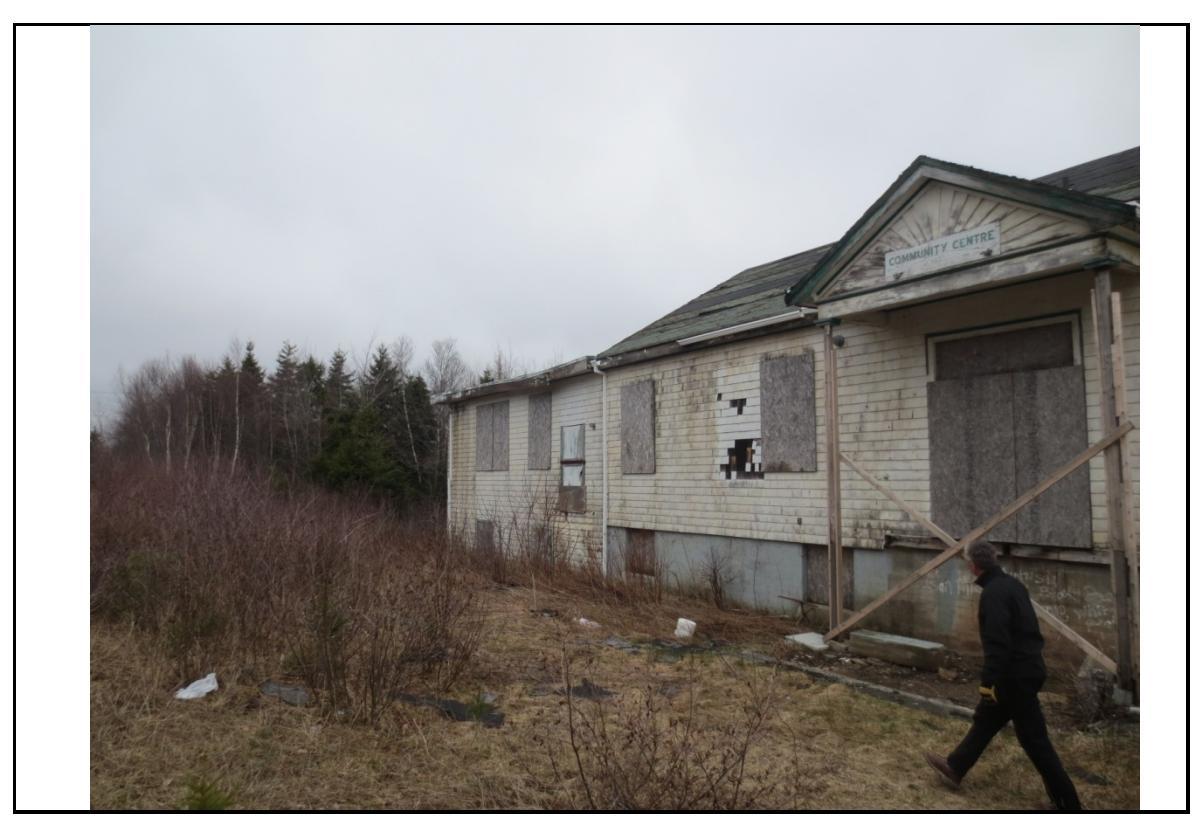
Photo 28: Overgrown landscape.
