P.O. Box 1749
Halifax, Nova Scotia
B3J 3A5 Canada

Halifax Regional Council
February 7, 2006

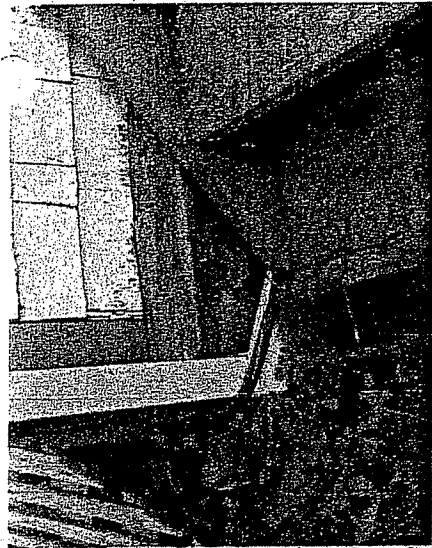
ORIGINAL WOOD TABLE - TIGHT

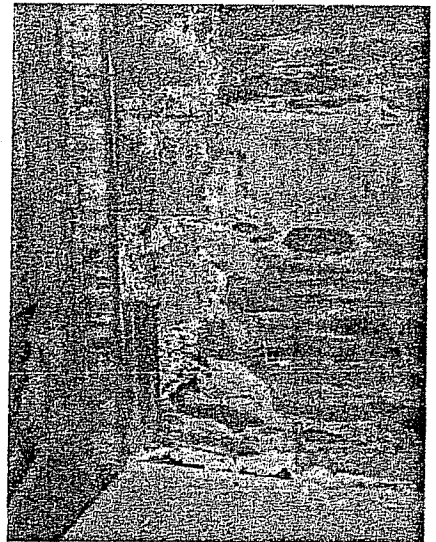
SOUTH WALL FOUNDATION - FRONT WALL

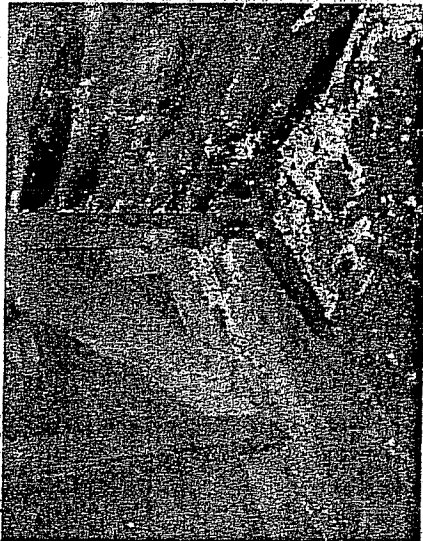
SILL AT WEST FOUNDATION

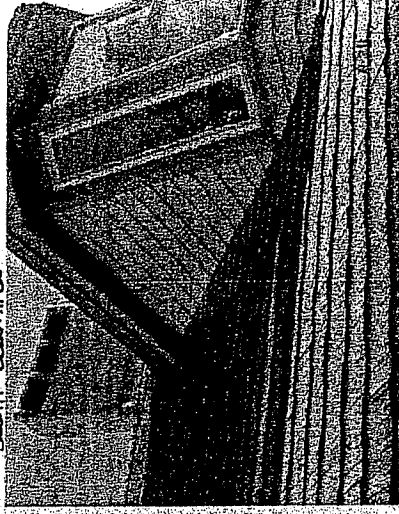
CHIMNEY DETERIORATION

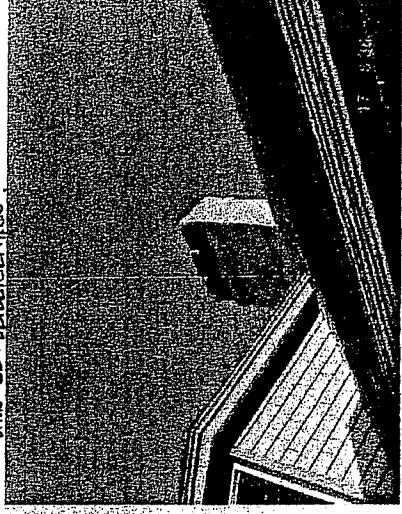
CHIMNEY FLASHING - POOR W/C

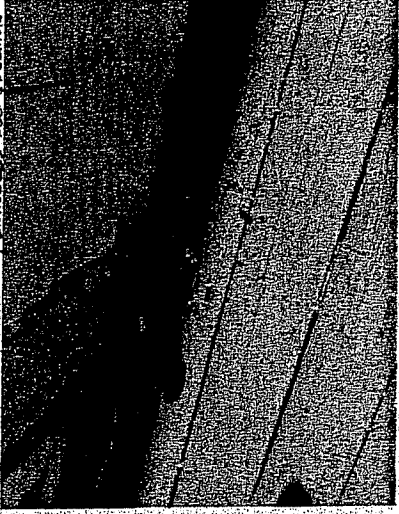
ROT, DECAY, MISSING SHINGLES

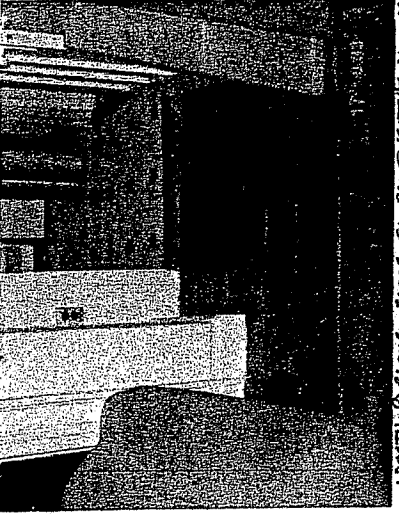
MOLD IN BELOW FLOOR SINK @ KITCHEN 4/82

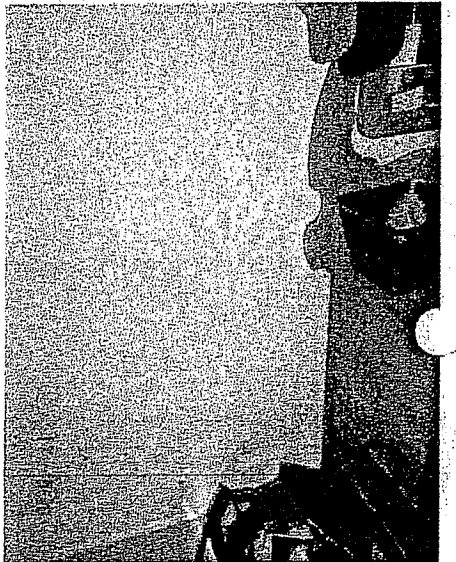
ATTIC EXHIBIT - CHIMNEY

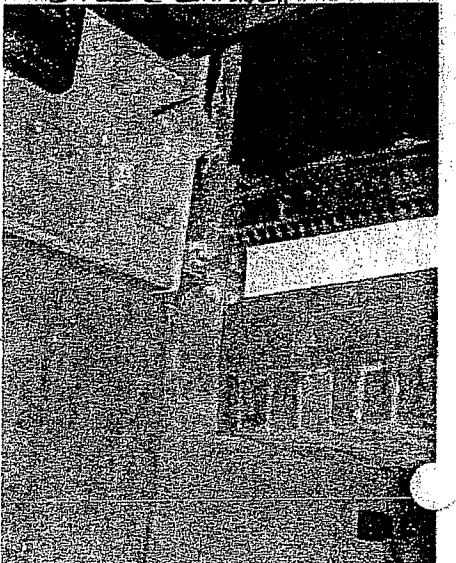
CHIMNEY / FIBERGLASS HANGING MID. MOUNTAIN.

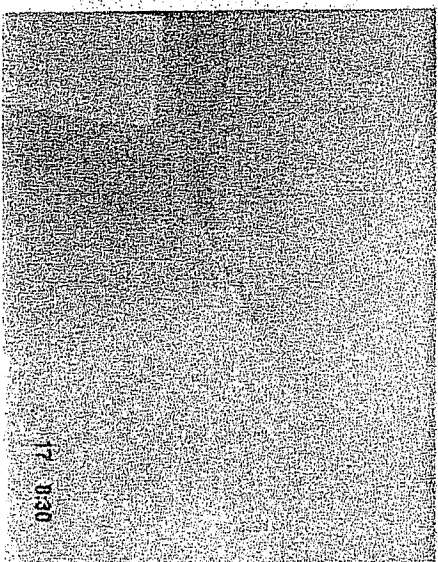
WATER STAIN CEILING.

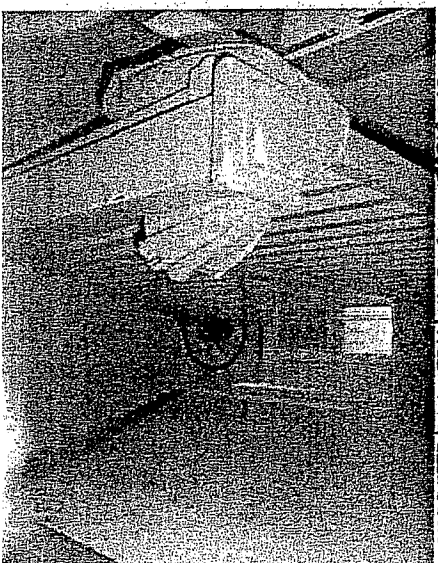
WOOD STOVE - SOUTH PINELAKE. ROOF SAVED UP

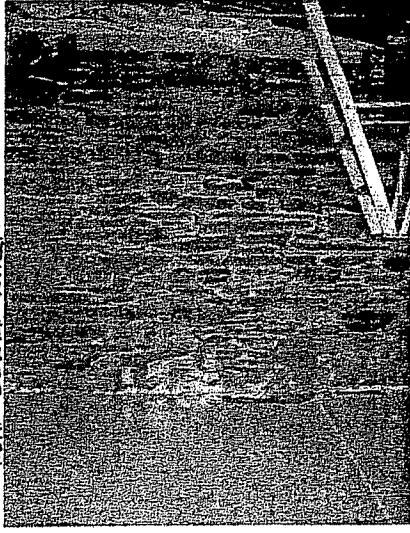
CRACK IN SOUTH RAFTERS

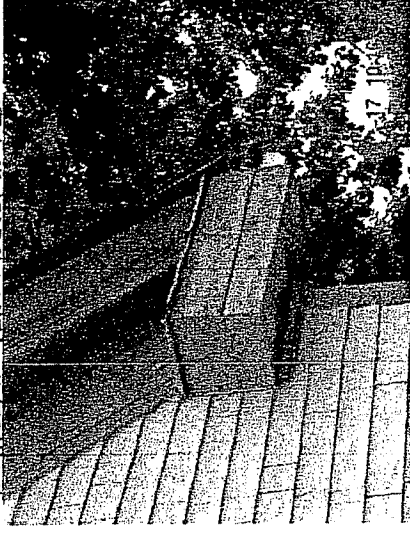
ORIGINAL CABLE DETAIL / TRIM

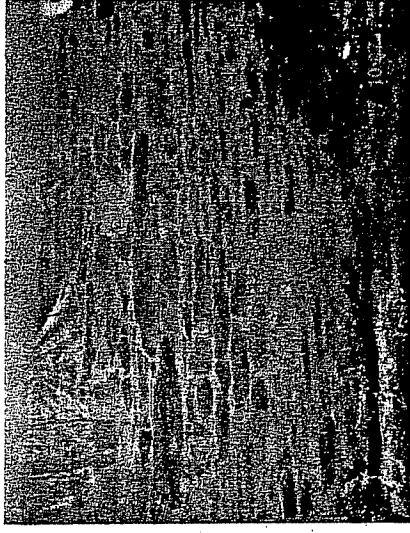
CRACK IN NORTH FOUND BRACKET

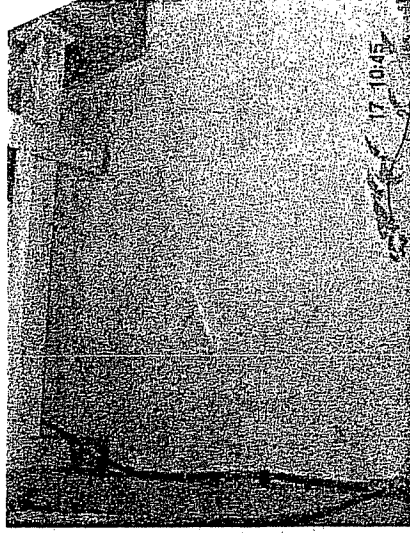
CRACK IN RAFTERS - SOUTH WALK
