**Item No. 1**  
**Halifax and West Community Council**  
**March 25, 2014**

**SUBJECT:** **Effectiveness of the Armdale Rotary-to-Roundabout Conversion**

**INFORMATION REPORT**

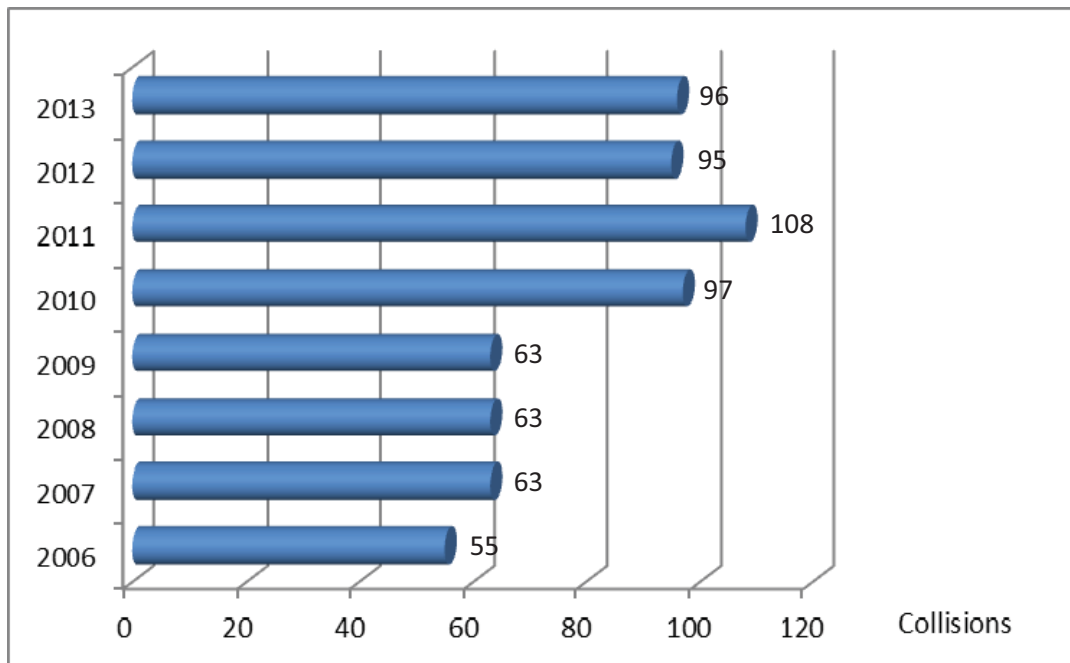
***Figure 1 - Collisions by Year – Armdale Roundabout:***

The graph shows a distinct increase in collisions from 2009 to 2010, which does not appear to be returning to pre-2010 levels. It is difficult to attribute that increase to any regulatory or physical changes to the roundabout since those occurred in 2005 and 2007 respectively. Of the 640 collisions reported during this time frame, only two (2) were indicated as involving a pedestrian and six (6) involving a bicycle. Staff has reviewed the data extensively and mapped collisions by type and location but have not found any commonality that would explain this increase.

To explore this issue further, an expert in roundabouts has been retained to conduct a safety audit and to recommend measures to improve overall safety.
