Item No. 9.1.3
Audit & Finance Standing Committee
October 15, 2014

SUBJECT: Project No. CB000043 - Hubbards Recreation Centre

**RE: STRUCTURAL ASSESMENT
9856 ST. MARGARET'S BAY ROAD, HUBBARDS NOVA SCOTIA**

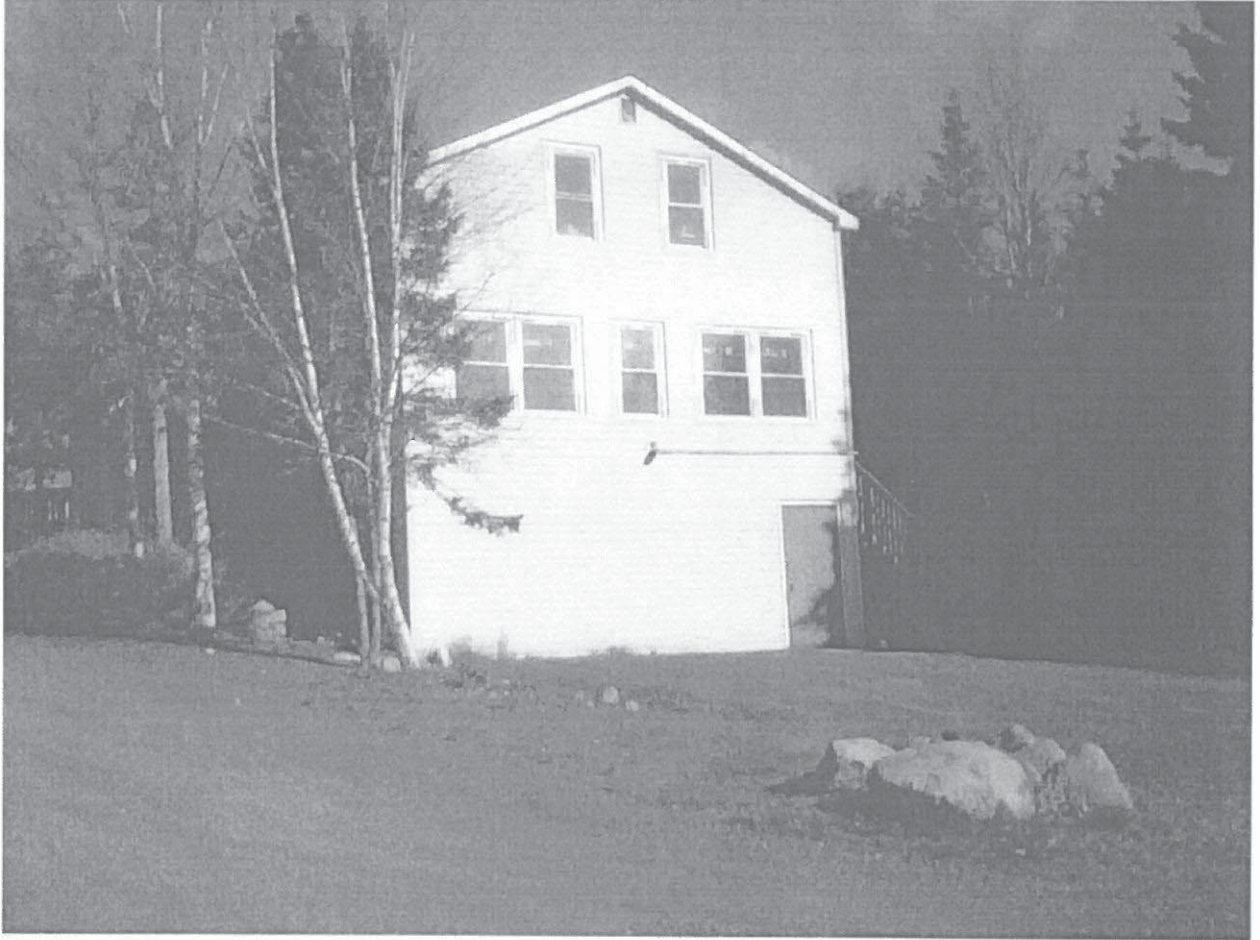
PHOTO #1
FRONT ELEVATION

The existing wood framed three storey building measuring approximately 24 feet wide by 34 feet long in plan was originally located in another location. The building was moved to its present location from local accounts and was converted from a residence to a Community Centre. See Photo #1.
