M E M O R A N D U M

FROM: David Lane, Senior Planner
DATE: February 29, 2012
SUBJECT: **Former Penhorn Mall Site Demolition Remediation**

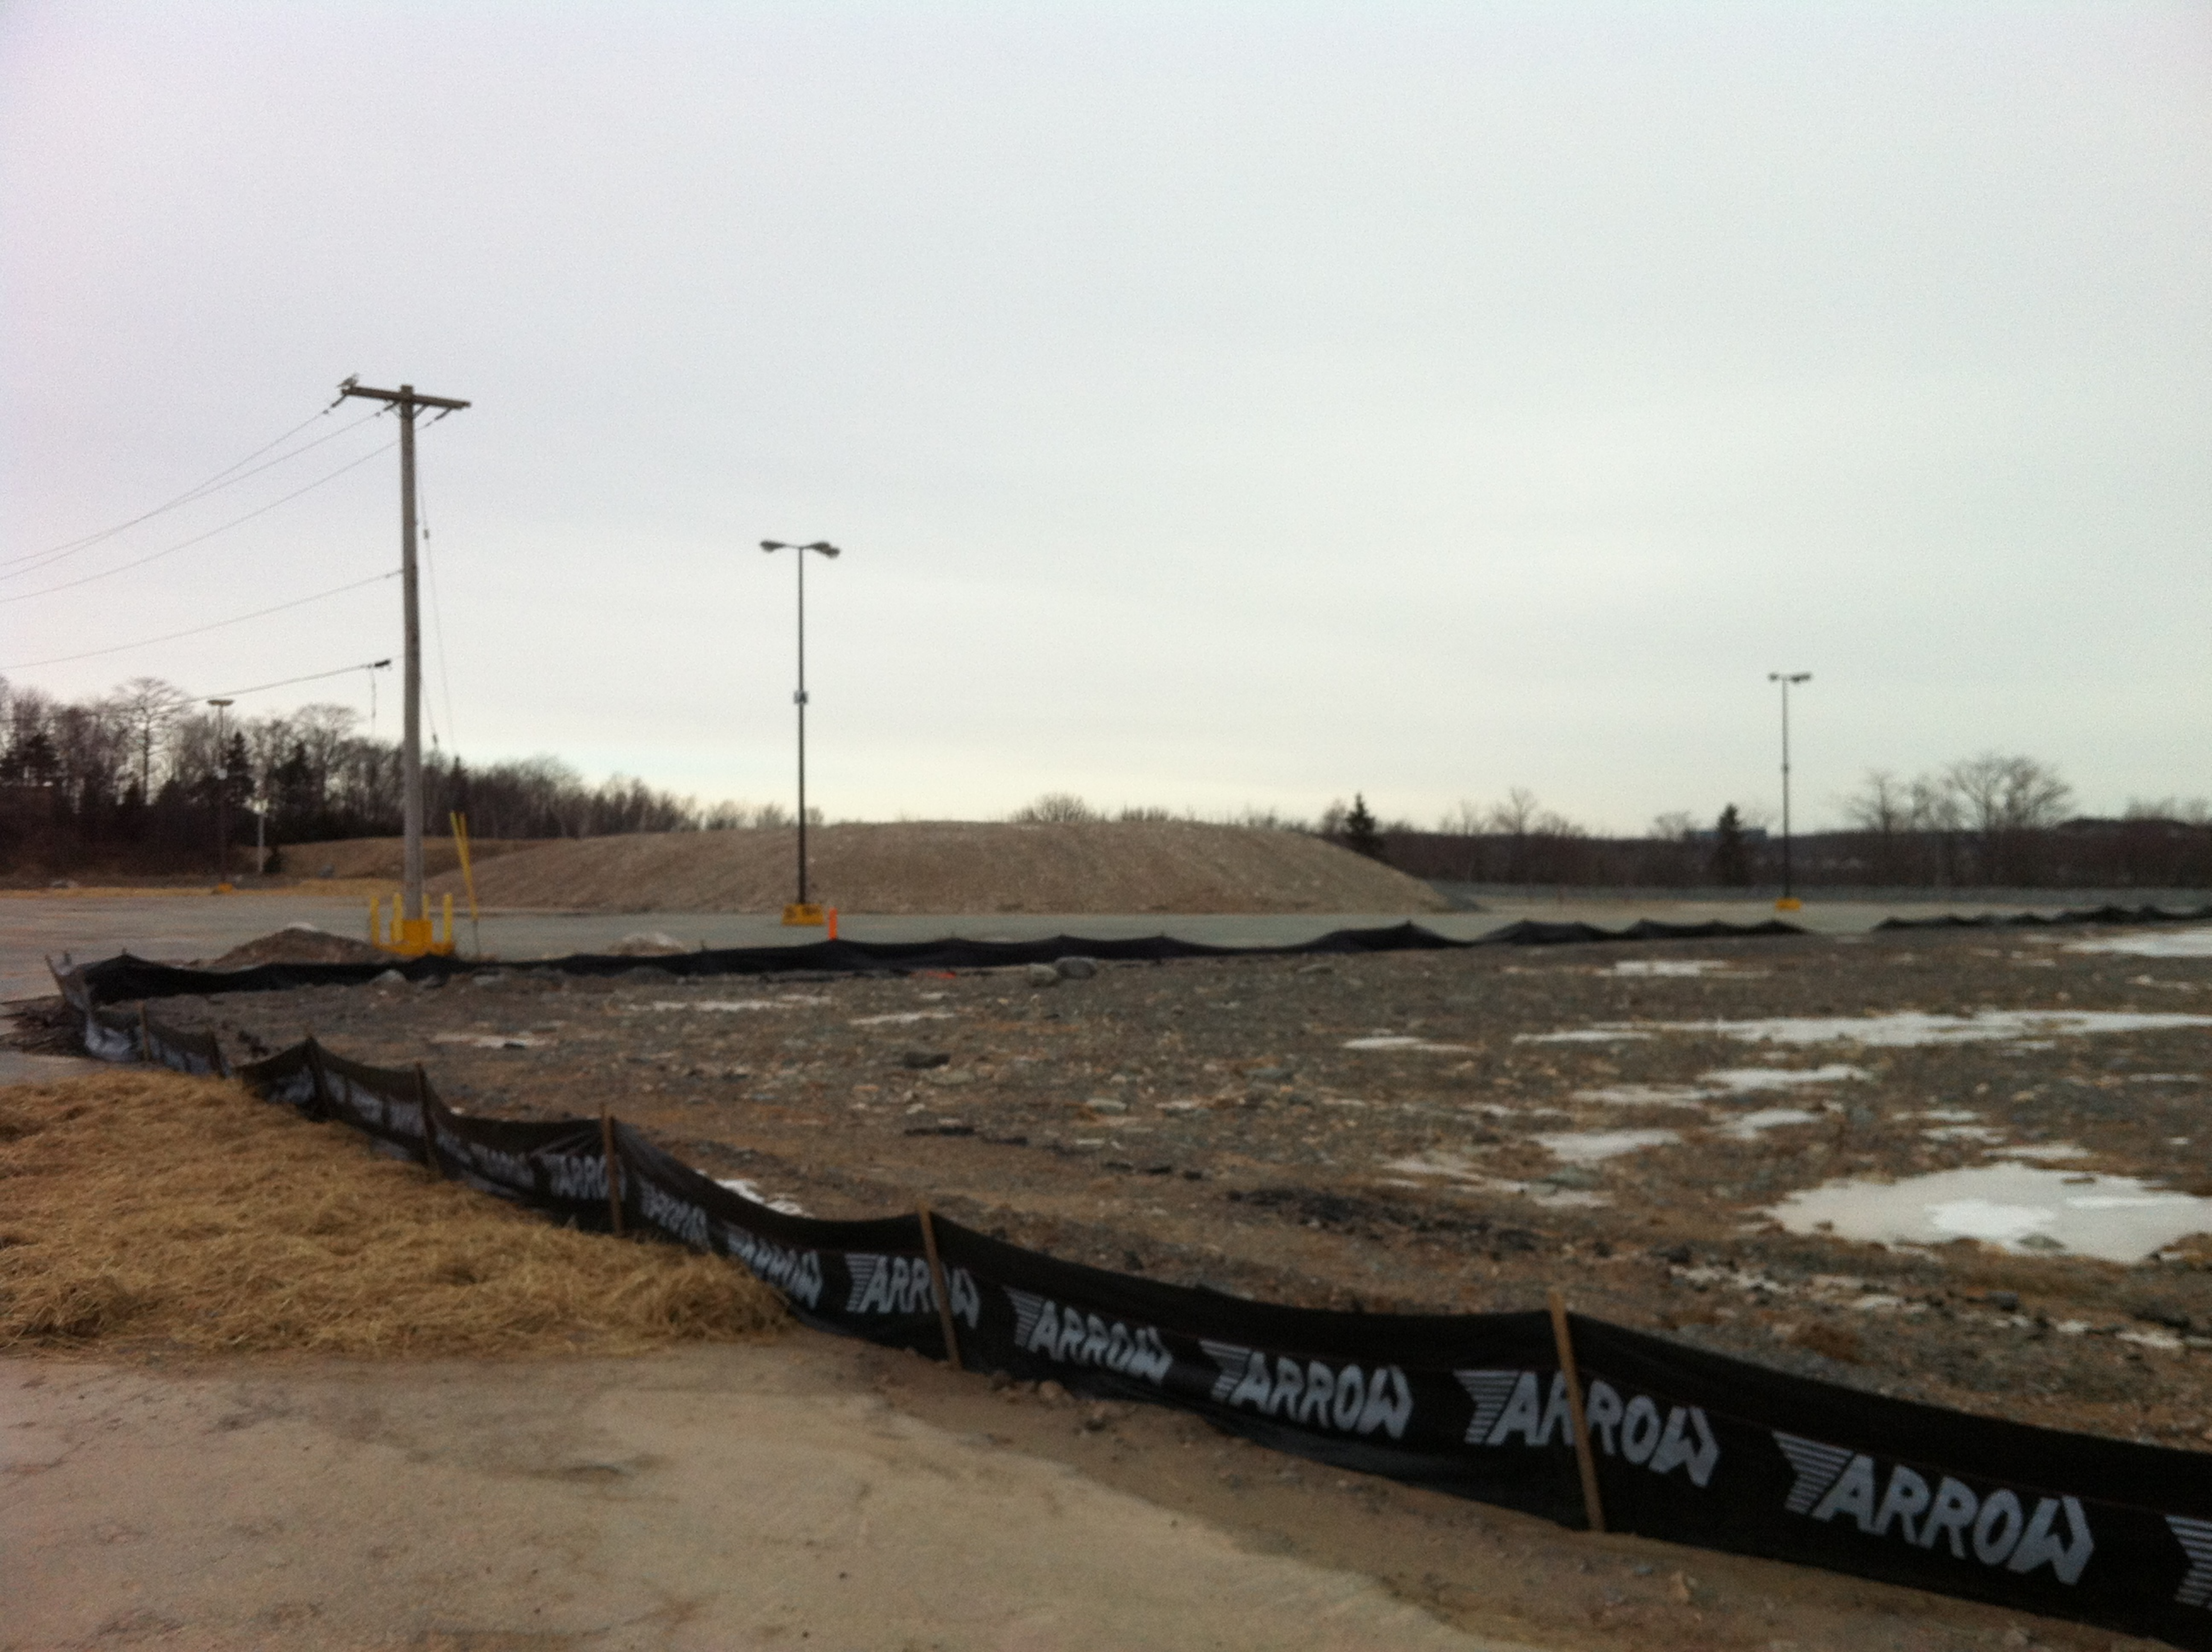
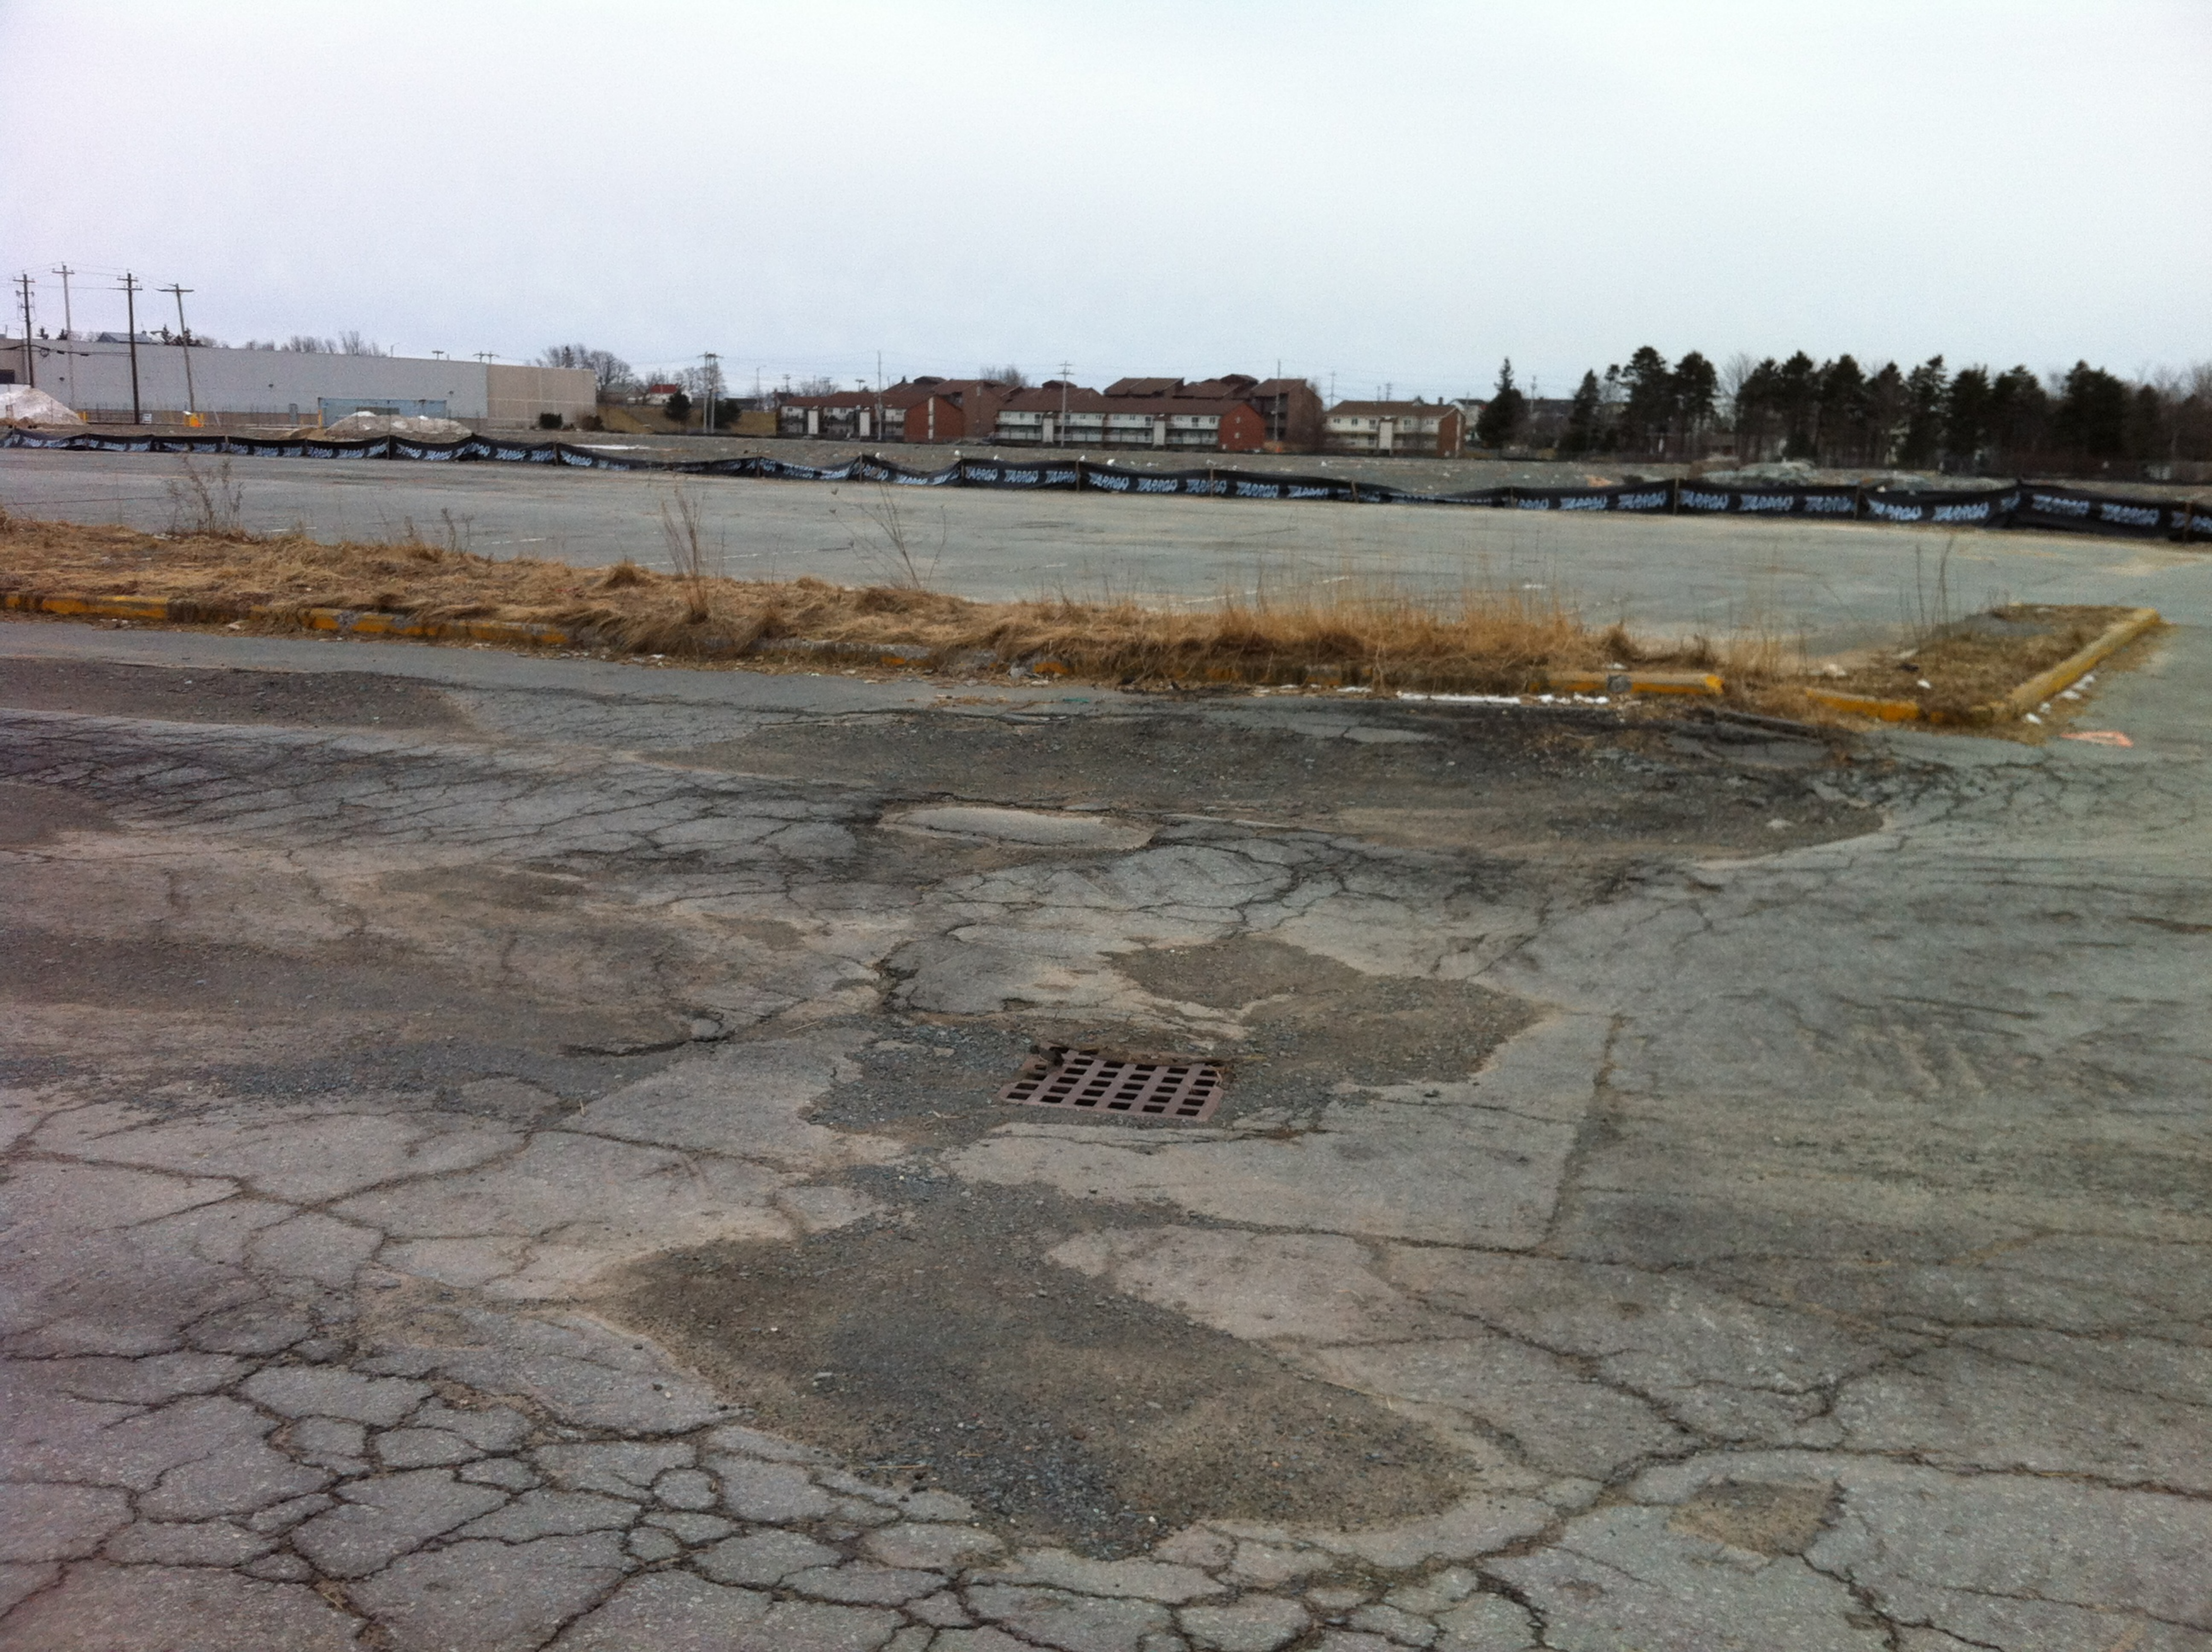
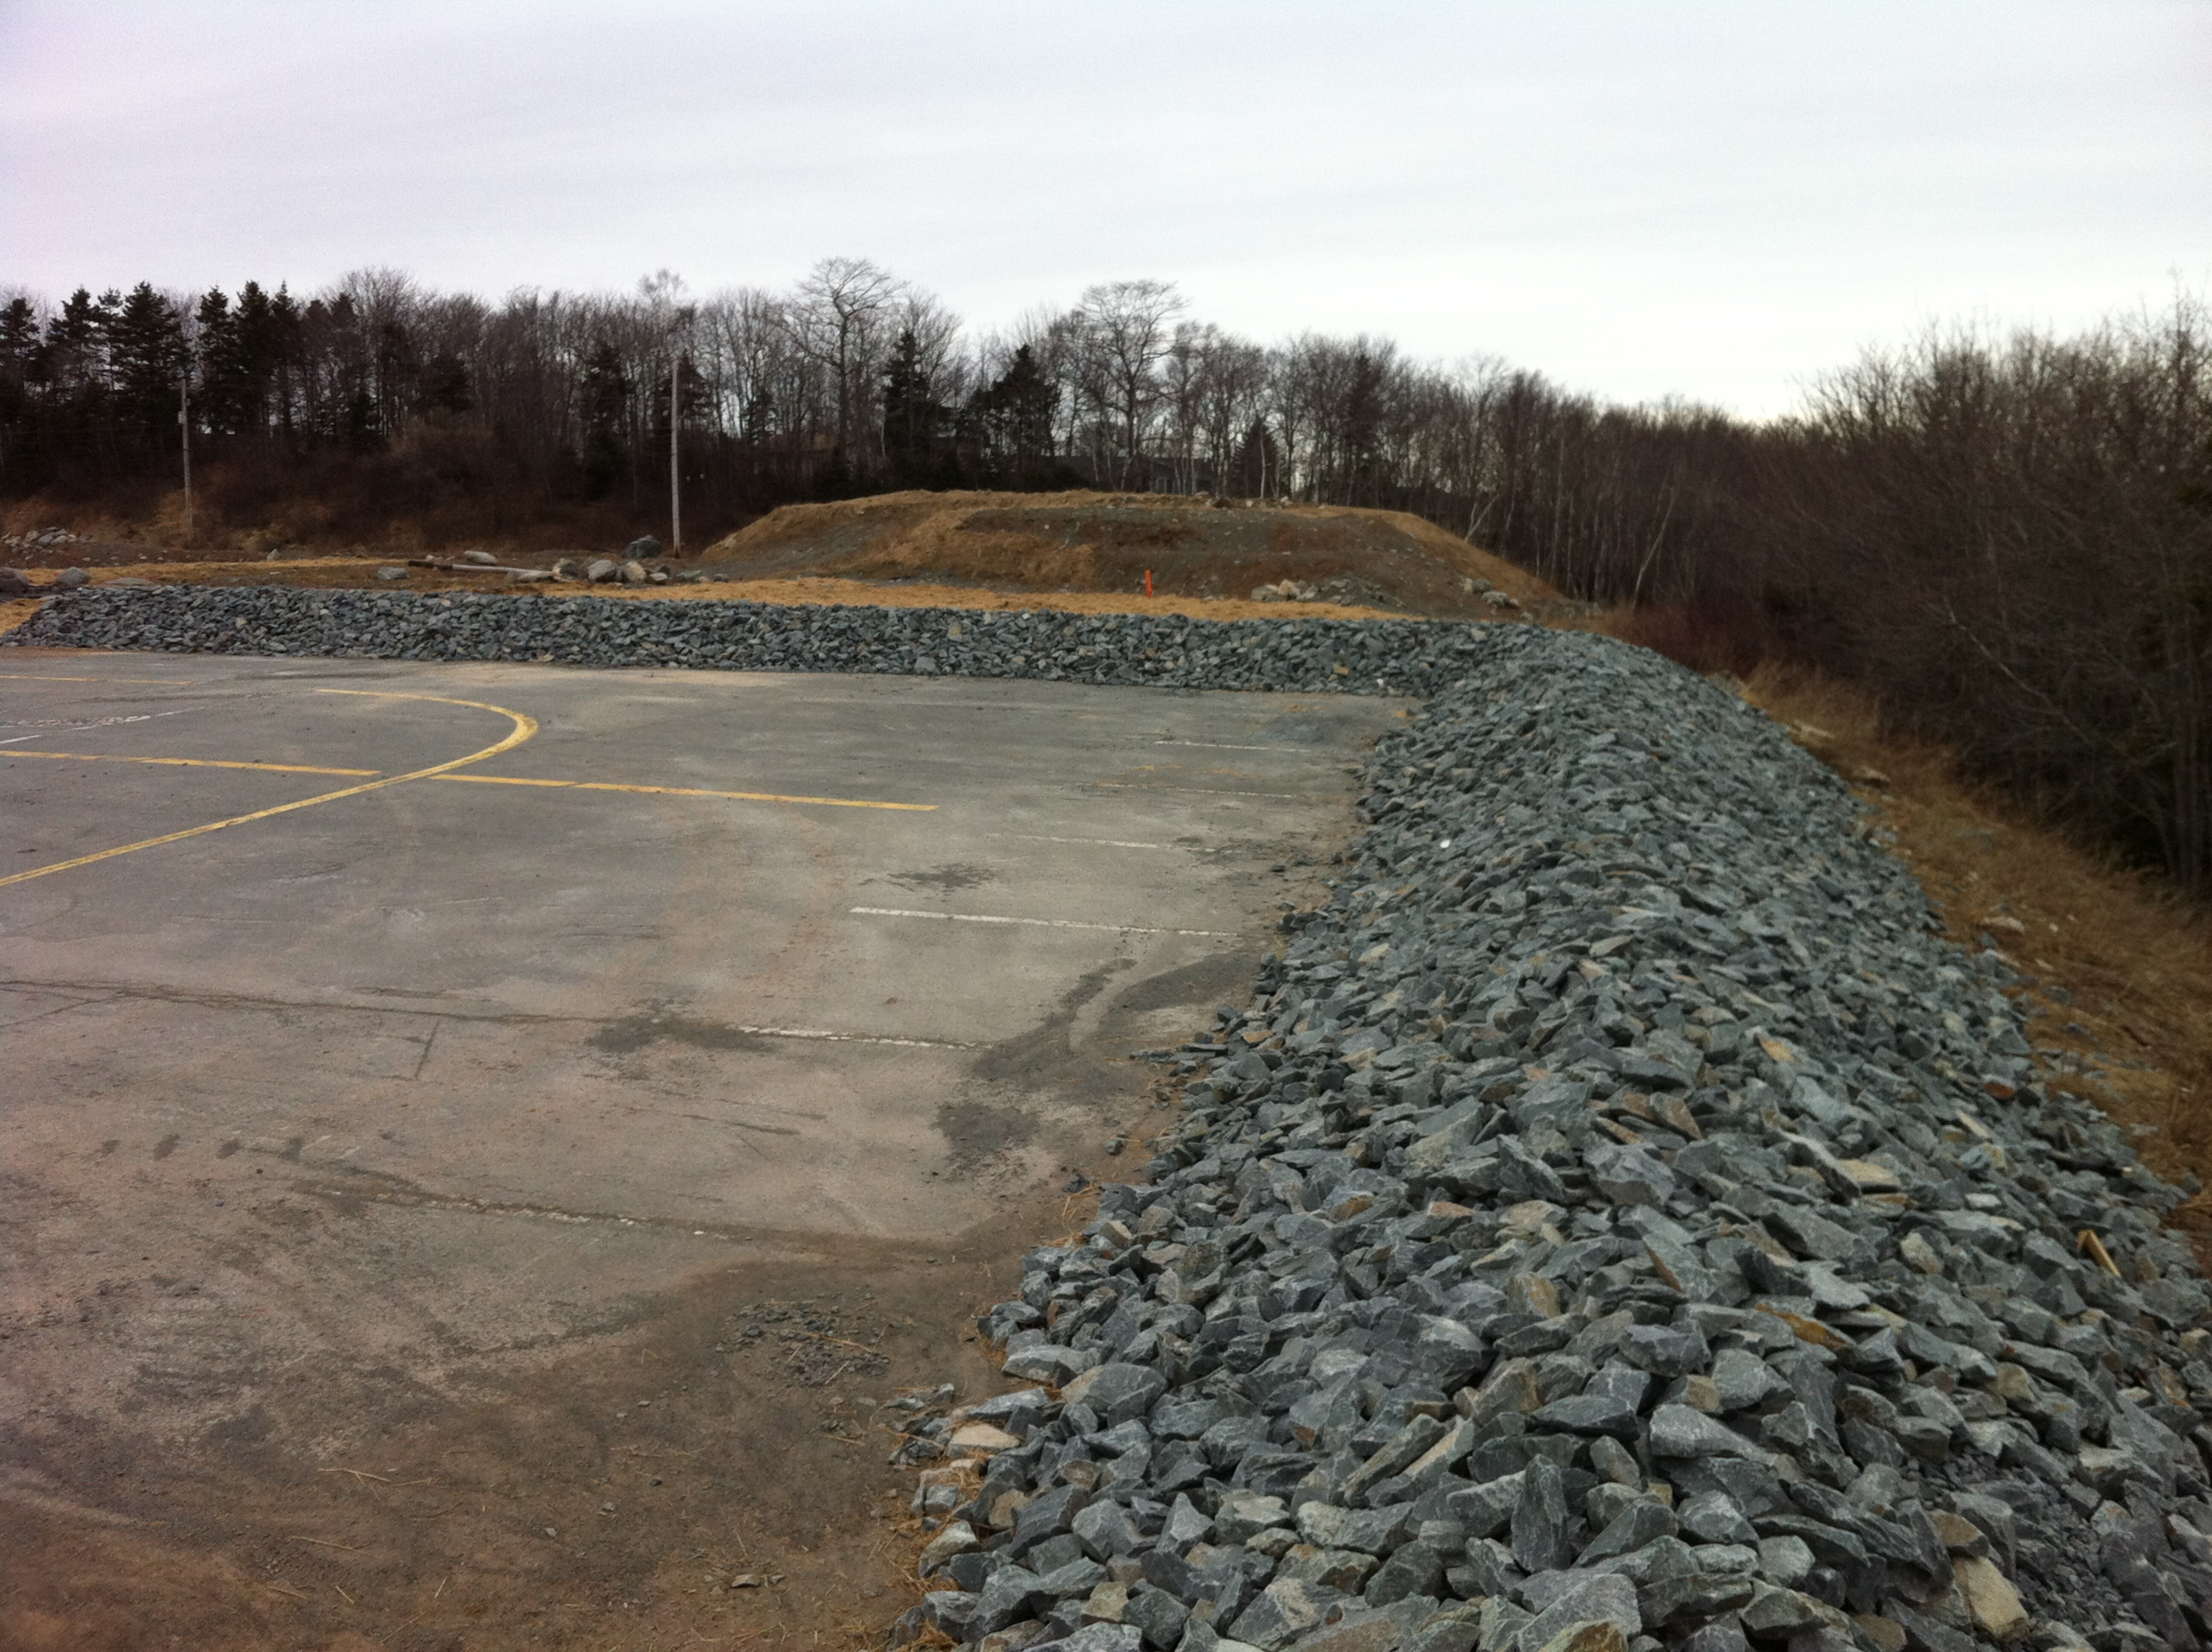
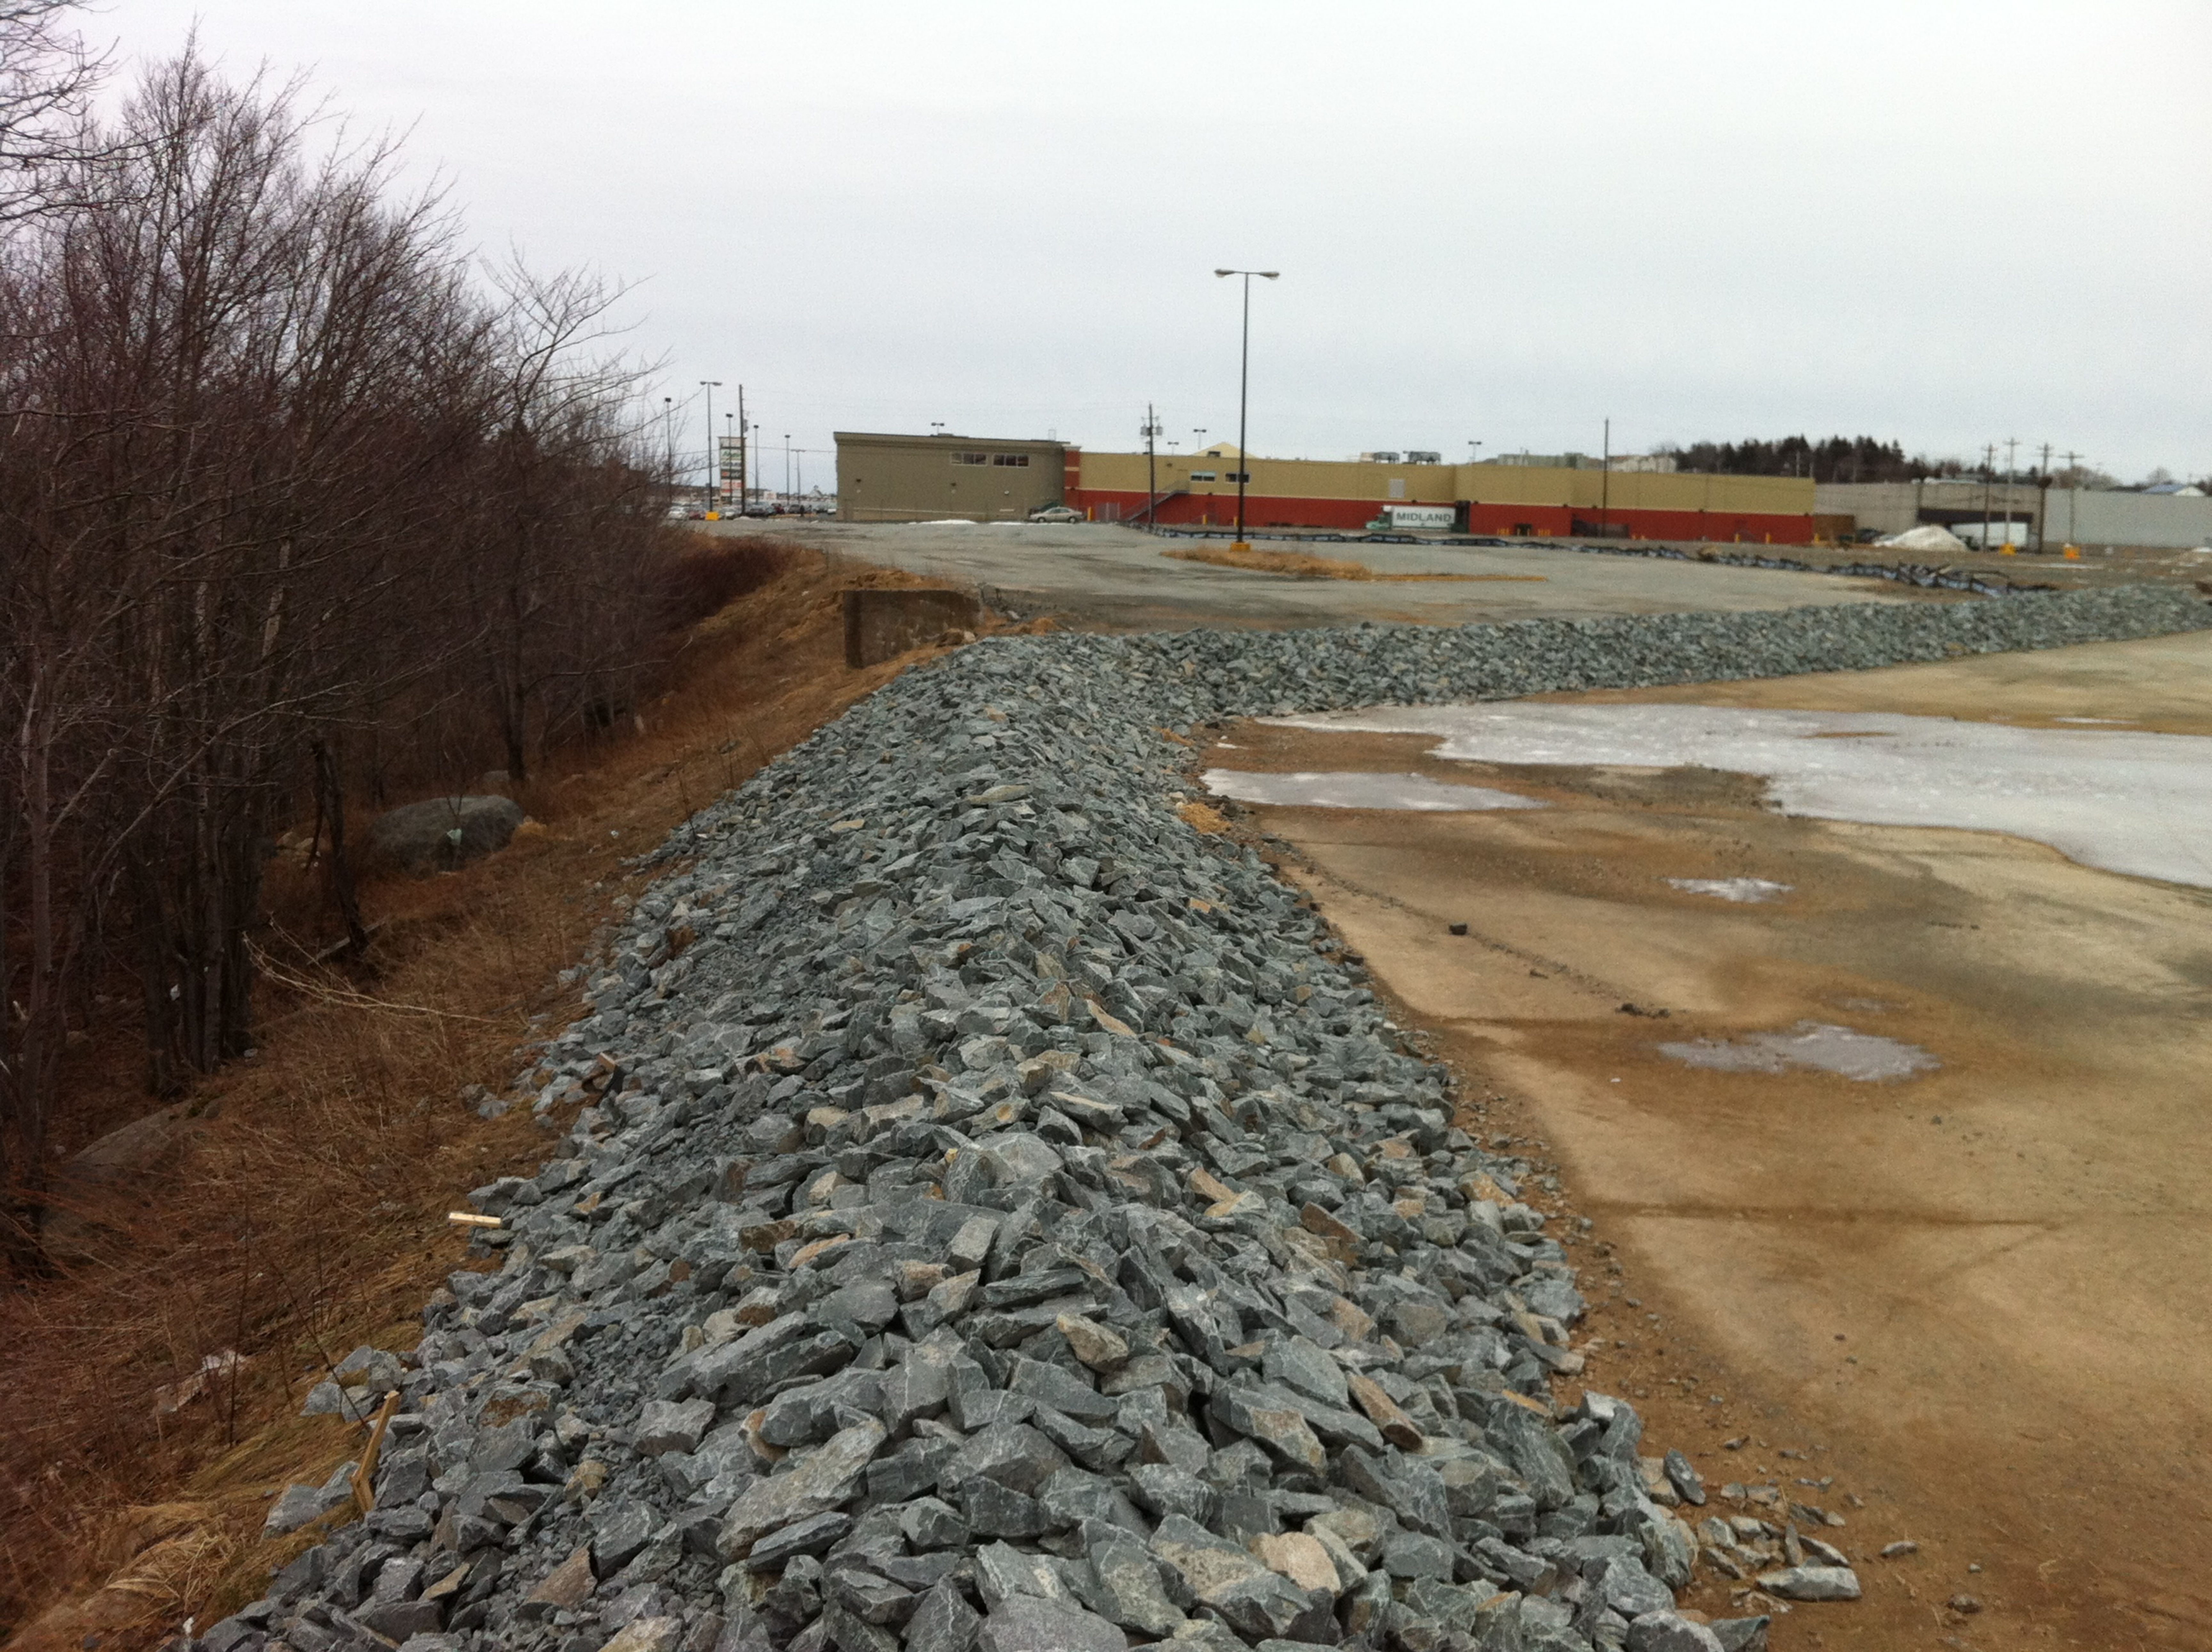
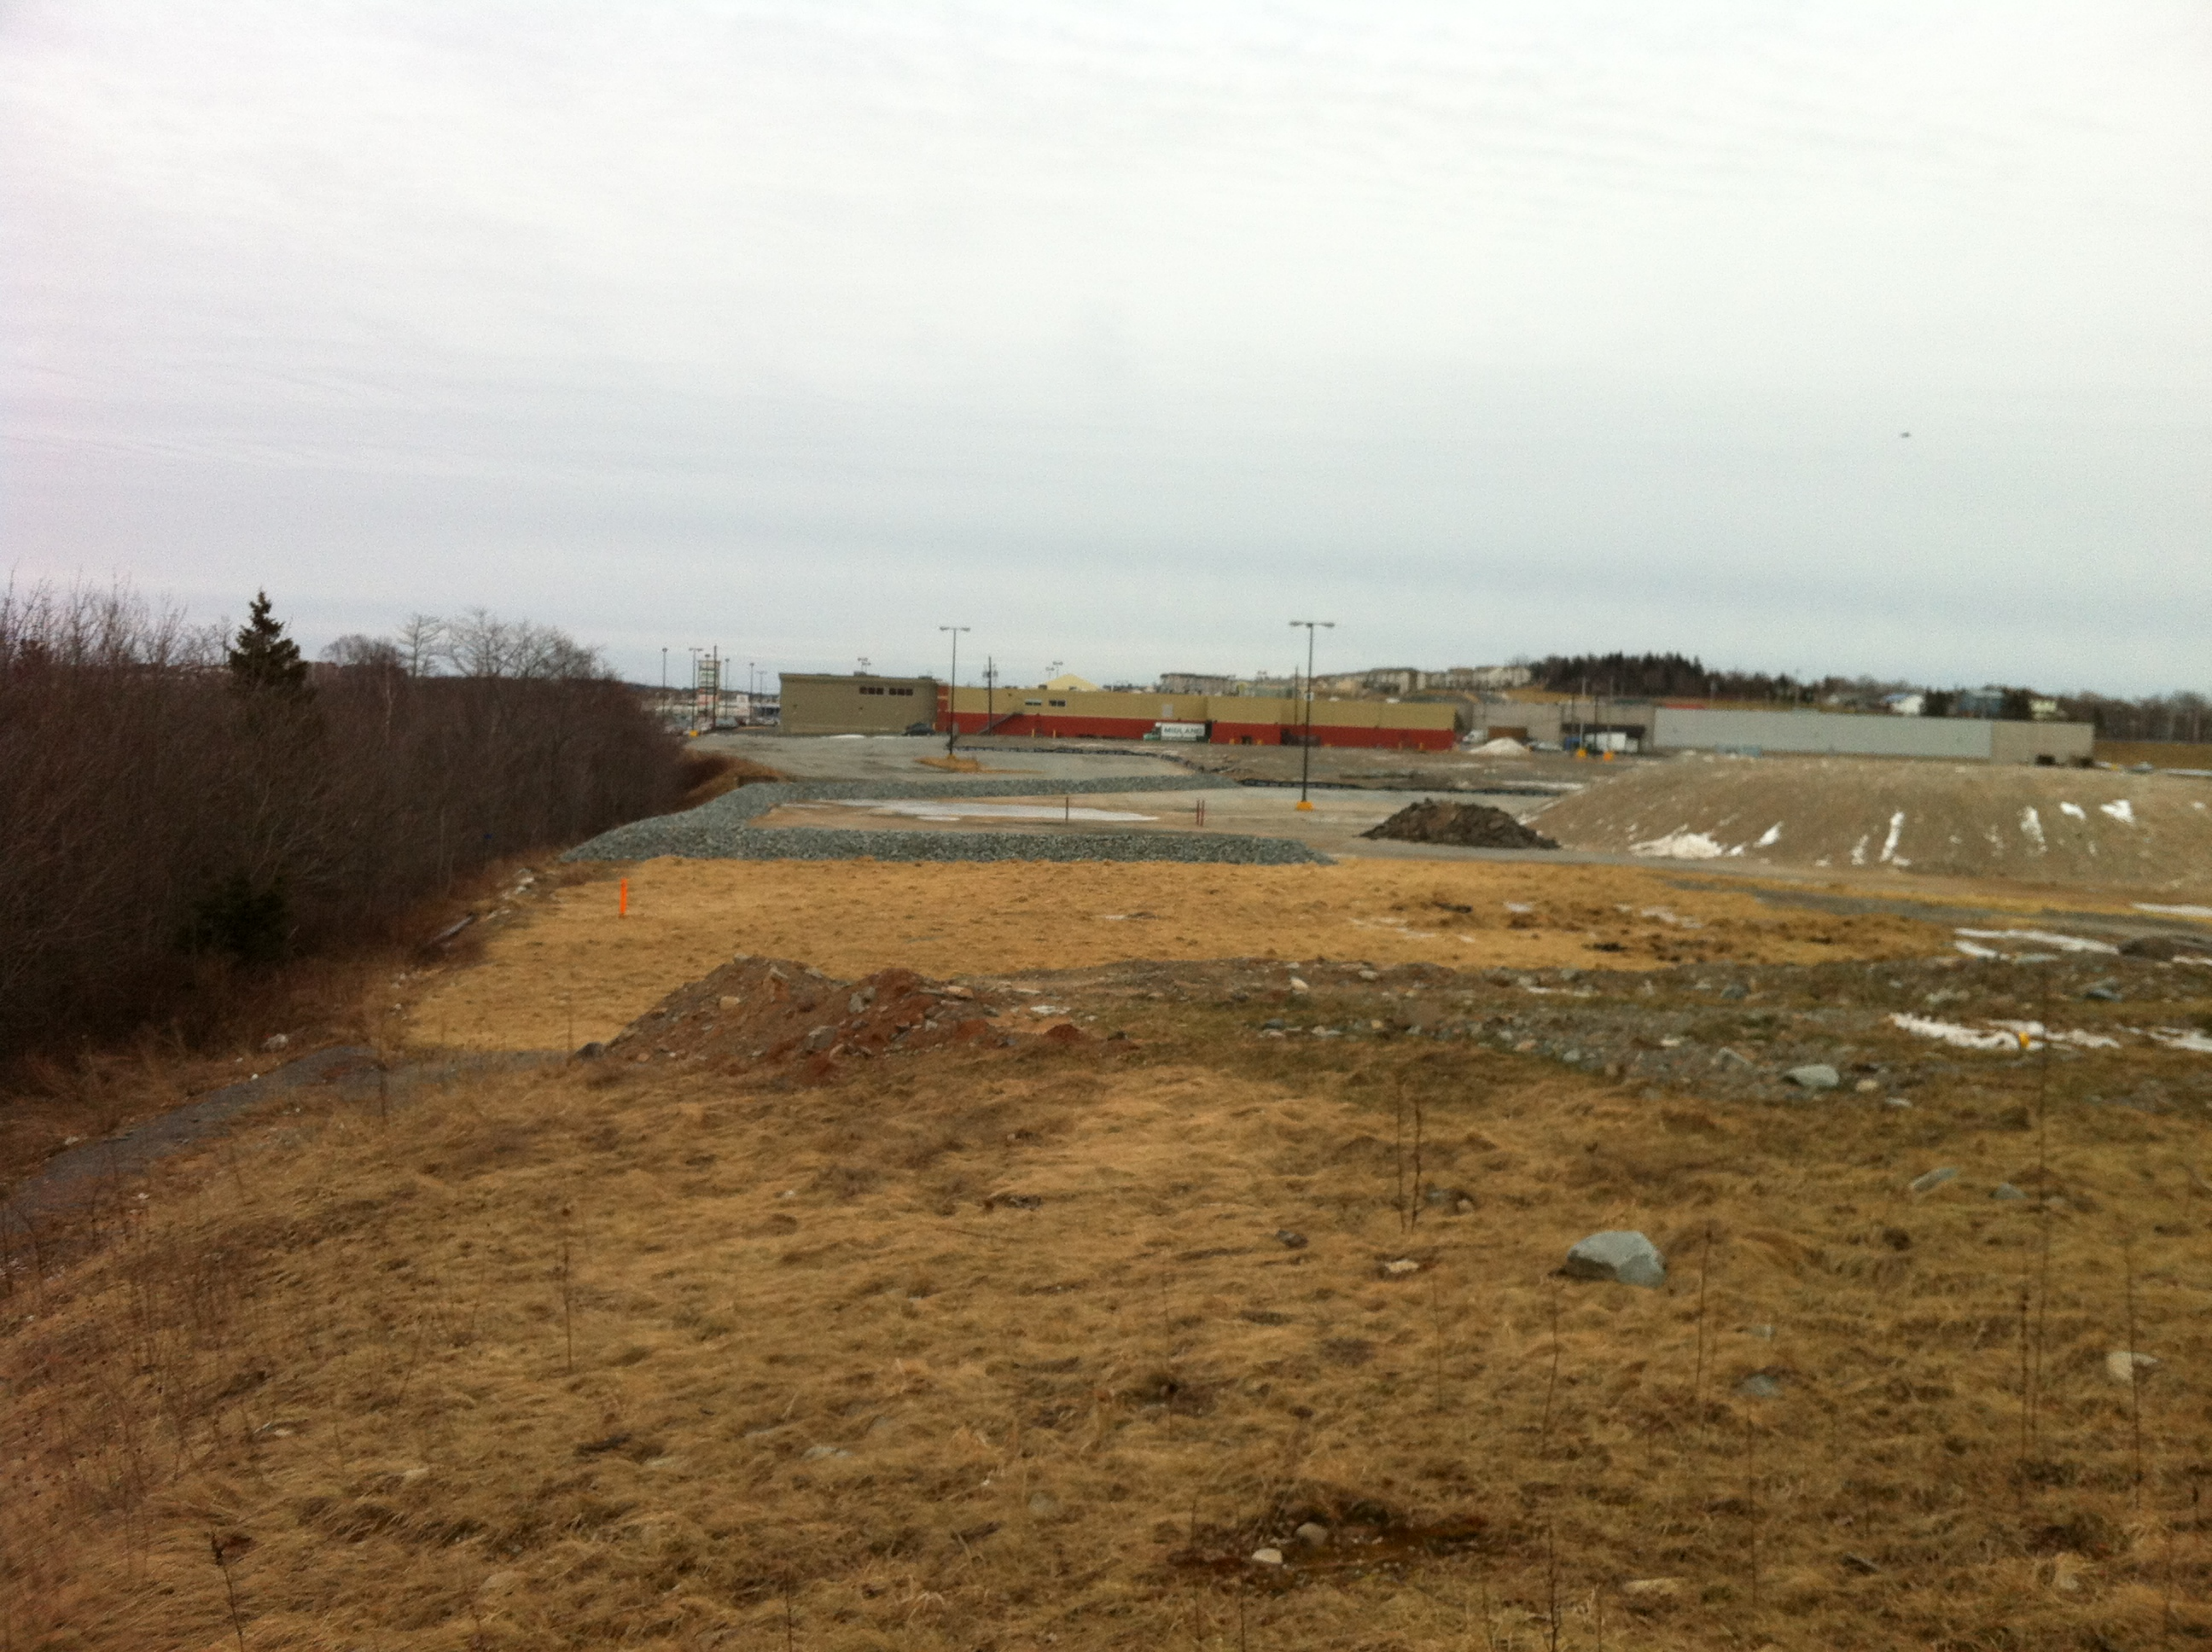
The enclosed site pictures (Feb.9/12) document the on-site improvements of stormwater containment systems, featuring reinforced berms and hay/straw ground cover application to reduce sedimentation of surface water run-off. (Note: colour reproduction of the photos inadvertently resulted in a red colour hue of the yellow hay/vegetation).
