**SUBJECT:** Union Street Flooding

SGE Acres Limited was retained to undertake this study. Their report, Union Street Flood Control, has been completed and has been circulated to the North West Community Council and the Bedford Water Advisory Board (BWAB).

## Union Street Flood Control Project

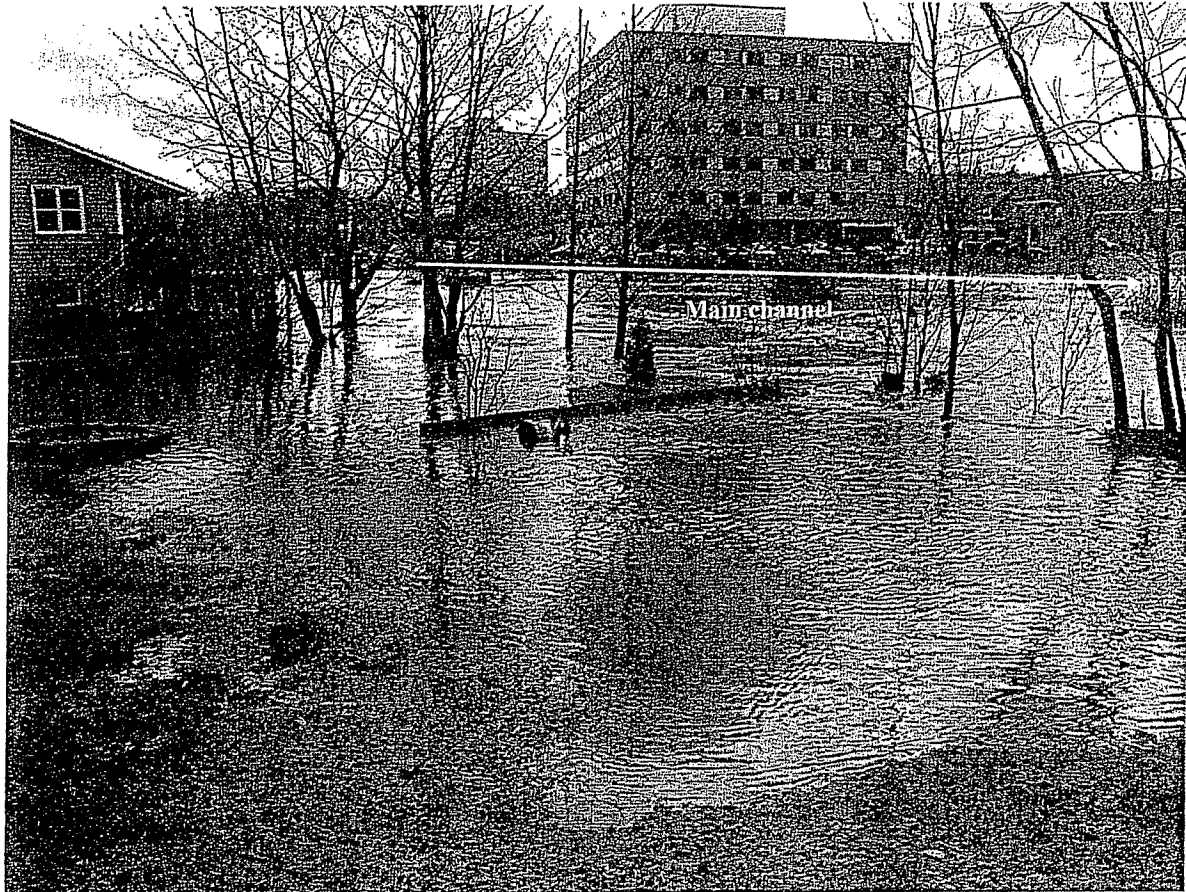
Location #2 (Union St. #27, just downstream of Bedford Tower)  
Simulated Level (STA 530) = 6.5 m  
Lowest Elevation of Residence = 6.37 m

(Looking upstream to Bedford Tower from Union Street)

Note: Photos taken on March 31, 2003. Flow unknown due to uncertainty re: time of photo relative to time of peak.

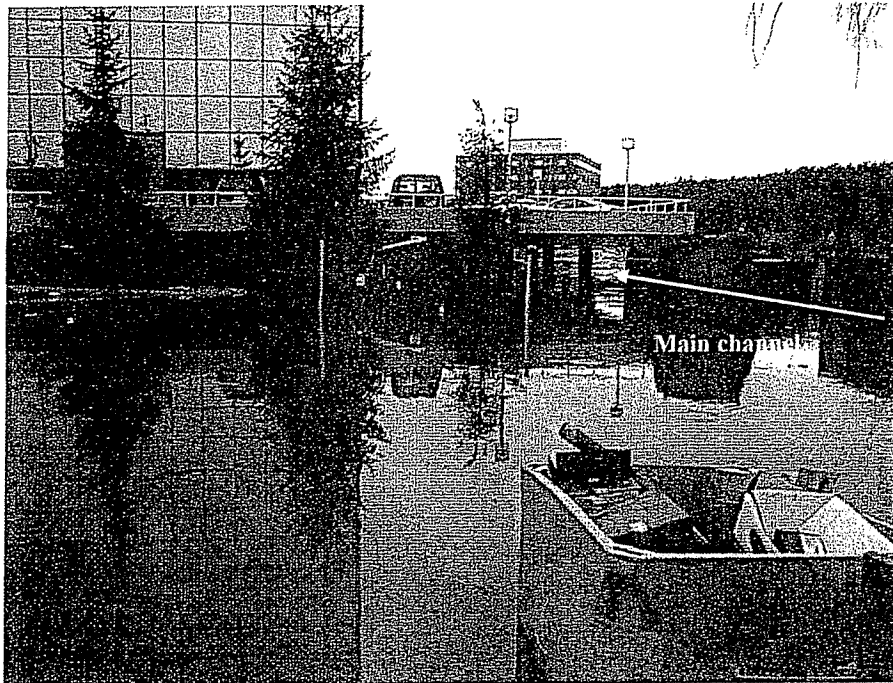
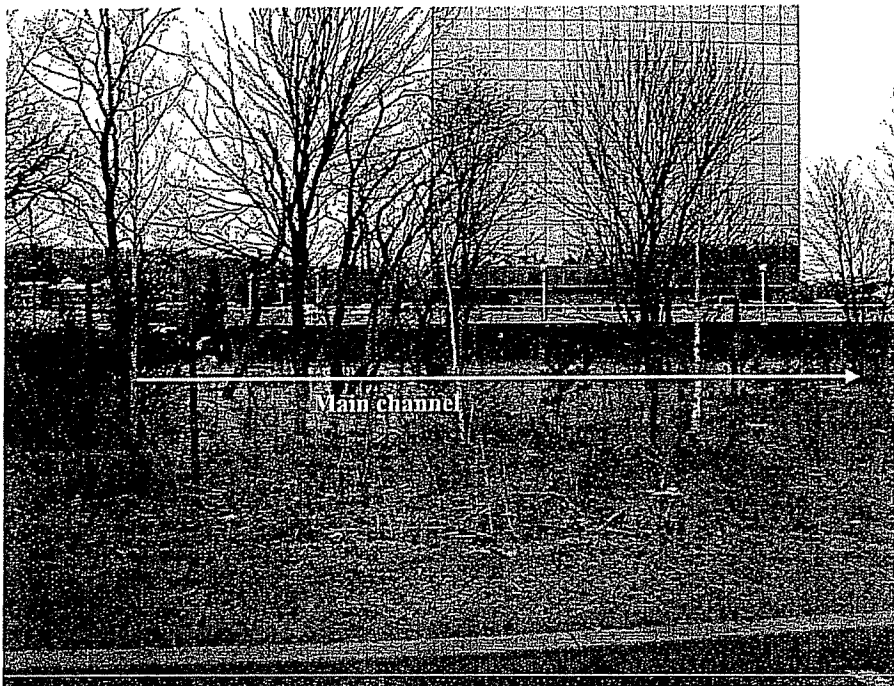
Location #4 (Sun Tower)  
Simulated Level (STA 790) = 6.7 m  
Lowest Elevation of Parking Structure Foundation = 4.85 m

(Upstream side of Sun Tower, Bedford Tower in background)

(Looking East across Sackville River to Sun Tower)

Note: Photos taken on March 31, 2003. Flow unknown due to uncertainty re: time of photo relative to time of peak.

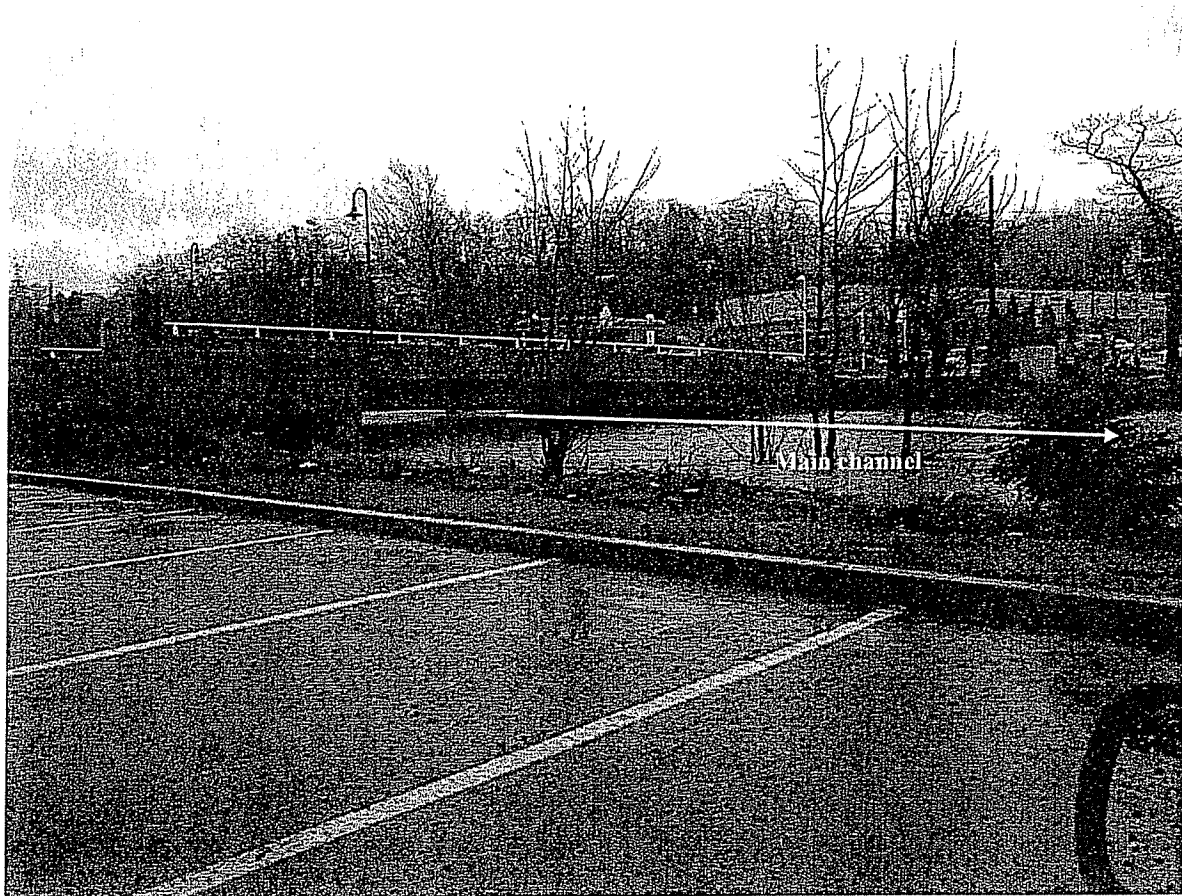
Location #6 (Bridge constructed in 2002 downstream of Towers Bridge)  
Simulated Level (STA 1065) = 6.9 m  
Elevation of Bridge Deck = 7.87 m to 8.79 m

(Downstream Side of 2002 Bridge)

Note: Photos taken on March 31, 2003. Flow unknown due to uncertainty re: time of photo relative to time of peak.

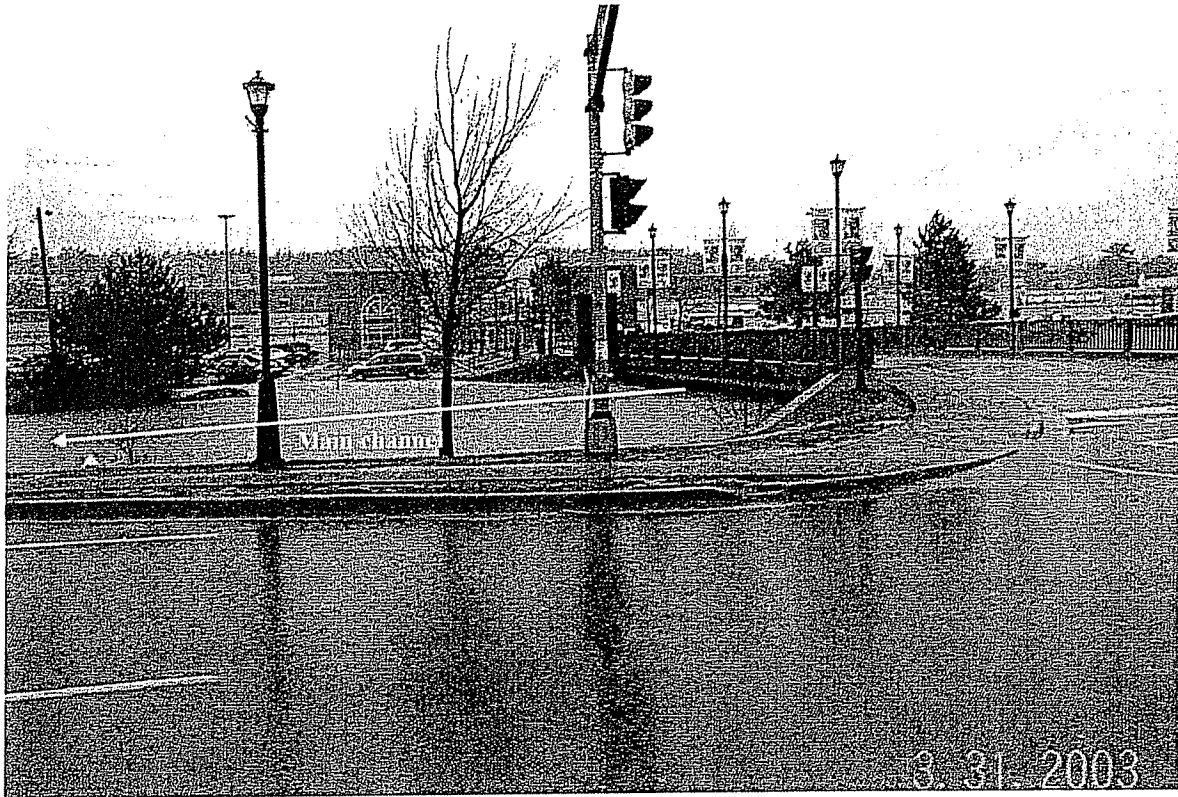
Location #7 (Towers Bridge)  
Simulated Level (STA 1215) = 7.0 m  
Elevation of Bridge Deck = 7.53 m to 7.62 m

(Downstream Side of Towers Bridge)

Note: Photos taken on March 31, 2003. Flow unknown due to uncertainty re: time of photo relative to time of peak.
