Item No. 9.1
Halifax Regional Council
April 29, 2014

SUBJECT: **Case 19046: Appeal of the Design Review Committee Substantive Site Plan Approval for 22nd Commerce Square Development, Halifax**

Appeal of the Design Review Committee's February 13, 2014 decision on a development proposal for the lands bounded by Hollis, George, Granville, and Duke Streets, Halifax.

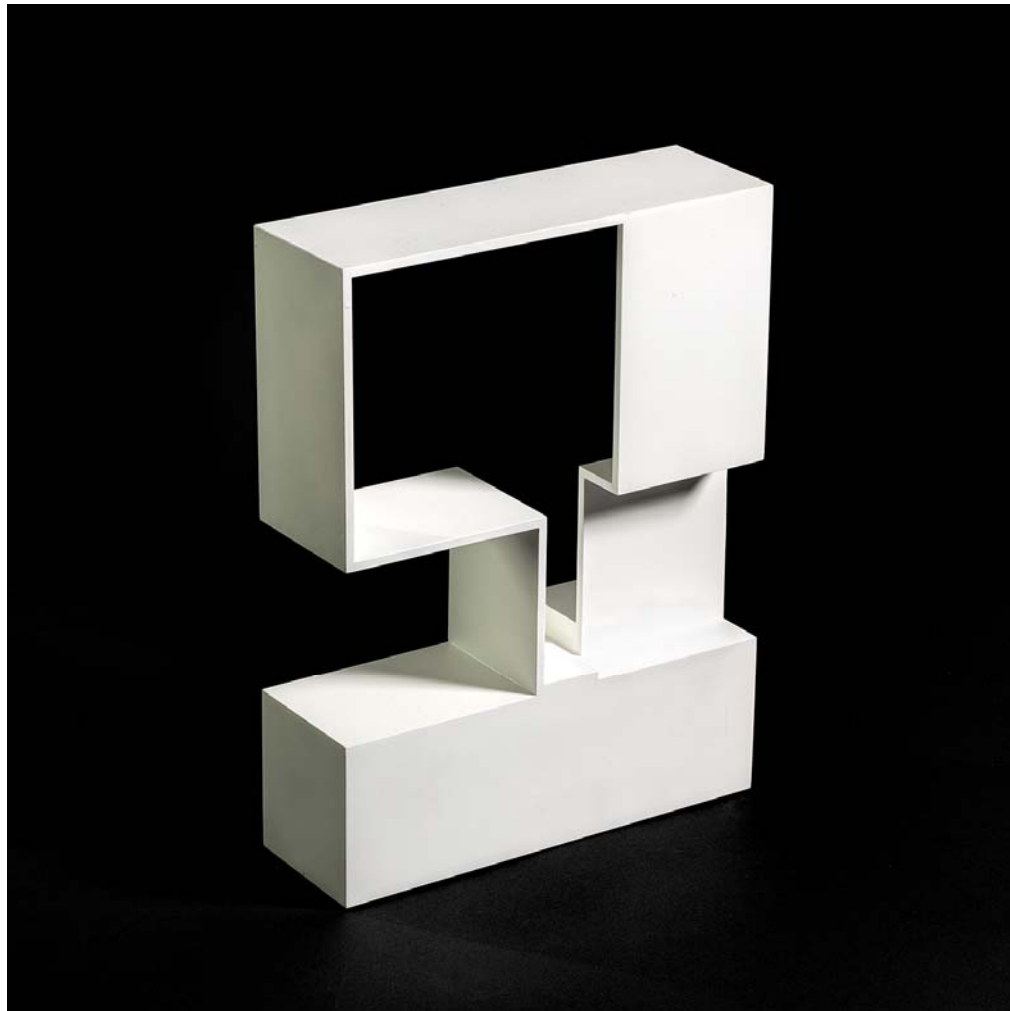
Fig.6A: Unification of volumes and uses with ceramic ribbon

The four main elements of the scheme comprise a strong, street-scale base which includes several existing facades, a central body or middle comprising the two towers, and a concluding top plane of white ceramic tile which unifies the two towers into a single entity in a distinctive manner (Fig.6). (HRM Design Manual 3.3.4(a)) The fourth element is the minimally detailed Atrium whose glass enclosed wooden portals define a new Civic place in the city, and a connection between Hollis and Granville Streets; enhancing pedestrian permeability. (HRM Design Manual 3.3.1.(a))

The white colored, glazed ceramic tile ribbon is a contextual reference intended to acknowledge the finely detailed white terracotta of the Merchants Bank of Canada Building whose façade is representative of the classic age of Mercantile Architecture in the early twentieth century. (HRM Design Manual 3.3.1.(b)) Its ribbon-like quality acts as a unifying element through the entire development (Fig.6A). As a compositional device, it rationalizes setbacks and changes in use while creating a unique architectural expression.

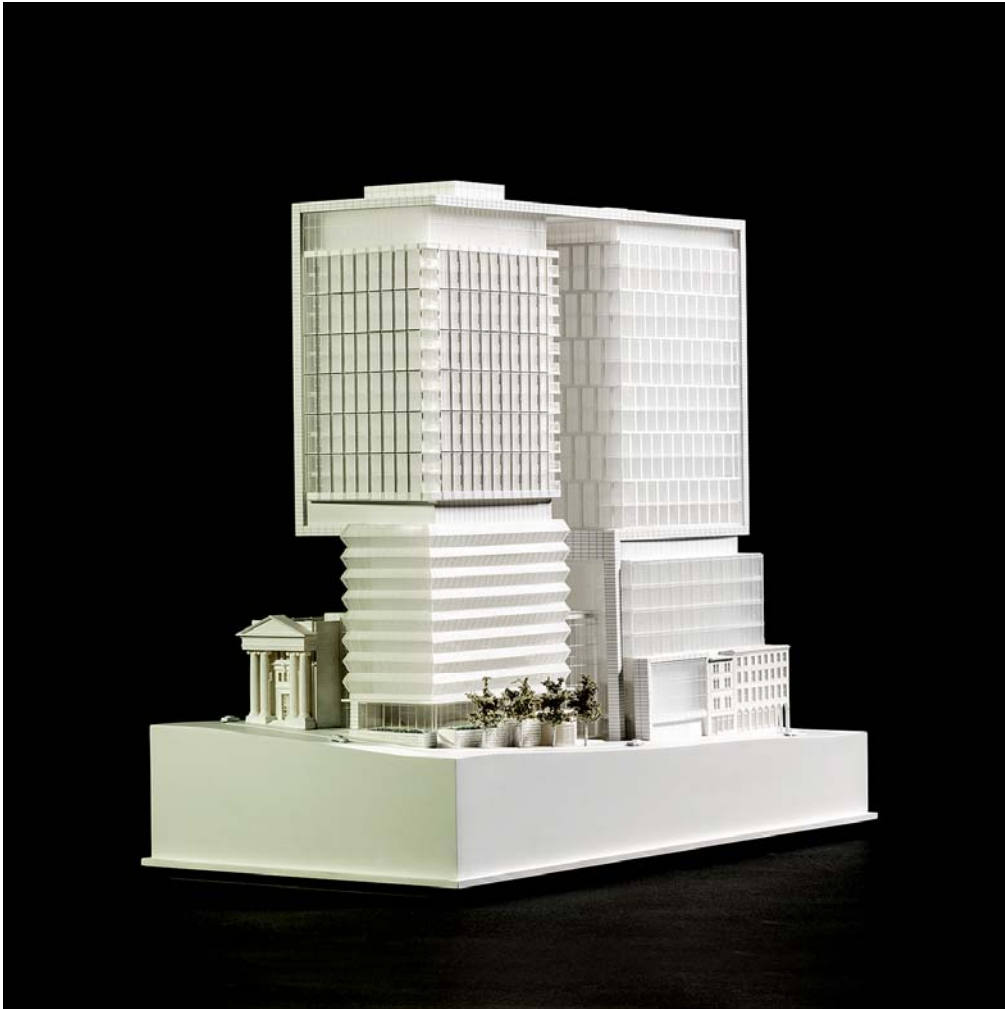
Fig.6B: The Ceramic Ribbon in abstract.

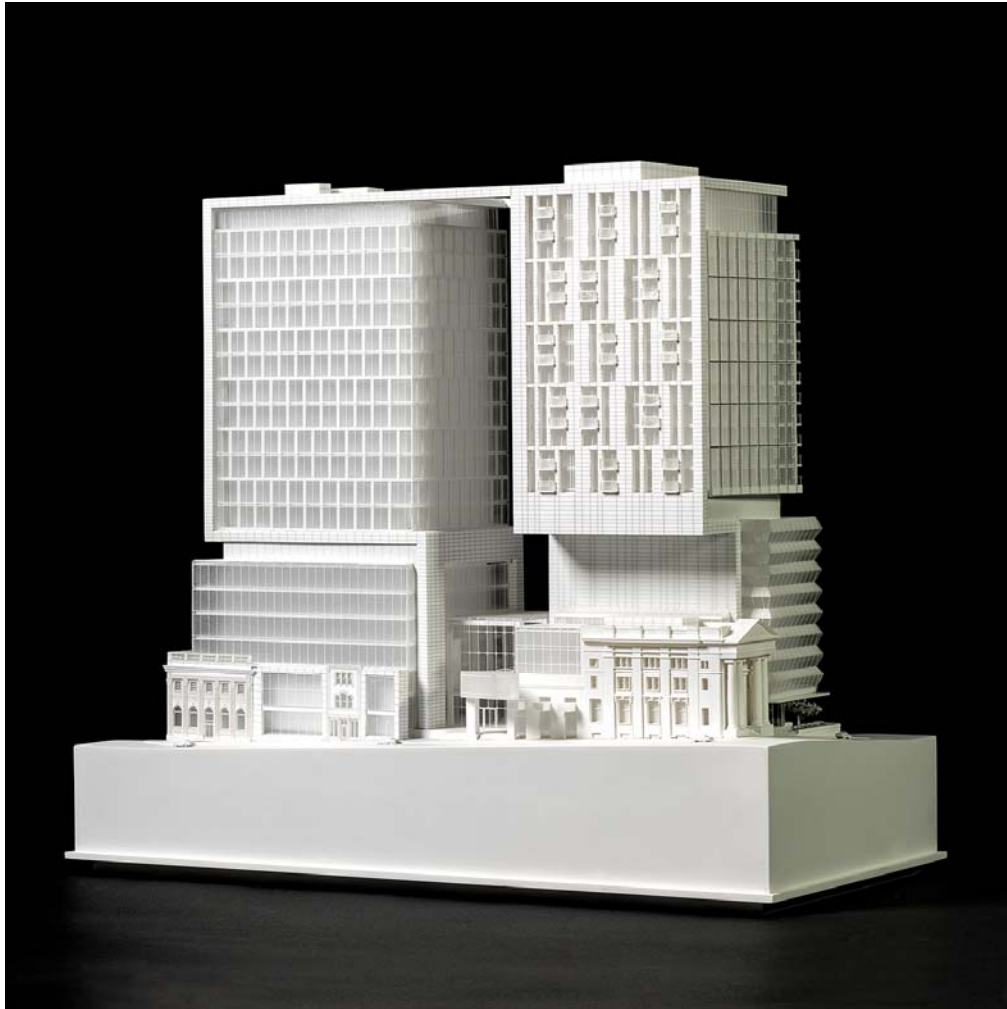
Fig.6C: Architectural Model of the Proposed Development - George and Hollis Street Facades.

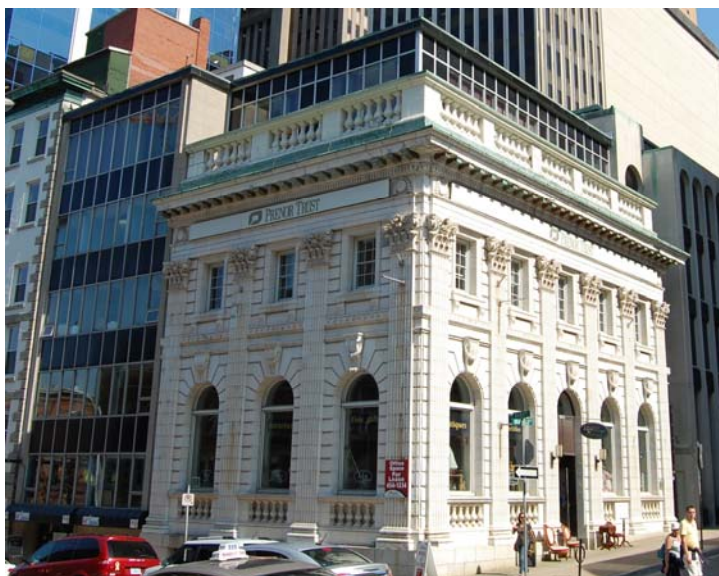
Fig.7-8: Photo of Existing Original Old Merchants Bank and Flinn Facades to be conserved.

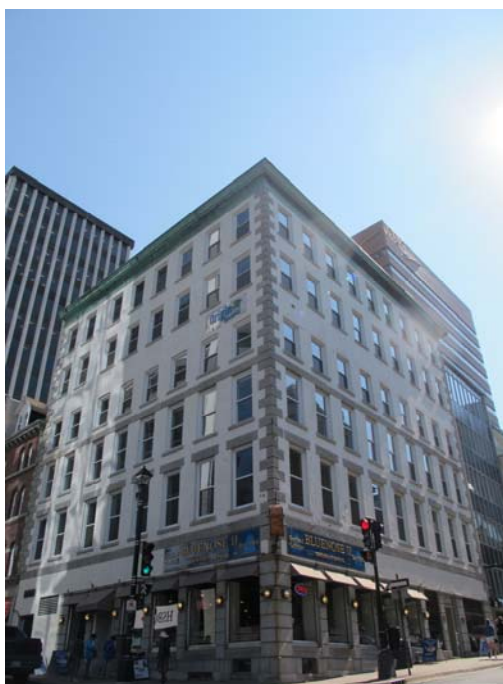
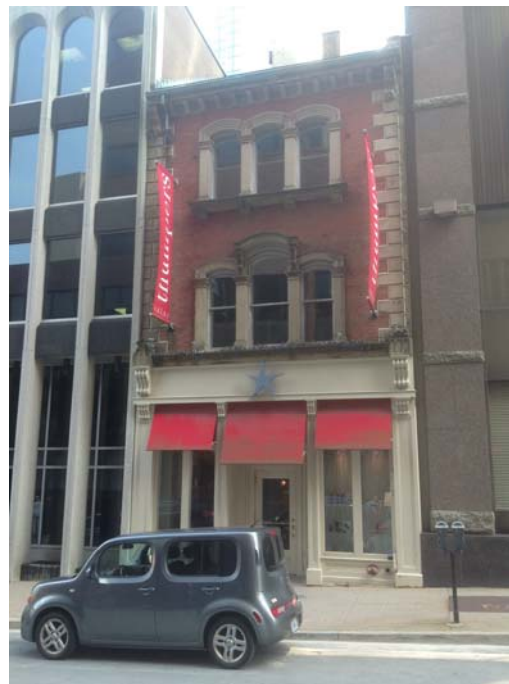
Fig.9-10: Existing Facades of Champlain, Hayes Insurance Building, to be conserved.

Approaches to the conservation of existing facades balance reverence for their inherent historic legacy, and the practical needs of the project as a whole. Approaches vary between the manageable repairs required for the Bank of Commerce, Hayes Insurance and Flinn Building facades, to the more extensive major repairs and restoration needed at the Old Merchants Bank Building, to the restoration of the dignified qualities of the Champlain Building's original 4-storey facade. Reference to the Heritage Impact Statement should be made in regards to proposed works to these buildings.

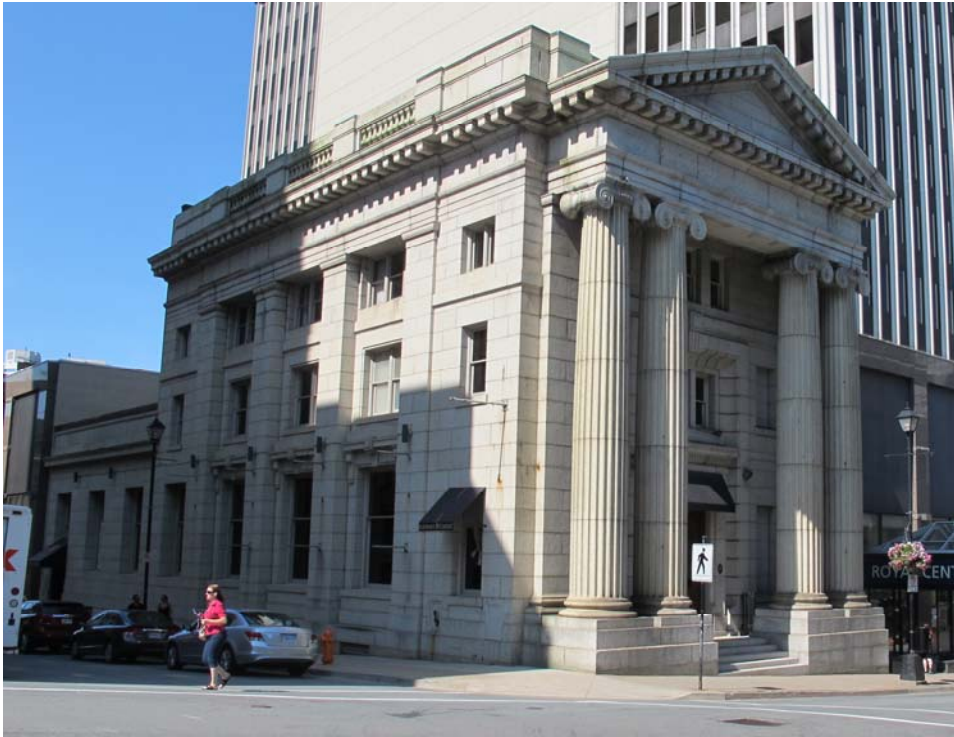
Fig.11 Existing Facade and main space of the Bank of Commerce Building, to be conserved.

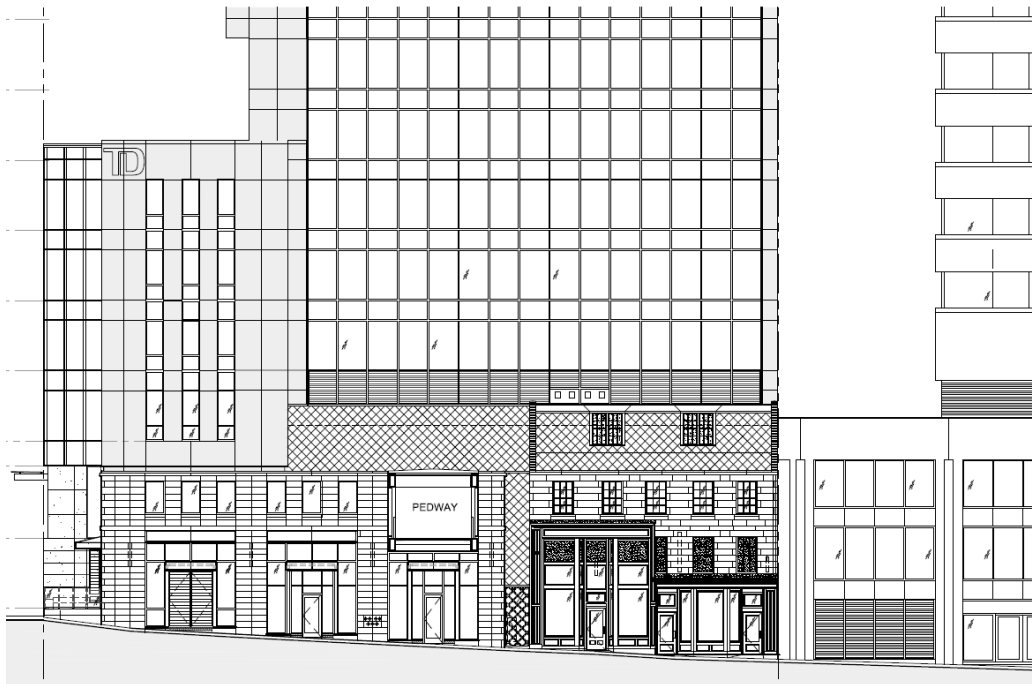
Fig.12: Future location of proposed Pedway and impact on the TD building.

In the long term, a Pedestrian Bridge or Pedway will provide an umbilical like connection between the new TD Tower across Granville Street, and the 22nd Commerce Square Building. The TD Tower contains few amenities other than the retail banking branch on Barrington Street. It is therefore the intention to extend the established public Pedway through downtown whilst providing occupants with all weather linkage to the facilities and food and retail uses that the new building will provide; some of which are accessible off the atrium and adjacent common areas.

The single storey Pedway will be designed to maximize its transparency in order to minimize its impact in views along Granville Street. Its design will also take account of Pedestrian comfort in regards to wind strength around and below its location. (*Ref. HRM MPS Map 12, HRM DG 3,2,6*)

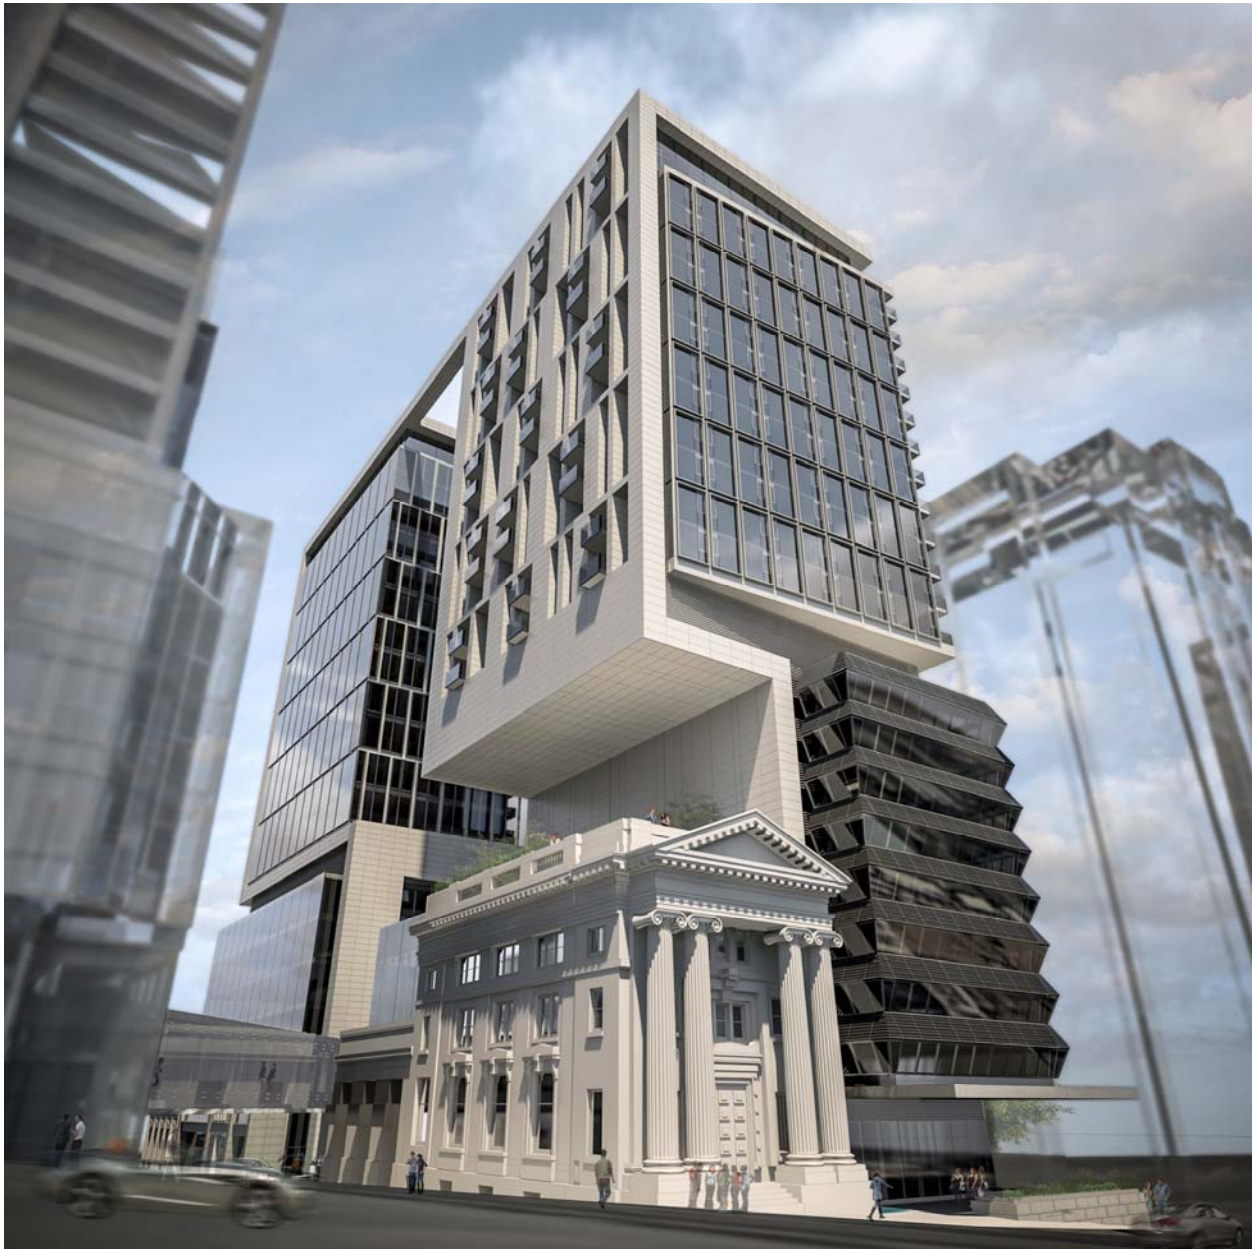
View of South facing elevation from George Street.

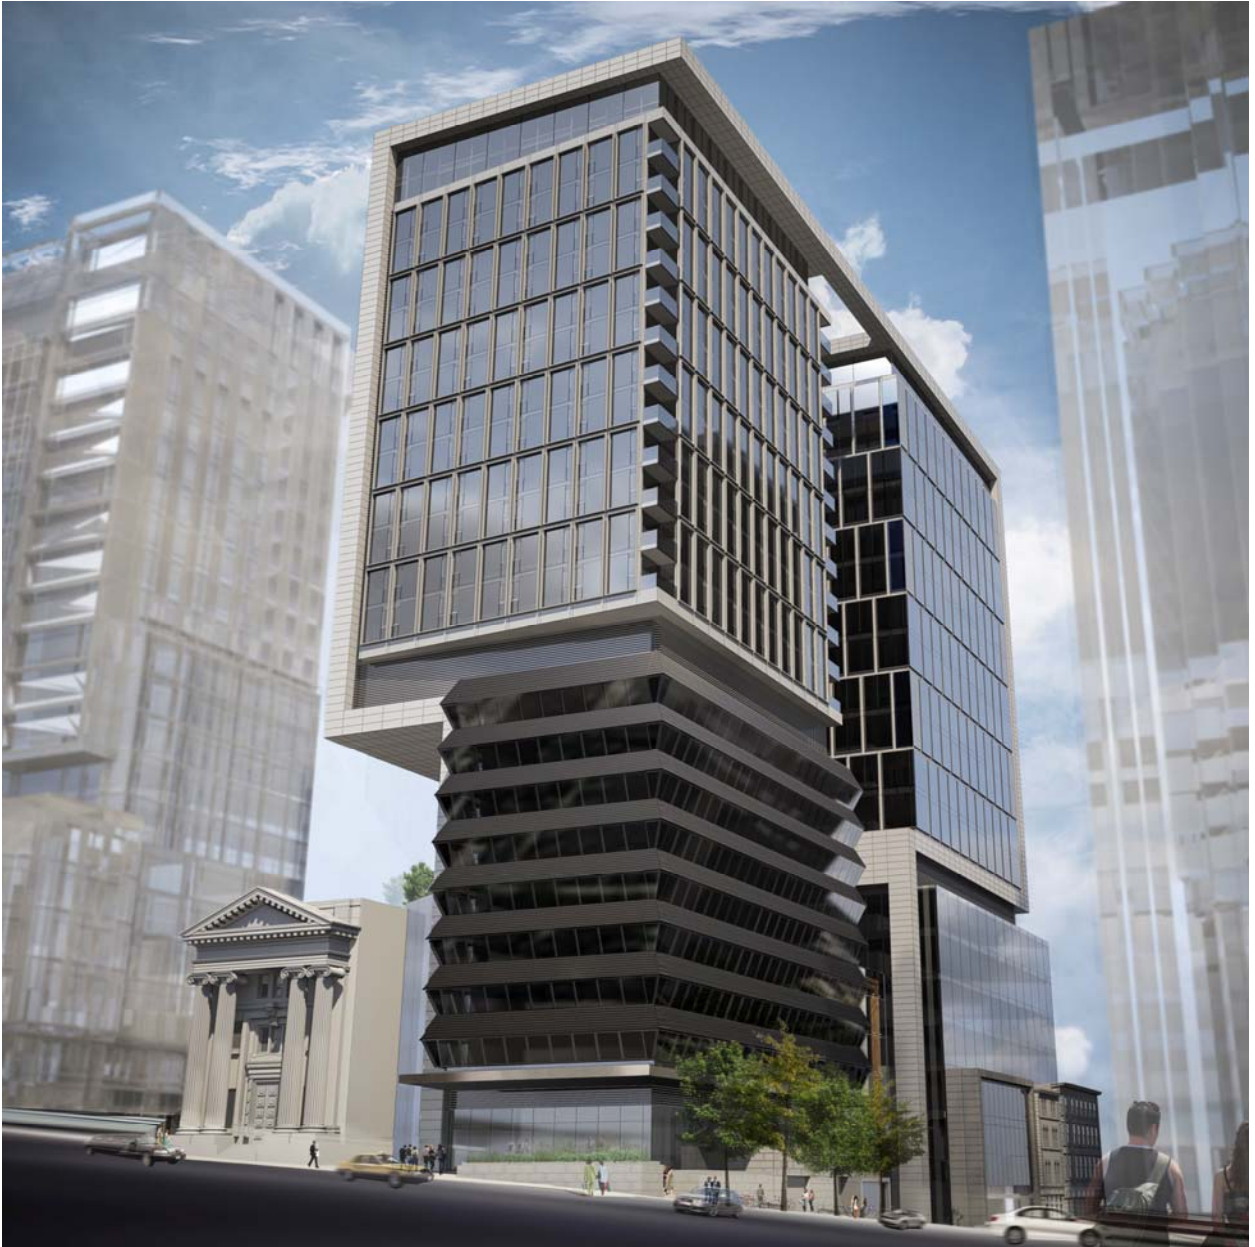
View of South facing façade from Hollis Street.

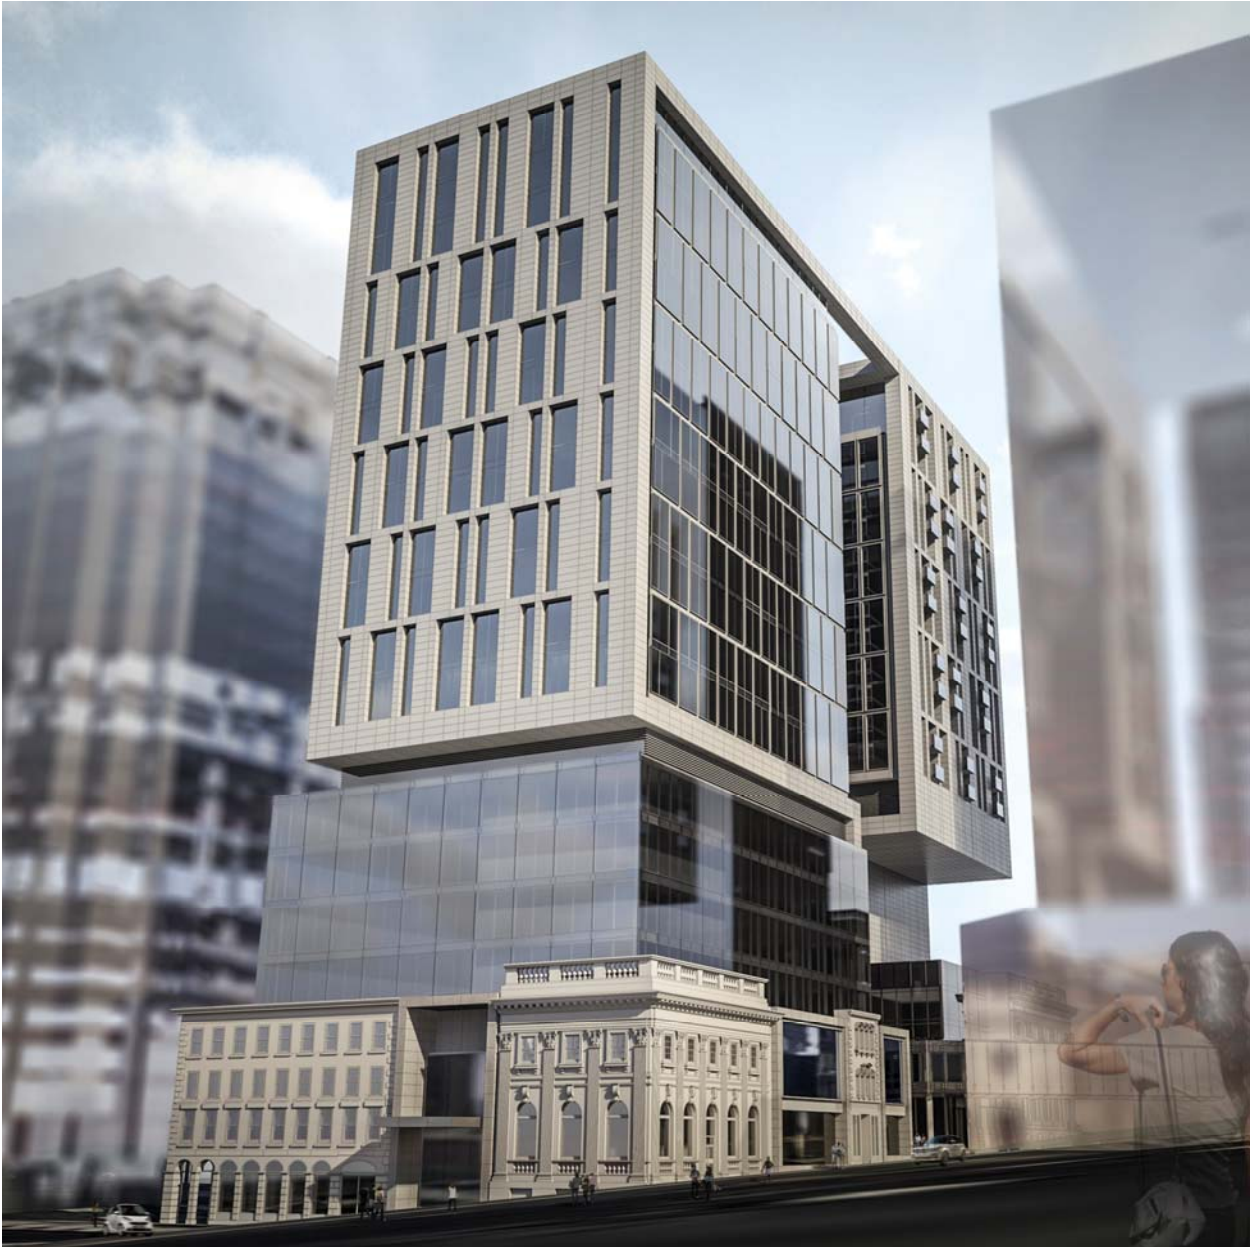
View of North facing façade along Granville Street.

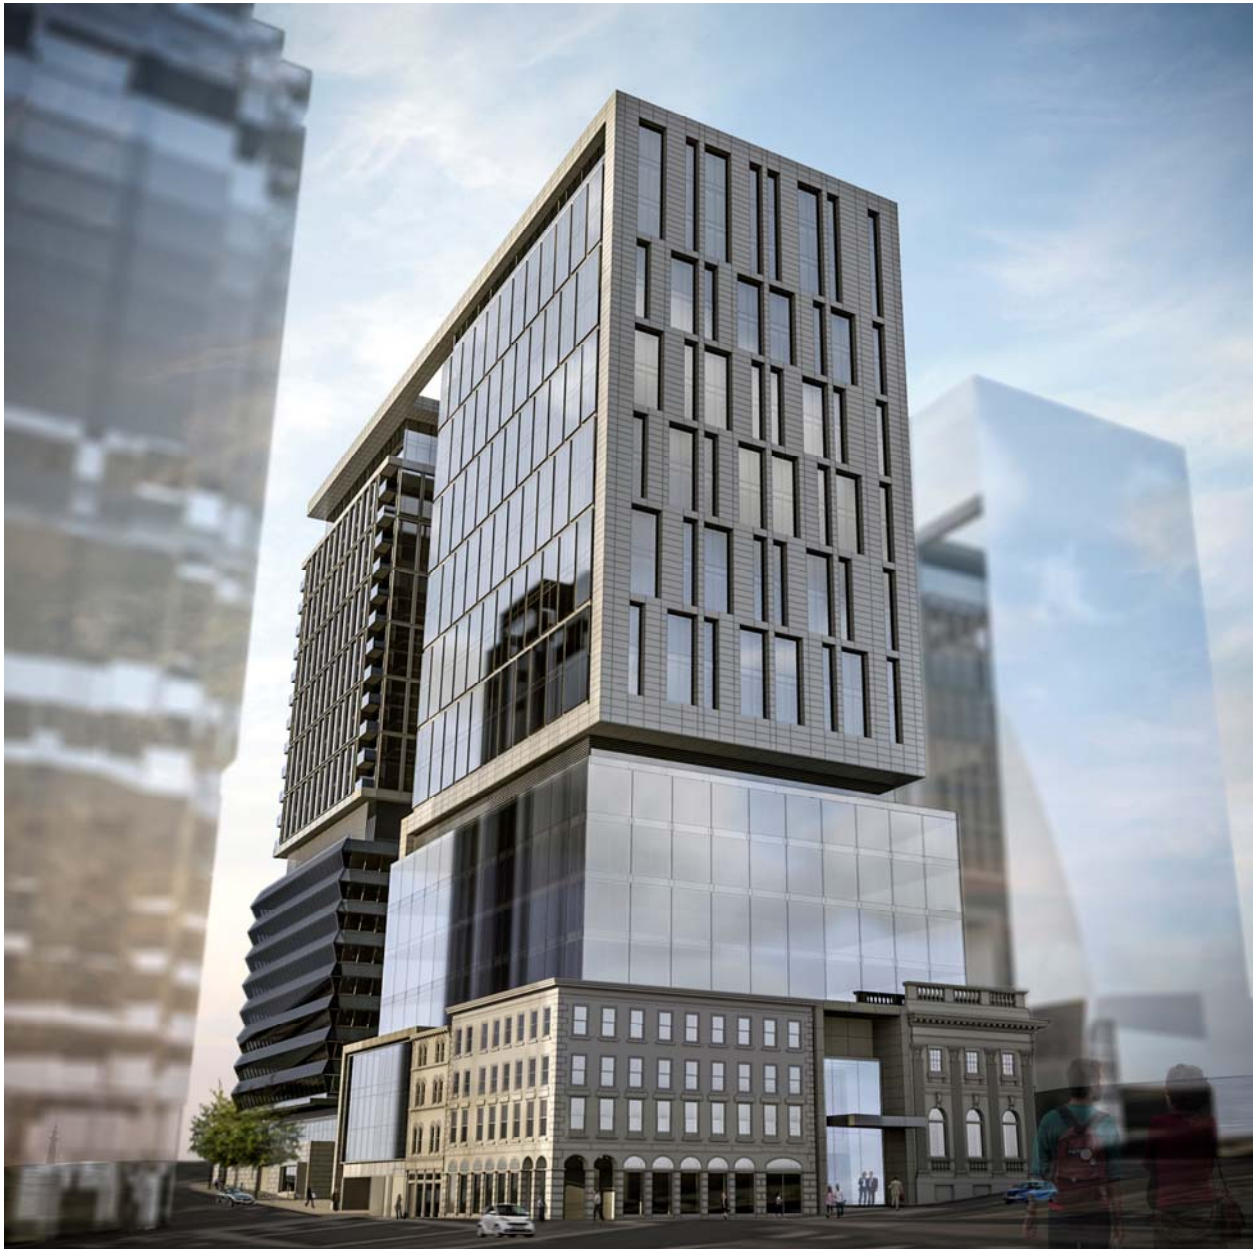
View of North facing façade along Hollis Street.

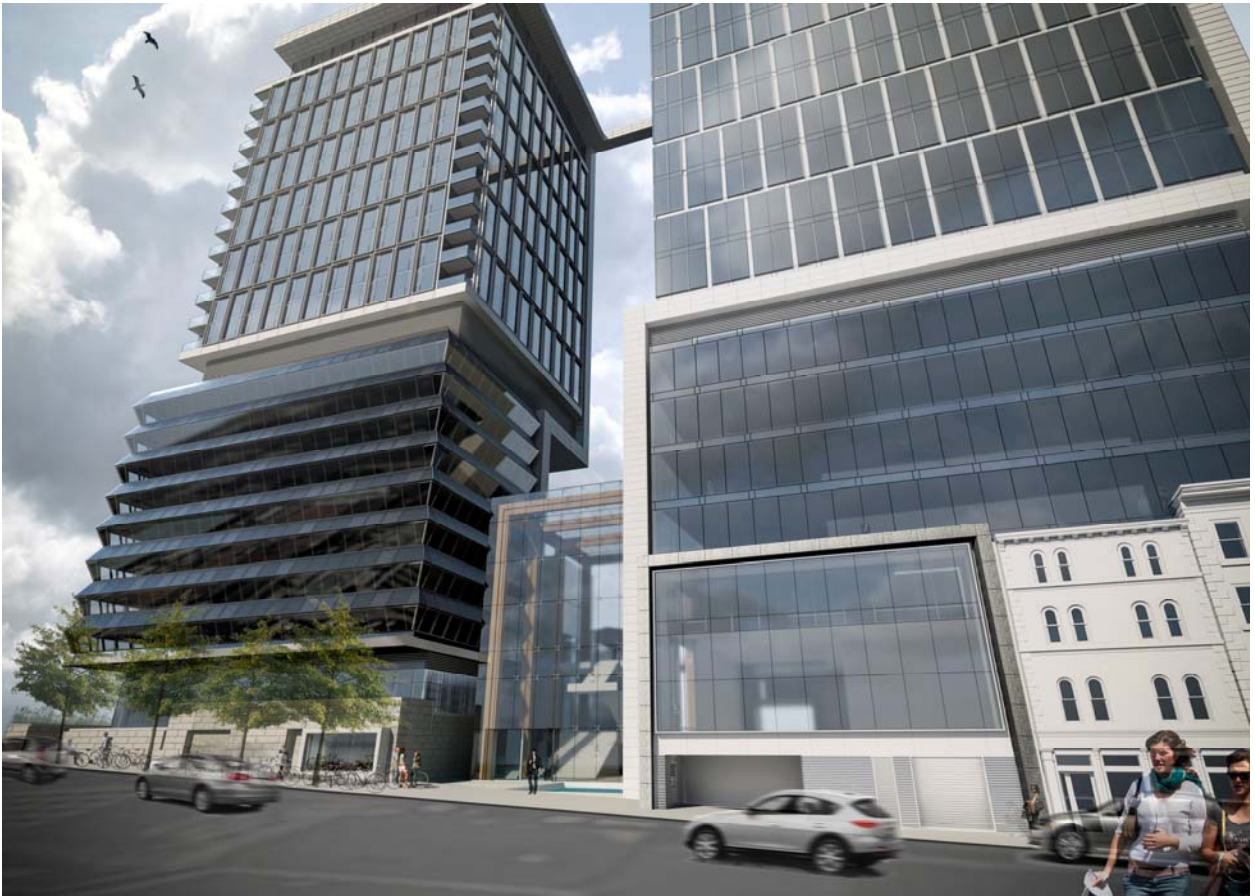
View of Plaza and Atrium facing Hollis Street.

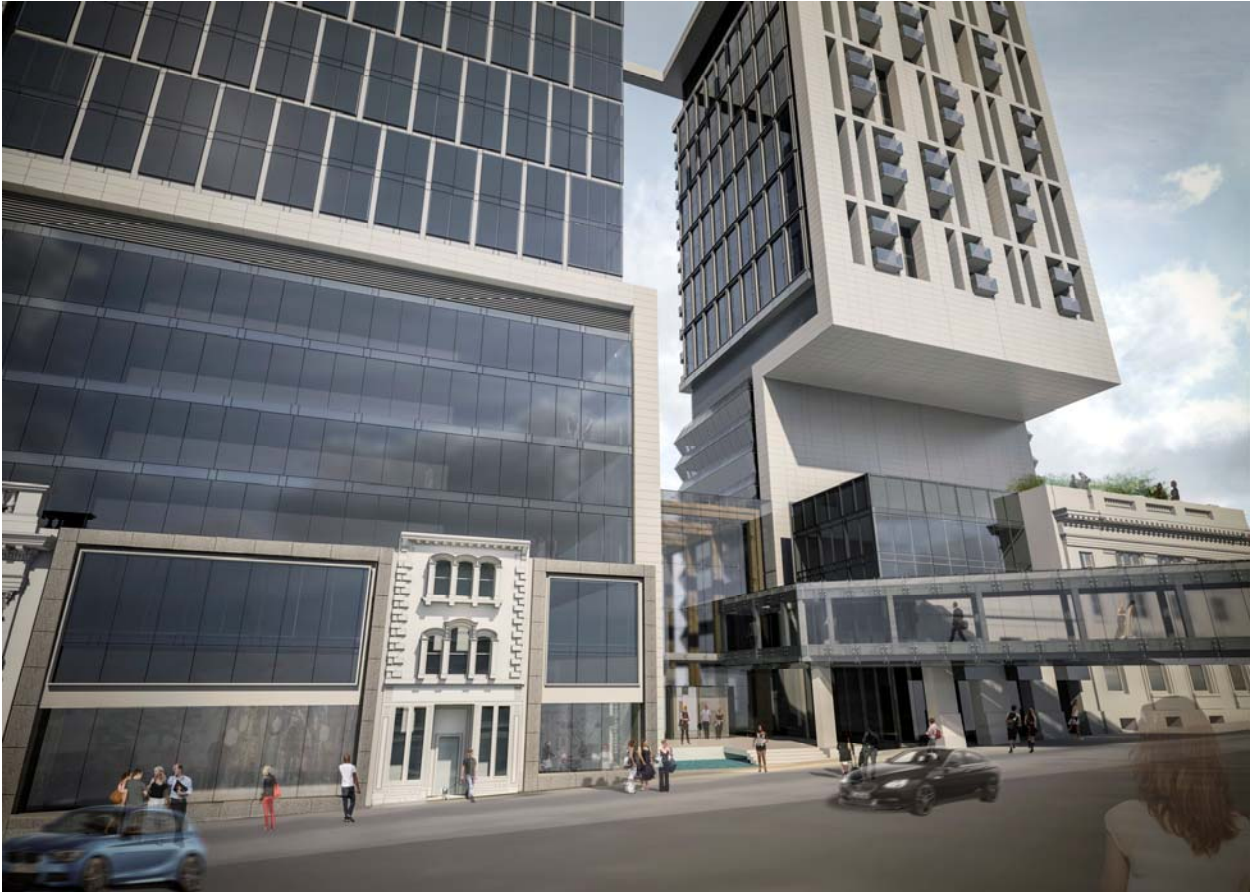
View of West Plaza, Atrium and restored facades along Granville Street.

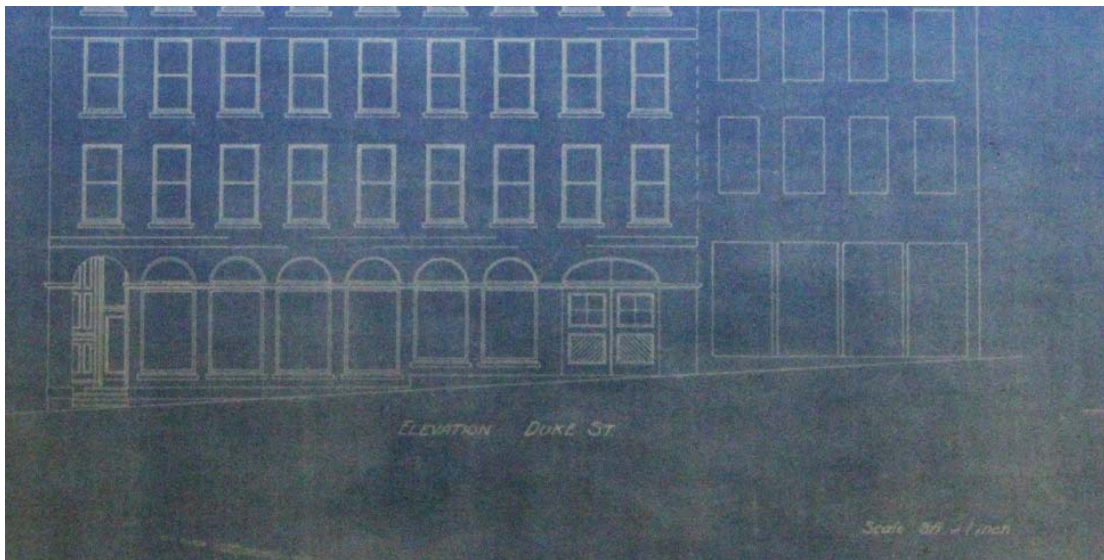
As previously noted in this report, the upper 2 levels of the façade will be removed while the lower 4 levels will be retained and restored. While this solves the logistical challenges during construction, it also offers an opportunity to restore the facades in a manner that will more closely resemble their original and intended appearance. Most noticeably, this will re-introduce the ground floor arched windows, which were arguably the character-defining elements with the greatest impact to the streetscapes. In addition, a new corner entrance will be created at the intersection of Duke and Hollis Street as was intended in a 1911 architectural drawing which was never realized (see image below).

The restoration of the original 4 floors of the Champlain façade will re-establish a consistent streetwall height in relation to its neighbouring heritage buildings, which will be further enhanced and reinforced by the height of the new infill facades, thus creating a consistent streetwall around the block. The restoration of the ground floor arched windows and creation of the corner entrance become viable enhancements made possible as a result of not investing in the reconstruction the upper 2 levels of the façade. If reconstructed, the upper 2 levels

The lower 4 levels, which are to be retained, will be cleaned and repaired. The parged finish, which comprises the majority of the façade, will require remedial repair to conceal stains that have been translated through as a result of rusted wire mesh directly in-behind the parging. Any new parging will be finished to match the existing texture. The entire facade will then be refinished with an appropriate paint coating that can bond to the existing finish. This may become part of an ongoing maintenance program as more rust may continue to become visible.

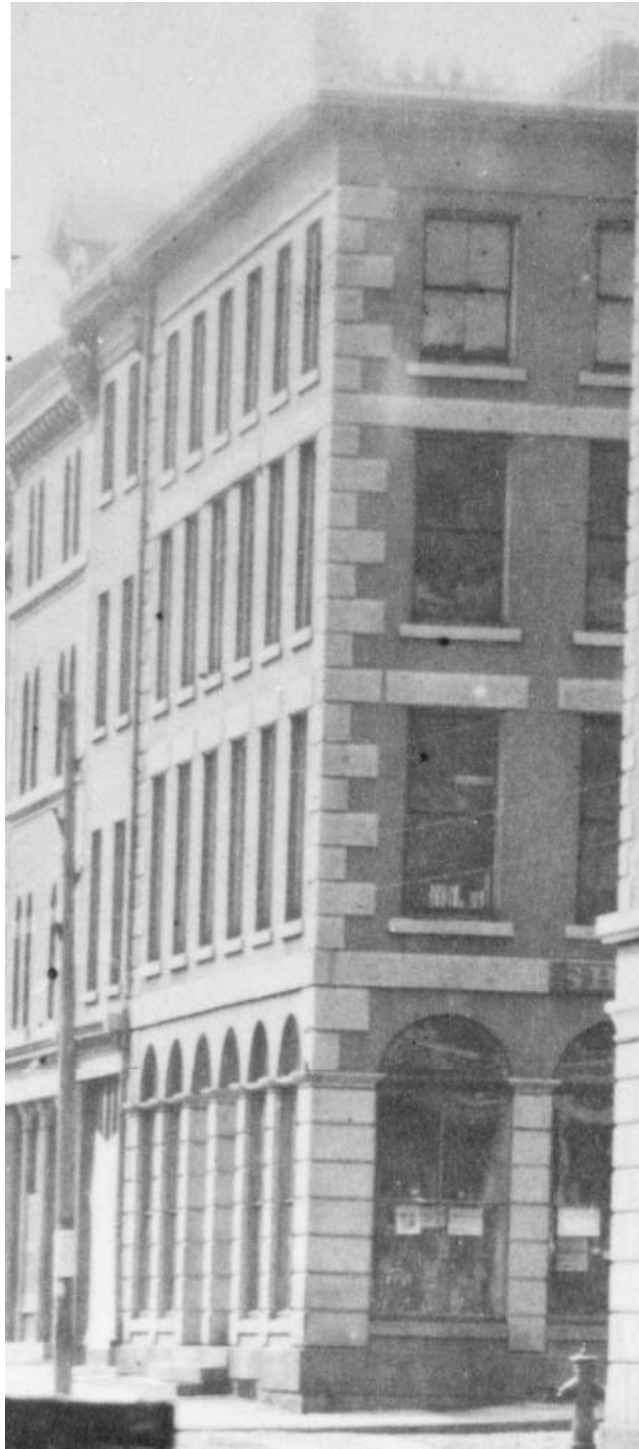
Photo taken in 1871 showing original building including arched windows and frieze/cornice condition

A new frieze and cornice will be constructed along the top of the 4-storey façade which will resemble the original design to the extent that it can be determined from archival photographs (see photo below). The entire façade will have new wood windows installed in keeping with its original appearance. Overall, a restored 4 storey façade of the Champlain Building will recapture much of its original character-defining elements including its ground floor arched windows and its original scale within the block.

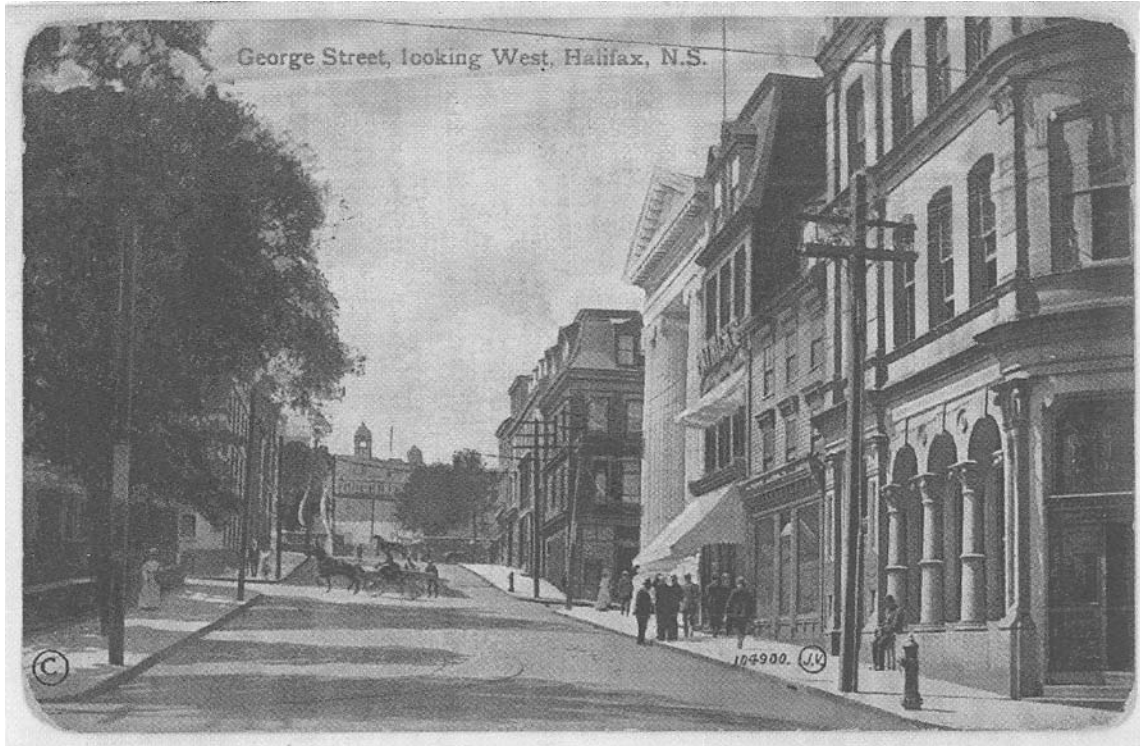
Notes: Single storey addition to the north side of the bank (Granville Street elevation). Part of the alterations included removing a side door (second opening from right in illustration above) and converting the opening into a window. The windows shown at far left are now a door.

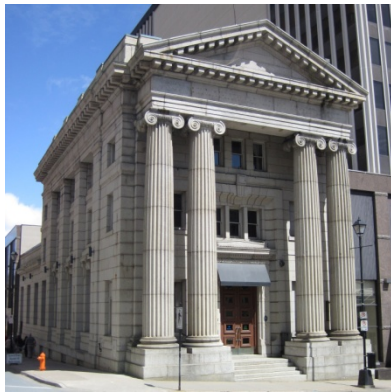
This richly inherited classical building (fig 1) is composed of large granite block units set in coursed construction. It has regular window openings; has a cornice below a balustrade parapet at roof level; is detached column and pedimented at the main entrance elevation. The majority of stone construction is located along the west and south elevations.

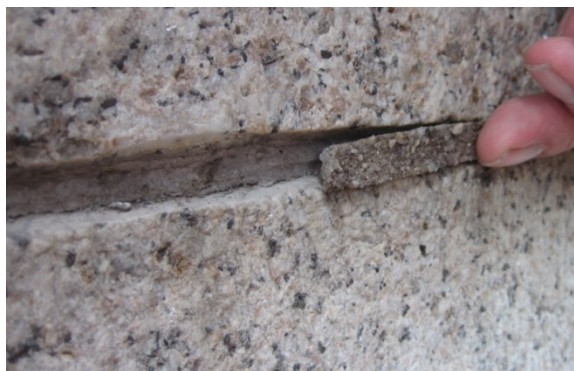
It has been observed that a repointing regime has been completed in recent years. By all appearances, carborundum cutting wheels were used to remove original mortar. This is evidenced by smooth rounded form cuts along observed joints (fig. 2). The joint width has been widened in the process from original joint dimensions between 3 and 5 mm to 6-8 mm. The pointing executed appears only superficial for the most part, with depth of repointing work often only a few mm in depth. The repointing mortar is a brittle and dense mortar that is often observed to be debonded from the granite, likely due to improper preparation of the joints before applying mortar. The original mortar behind this repointing material has been observed to be both voided as well as full. Vertical joints are felt to be largely voided.

Fig 2. Note shallow repointing, lack of bond, widening of joints

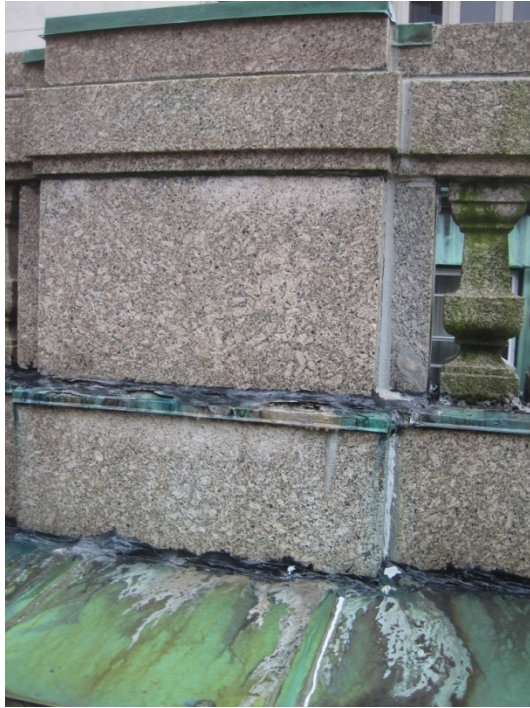
been a history of patching the mortar joints, using both caulking and gobs of tar during at least two desperate attempts to curtail the infiltration of precipitated water. That the precipitated moisture is travelling through the wall is witnessed by the fact that the face of the projecting cornice is dry while under it, at the wall, saturated joints with biogrowth and alkali cement white staining is present. It is obvious that water moves downward at the parapet location and straight into the masonry wall below.

Fig.2. Precipitate salts from water infiltration. Caulking and tar in efforts to stem falling water through the masonry.

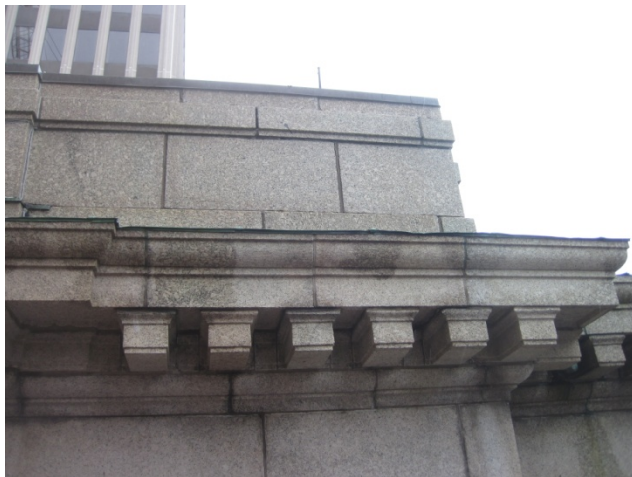
Fig. 3. Substantial lateral movement of the parapet wall.

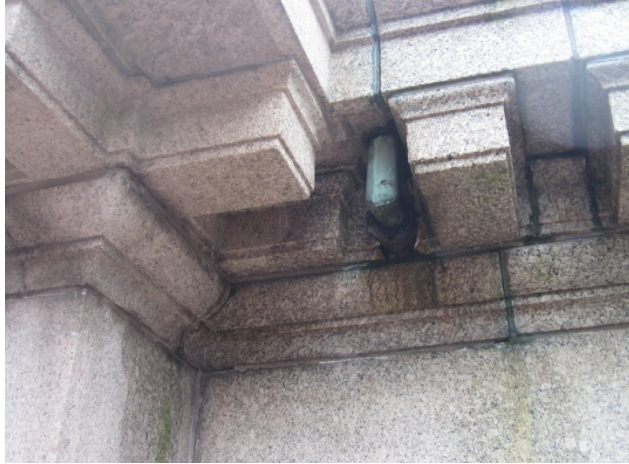
The down pipe drain system at the southwest corner junction of the main elevation is also contributing to problem of water infiltration (fig. 4).

Fig. 4. Down pipe dysfunction. Masonry spreading as witnessed by joint movement. At very left, fracture of moulded stone a result of exerted lateral forces.

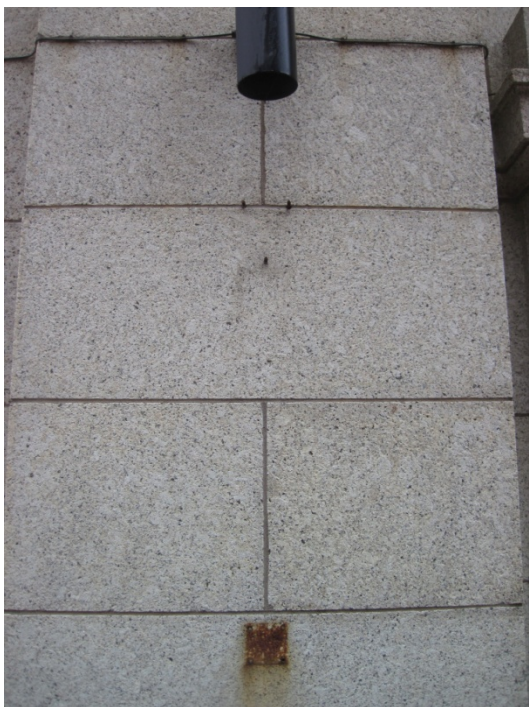
Ferric staining streaks specific areas of the masonry, usually on the down side of embedded anchors or fasteners used for restraining both obsolete and current utility wires and conduits (fig. 5).

Fig. 5. Ferric staining marking otherwise clean wall.

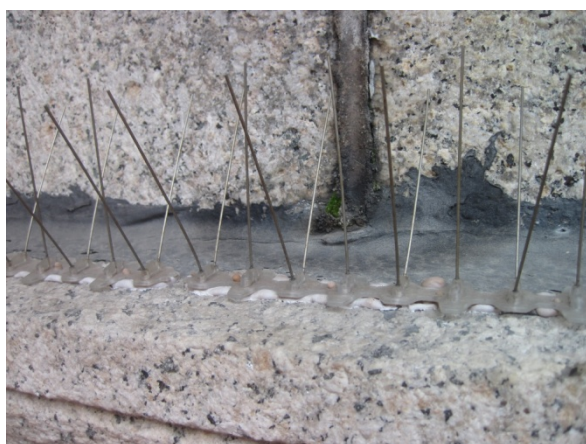
The second form is moss, which is growing out of the mortar joints throughout the saturated areas of upper masonry describe above. Moss will grow thick in such ideal conditions of moisture and alkali conditions fed by the joint mortar (fig. 6).

Fig. 6. Note the growth of moss in the saturated mortar joint. Also, typical bird deterrent and related tar adhesive to typical at top of ledges.

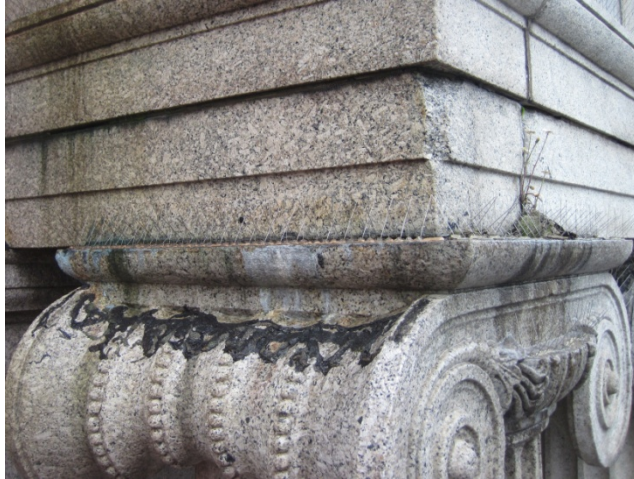
Fig. 7. Bird deterrent gel of tar ingredient. Note also the spreading joint at front face, and plucked stone loss at corner due to movement pressure.

Removal techniques and materials would include freezing with CO₂, organic solvents such as toluene or xylene in poultices, with some assistance with microabrasive systems such as Rotek.

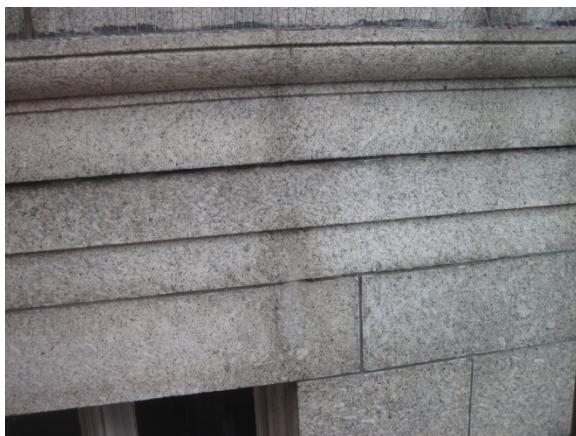
Granite has very high compressive strength resistance, but poor flexibility. As a result, vertical fractures through the considerably dimensioned bodies of stone can be observed where point load or eccentric load forces within the masonry wall take place. We have several examples of fractured or crack stone on the building. The most significant is found at the upper wall portion of the west wall where it meets the front elevation. Forces, presumed to be related to saturation and freezing of the wall core or possibly structural steel expansion have caused a vertical crack running through several courses of stone (fig.8).

Fig. 8. Difficult to see, but vertical crack at window upward.

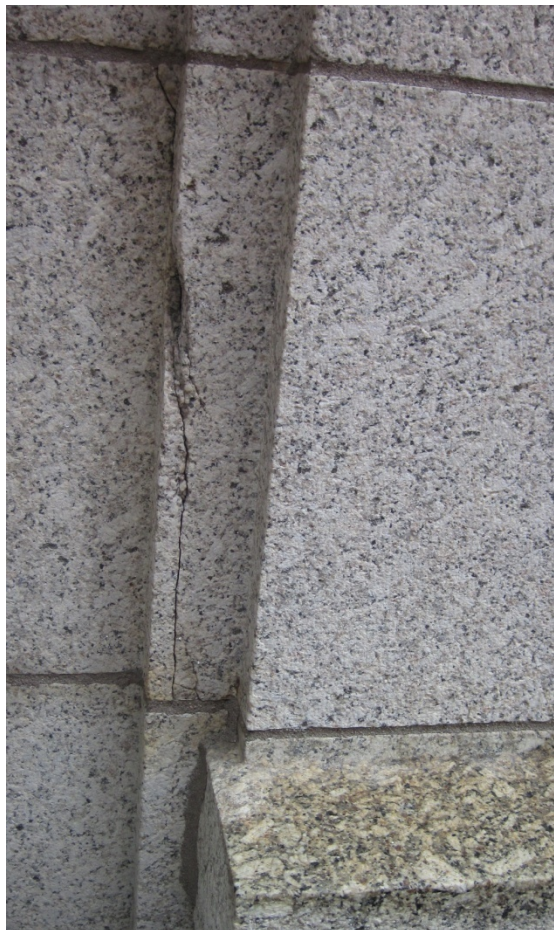
Small cracks and fissures are quite isolated and related to very location-specific issues of stress. This building does not display losses of any major note related to cracking or fracturing (fig.9).

Fig. 9. Fractured stone due to isolated loaded of stone along vulnerable detailing.

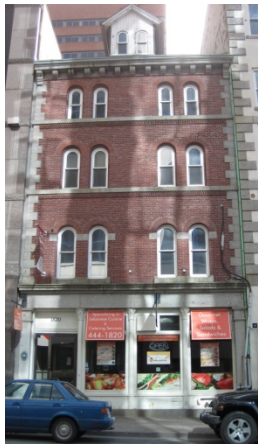
Fig. 10

This four storey building is simply put together with a non-masonry lower first shop level and an upper three levels of brick wall and window openings with local dressed Halifax granite forming string courses, quoins and upper cornice/roof level (fig.10). All the masonry is in very good condition.

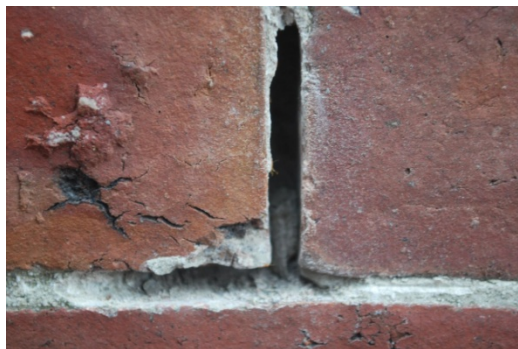
The mortar joints of the brickwork appear to be a soft sympathetic type, though the depth of the most recent repointing does seem to be shallow and rather superficial. Cut testing into the joints during the investigation, it was observed that the front mortar, while mostly soft and easy to remove, was also brittle and slightly over pointed onto the faces of the brick work (fig.11). The vertical head joints are felt to be largely voided. This latter condition is quite typical with traditional construction and is not really considered an issue unless there is a deterioration related to the condition.

Fig. 11. Behind the recent front pointing which is shallow placed, we see the original mortar is remains voided and will require better repointing supervision next time.
