Item No. 9.1
Halifax Regional Council
April 29, 2014

SUBJECT: **Case 19046: Appeal of the Design Review Committee Substantive Site Plan Approval for 22nd Commerce Square Development, Halifax**

Appeal of the Design Review Committee's February 13, 2014 decision on a development proposal for the lands bounded by Hollis, George, Granville, and Duke Streets, Halifax.

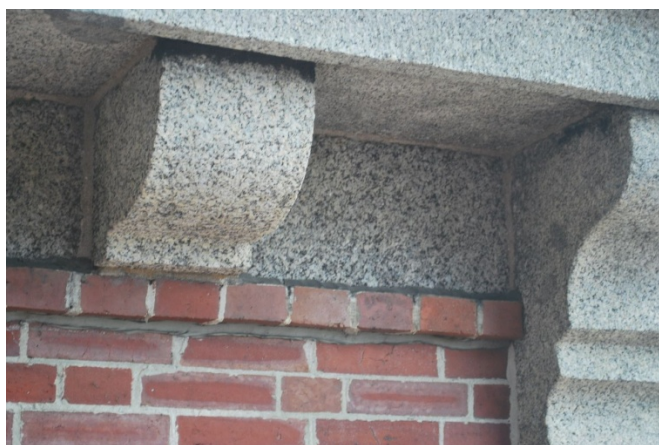
There is some repointing at the upper granite course and into the top few courses of brick masonry which is of a dense Portland cement mortar. It is felt that this represents a very recent attempt of ill-informed mortar mixing and installation to fill a prematurely deteriorated set of joints at the very exposed gutter area (fig.12).

Fig. 12. Hard dense repointing mortar located at the upper granite and first course of brick. This suggests needed maintenance work to keep joints sealed in. However, it may mean another issue of leakage at roof and gutter is present.

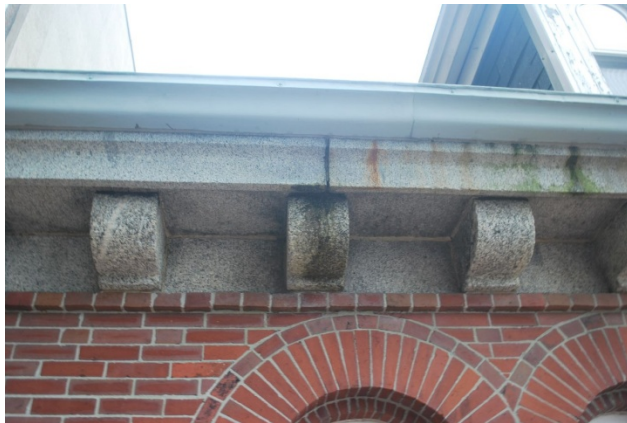
The masonry is clean and does not require attention except for general rinsing. It is most likely that the building was recently cleaned. Some streaking over the surface of the bricks suggests an acid cleaning system was used. While unfortunate, the streaking is not related to any issues related to deterioration, at least on this first inspection. Some minor staining of iron, and some biogrowth film is seen at the upper roofline gutter course, but only light cleaning with chemical and the application of Algaecide is necessary (fig. 13).

Fig 13. Showing ferric staining, biogrowth and other general forms of surface dirt on the surface of the gutter level granite. Each can be removed with relative ease.

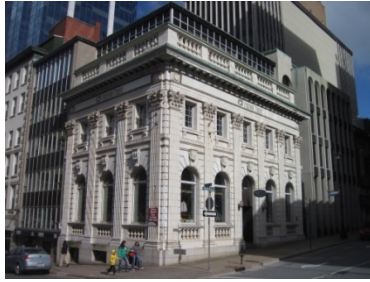
Fig. 14

This fine example of terracotta construction is in advanced state of deterioration at specific areas of its architectural elements (fig.14), most prominently in the upper area of the cornice and balustrade attic level, as well as the northwest corner from top to bottom (fig. 15).

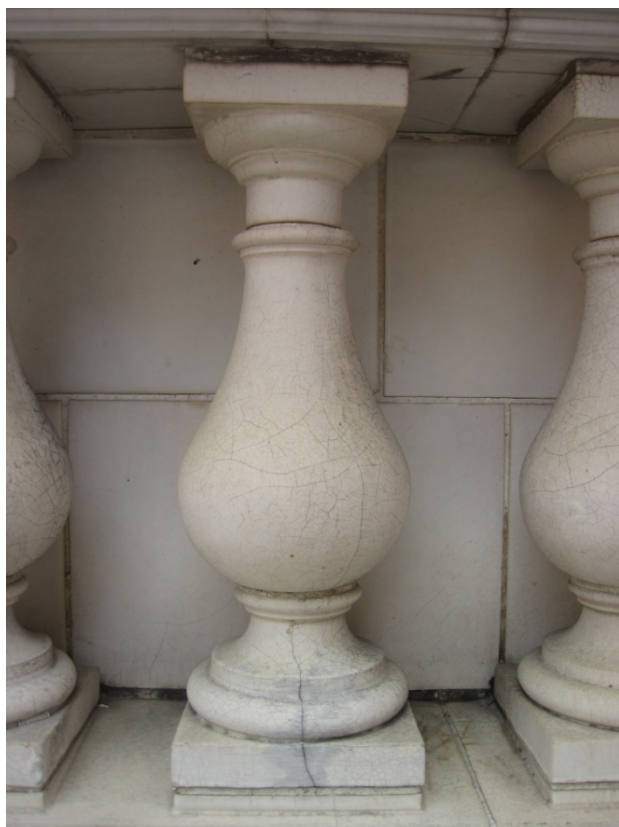
Crazing of the glazed surface, which is present on the Prenor Trust building terracotta units, does not necessarily indicate an issue of poor terracotta as long as the biscuit has a similar porosity as the glaze. In fact, fine spider webbing of the terracotta surface can simply indicate a shrinkage issue that occurred at the glaze soon after firing and cooling. Atmospheric dirt settling in the hairline marks can enhance an otherwise innocuous condition. However, it is only by testing the porosity and vapour characteristics of the terracotta that will determine if this is an issue or not (fig. 16).

Fig. 16. Showing typical hairline crazing of terracotta surface.

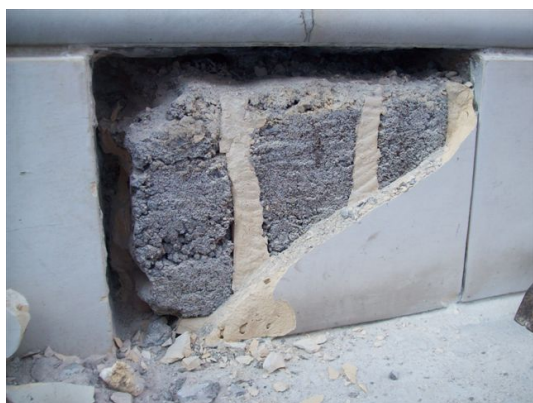
suggest that such thorough filling of cavities of the terracotta units will have contributed to the en masse failure of terracotta masonry units in the upper cornice and parapet levels. It is hoped that current materials testing will detect whether the grout that was used has expansion characteristics. Even if this is not found to be the case, the fact that the grout filled the cavity so completely means that any water that entered the space will have had little room to escape by draining (called ponding) or to expand when frozen.

Fig. 17. Showing grout (and brick) filled core of terracotta unit.

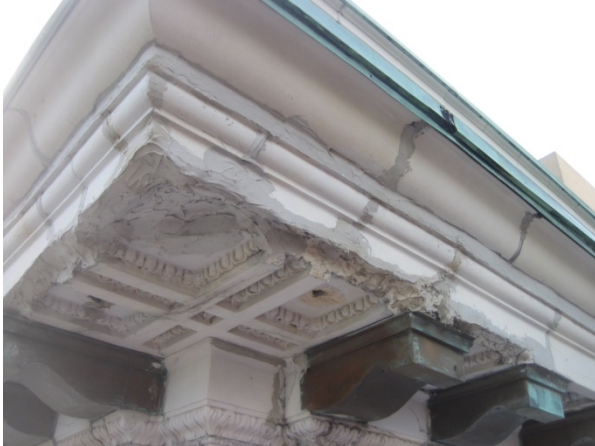
This material has been use without much apparent preparation, being simply pushed onto seriously damaged terracotta surface with the hope, it would seem, of holding pieces of terracotta from falling away. The intervention is unsightly and will have had only minimal value to stopping deterioration. It is in fact dangerous in many instances (fig. 19).

Fig. 19. Polyester resin, essentially auto body repair material used to adhere and patch severely deteriorated and dangerous overhanging terracotta.

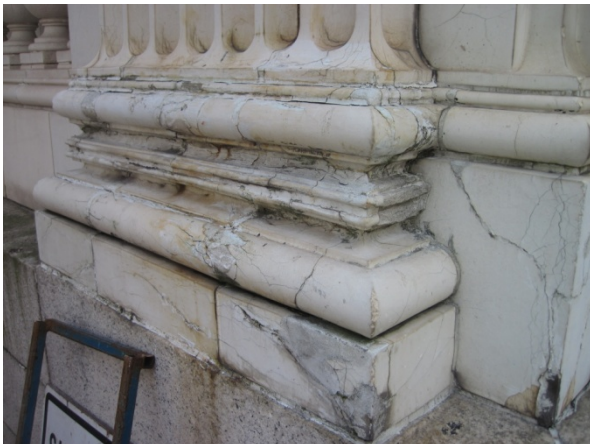
Fig. 20. Showing excessive use of polyester resin repairs. The condition of the terracotta is far beyond repair.

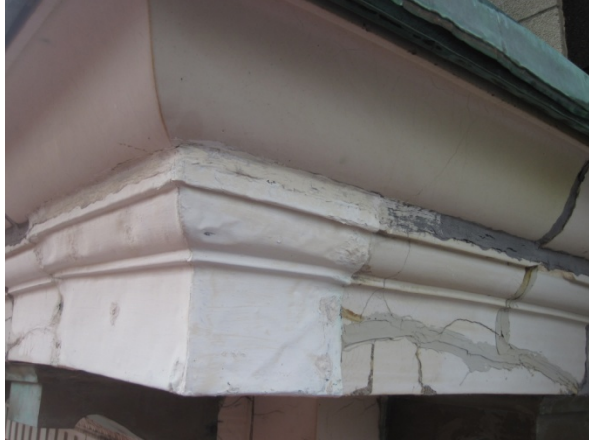
Sheeting has been used to cover seriously fractured terracotta units in what appears to have been an effort of providing an exterior adhere restraint structure. Again, the help it provided is questionable and the dangers that it added by over-optimism are apparent (fig. 21).

Fig. 21. Showing sheet metal tin to repair, conceal, and replace

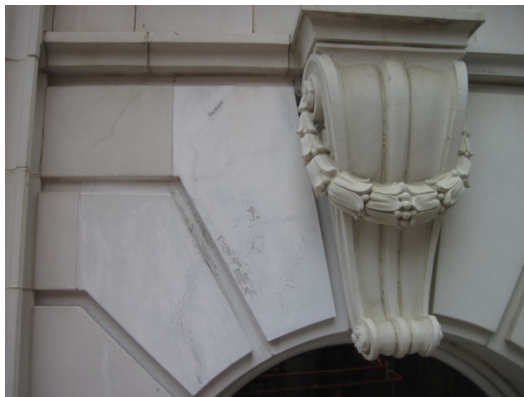
Fig. 22. Painted surfaces. Possibly to hide the extensive repairs completed with dark filler material that is just visible under the paint surface. Not successful.

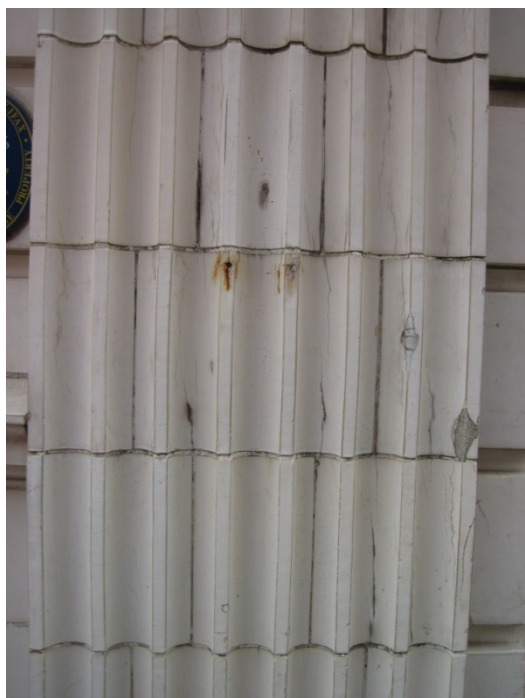
Fig. 23. Fissures and spalls, some previously filled with mismatching materials and colours, can be made good by cosmetic conservation repairs.

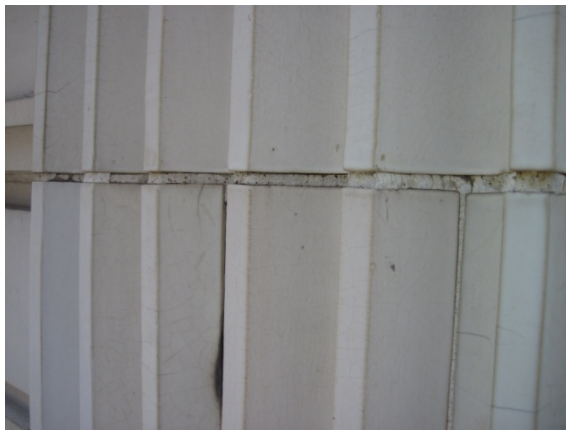
Fig. 24. Original mortar. Showing weathering, cracking, attrition.

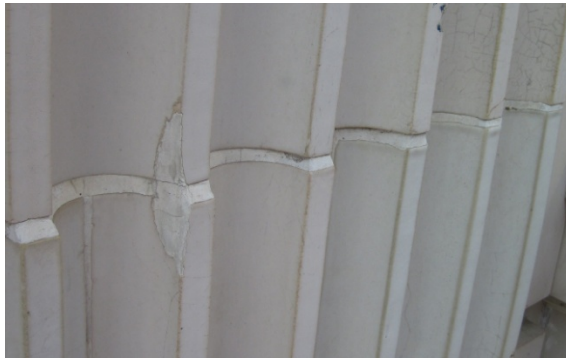
Fig. 25. Showing repointing of joints with hard and impervious polyester resin, a material often observed for filling patches in the terracotta as well.

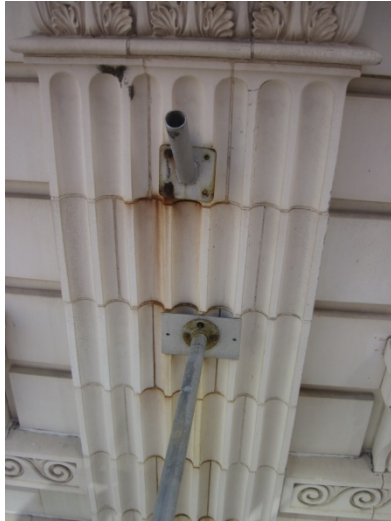
Fig. 26. Ferric staining from fasteners used to anchor fixings.

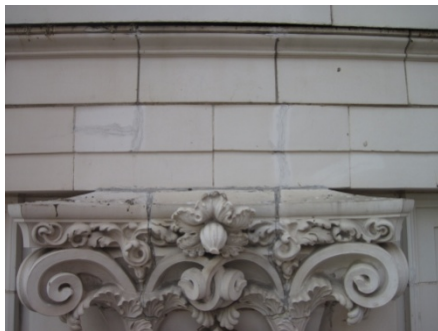
Fig. 27. Typical twin vertical cracks or fissures observed above Coninthian Capitals. Further consideration of this issue by a Conservation Engineer is recommended.

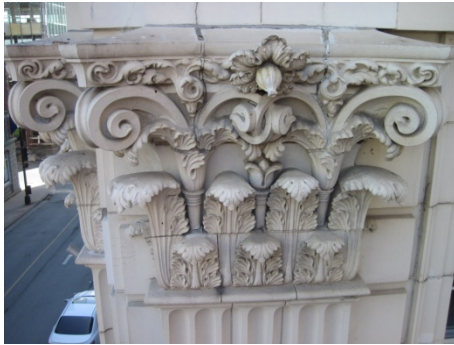
Fig. 28. Corinthian Capitals are all in good preservation with only minor forms of conservation repairs required.

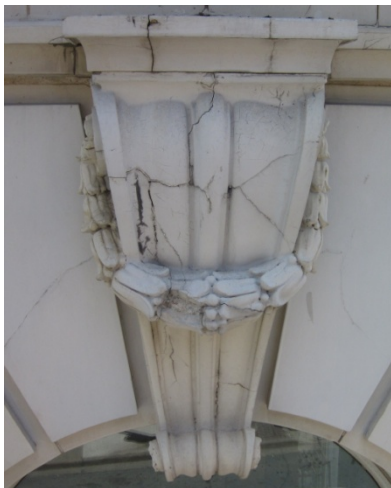
Fig. 29. Decorative key stones are all in good preservation except this one at the north elevation, west side. Major fracturing will mean replacement is necessary.

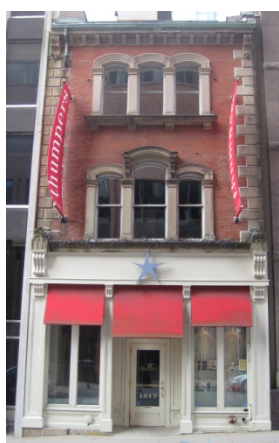
Fig. 30

A sophisticated small three storey building with non masonry forming the street storey, and brick walled, sandstone trimmed detailing at the middle and third stories (fig. 30). Both the middle and upper levels have decorated tri-partite windows of sandstone trim, the outer quoins are of sandstone, as are the cornice gutter course. The sandstone comes from the Wallace quarry, north shore, Nova Scotia.

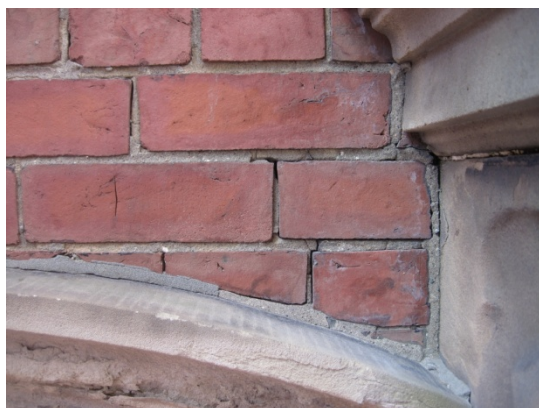
Fig. 31. Showing typical good condition of brick, but poor condition of the joint mortar. Shallow and superficial repointing of the past can be seen here.

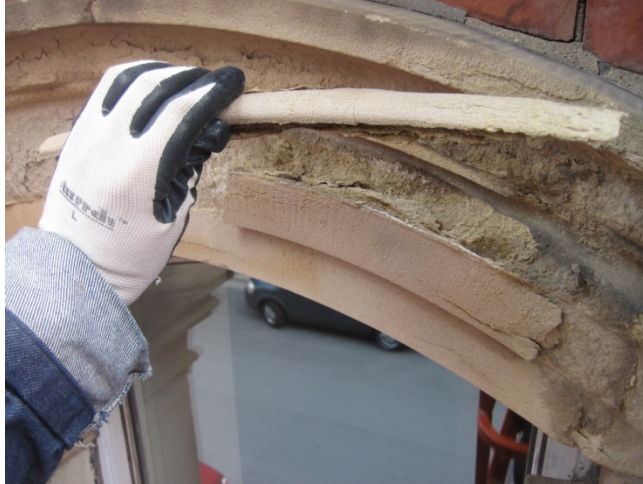
Fig. 32. Major deterioration and loss of decorative moulded window stones. Extensive replacement is necessary.

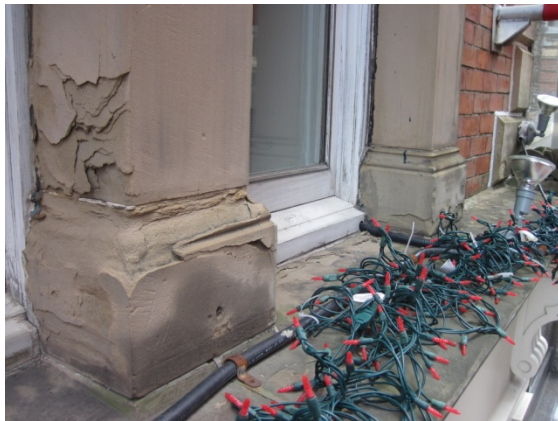
Fig. 33. Major deterioration of decorative surface, despite being properly bedded in natural orientation.

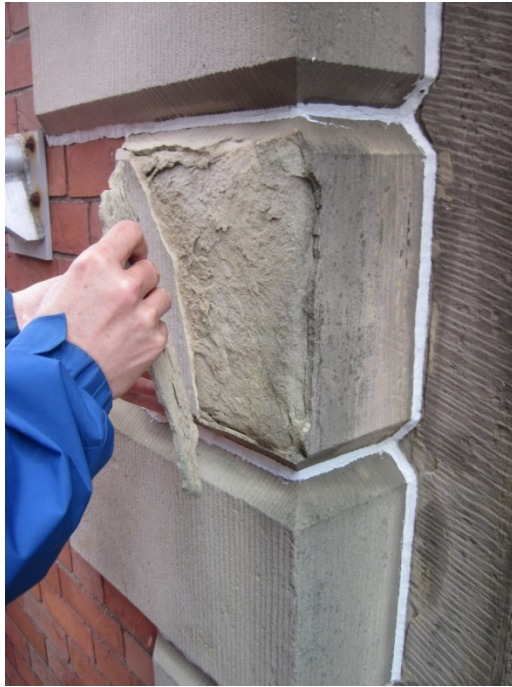
Fig. 34. Quoin stone exfoliation in the extreme.

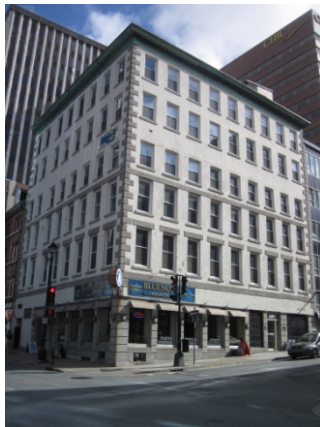
Fig. 35

This large corner building (fig. 35) is little understood. Sometime in the 20th century, possibly 1970's, it was covered over by an extremely hard and dense wire-reinforced render which appears to very bonded to the substrate masonry, which is presumed to be brick. The thickness varies but appears to have a thickness of 25mm. This parged render is brown in colour.

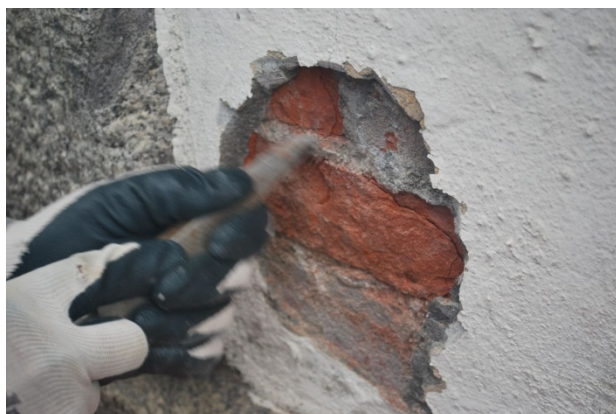
Fig. 36. Small opening suggest, spalled brick covered with a hard render layer (dark colour) and topped with a white polymer coating. Note the adhesions of the render to the original brick face, which would be near impossible to remove if there was any wish to remove render to original brick face.

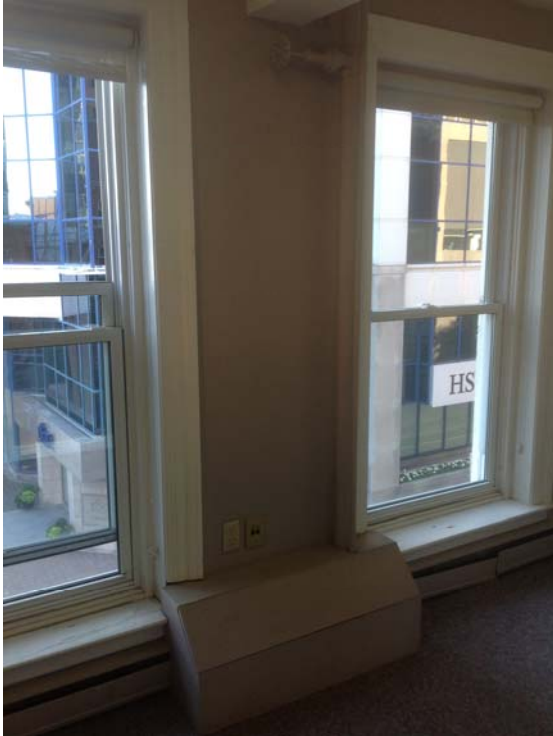
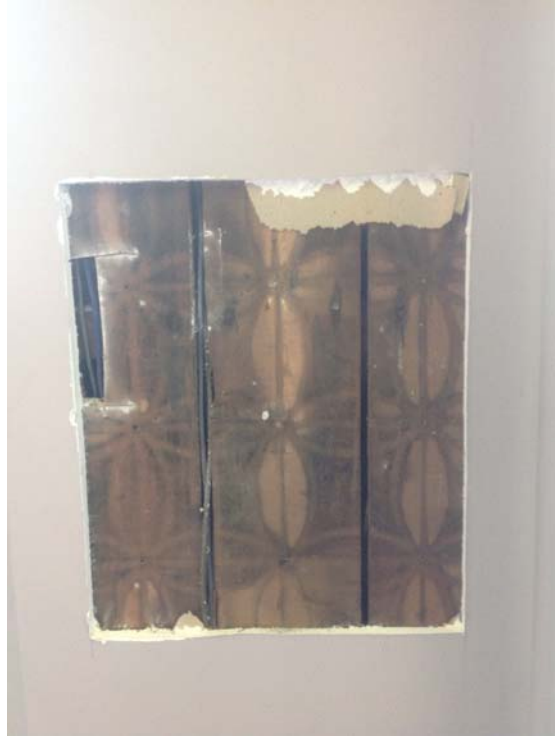
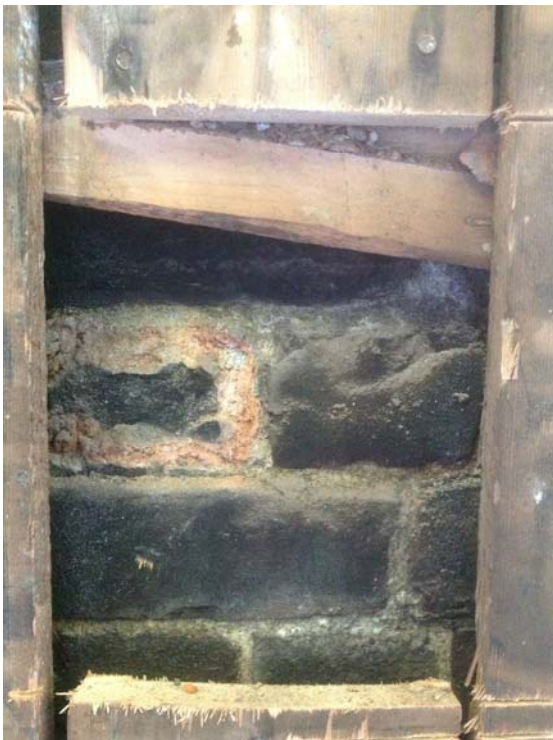
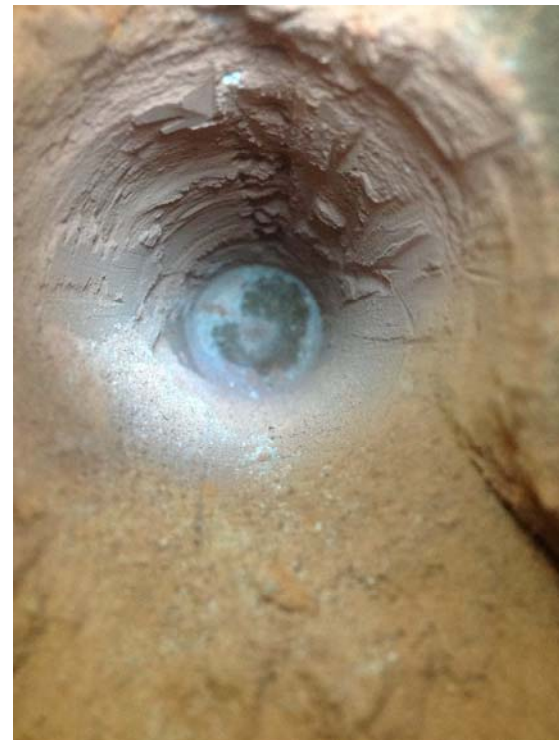
Core #1 Photos 1 – 4.

Core #1 – South Façade. Level 3. 5th pier from south. Original Starr Warehouse/Champlain Building Building of 1860.
Photos 1-4.

The conditions found point to at least the inner portions of the façade on the former 1824 Hollis Street being contemporary with the addition above the original Starr Warehouse/Champlain Building. This may differ from the position presented in the current tombstone report. It is known that the former 1824 Hollis Street did not match the adjacent Starr warehouse in terms of window sill and head heights, corner detail and string course detail in 1871. This may point to this portion of the façade being either remodeled or rebuilt in 1911 when the additional two floors were added to the entire building. Available drawings from that time indicate this intention. The brick masonry encountered within core #2 was consistent through its depth pointing to reconstruction as the likely option.

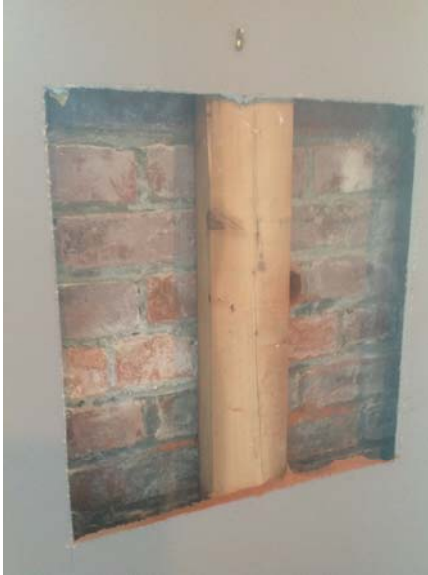
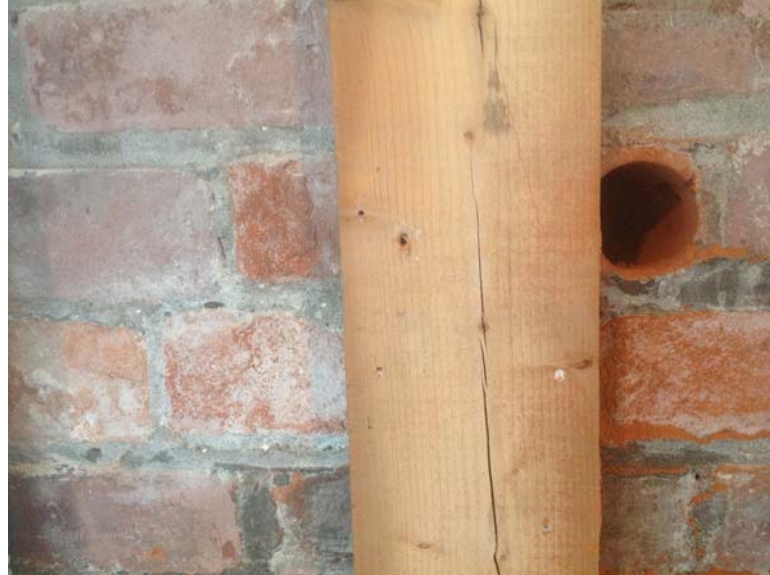
Core #3 Photos 8-9.

Core #3 – South façade. Level 5. 5th pier from south. Addition to Original Starr Warehouse/Champlain Building. 1911.
Photos 8-9.

Assembly Description from Exterior:-

- White Painted Cement Parging varying in thickness between $\frac{1}{4}$ and $\frac{3}{8}$ ".
- Solid, loadbearing Brick Masonry. Brick appeared to be high density (untested). Thickness 16".
- Clean, regular interior surface. Dry. Cement mortar good.
- Air cavity varying between 0 and $\frac{1}{4}$ ".
- 2"x 6" vertical wood studs (appeared relatively new).
- $\frac{1}{2}$ " drywall, taped. Paint finish.
- Total assembly thickness 16 $\frac{1}{2}$ ".

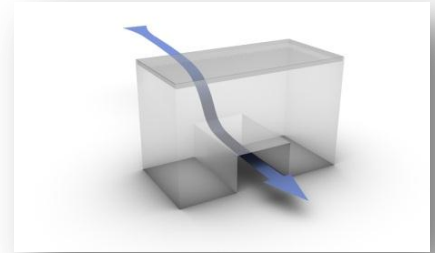
Image 3 – Passage Acceleration

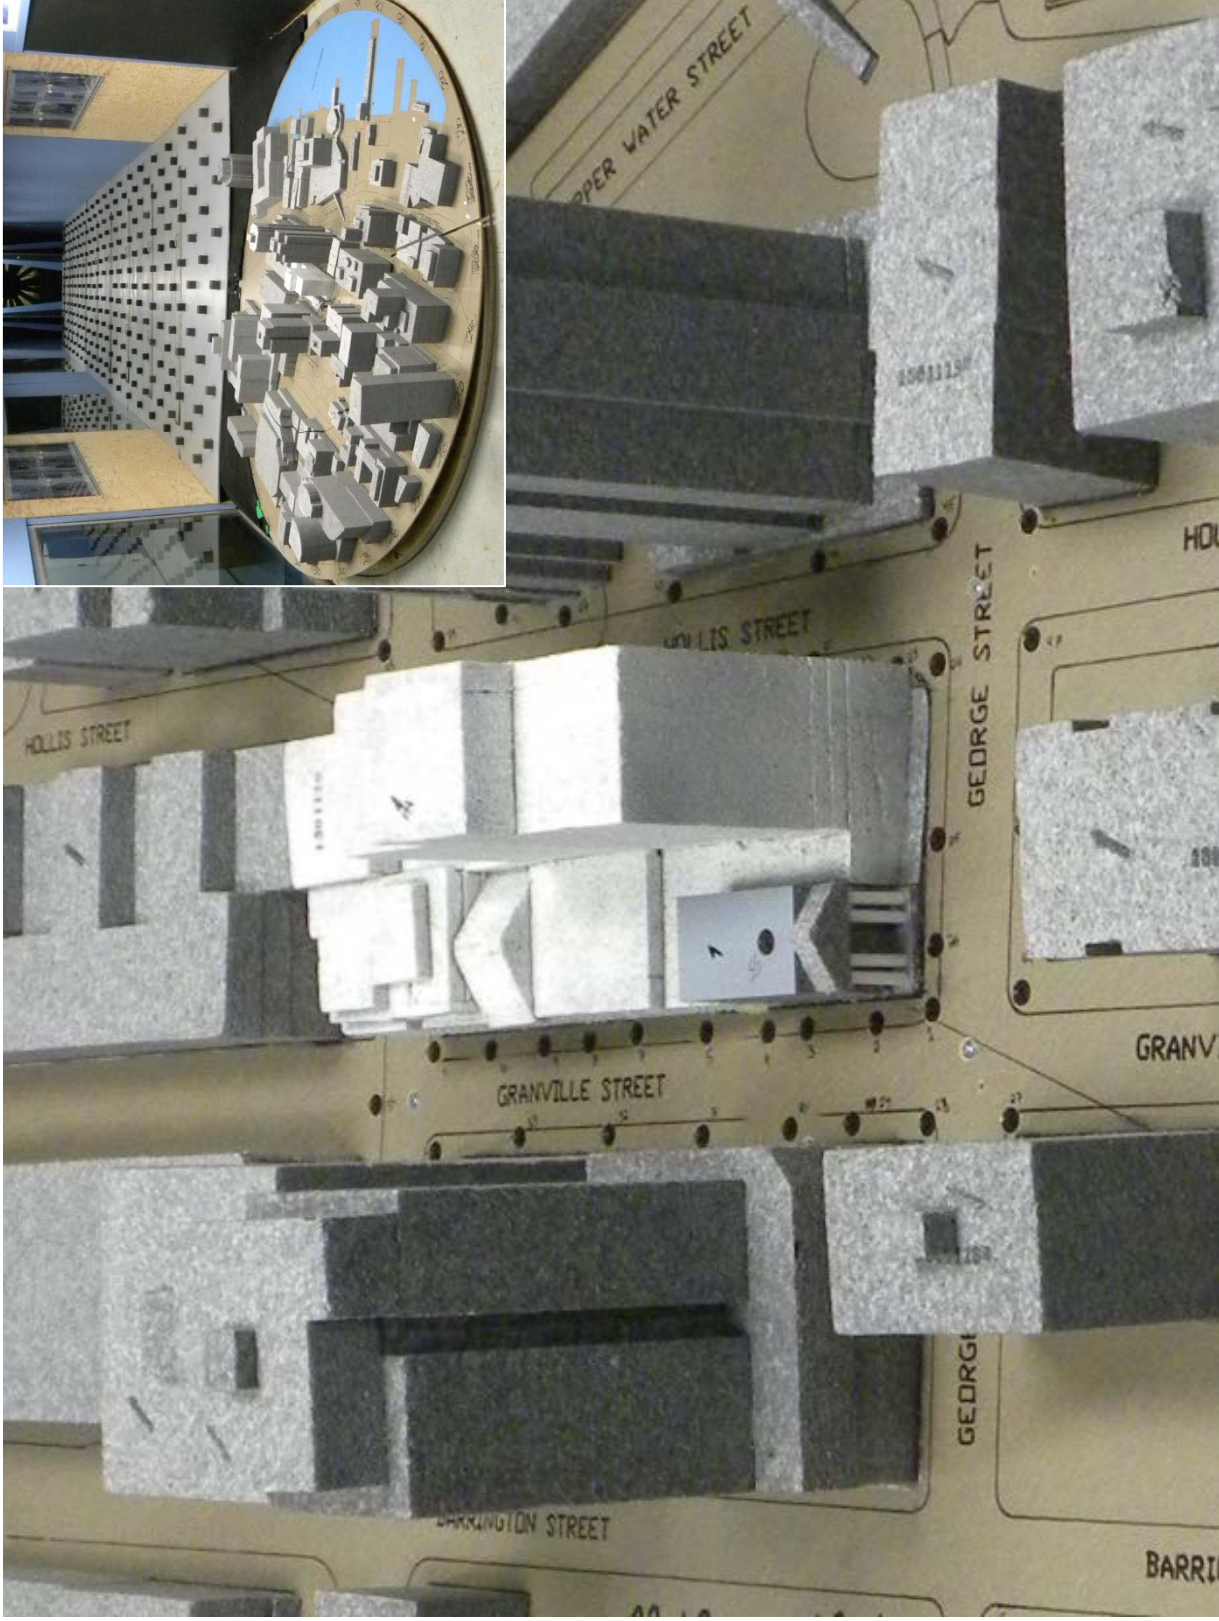
**Wind Tunnel Study Model
Existing Configuration**

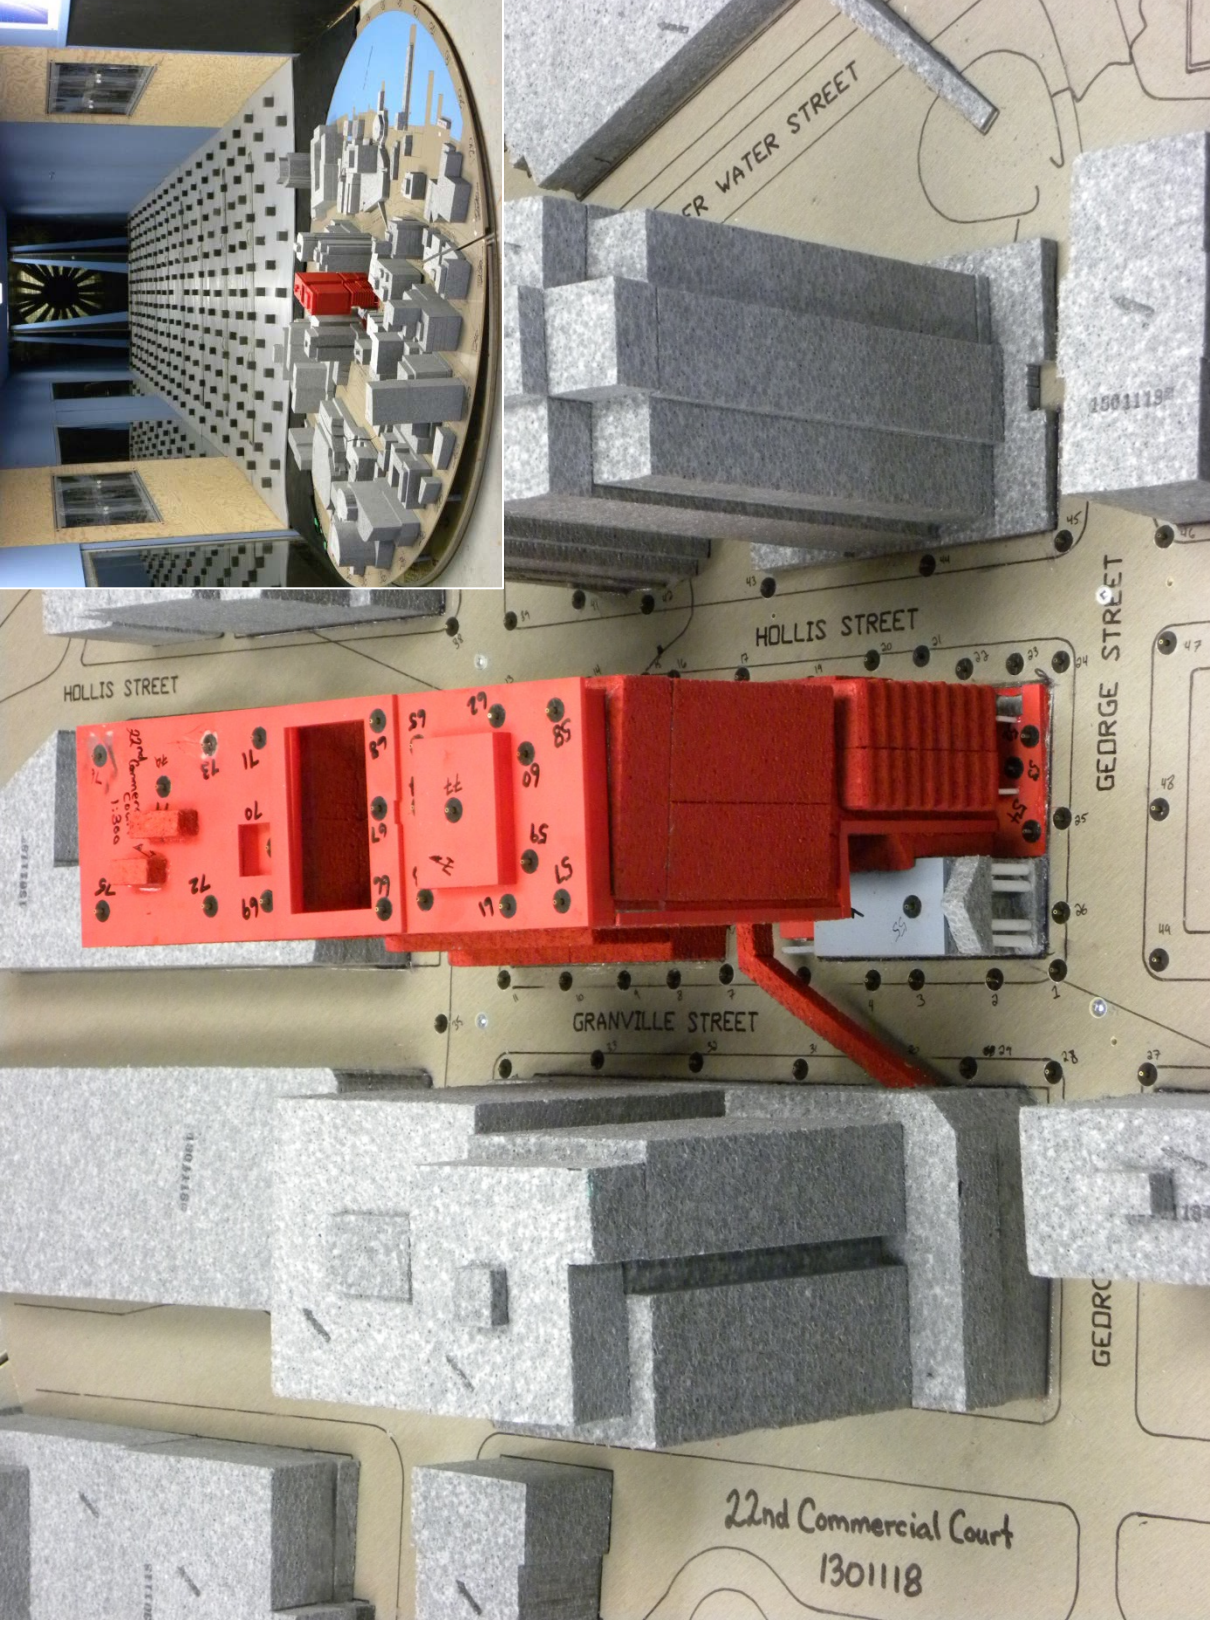
**Wind Tunnel Study Model
Proposed Configuration**

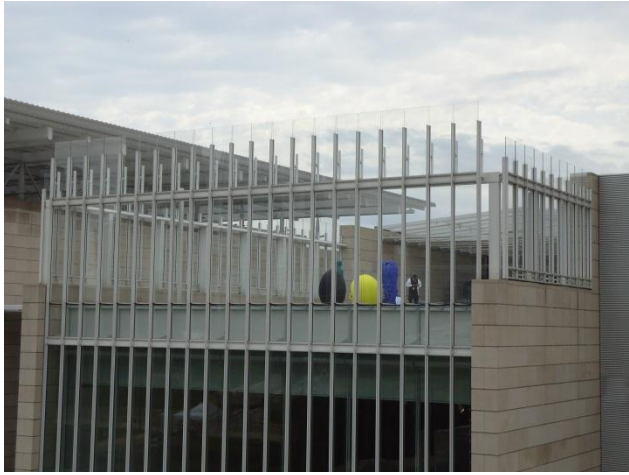
Image 7: Example Extended Parapet

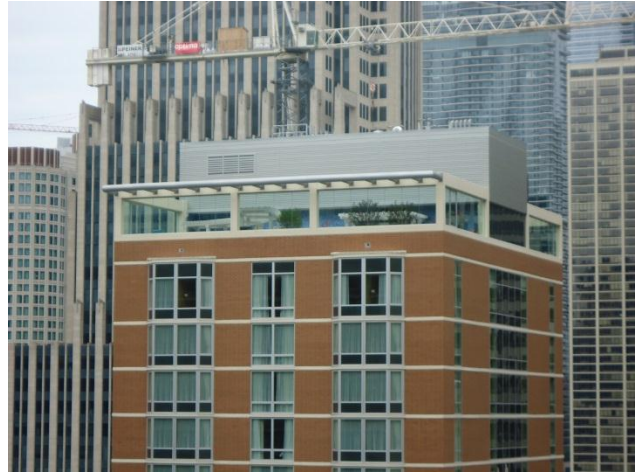
Image 8: Example Extended Parapet

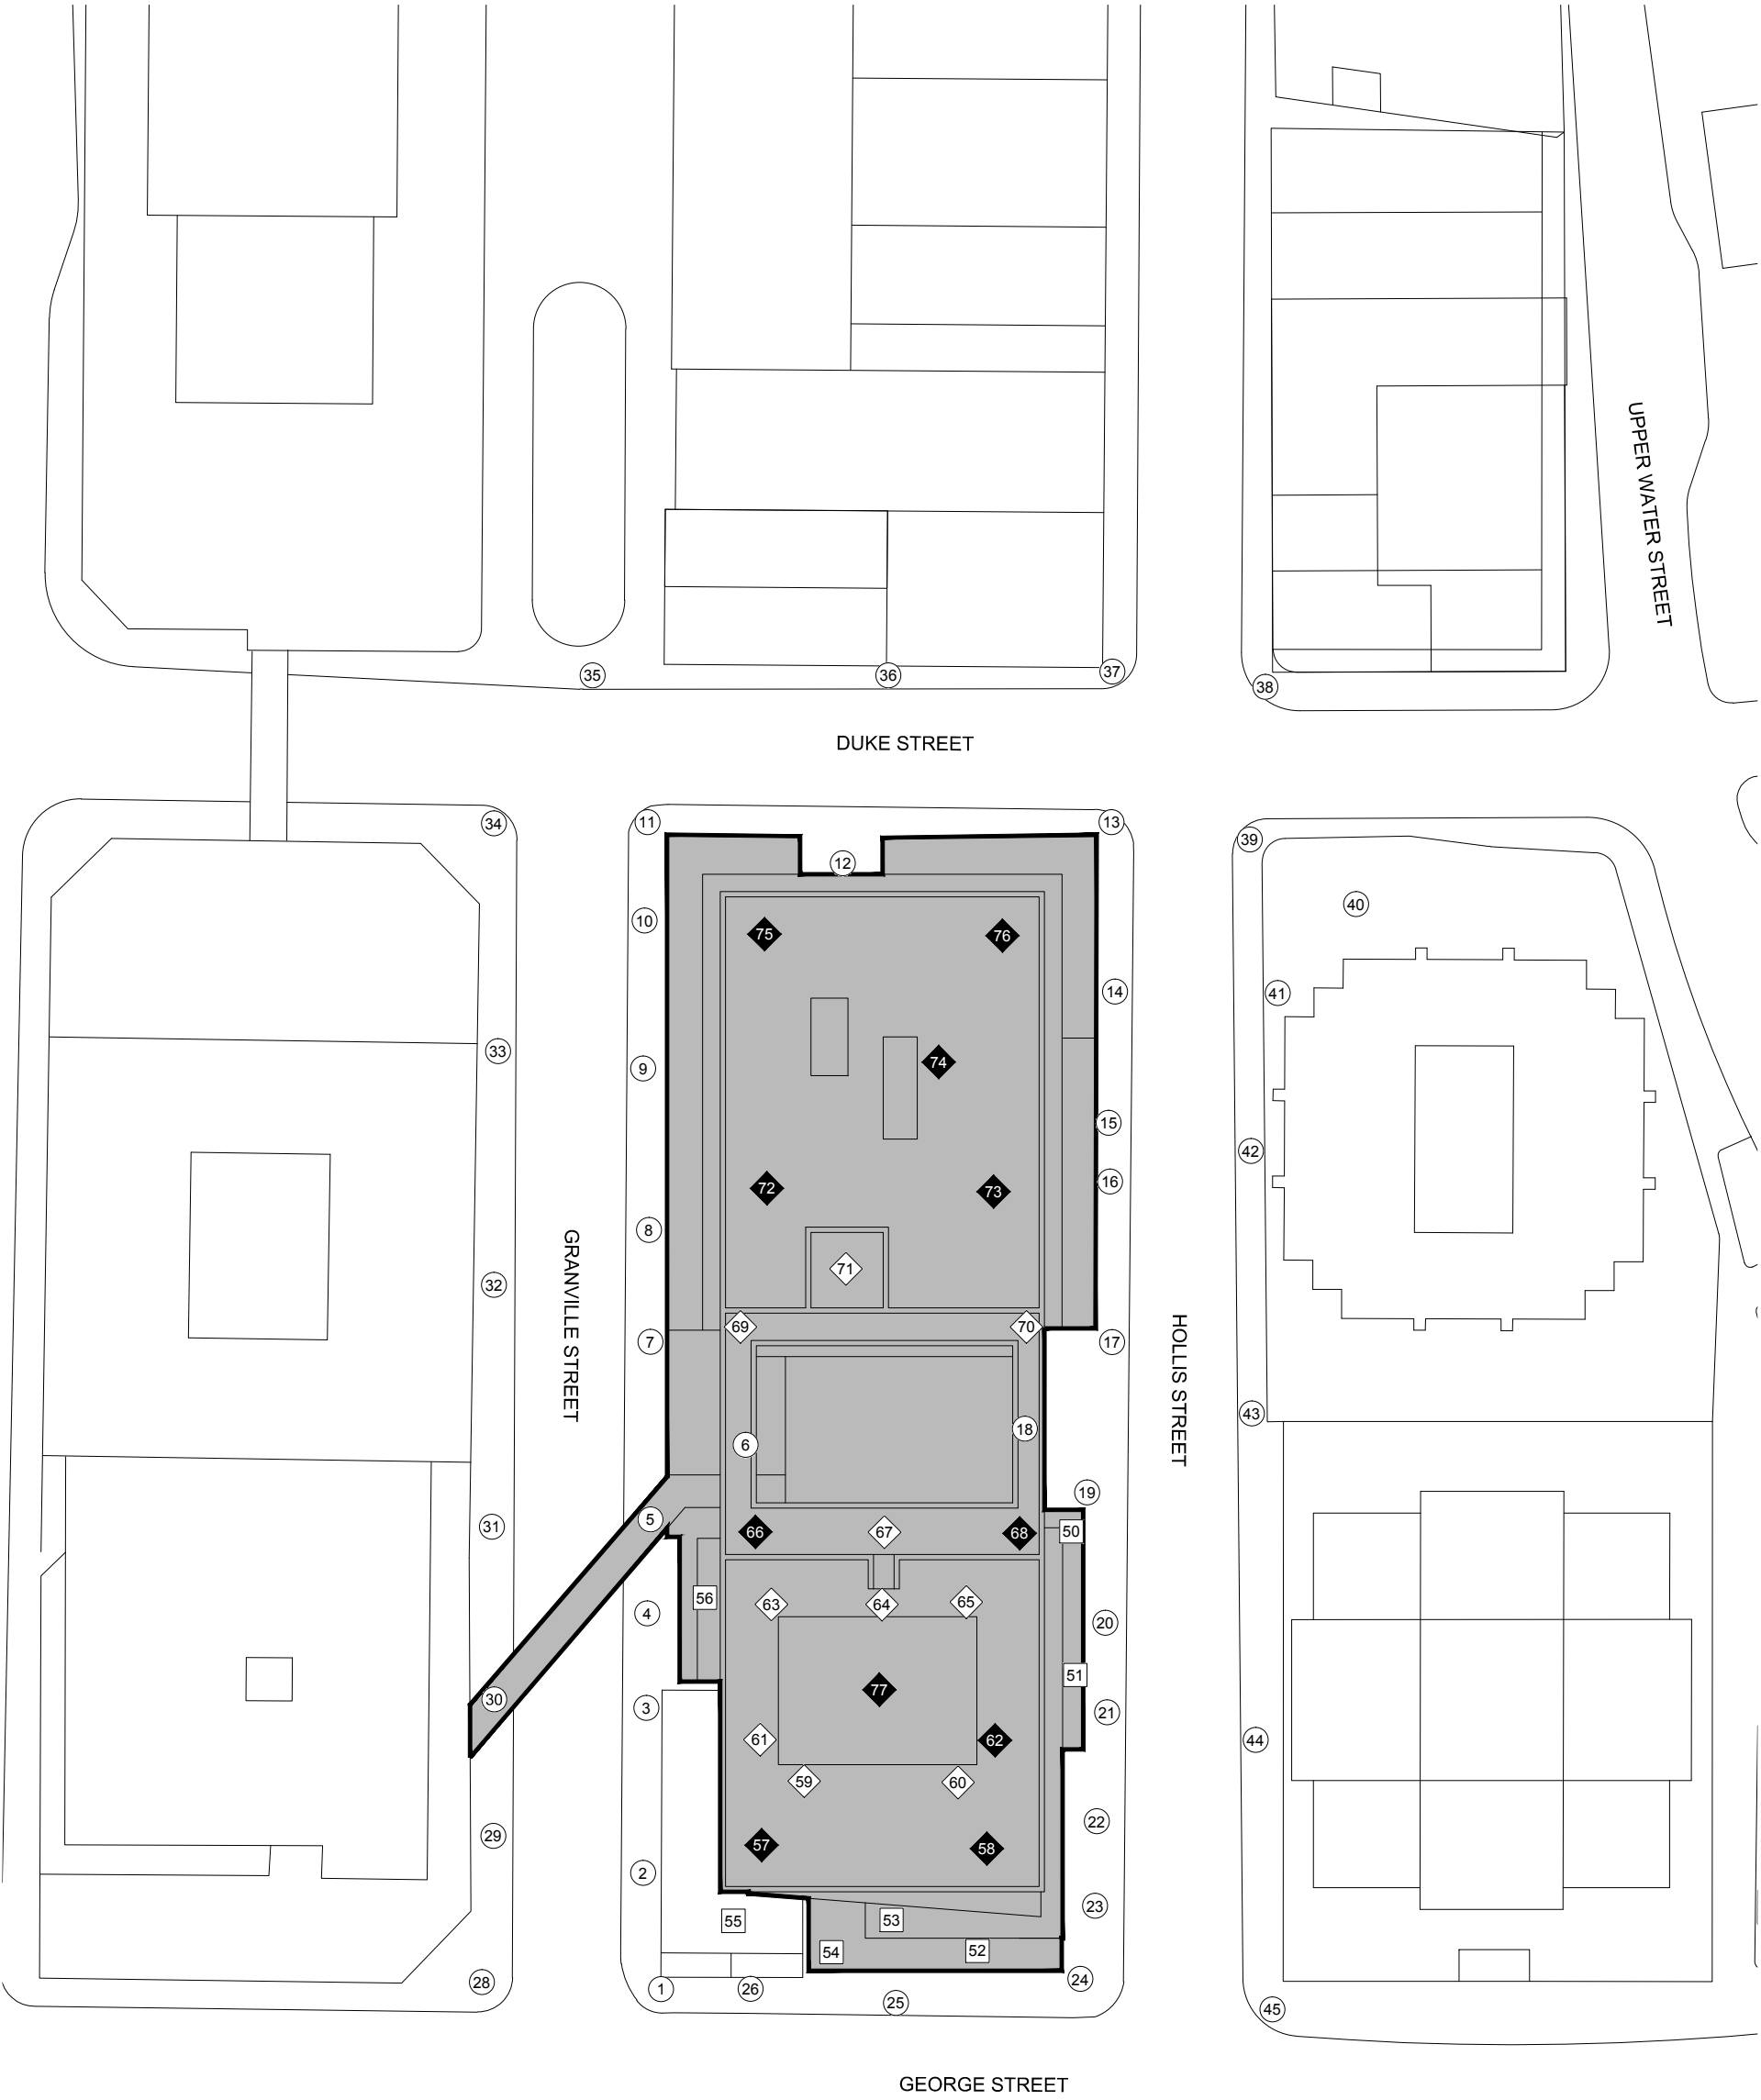
Pedestrian Wind Safety Conditions - Proposed
Annual (January to December, 1:00 to 24:00)
