ARCHAEOLOGICAL ASSESSMENT
HALIFAX SEWAGE TREATMENT PLANT
PROPERTY
HALIFAX, NOVA SCOTIA

ARCHAEOLOGICAL IMPACT ASSESSMENT
FINAL REPORT

**ARCHAEOLOGICAL ASSESSMENT OF
THE HALIFAX SEWAGE TREATMENT SITE PROPERTY
Halifax, Nova Scotia**

**Heritage Research Permit A2002NS22
Final Report**

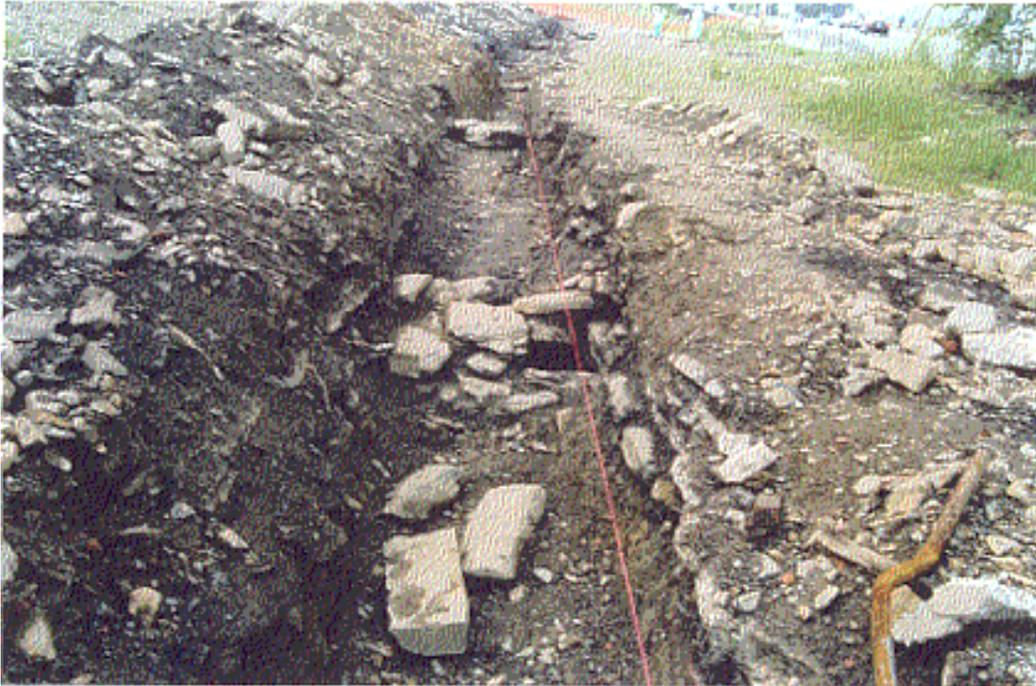
PLATE 5: General View of Features Exposed in Trench 1. Looking North.

Excavation of the trench on Monday, July 8, and the subsequent cleaning of the trench, yielded evidence of 16 discrete features reflecting various stages of Euro-Canadian development within the property (*Plate 5; Figure 11*). The following discussion of the features found in Trench 1 follows a rough progression from south to north along the length of the trench.

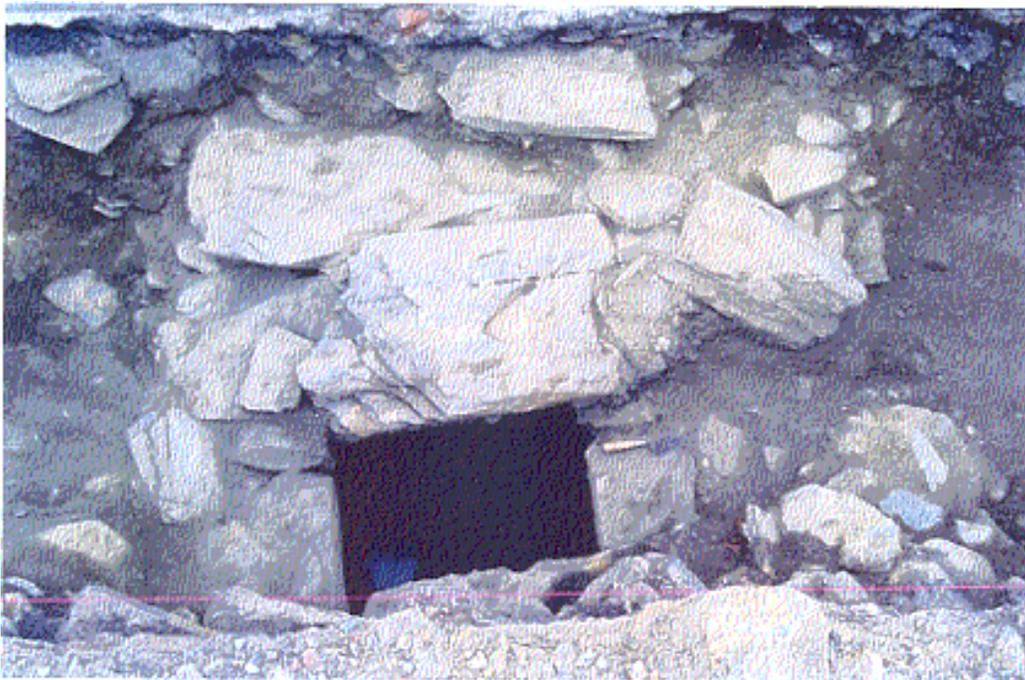
PLATE 6: Detail of Ironstone Drain (T-1/F-3) Crossing Trench 1. Looking West.

Feature 3 is an ironstone drain oriented west to east which carried ground water and surface run-off from the rear yards along Upper Water Street down slope toward the harbour (**Plate 6; Figure 12**). The drain consists of two parallel walls built of 6 to 8 courses of ironstone slabs creating a spillway which was, in turn, surmounted by north-south oriented capstones. The drain was built in a trench excavated approximately 120 cm into undisturbed subsoil. Wooden planks form the bottom of the spillway, which was sealed beneath an 18 cm thick layer of black sludge or silt. Visual examination within the channel indicated that the drain was collapsed to the west of the trench and silted up to the east. On average, the spillway is 75 cm in width and 76 cm in height. The centre of the spillway lies approximately 16.20 metres north on the property boundary. The overall feature, including builders' trench, is approximately 2.20 metres wide.

Within the section of drain exposed in Trench 1, a change in the orientation of the capstones was observed. Closer examination of the feature indicated that the change in orientation represented a modification to the drain which accommodated the placement of a secondary drain feeding into the main drain from the north. The secondary drain was represented by the remains of a wooden plank found overlying the north wall of the spillway which lead into the opening created by the gap in capstones over the main drain.

Examination of historic mapping for the study area suggest that the drain follows the approximate alignment of a property line which, in the late 1870s, formed the northern boundary of the Cunard & Co. coal yards.

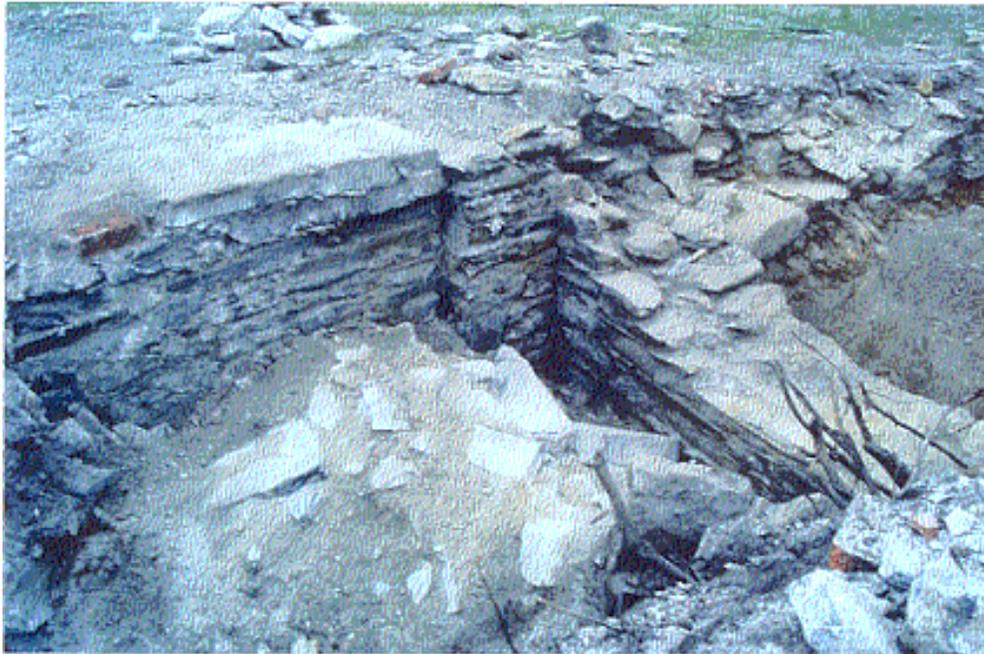
PLATE 7: Relationship of Masonry Walls (T1/F6, 7 & 8) in Central Section of Trench 1. Looking Southeast.

Between approximately 34 metres and 38.7 metres north, the back-hoe exposed a complex mix of ironstone foundation walls and other architectural features (*Plate 7; Figure 13*). For ease of description and interpretation, the features (Features 6, 7 & 8) will be addressed together.

The complex of features was initially observed when the back-hoe exposed an ironstone foundation wall (Feature 6) running east-west across the trench (37.53 to 38.25 metres north). The exposed section of wall (Feature 6) is 71 cm wide and made up of 7 courses of ironstone (87 cm) laid in mortar. The bottom of the wall was not exposed. The wall was built within a builders' trench excavated into undisturbed subsoil. The trench extends approximately 48 cm south of the wall itself and was backfilled with rubble and redeposited subsoil.

Close examination of the trench's eastern profile, revealed that Feature 6 was directly associated with two north-south oriented walls which aligned almost perfectly with the eastern edge of Trench 1. At the eastern edge of the excavation trench, the wall (Feature 6) turns abruptly north at right angles, creating a 45 cm long section of well constructed ironstone wall (Feature 8). The northern edge of the wall abuts another wall (Feature 10) which will be discussed in the following section. This short section of wall extends from just 10 cm BS (4.33 MASL) to a depth of over 130 cm BS. The full depth of the foundation is not known since the bottom of the wall was not exposed during the assessment. Examination of the corner formed by the two walls (Features 6 & 8) clearly revealed the integrated construction, suggesting that the walls were built at the same time.

Extending south from Feature 6 for a distance of approximately 3.41 metres (37.45 metres to 34.04 metres north) was another ironstone wall (Feature 7). This southern extension consisted of two to three courses of dry-laid angular ironstone and rounded field stone built directly on undisturbed subsoil. It was noted that the wall abutted Feature 6 rather than being interlocked in construction. The surface of Feature 7, lying approximately 16 cm BS (3.90 MASL), was surmounted by a 3 cm to 5 cm thick layer of mortar.

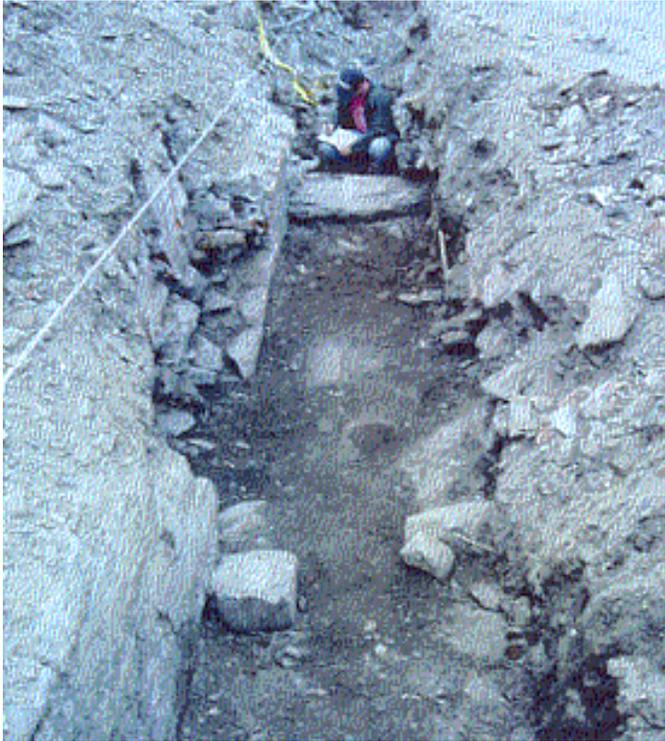
PLATE 9: General View of Features Related to Scriven & Son's Bakery (T1/F12, 13,14 & 15) within Trench 1. Looking North.

In the context of a steam bakery, the associated brick and masonry features (Feature 14) found within Trench 1 may represent an oven and associated chimney or possibly part of the steam plant which would have heated ovens located elsewhere in the complex.

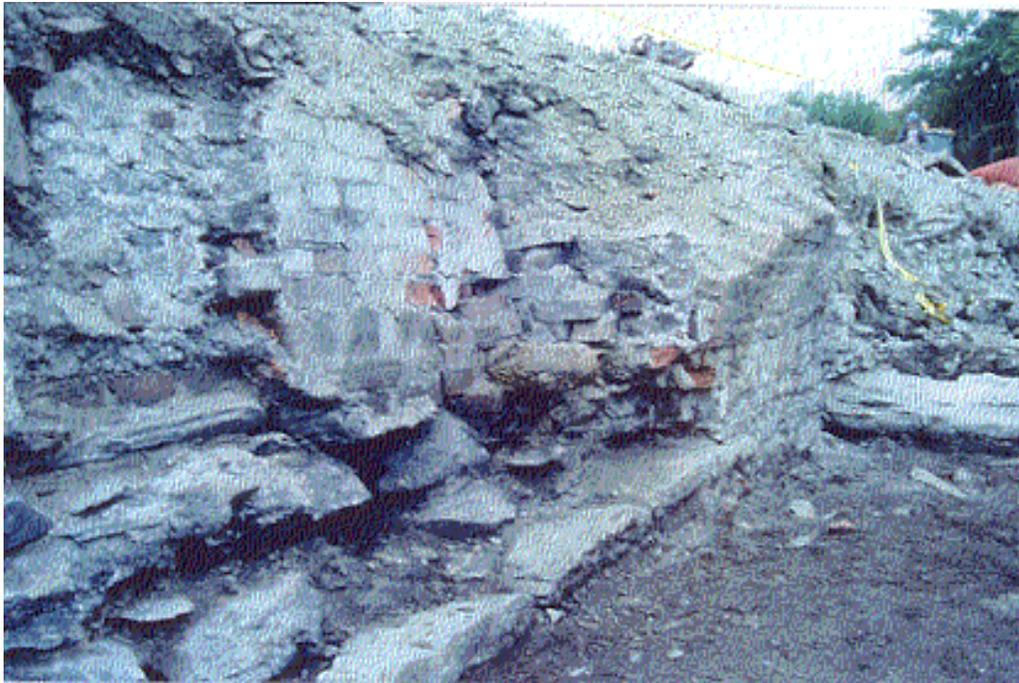
PLATE 10: Detail of Masonry Features Related to Scriven & Son's Bakery (T1/F13, 14 & 15) within Trench 1. Looking Northwest.

Also extending north from the cinder block wall but along the west baulk of the trench was a substantial ironstone wall (Feature 13). The remains of the wall extend north some 6.5 metres (53.92 metres to 60.42 metres north) from the concrete slab to butt against an east-west oriented ironstone foundation wall (Feature 15). It appears that the southern end of the wall had been modified to accommodate the construction of the concrete slab and cinder block wall, while the northern end was built to butt up against an exterior wall (Feature 15). Due to its position relative to the edge of the trench, the width of the wall could not be determined. The wall survived demolition to a maximum height of 4.37 MASL (maximum exposed face of wall was 1.25 metres), just below the overlying ground surface. Trench excavation did not extend deep enough to expose the base of the wall. A portion of the wall between 56.20 metres and 60.52 north appears to have been partially demolished or modified to accommodate the construction of a brick and rubble feature designated as Feature 14 (*Plate 10*). As the fill material encountered within the overall basement feature was clearly modern (20th century), no artifacts were retained.

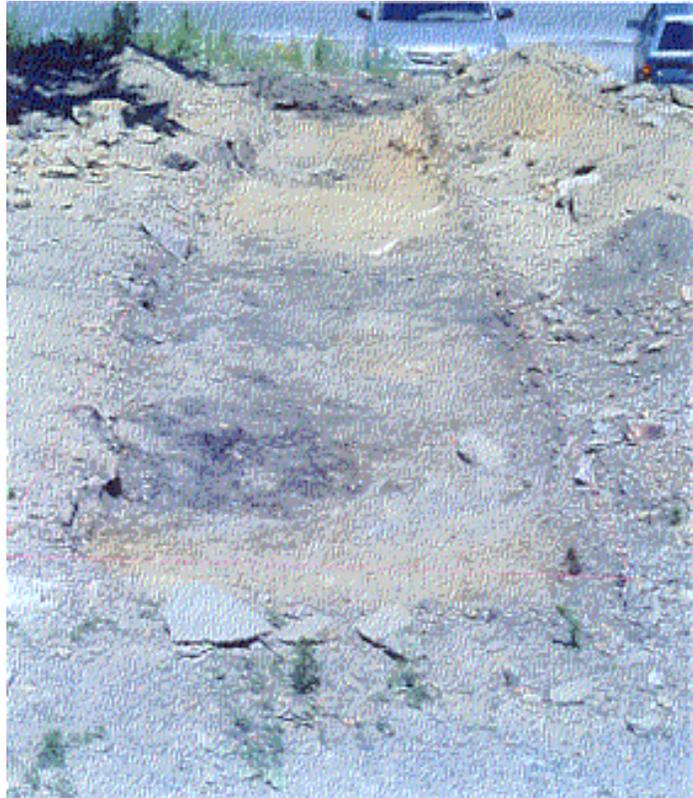
PLATE 14: Dark Stains Indicating
the Presence of
Features (T4/F1 & 2) in
Trench 4.
Looking East.

Feature 1 is an east-west oriented ironstone pad or wall capped with mortar found lying between 46.0 metres and 48.2 metres south of Cornwallis. The 2.20 metres wide feature was encountered at a depth of approximately 140 cm BS (4.01 MASL). Examination of the west profile of Trench 7 indicated that the pad or wall was built within a builders' trench excavated into undisturbed subsoil. No artifacts were recovered in association with the feature.

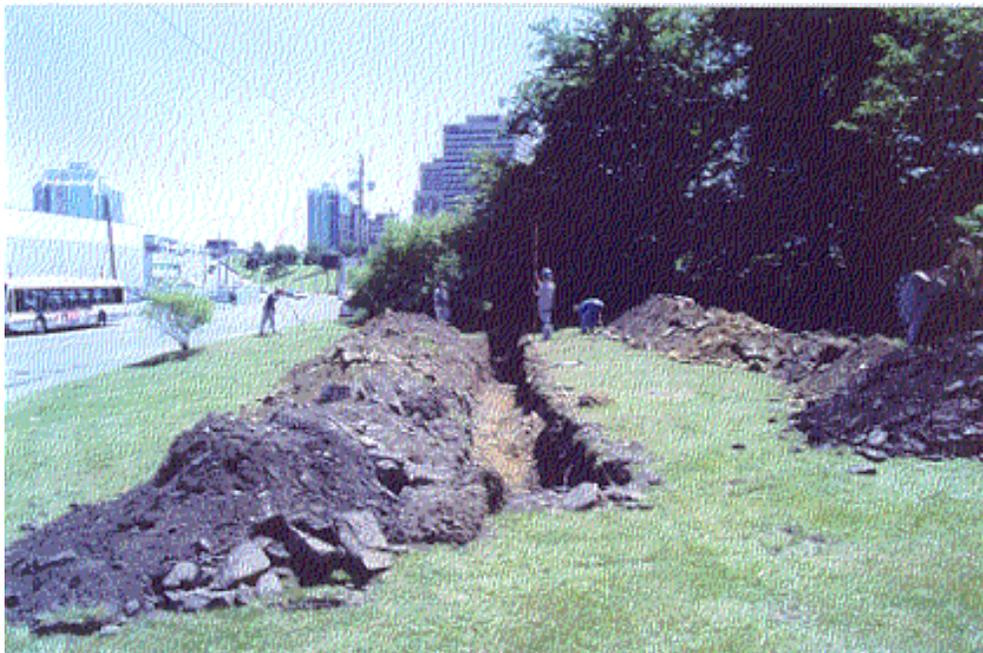
PLATE 18: Documentation of Trenches 7 and 8, NE Quadrant of Property.
Looking South.

Excavation of the trench yielded evidence of extensive disturbance in the northeast quadrant of the property (***Plate 18***). The stratigraphy as revealed in the Trench 7 profile was relatively simple with a dark brown loam fill material extending from sod to undisturbed sterile subsoil. The fill material contained a mix of mid-to-late twentieth century garbage which included plastic grocery bags and Styrofoam coffee cups. The fill material also included some construction rubble, but in relatively low concentrations and primarily in the northern end of the trench. Sterile subsoil was exposed throughout most of the trench at depths ranging from 100 cm BS to just below the sod. Bedrock was encountered at the south end of the trench at a depth of 109 cm BS (3.94 MASL) and approximately 38.5 metres south of Cornwallis at 173 cm BS (4.47 MASL).

Trench 8 is also located in the northeast quadrant of the property, lying parallel to Upper Water Street and Trench 7 (**Plate 18; Figure 10**). Like Trench 7, Trench 8 was excavated to assess archaeological potential within the open grassy area near the intersection of Cornwallis and Upper Water streets. Positioned 23.0 metres west of Upper Water Street (inside face of curb), the trench ran between 52.3 metres and 32.3 metres south from the original alignment of Cornwallis Street. The trench averaged 110 cm in width and ranged in depth between 60 and 240 cm.

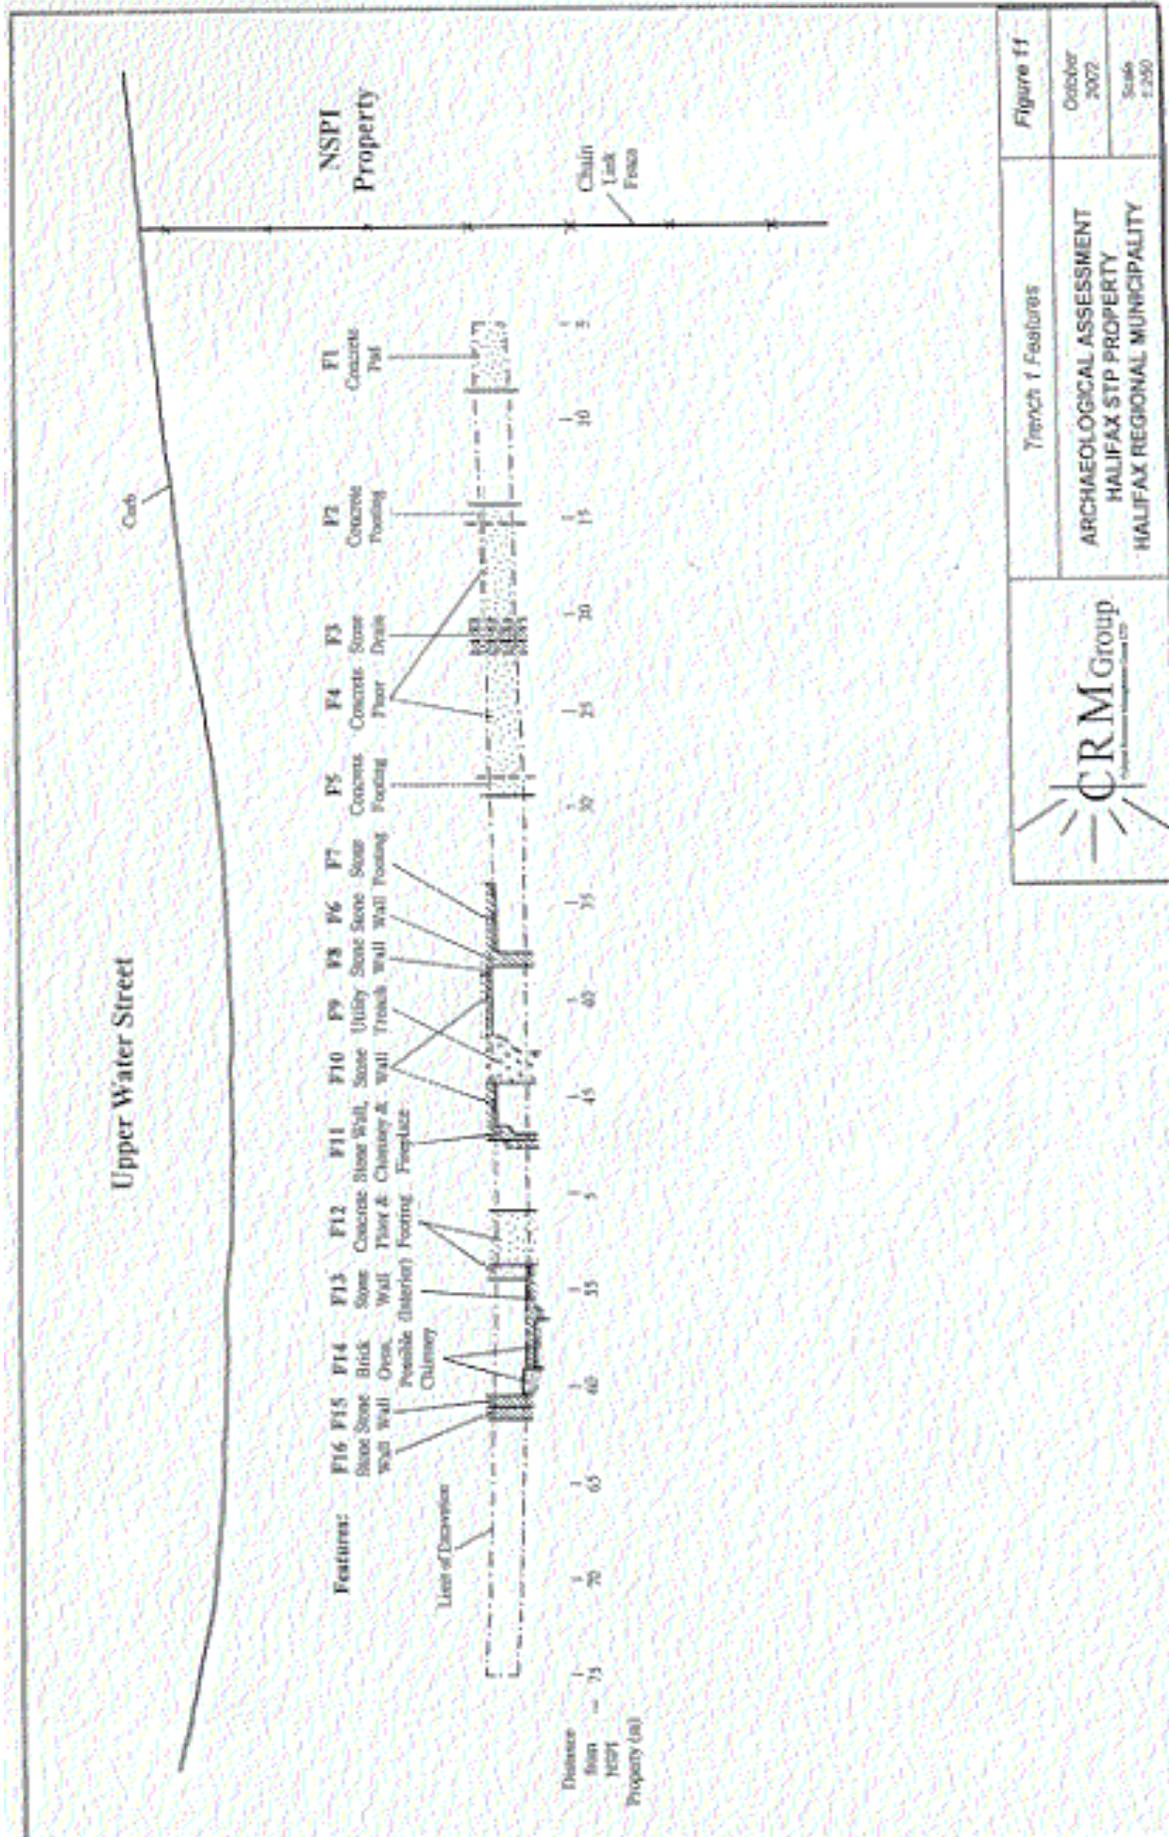
Figure 11

Trench 1 Features

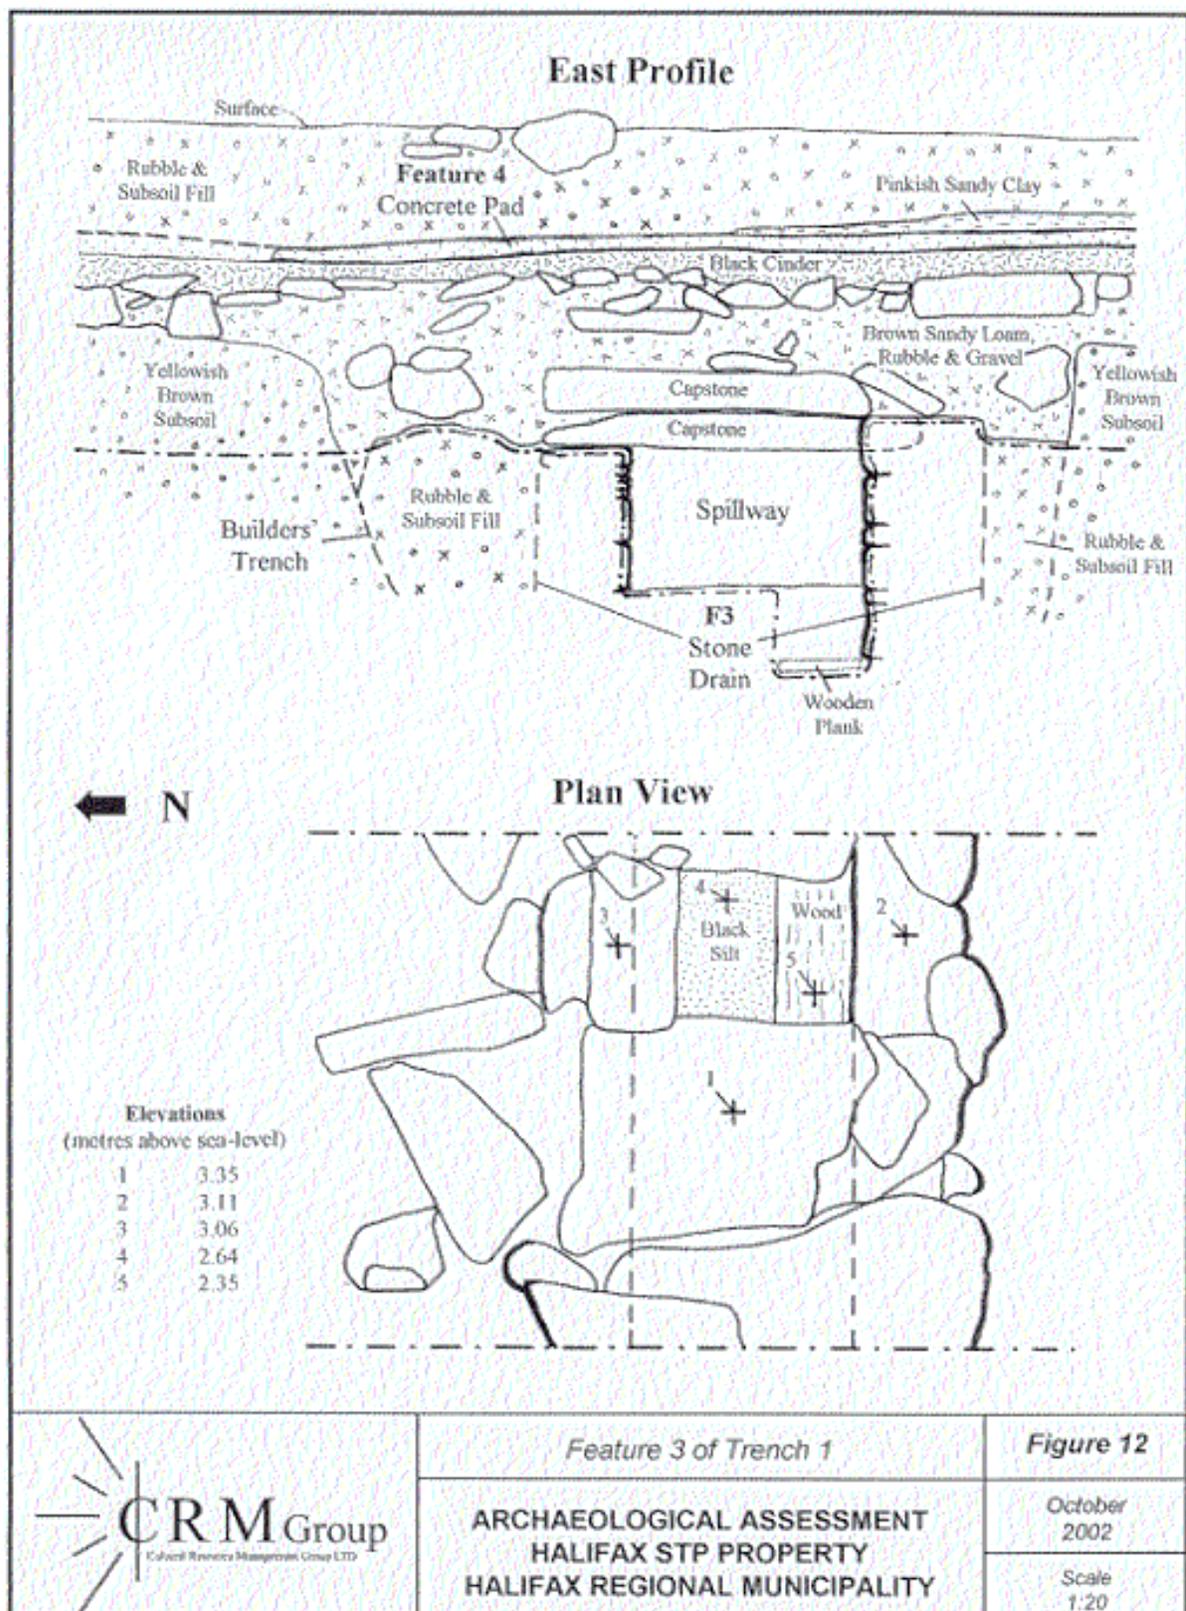
Figure 12

Feature 3 of Trench 1

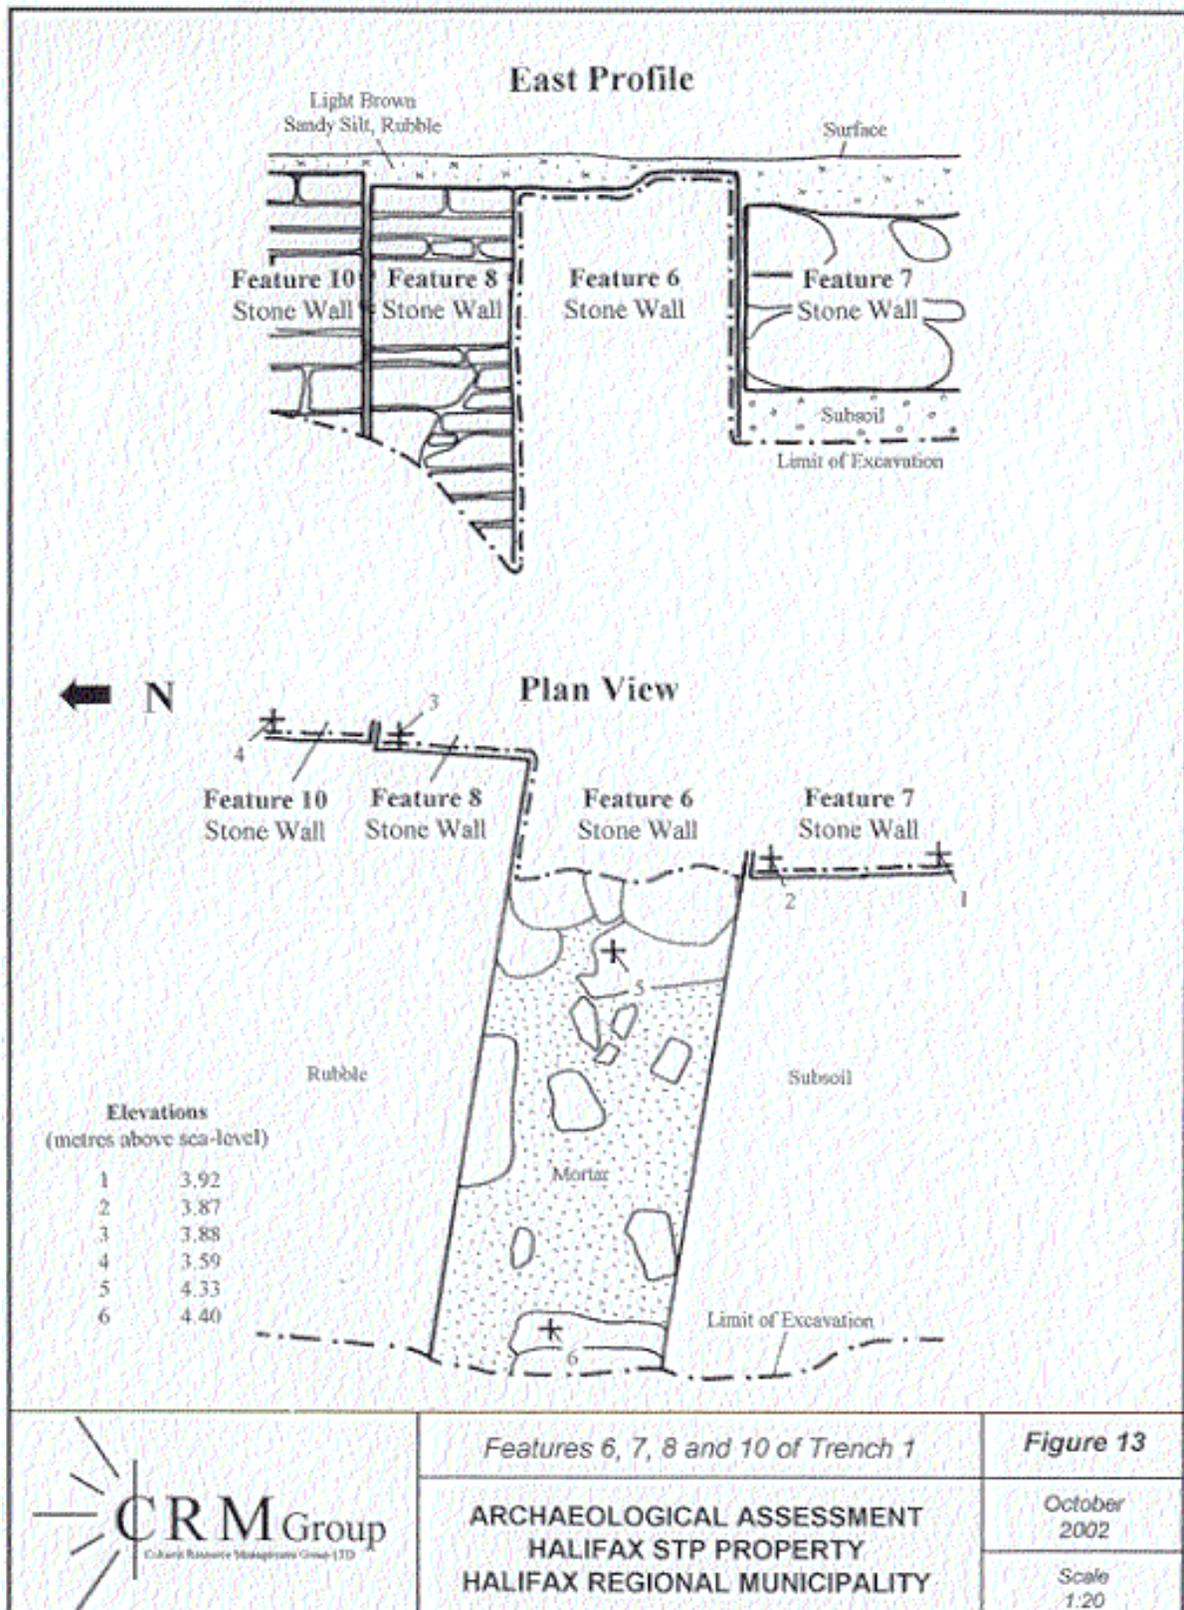
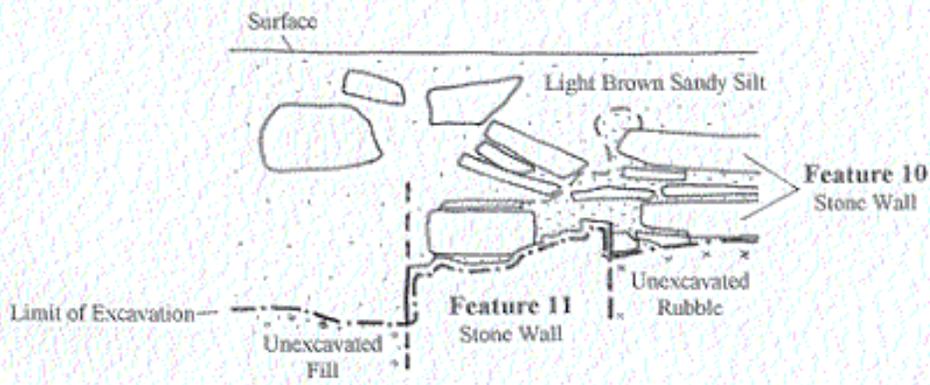
East Profile

Plan View

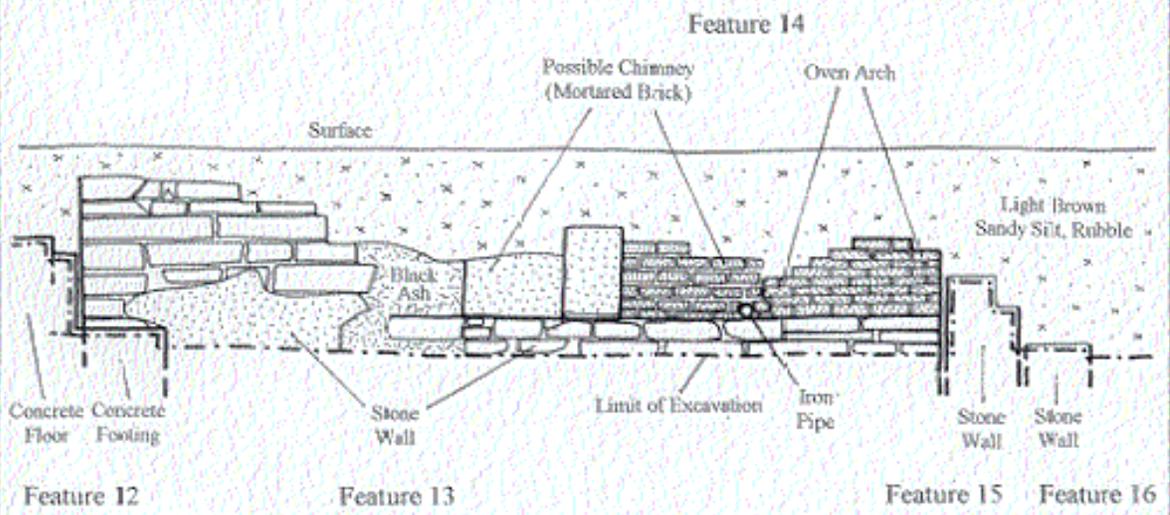
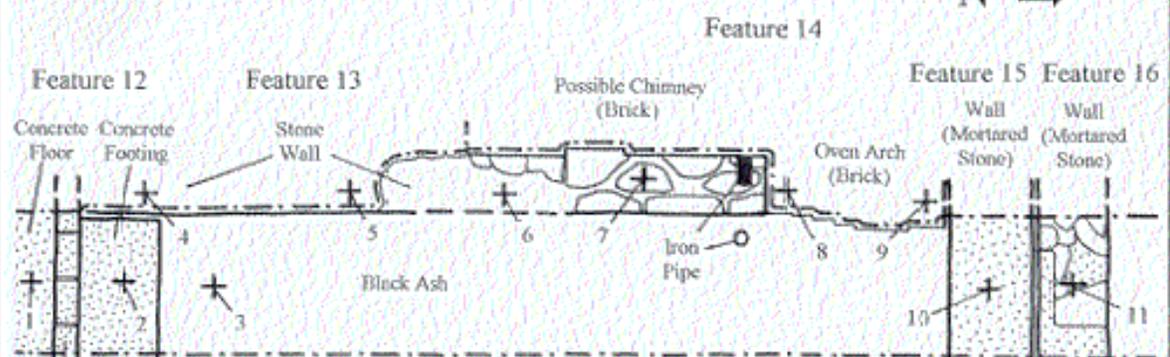
West Profile

Plan View
