**SUBJECT:** Crosswalk Safety Advisory Committee – Crosswalk Safety Work Plan

**INFORMATION REPORT**

## **VEHICLE / PEDESTRIAN COLLISIONS (HRM: 2013)**

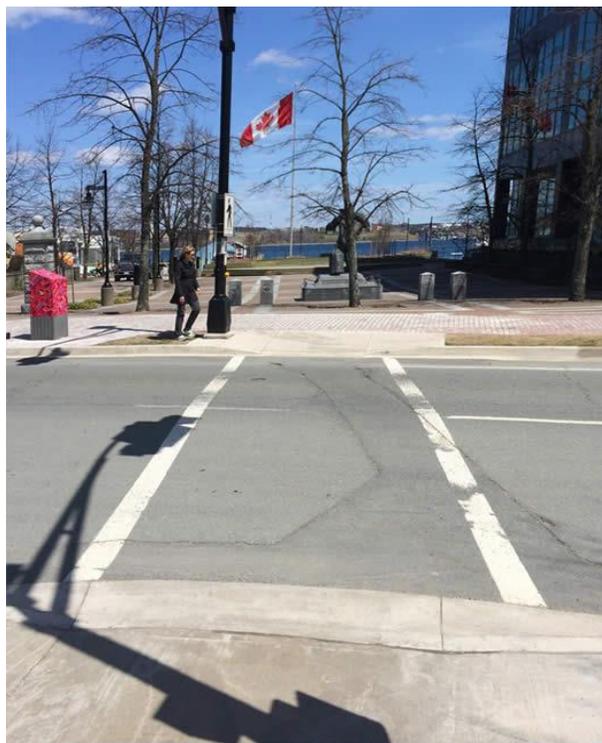
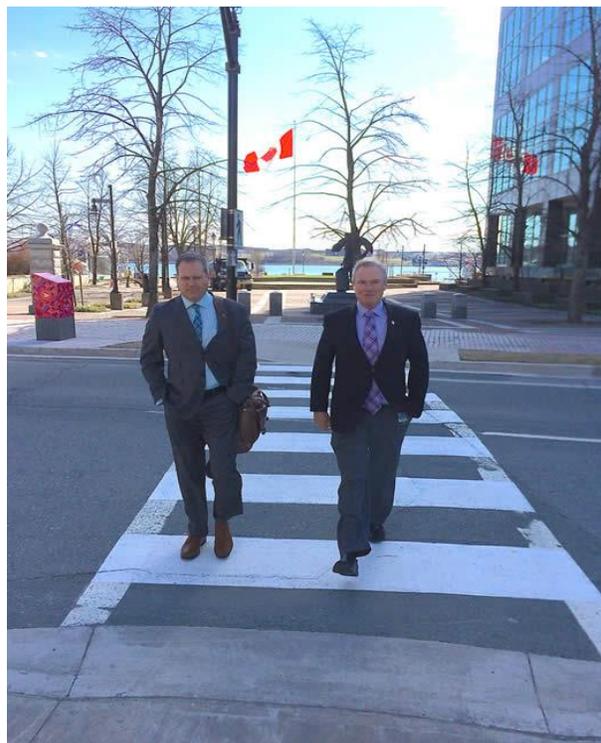
*RA-5 Crosswalk, Lower Water Street at Sackville Street (Before & After Installation of Zebra Crosswalk Markings)*

Funding for this action was approved by Council in the 2014/2015 operating budget and painting of zebra markings at marked, uncontrolled crosswalks. Installation of zebra markings has begun and will be completed at all marked, uncontrolled crosswalks in conjunction with the 2014 Pavement Marking Program.

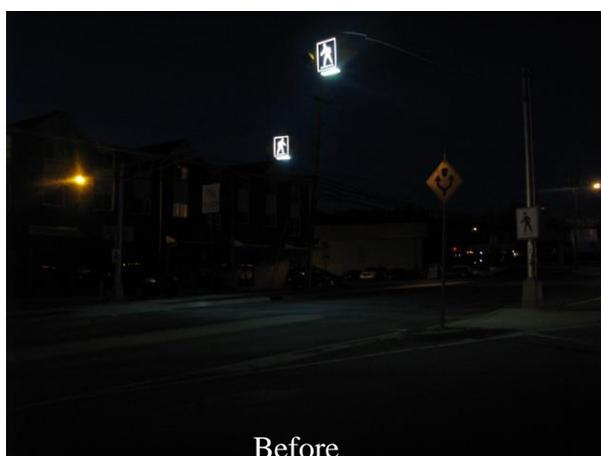
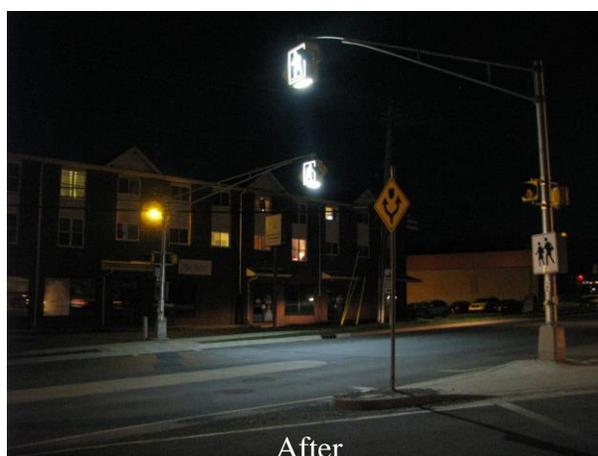
The RA-5 crosswalk on Cole Harbour Road at Bissett Road was recently upgraded with all three of the above items. The following photos illustrate the improvement achieved through the noted upgrades.

*RA-5 Crosswalk on Cole Harbour Road at Bissett Road – Before and After Lighting and Signage Upgrades*

- Replacement of old, side mounted RA-4 crosswalk signs to ensure maximum reflectivity
- Upgrading down-lighting at overhead RA-5 crosswalks to brighter LED lighting
- Installing side mounted flashing beacons in addition to the overhead beacons at certain RA-5 crosswalk locations

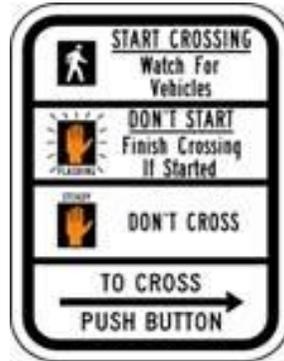
*Pedestrian Signage Used at Signalized Intersections and Pedestrian Half Signals*

HRM currently has signs at signalized crosswalks advising pedestrians on the proper interpretation of the pedestrian signal displays and safe crossing procedure. Other pedestrian oriented signage also exists at several other locations, based on specific conditions at the particular location, in order to advise the pedestrian of particular conditions that require additional attention or guidance. Below are some examples of existing pedestrian related signage currently being used on HRM roads. To move forward with the widespread installation of generic pedestrian oriented signage at all crosswalks would not provide any real benefit because unless there is a specific condition associated with the sign, it will simply become unnoticed background clutter shortly after the initial installation. Staff will however, continue to install signage, similar to that shown below, at specific locations where it has been determined a condition exists that requires additional guidance for pedestrians and/or drivers. If the intent behind this particular action item is for the signage to provide general education (i.e., reminding pedestrians to look both ways), then this would be better dealt with through formalized public education campaigns, not through the posting of signs. As indicated above, signage providing general education messages would quickly become ineffective and unnoticed background clutter.

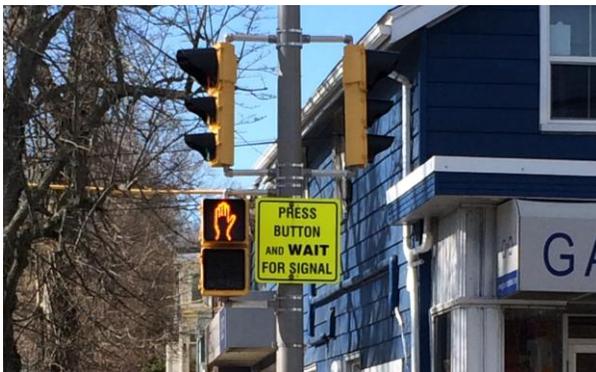
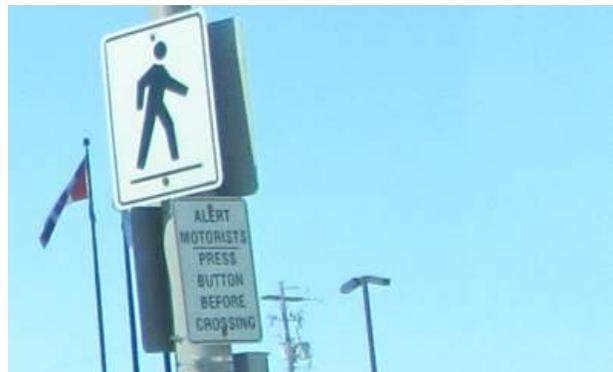
*Signage Used at a Pedestrian Half Signal on Quinpool Road at Beech Street (left) and RA-5 Crosswalk on Wyse Road at Dartmouth Sportsplex (right)*

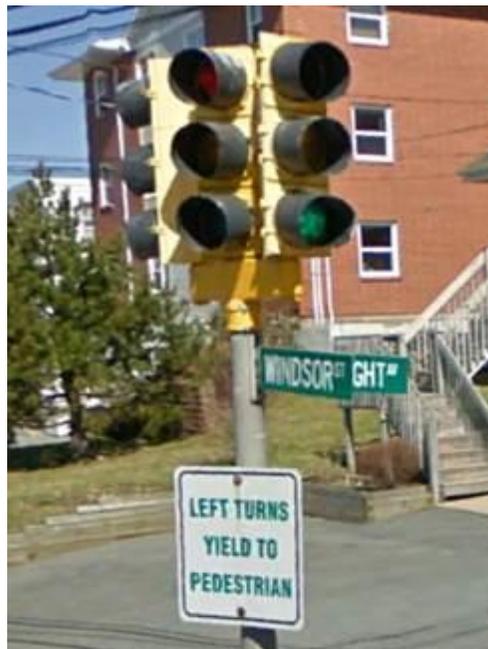
*Signage Installed at the Connaught Avenue / Windsor Street Intersection*

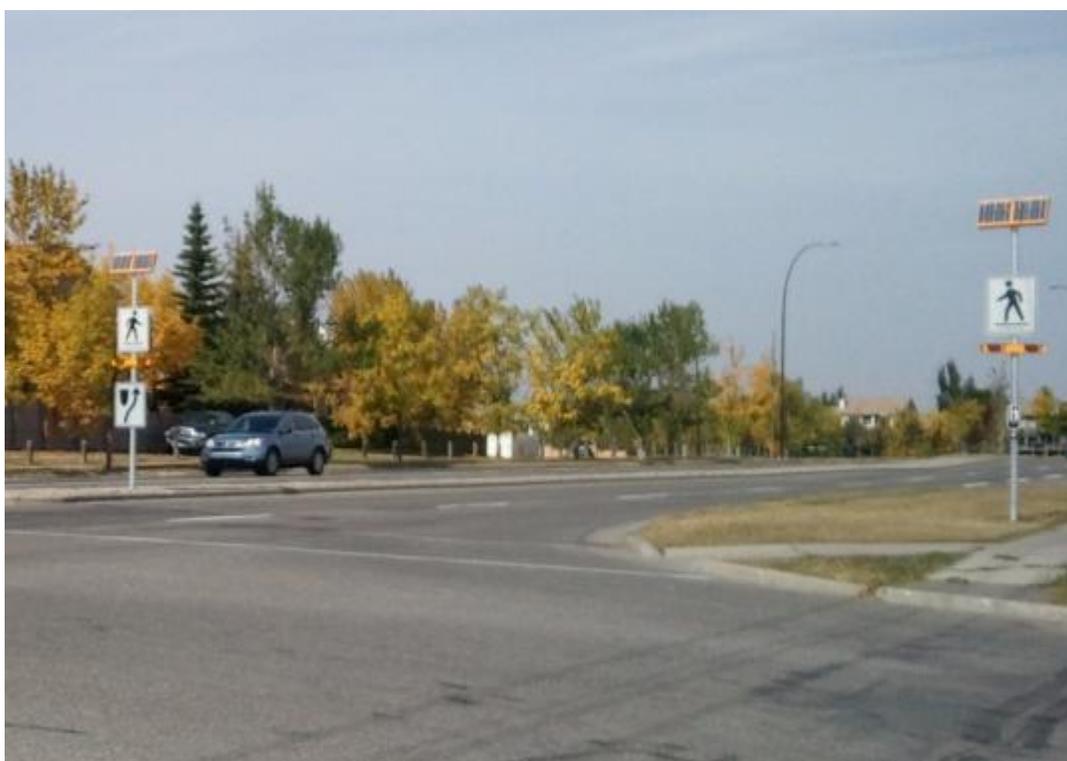
*Crosswalk Upgraded with RRFB in Calgary*

lighting and AC hard-wiring). Initial testing at trial locations in Calgary have identified issues related to the reliability of solar power (battery failures, increased maintenance requirements for the solar panels and water damage) and potential difficulties in tying in to hard-wired power sources. At this point in the study, recommendations are also being made regarding the need to come up with a warrant system for determining the conditions under which to augment standard crosswalks with the RRFB equipment.

Staff is not confident in the reliability of the solar powered beacons at this point and is awaiting the recommendations of the study upon its completion which is anticipated to be the Fall of 2014. At that time staff will review the recommendations related to installation of the beacons and power sources in order to determine how best to proceed with potential installations within HRM.

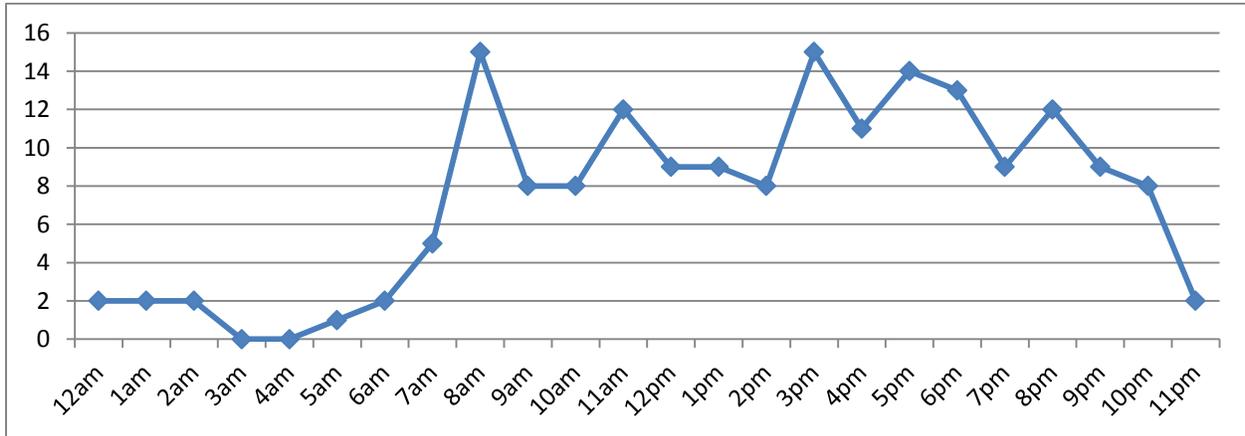
## PEAK COLLISION TIMES

Early mornings (8:00-9:00am) and late afternoon/evenings (3:00pm-7:00pm) were the most common times for vehicle/pedestrian accidents, followed by the 11:00am-12:00pm and 8:00pm-9:00pm time periods.

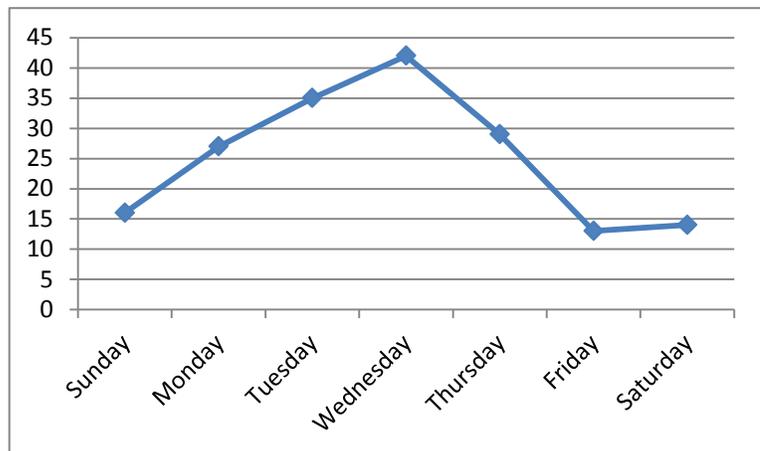
Wednesdays saw the largest number of vehicle/pedestrian collisions (42). This accounts for nearly a quarter of the collisions (23.8%). The number of collisions that occurred on Tuesdays followed closely behind (35 collisions).

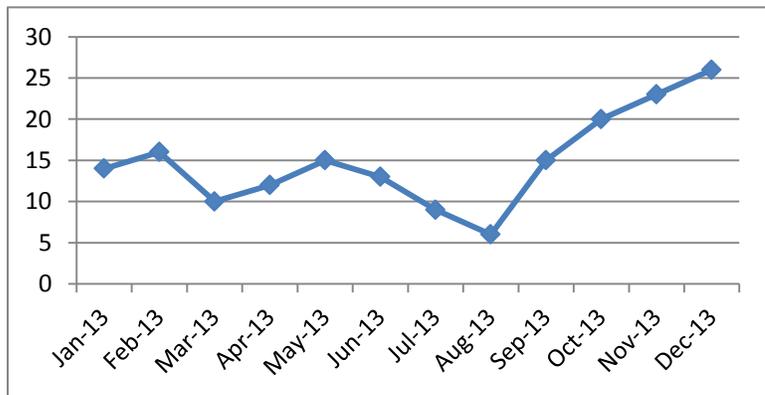
Vehicle/pedestrian collisions were at a consistent level at the start of 2013, ranging from 12 to 16 per month from January to June. Collisions were fewest during the summer months of July and August, with the lowest number recorded in August (six). The number of collisions gradually increased thereafter throughout the rest of the year, ending with 26 in December.

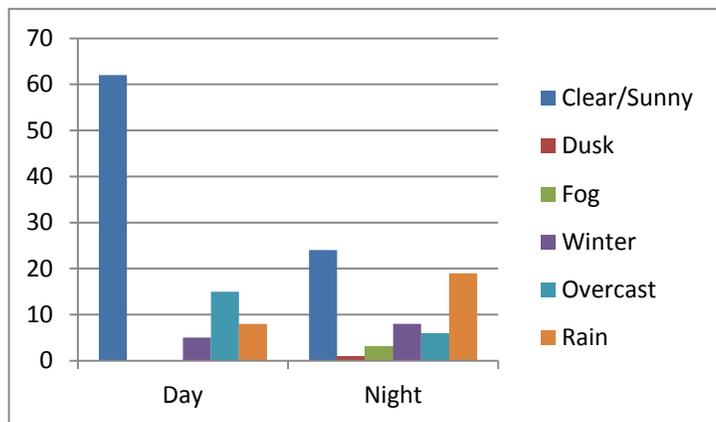
## WEATHER CONDITIONS

The majority of vehicle/pedestrian collisions in 2013 occurred during clear/sunny weather conditions (57%) Nearly 32% of collisions took place during overcast or rainy conditions.

Clear/sunny conditions were present for most day-time and night-time collisions (69% and 39% respectively).
