Russell Lake West Buffer Zone Management Plan Phase 5

This is our third report on the Clayton Developments residential properties along Russell Lake West extending along the Freshwater Trail section to its terminus and comprises the areas shown on the map on the cover page. This report includes observations from site visits, July 10 and August 15, 2008 when pictures were taken to demonstrate the effectiveness of the Buffer Zone Management Plan to date

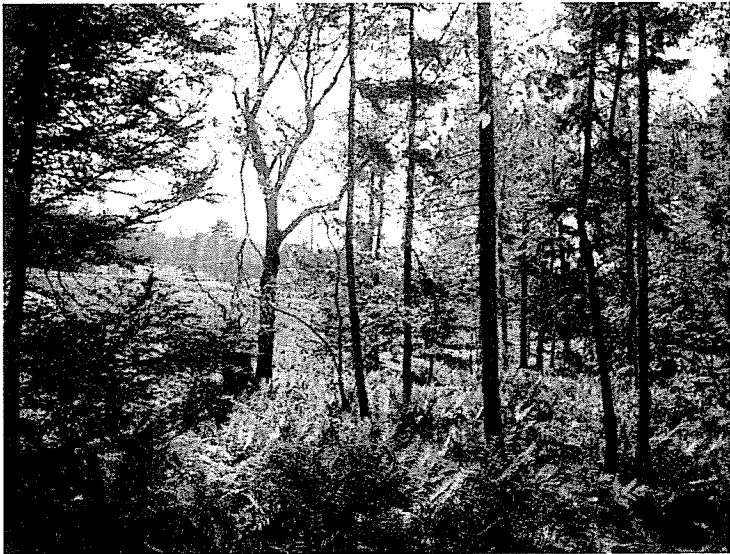
100 ft. Buffer zone along Russell Lake West

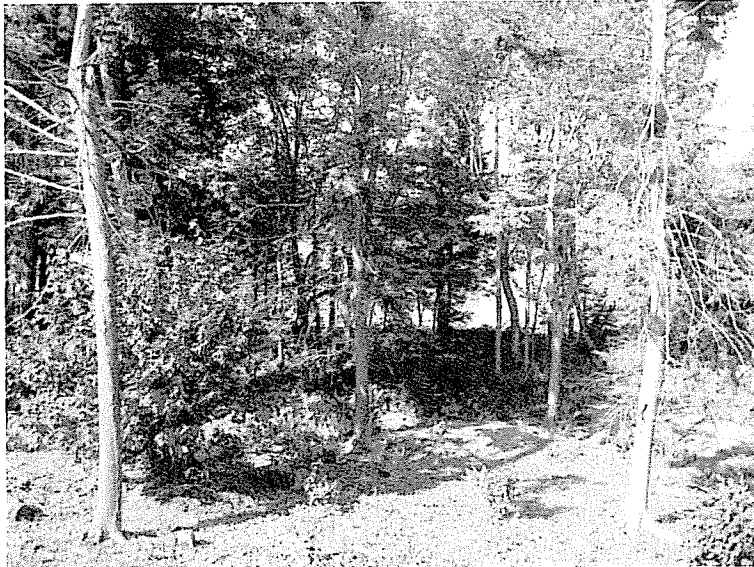
After clearing on Phase five Section

As you can see from the above picture, there is pretty good visibility of the lake from this future residential lot. The picture below shows the forest bottom after clearing and chipping and spread over the forest ground.

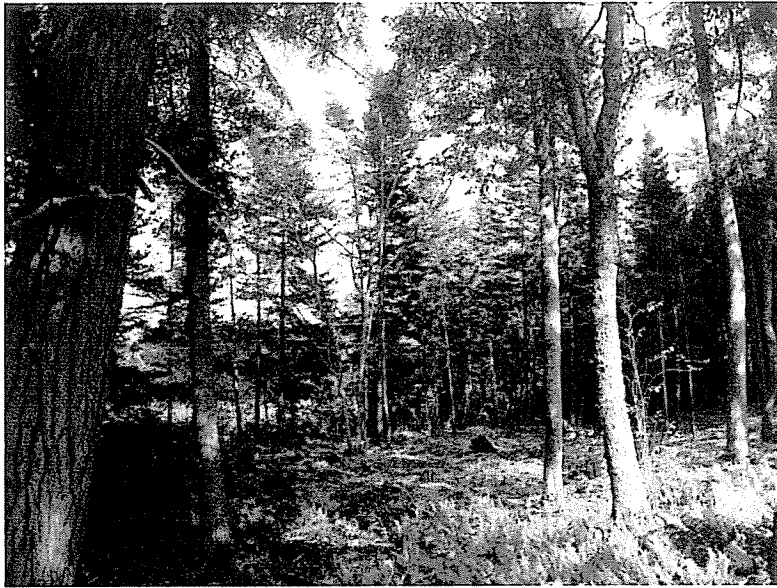
There appears to have been a good effort to preserve as much of the native ground covers (ferns, Bunchberries and wild Azaleas with good regeneration coming up through the mulched areas.

Buffer Zone after clearing and chipping completed

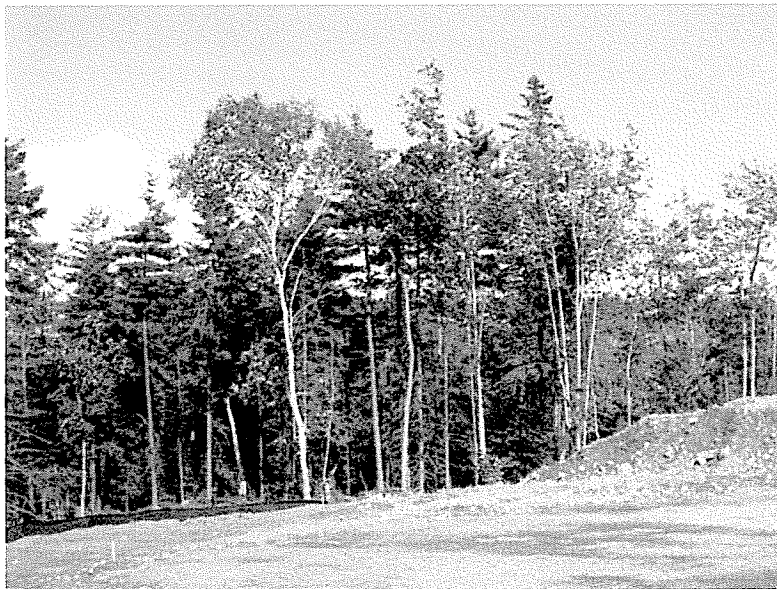
With respect to the remaining softwood species there is a good selection of Native White Pine, Hemlock, Black and White spruce. These have had selected thinning of vegetation around them to allow better crown development. There are some examples shown on the two pictures located on the following page.

View from the top showing remaining hardwoods and conifers preserved after selected thinning and cleanup

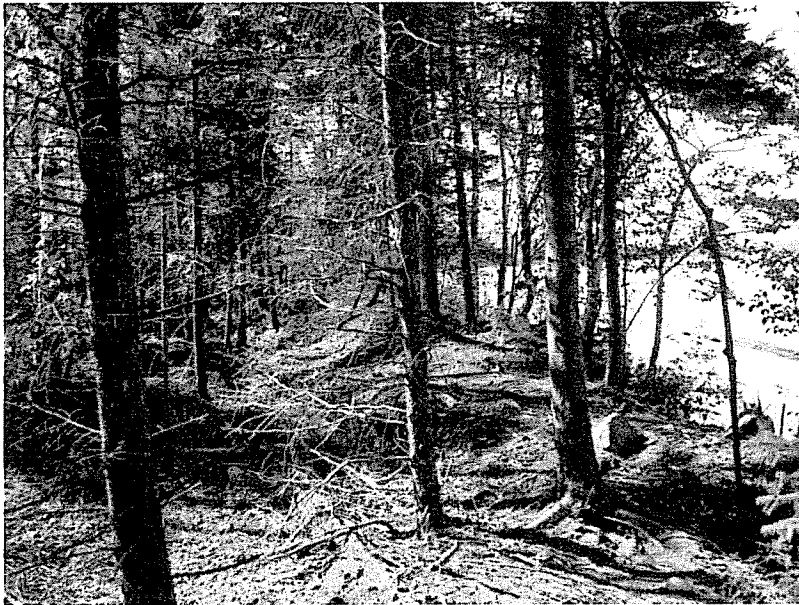
Along the water's edge on Phase Five below Freshwater Trail
