Project Nos. 11263/13623

**Re: Washmill Lake Court Extension Area Wetlands
Bayers Lake/Fairview, Halifax, Nova Scotia**

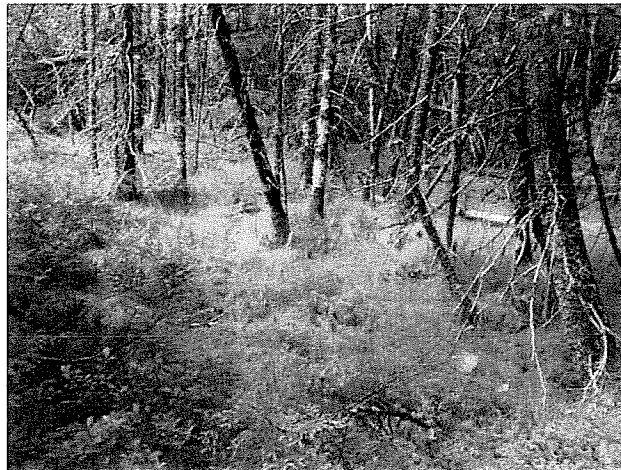
Wetland #4 (.11 ha) is an irregular-shaped outflow treed bog located on what is currently identified as Block B, north of the Washmill Lake Extension.

The dominant trees are Black Spruce, Red Maple and Grey Birch. The dominants in the shrub layer include Black Spruce saplings, Huckleberry, False Holly, Wild Raisin and Sheep Laurel. The herbaceous layer contains Cinnamon Fern, Pitcher Plant, Bunchberry and sphagnum.

The subsurface contains 30 to 45cm peat deposits overlying bedrock.

Intermittent drainage seeps from its southern extent toward the roadway. At the time of the assessment in June 2009, groundwater was at or near the ground surface and water was seeping out of Wetland #4 and into Wetland #3. HRM later received Approval to alter #3. During a subsequent visit on September 21, 2010, no surface water was present and there did not appear to be an inflow or out flow for this wetland. It was noted that the recent road construction would have interrupted its natural outlet flow, had the conditions been wetter.

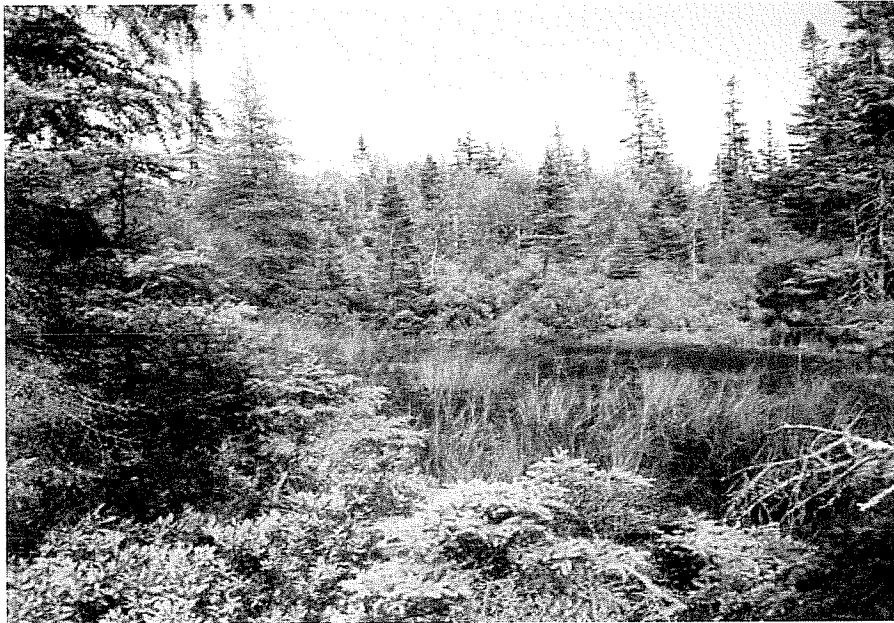
Wetland #7 (.040 ha) is located on what is currently identified as Block C. It appeared to be a pond at the time of our initial assessment on June 26, 2009. Water was observed seeping in three locations out of the pond and into Wetland #8; one location was overland flow and two locations appeared to be 'sidewall leaks' through fractures in the exposed slate bedrock sidewalls. On July 14, 2006, the 'pond' was no longer inundated and appeared more like a cranberry bog, though seeps were still ongoing toward Wetland #8. Peat accumulations are very shallow and in some places only moist soil exists containing pioneering plant species such as cranberry, suggesting that this wetland is in the early stages of bog development.

Wetland #7 is ringed by slate embankments vegetated with Black Spruce, Larch, Grey Birch, Highbush Blueberry (*Vaccinium corymbosum*; FACW-), Rhodora (*Rhododendron canadense*; FACW), Sheep Laurel, Lowbush Blueberry and Wintergreen / Teaberry (*Gaultheria procumbens*; FACU, although Tiner (1999) reported this to be an example of a common FACU species found in wetlands in the Northeast). The bog/pond itself contains sedges, Small Cranberry (*Vaccinium oxycoccus*; OBL), Pitcher Plant, Roundleaf Sundew (*Drosera rotundifolia*; OBL) and sphagnum.

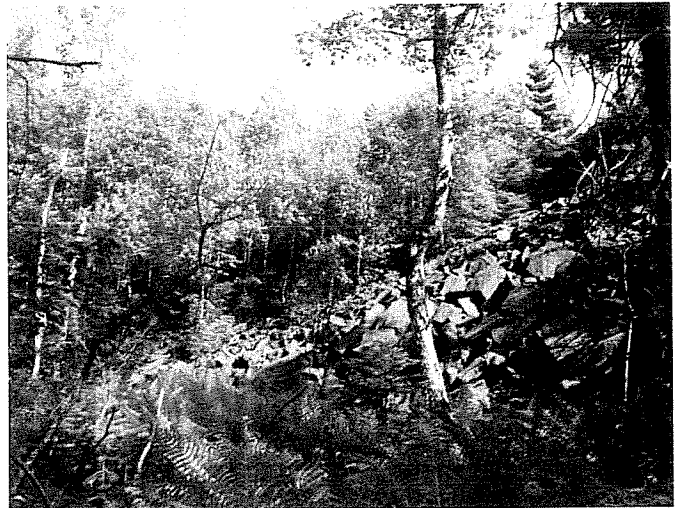
Wetland #9 is situated on what is now identified as Block D. It is a through-flow wetland with a peaty to mucky subsurface. During both of our site visits in June 2009 and September 2010 it contained standing water at its eastern extent where it discharges via a culvert through a slate fill embankment. We would characterize it as a treed swamp.

The dominant trees in wetland #9 are Red Maple, Grey Birch and Black Spruce. The dominant shrubs are Huckleberry, Rhodora and Sheep Laurel. The dominants in the herbaceous layer are Cinnamon Fern, Bunchberry and sphagnum.

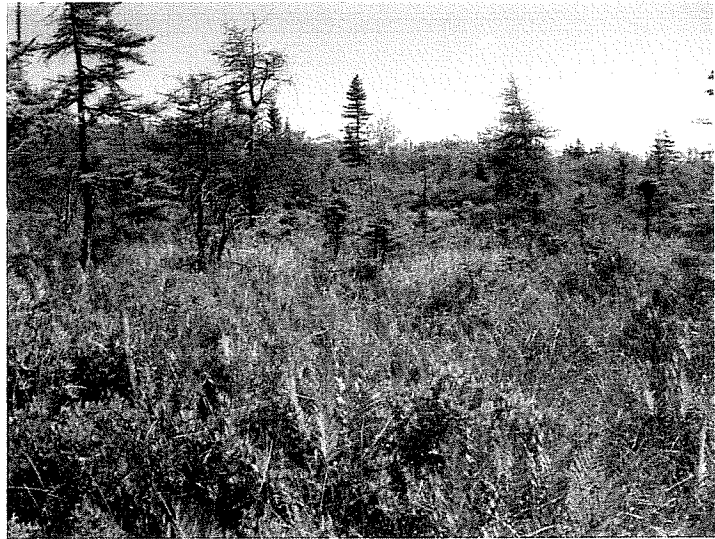
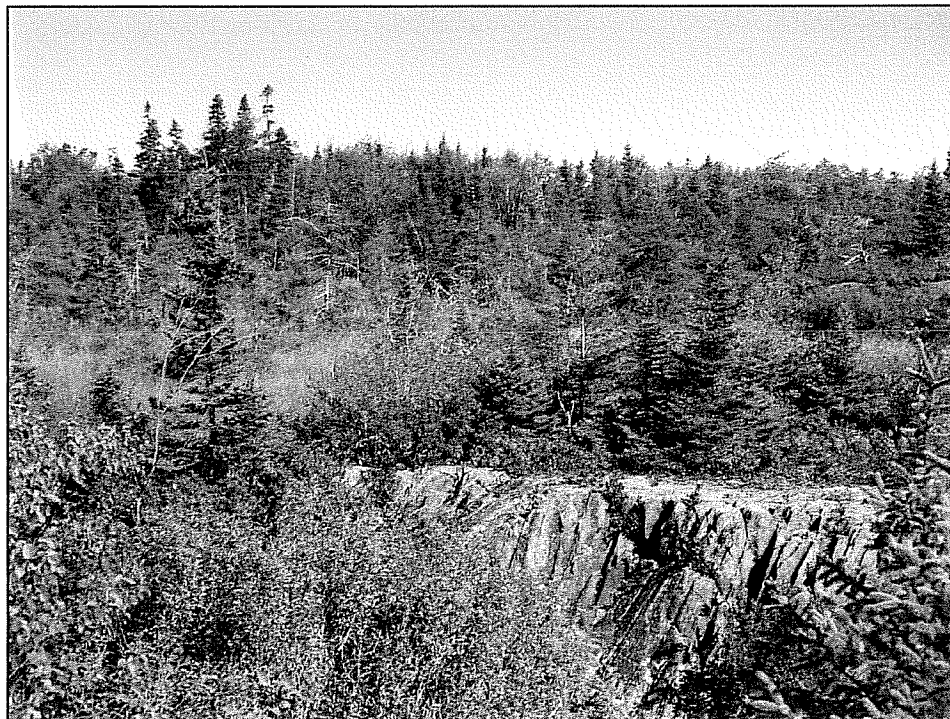
Wetland #10 (.38 ha) is situated on what is now identified as Block B. It is an "L" shaped wetland complex situated on uneven ground and containing elements of shrub swamp, bog/fen and meadow / fern wetland types. It receives surface water from adjacent steep uplands (note the slate outcrop in the wetland photo below) and there appears to be a narrow outflow channel on the southern end that likely flows only during spring run-off or after heavy rain events. It was dry on September 21, 2010 in spite of fairly heavy recent rainfall.

Wetland #10 in background, with slate outcrop in foreground.

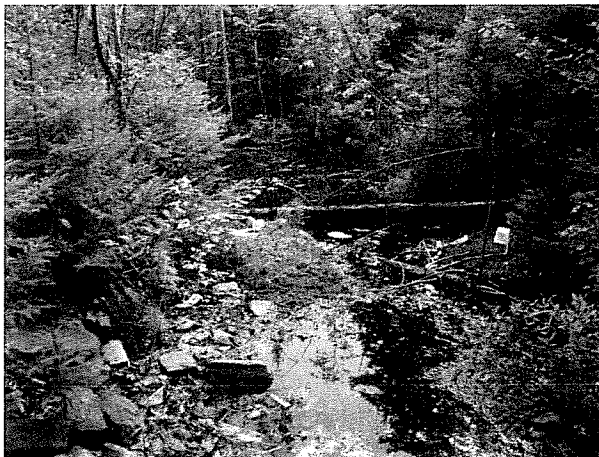
Inflow area at Wetland #11.

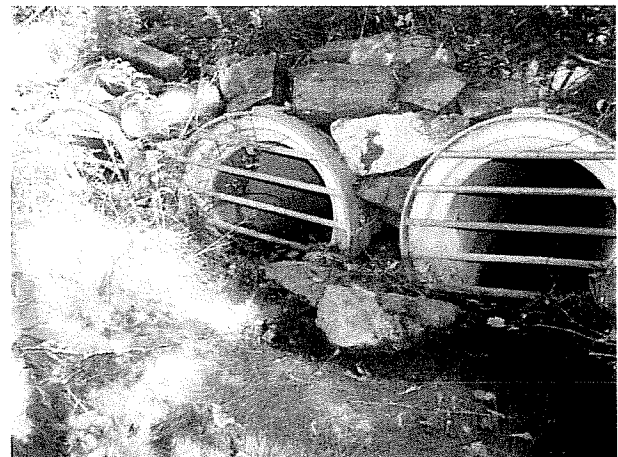
Outflow of Wetland #11 at Washmill Lake
Extension

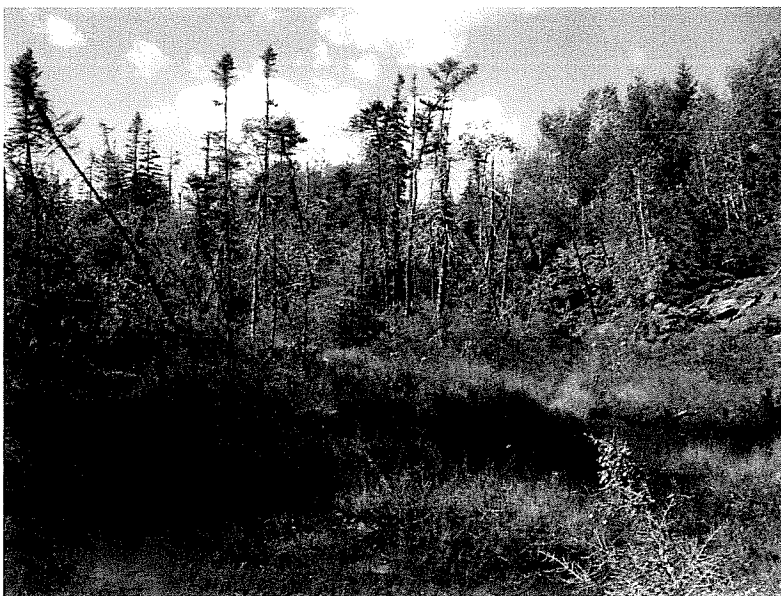
Wetland #11

Wetland # 11 (.32 ha) contains elements of a forested or shrub swamp as well as bog or fen characteristics. Vegetation includes scattered black spruce, and red maple and larch in the tree layer, huckleberry and sheep laurel in the shrub layer, and cinnamon fern, pitcher plant, sphagnum and sedges in the herbaceous layer. One or two small open water areas exist. It is surrounded by treed uplands. On the day of the site visit in September 2010, water was leaving the wetland through a well defined channel and then through a road culvert, indicating perhaps that this wetland receives surface water from surrounding upland sources regularly.
