January 28, 2013

HALIFAX REGIONAL MUNICIPALITY

Russell Lake Nutrient Source Desktop Assessment – Final

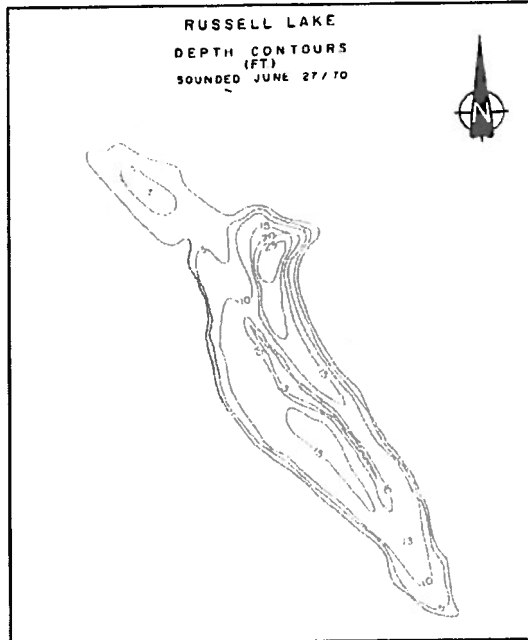
Drawing 1 Bathymetry Contours for Russell Lake (from OceanChem 1988)

Bathymetric contours for Russell Lake are provided in **Drawing 1**. It is noted that the deepest portion is near the outlet and the main lake is fairly shallow.

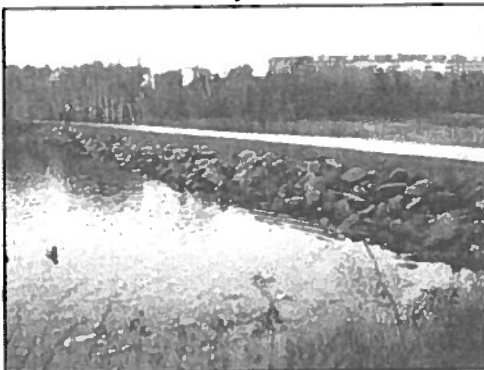
Photo 1 Causeway (Dec. 2012)

A small portion of the north end of the lake (north pond) is somewhat isolated from the main lake by a causeway road construction (trunk sewer) (**Photo 1**).

Based on the trunk sewer design drawings (Acres 1988), flow from the north pond area enters the main lake in three 750 mm pipe culverts located below the force main. The rock fill under the causeway may also allow some exchange of water between the pond and lake.

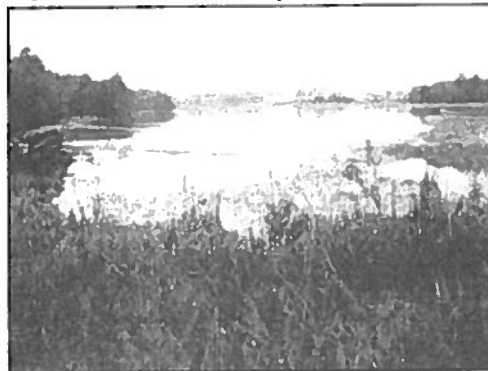
Photo 2 North Pond (Dec. 2012)

The lake shoreline is moderately steep along the east and west shores limiting rooted aquatic plant growth to the nearshore; but the shallower north pond (**Photo 2**), outlet cove and to some extent, the south tip of the lake allows extensive rooted plant development.

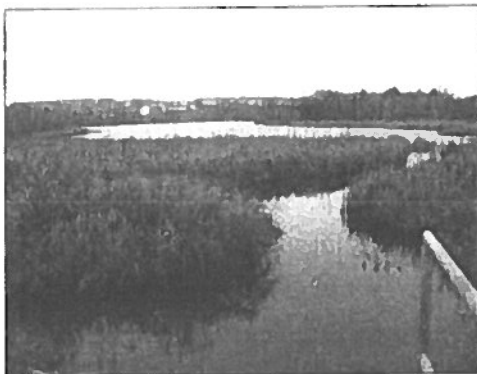
Photo 3 Lake Outlet Area (Dec. 2012)

The Russell Lake outlet draining to Morris Lake is within a cove at the north east end of the lake. Extensive wetland vegetation occurs at the head of the cove (**Photo 3**) and includes a wetland along the north side receiving stormwater drainage from the north. The outlet structure is concrete with stoplog control and fishway (Clean Nova Scotia 2011) (**Photo 4**).

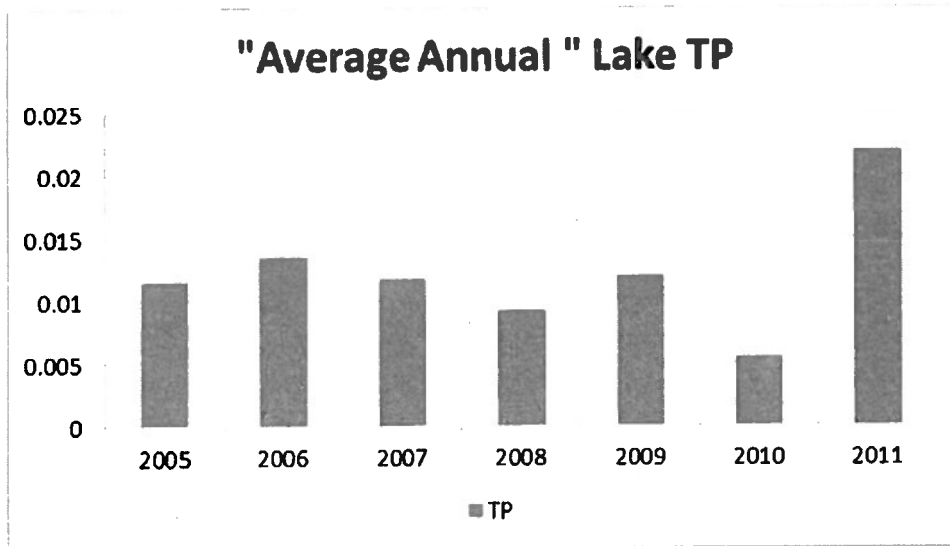
Graph 1. Average Russell Lake dataset annual TP concentration (mg/L)

In terms of lake TP concentrations, various indicators for trophic state are examined. The CCME trigger values for lake trophic status are based on mean annual TP. Most data sets do not provide a true mean annual value due to the frequency and timing of sampling and the variability of the data set. The Russell Lake dataset provides an estimate of mean TP (based on the seasonal sampling periods) (**Graph 1**). As a check on annual average, TP at spring turnover (mixed water column) has been used as a surrogate for mean annual TP (**Graph 2**).

The spring TP and the “average annual” TP generally show similar trends. Neither datasets show consistent increasing or decreasing trends over time. To consider potential rainfall influences, annual precipitation data (Halifax Airport Environment Canada Station) for the years of interest is provided in **Table 2** below. Again, clear indications of trends with annual precipitation are not evident, however datasets are limited.

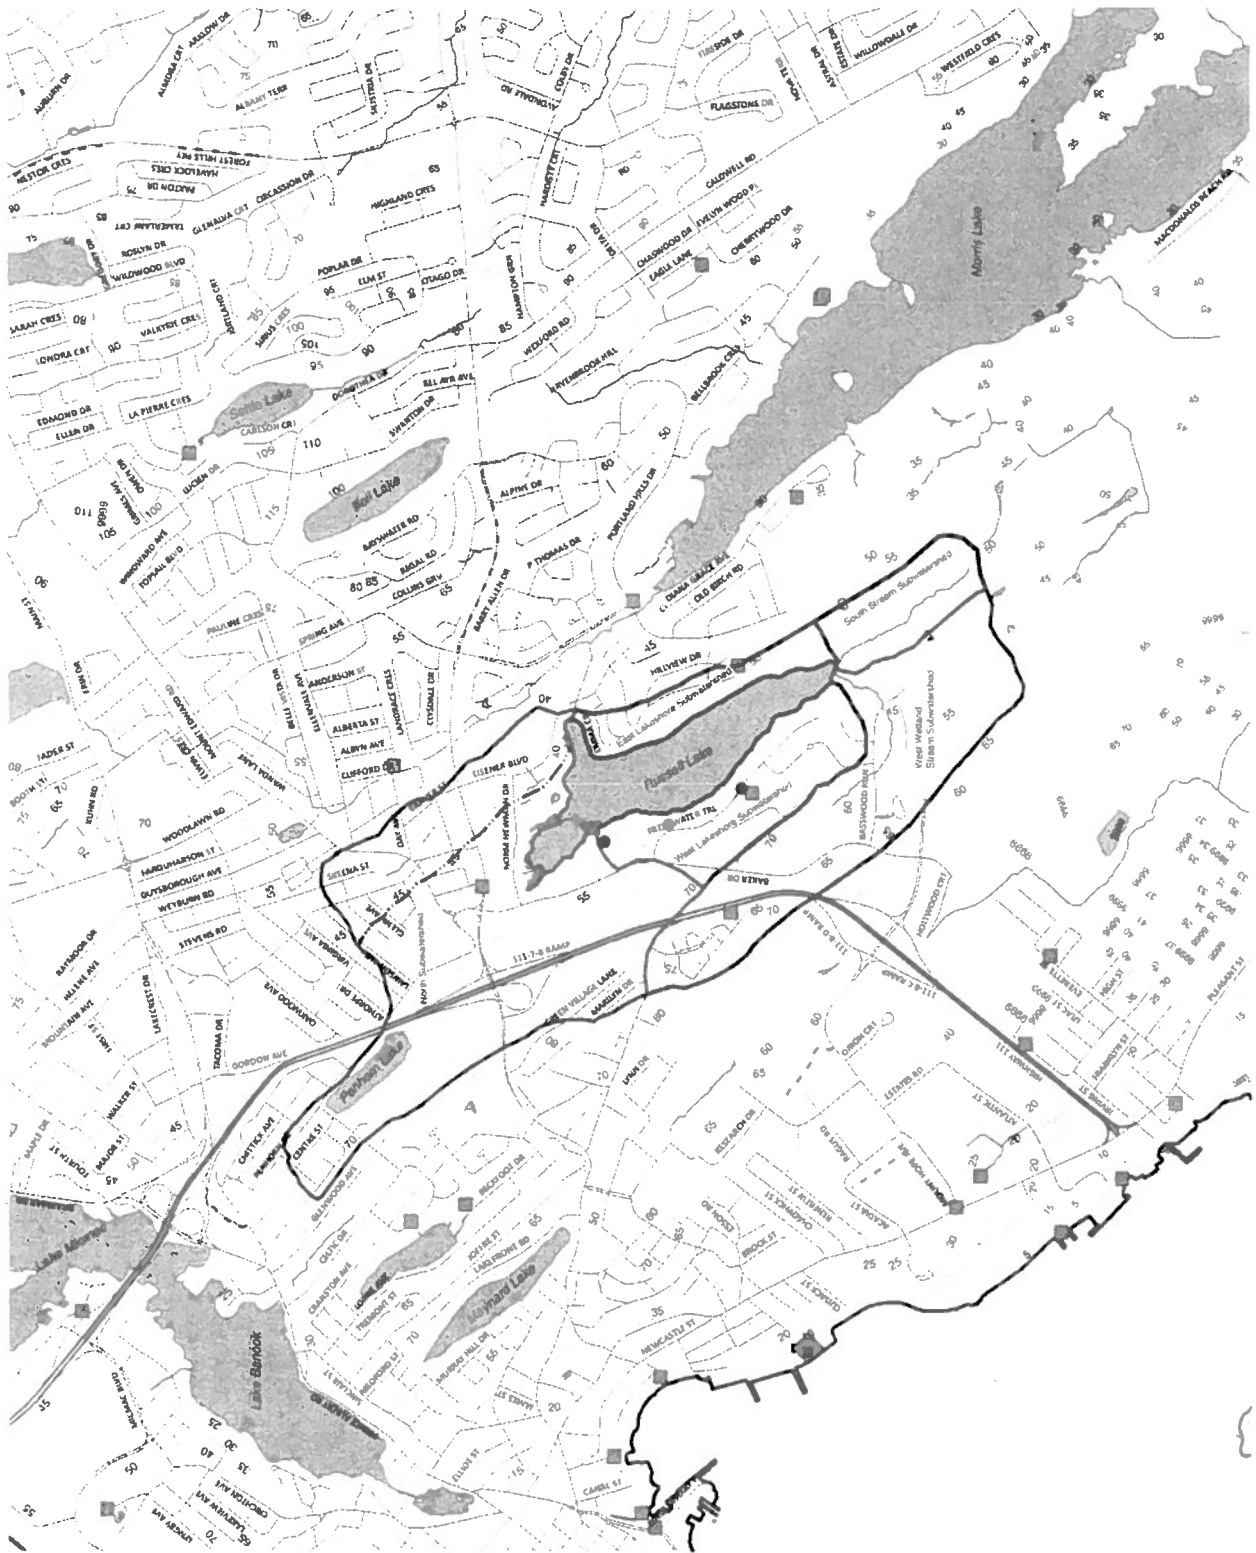
FIGURE 1
SURFACE WATER

Figure 1 depicts the area of the Russell Lake watershed based on the Watershed Management Plan delineation (Griffiths Muecke 1994) and subwatersheds based on topography and available stormwater infrastructure locations provided by Halifax Water. It is noted that detailed information regarding stormwater infrastructure was not available for the majority of recent development around the lake. Although sanitary sewer infrastructure in the watershed is directed to Eastern Passage, sewage pump stations are also shown on the figure for the consideration of potential overflows.

Halifax Water sanitary sewer pump stations within the subwatersheds are identified on **Figure 1**. The sanitary sewage generated in the Russell Lake sewershed is conveyed by five (5) sanitary sewer pumping stations:

The North subwatershed includes several individual storm sewer inputs to the lake. One of these (east end of Norm Newman Drive) reflects a historical subwatershed divide (noted as a dashed line on **Figure 1** and approximately 24% of the area of the total north subwatershed). This portion of the watershed drains to either the north pond or its associated wetland area. The area on the north shore of Russell Lake (south of Norm Newman Drive) is both a Nova Scotia Department of Natural Resources (NSDNR) identified wetland surrounding the north pond and a low-lying wetland/forest complex to the east of the identified wetland. The east (dashed) sub area appears to have runoff / storm-flow directed towards the east end of the outlet cove (**Figure 1**).

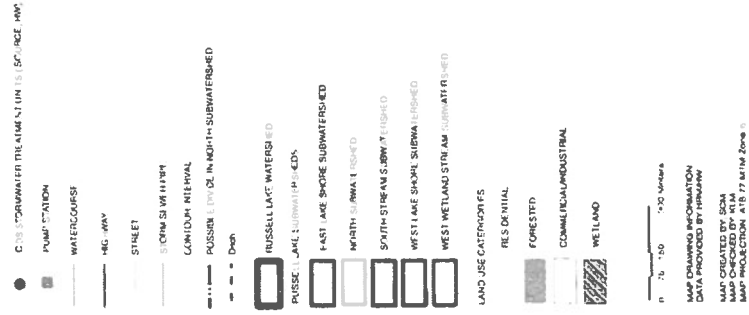
FIGURE 2
LAND USE

Table 3 identifies the land use breakdown within each subwatershed. Land use within the watershed was assessed based on August 2011 Google map coverage and is presented on **Figure 2**.

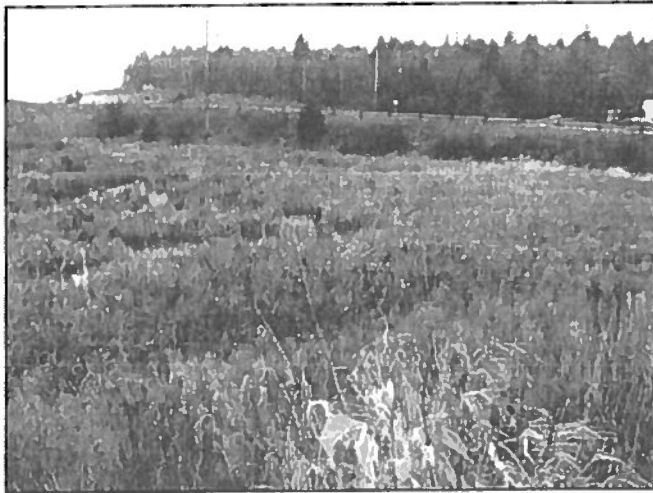
Photo 5 Cattail Area Downgradient of Pump Station (Dec. 2012)

In addition to historic point sources associated with the pig farm and pump station overflows, general storm runoff within this subwatershed occurs from the Gaston Road trailer park area (developed over 50-60 years ago), a small portion of the Russell Lake West and the Mount Hope Avenue commercial area (both developed in the past 10 years to on-going), limited drainage from the Circumferential Highway (built over 40 years ago) and general runoff from the largely forested area to the east of this development. The majority of the developed areas drain towards a small wetland (NSDNR identified). This wetland was identified as a potential sink and continual source for legacy point source TP loading (Stantec 2006). Peat samples taken in 2006 in the cattail wetland downgradient of the Circumferential had 8 times higher TP than control samples (**Photo 5** shows the cattail area downgradient of the pump station).

It is noted that although still present immediately downstream of the highway, the extent of this wetland downstream appears to have been reduced in recent years due to adjacent land use encroachment.

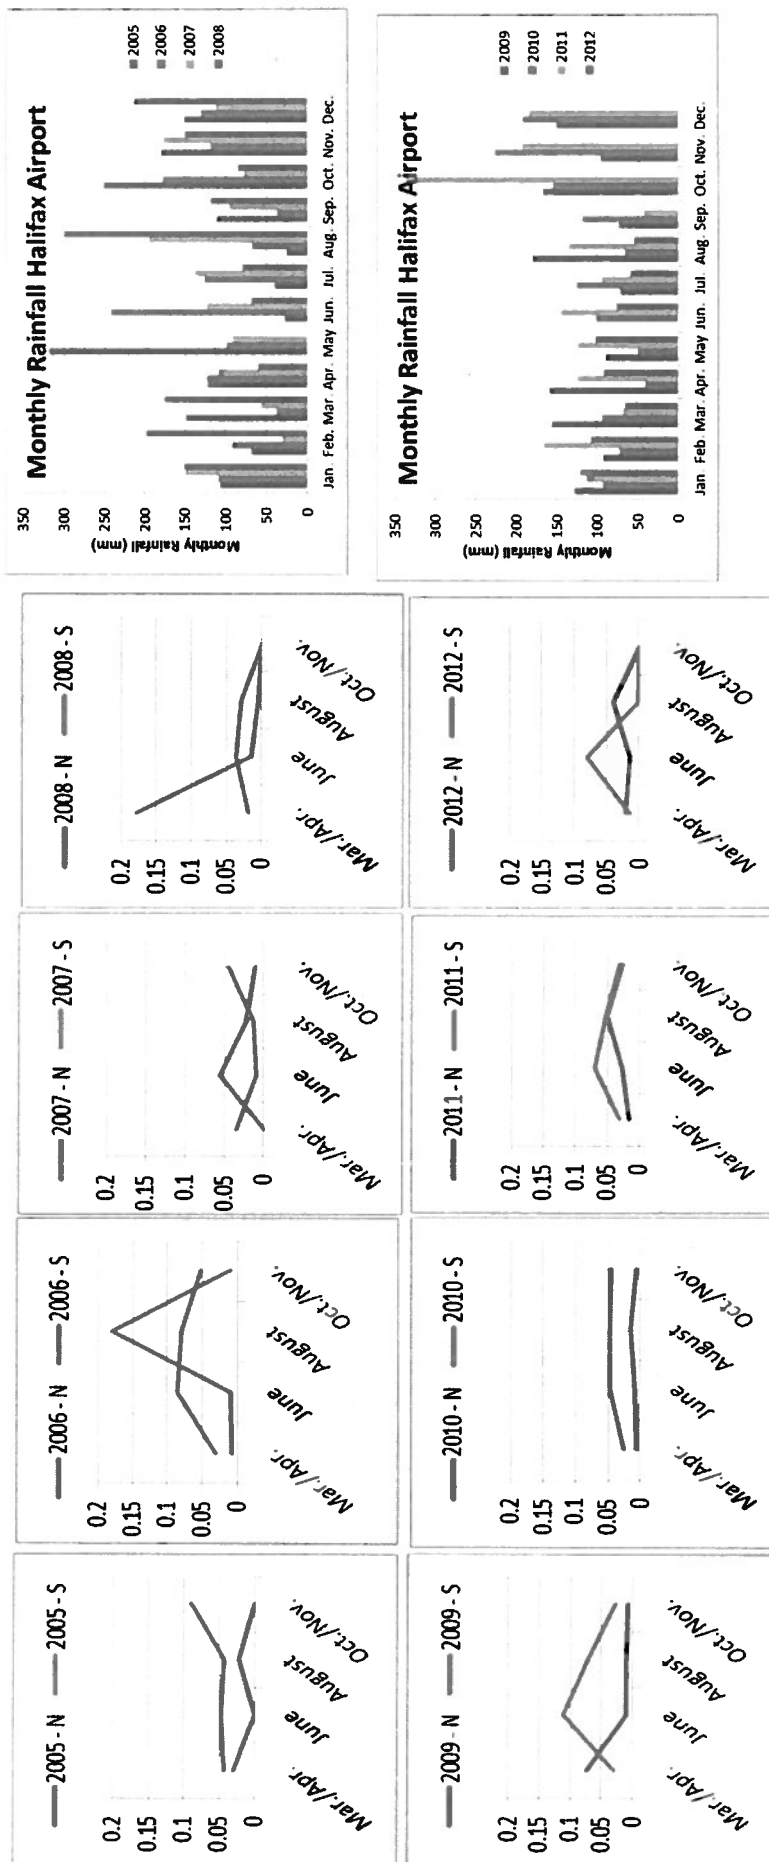
Graph 3 Comparison of North and South Monitoring Station TP Concentrations - mg/L (from Siantec monitoring 2005-2012) and Monthly Rainfall Data (Halifax Airport Environment Canada Station)

Graph 3 provides a time series of TP concentrations within both the north and south monitoring stations. The concentrations within the south drainage are typically (but not consistently) higher than concentrations in the north drainage. Concentrations in the south drainage also typically (but not consistently) peak during the early summer period. It is noted that storm water concentrations are typically higher than lake concentrations.

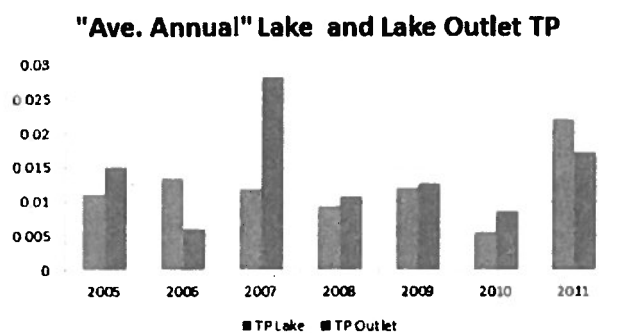
Graph 4 Lake and Outlet TP (mg/L)

- Further investigation is suggested to determine the potential for the relatively higher loading associated with the north watershed to incompletely mix within the main lake and "bypass" directly to the outlet. An initial determination (reported in Griffiths Muecke 1994) was that bypass was not significant. This assessment should be revisited based on current data. **Graph 4** provides a comparison of lake versus outlet data on an "annual average" basis. Generally the lake TP is slightly less than the outlet TP (with the exception of 2006).
