Halifax Harbour Solutions Project

Halifax Wastewater Treatment Facility - Update

Regional Council, April 14, 2009

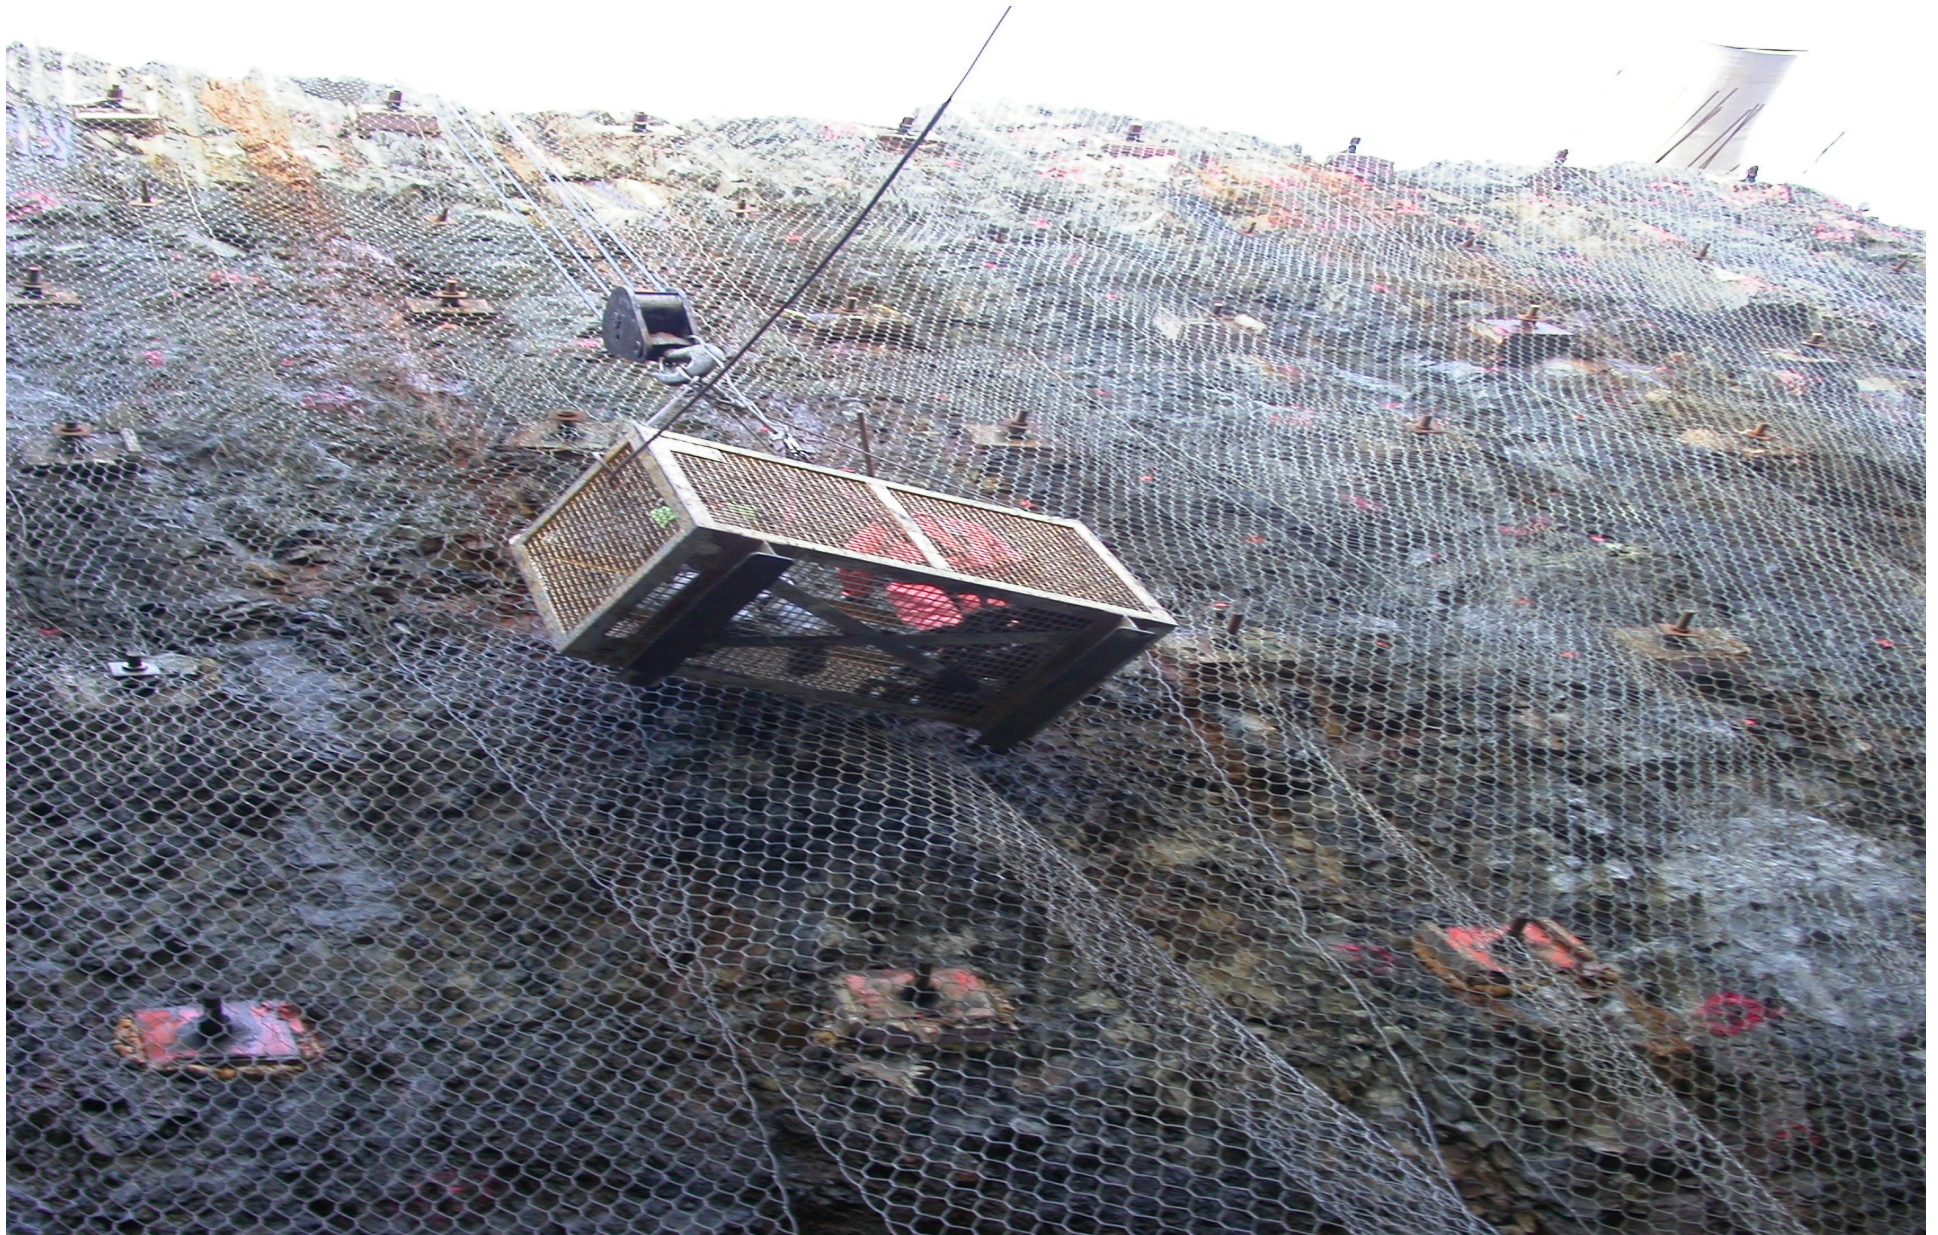
Crews Installing Safety Mesh in Wet Well

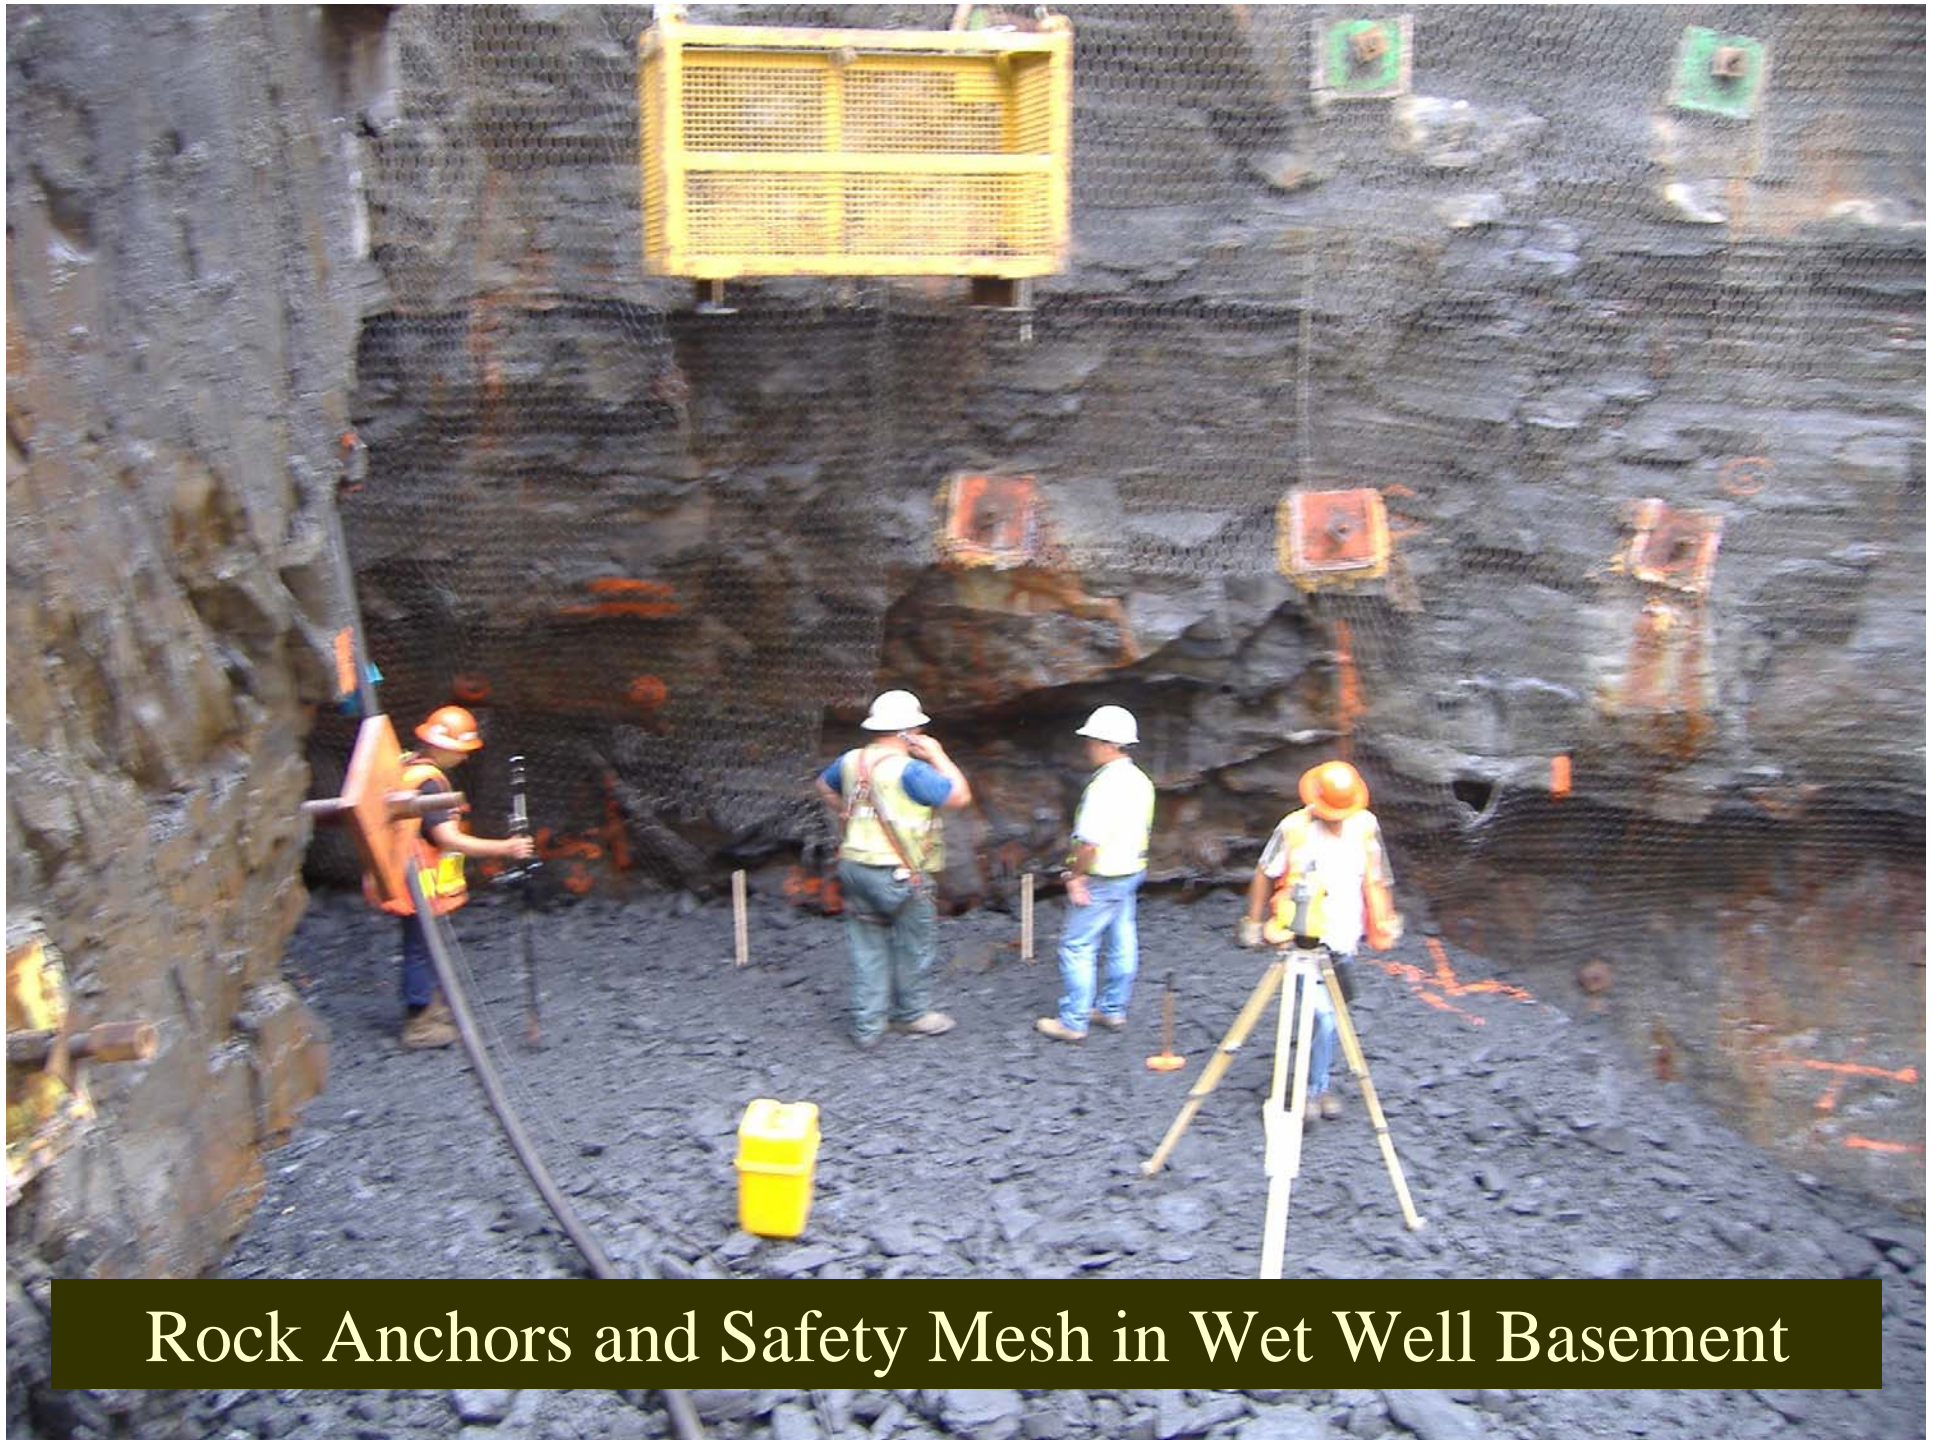
Rock Anchors and Safety Mesh in Wet Well Basement

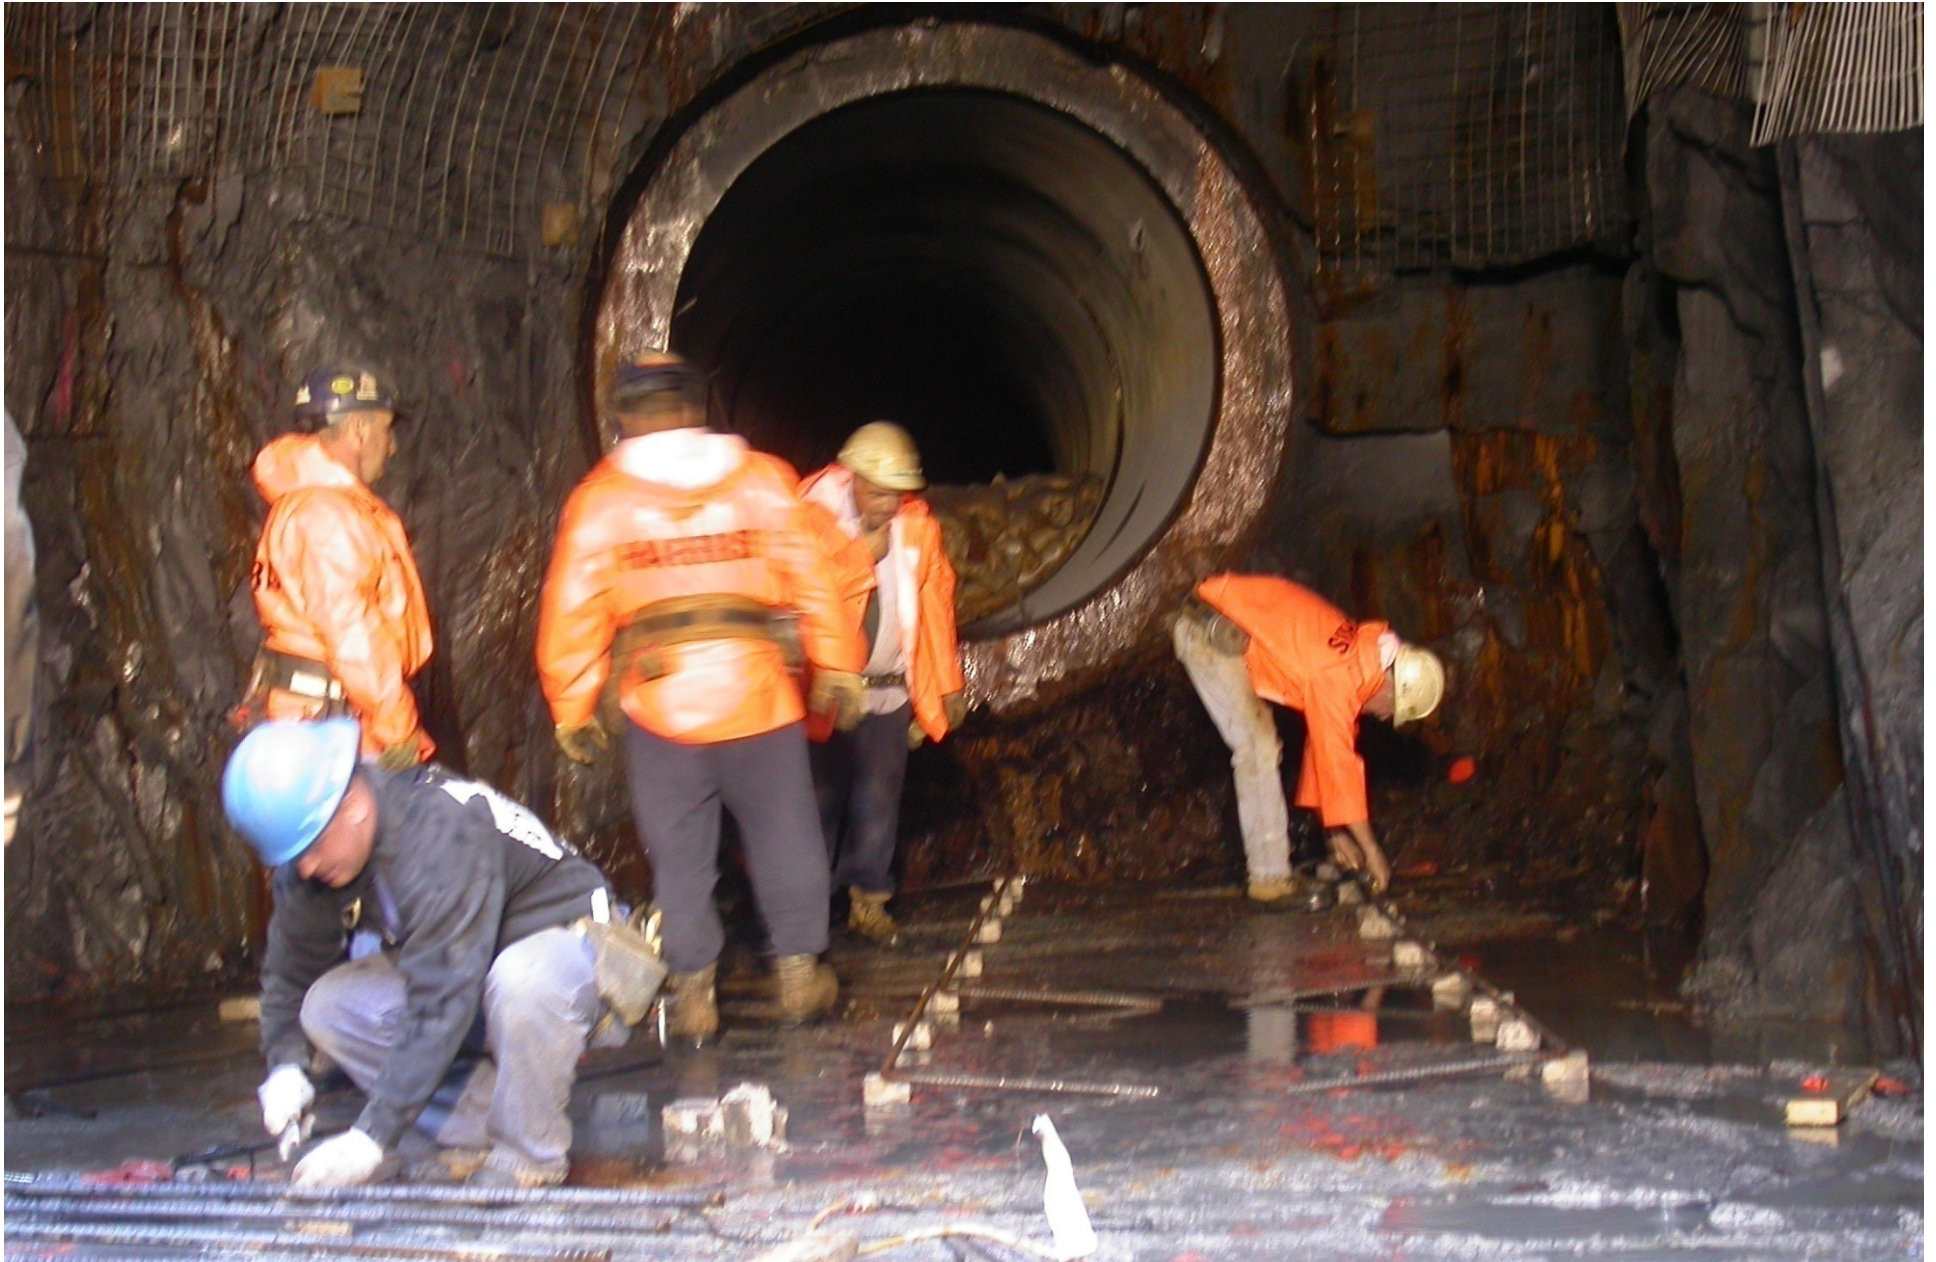
Tunnel Entrance to Wet Well – Approx. 85 feet Below
Grade

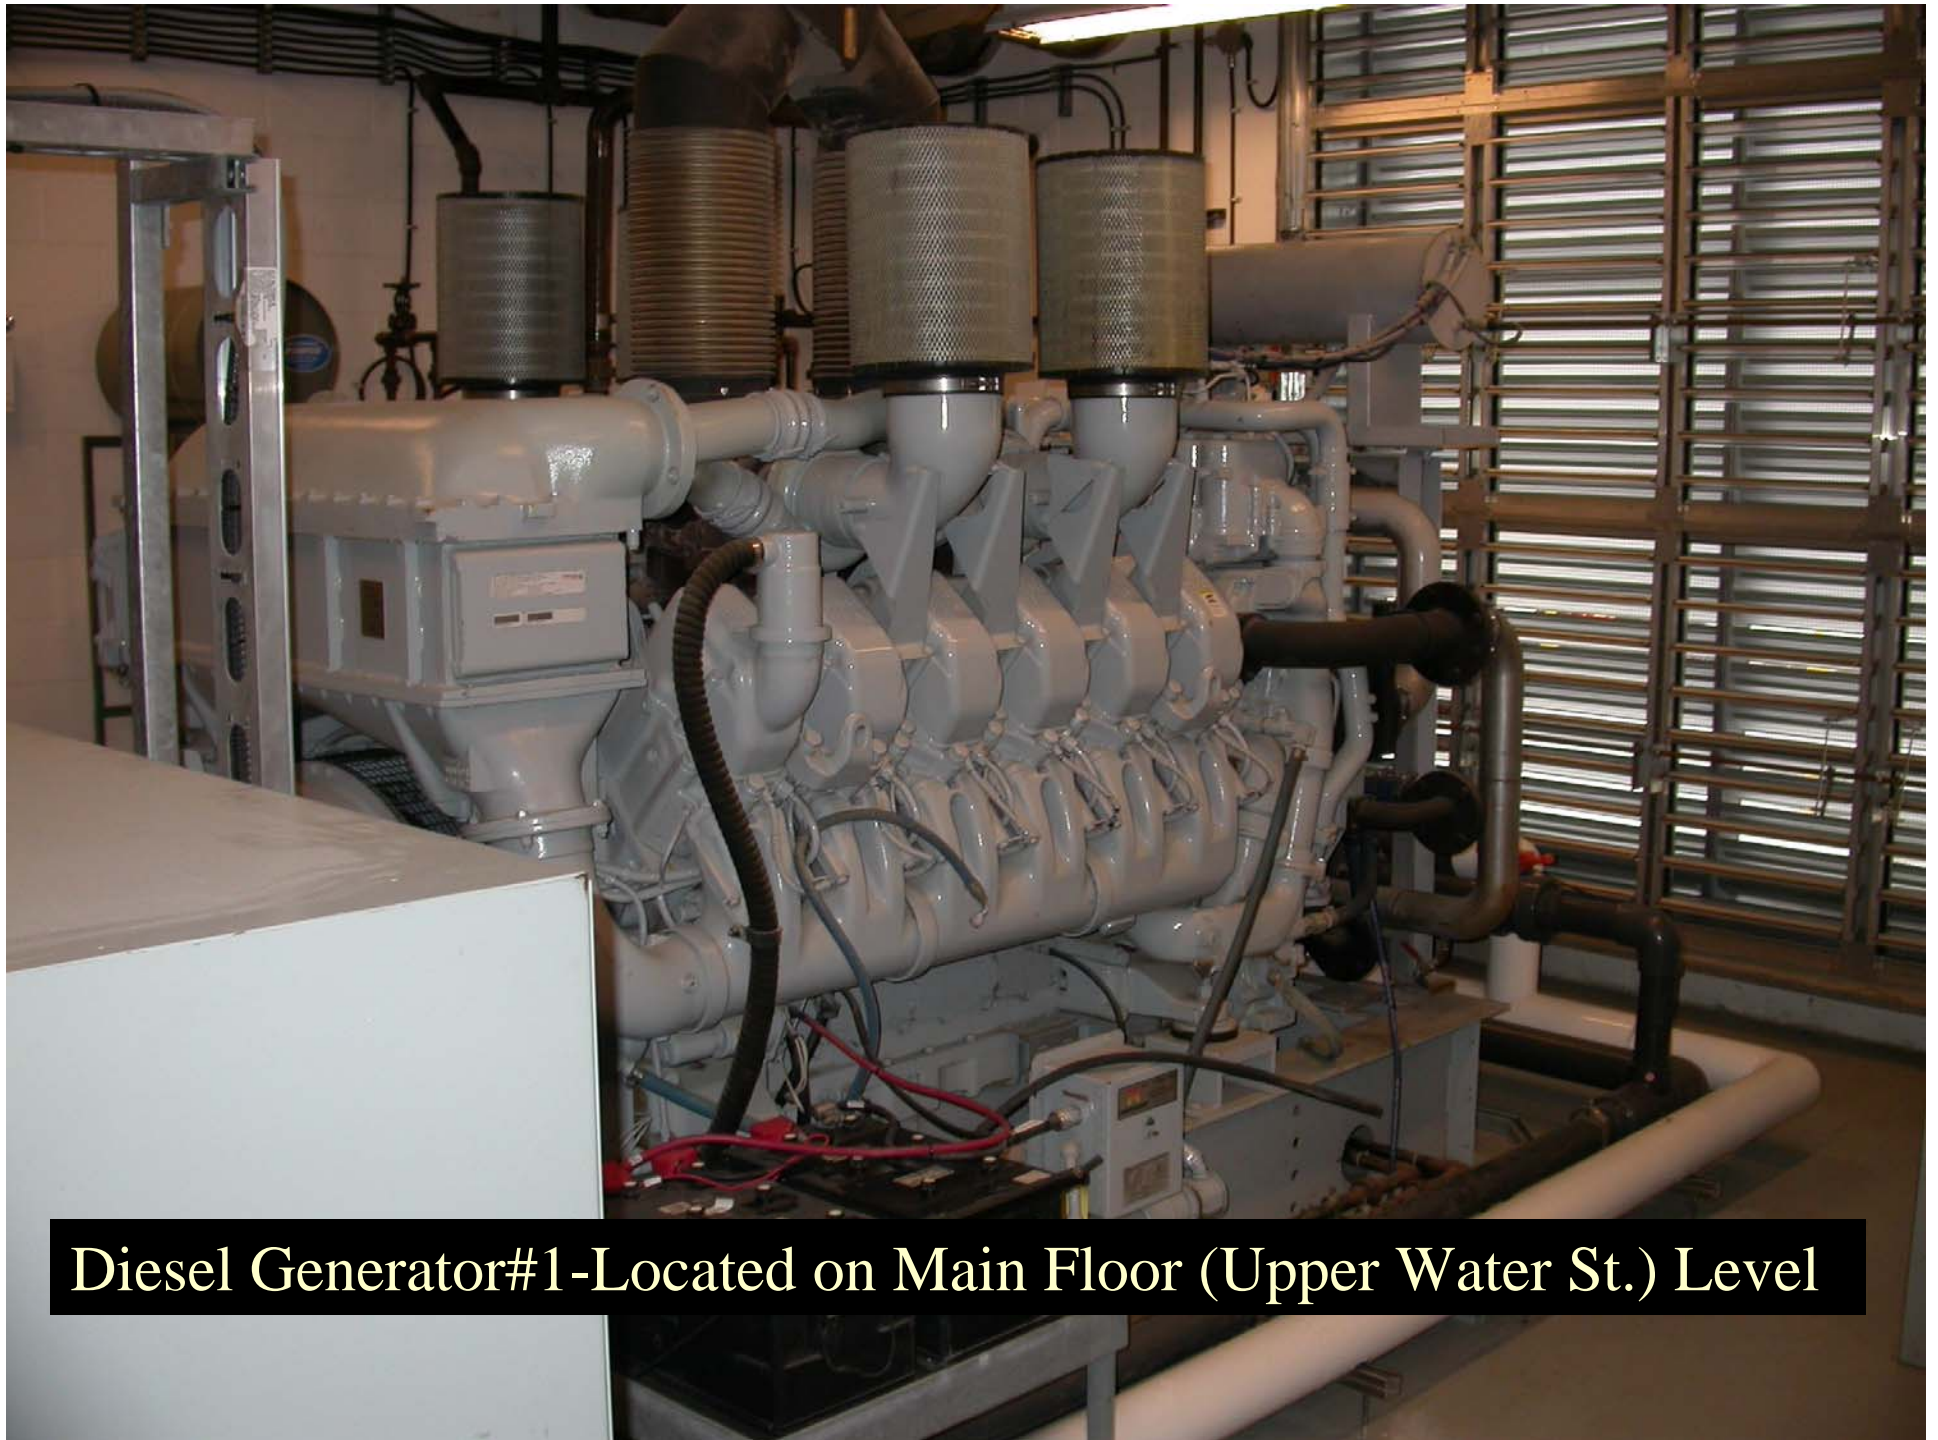
Diesel Generator#1-Located on Main Floor (Upper Water St.) Level

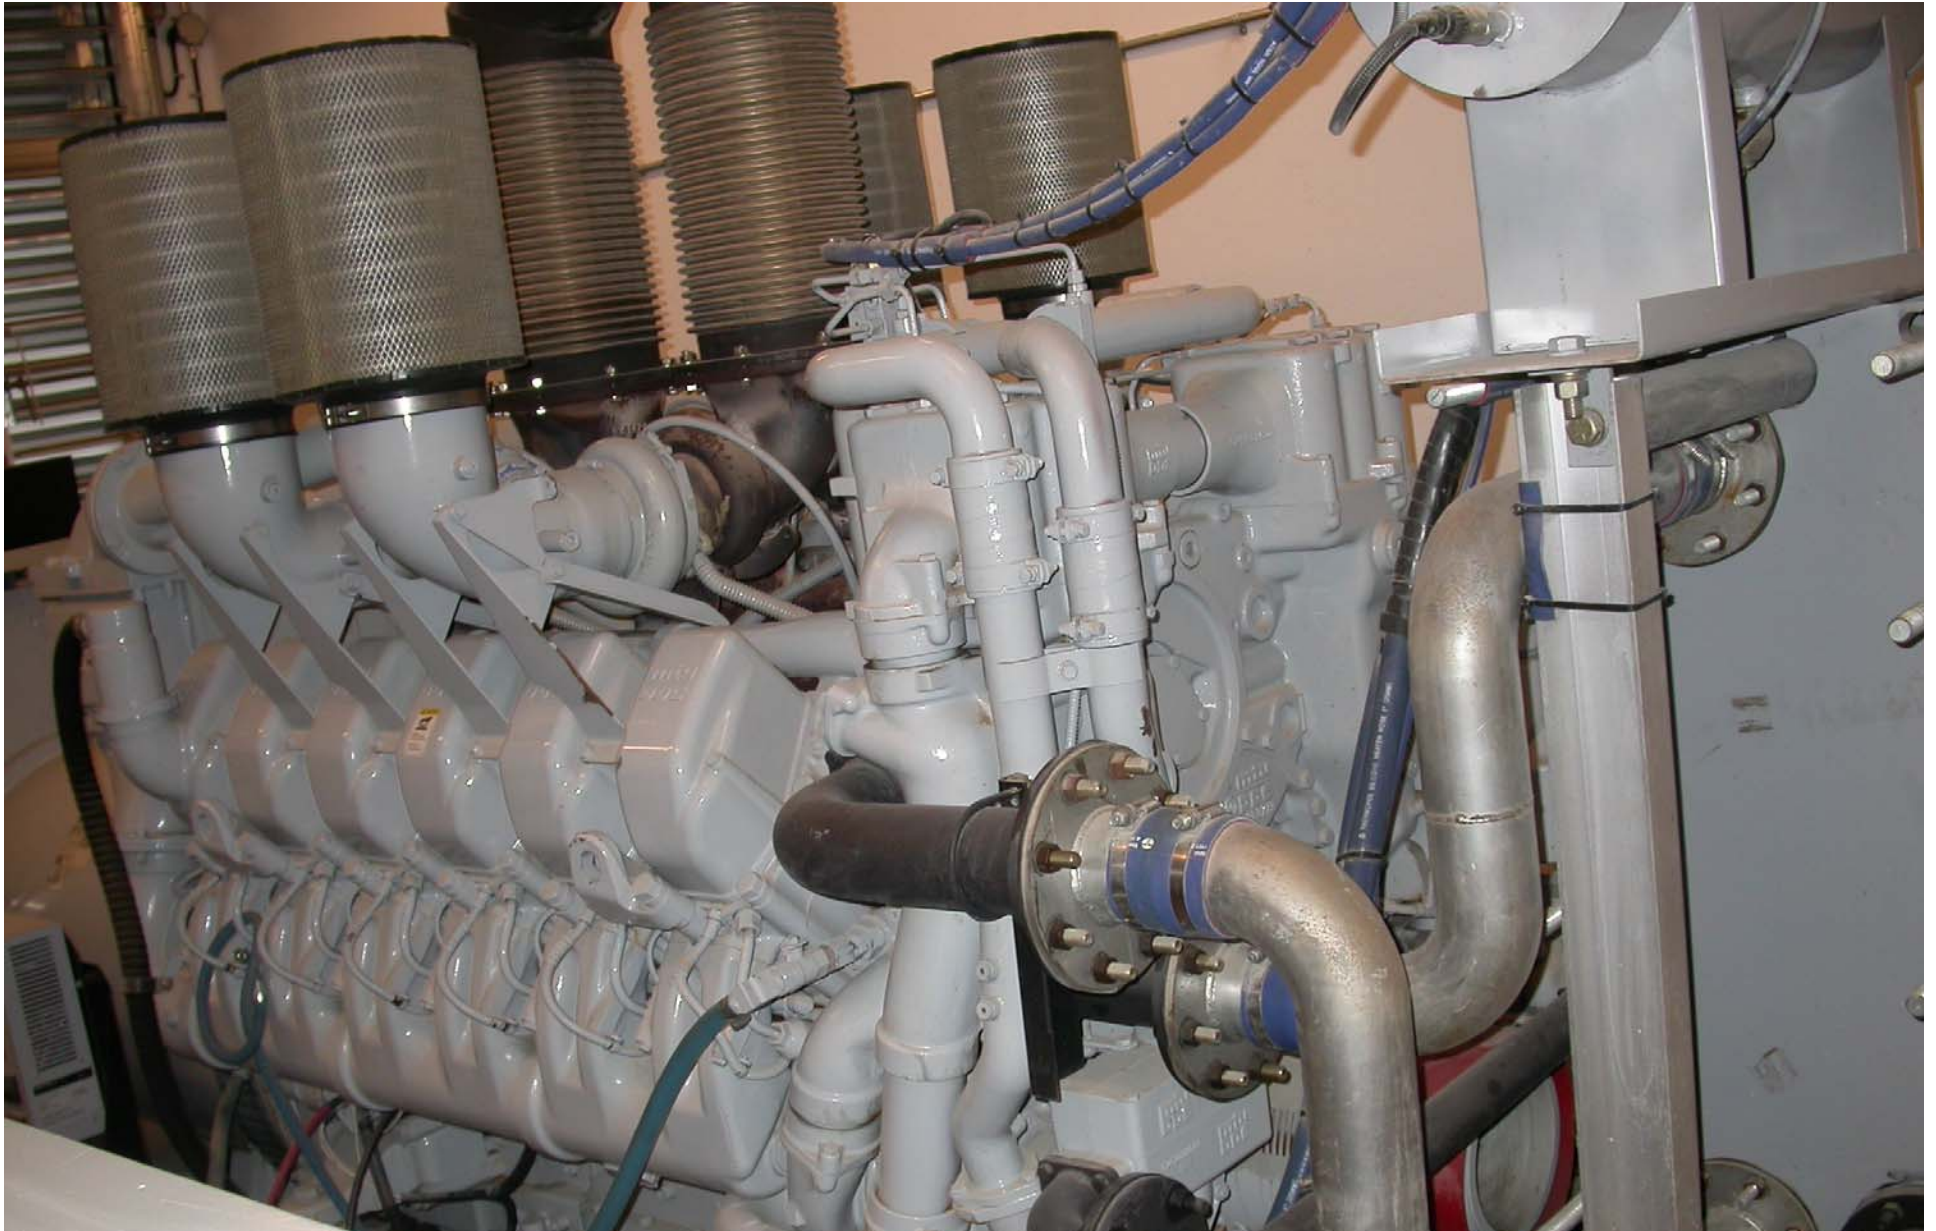
Diesel Generator#2-Located on Main Floor (Upper Water St.) Level

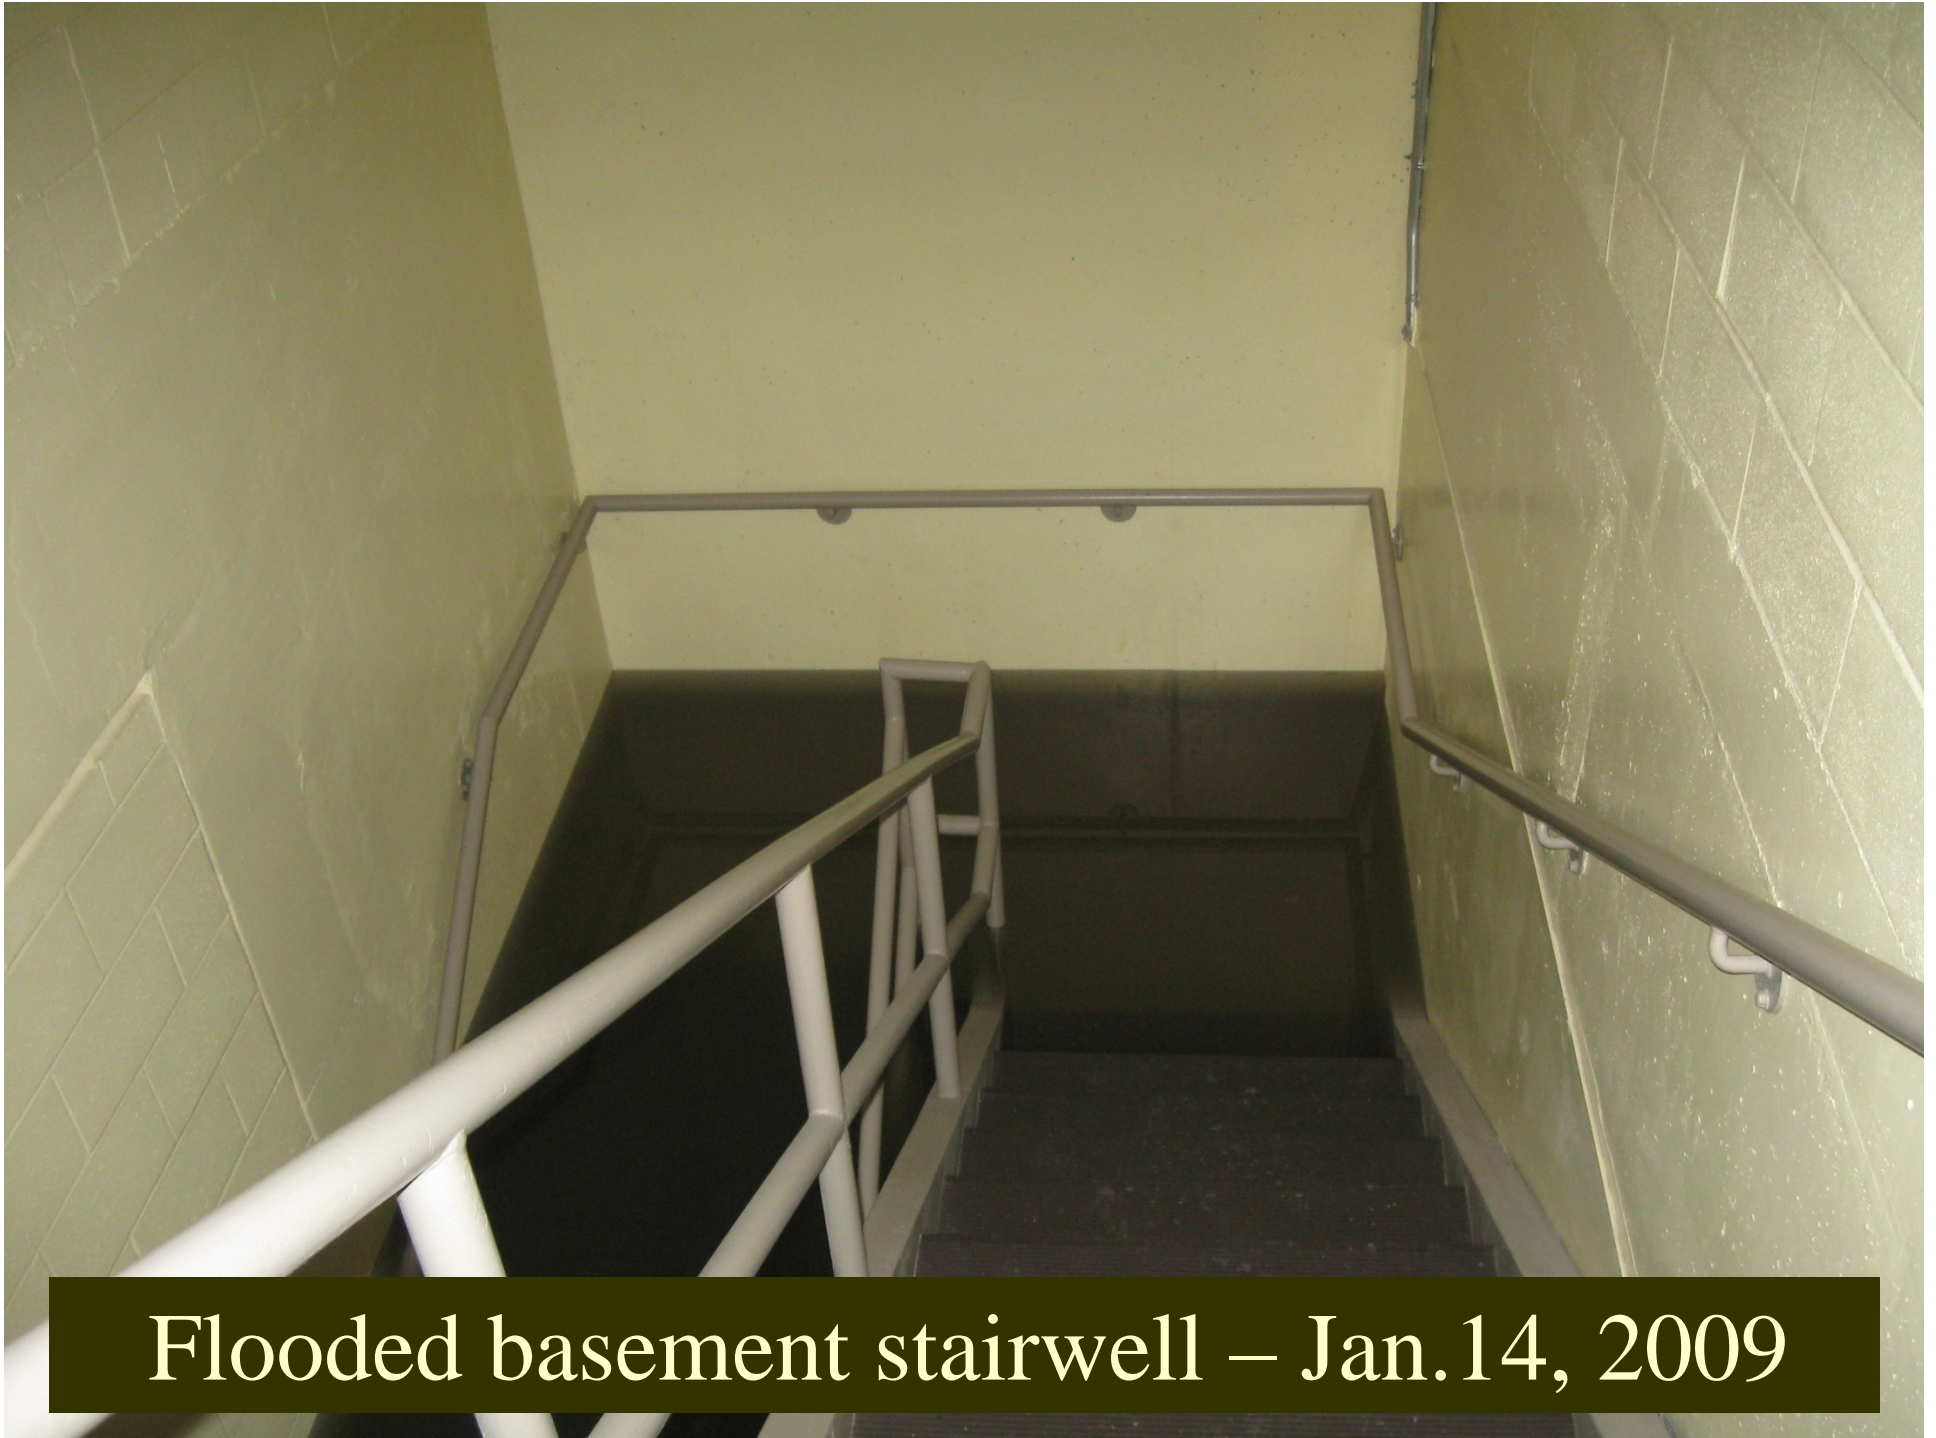
Flooded basement stairwell – Jan.14, 2009

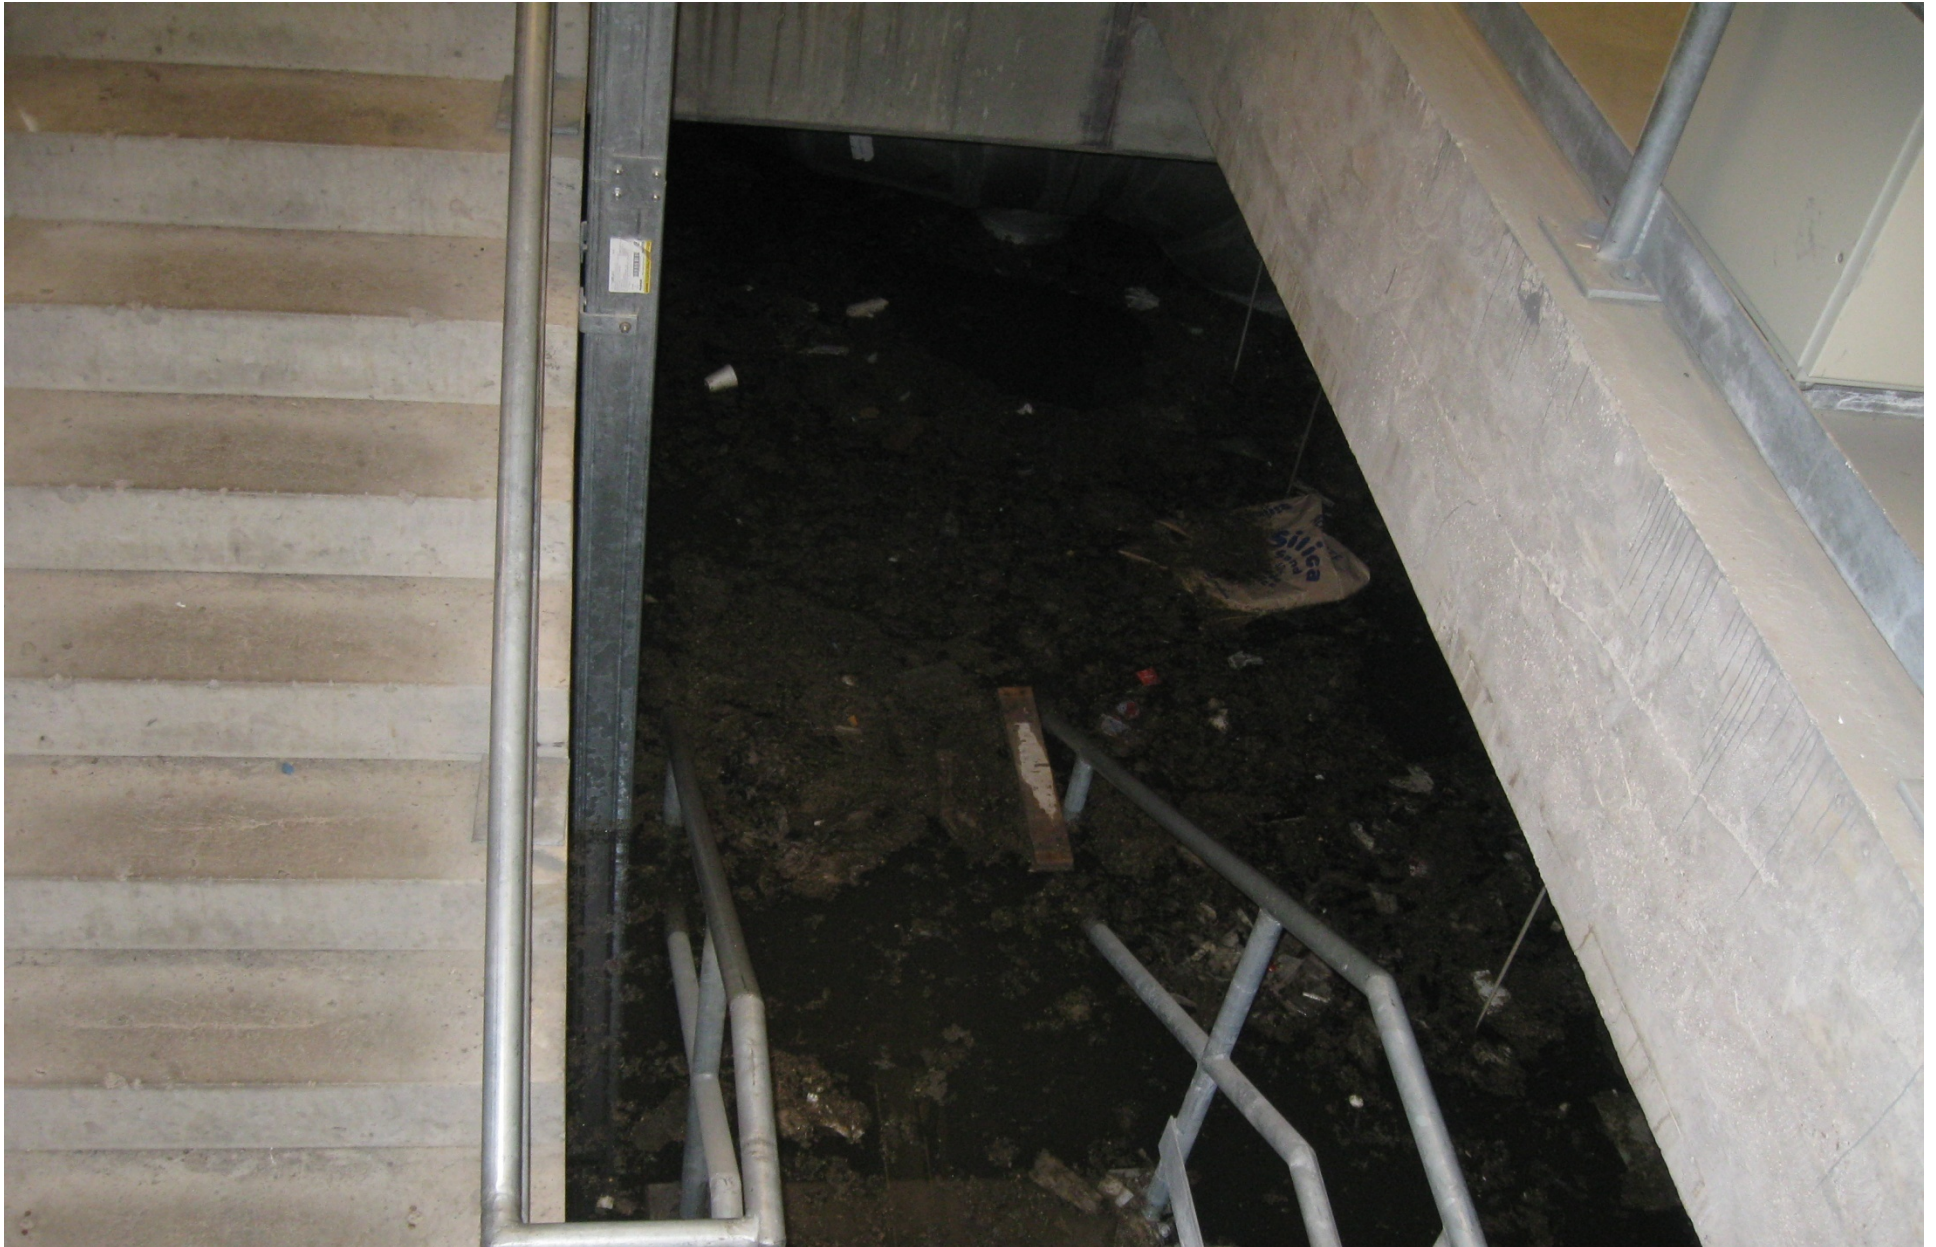
Flooded wet well area – Jan.14, 2009

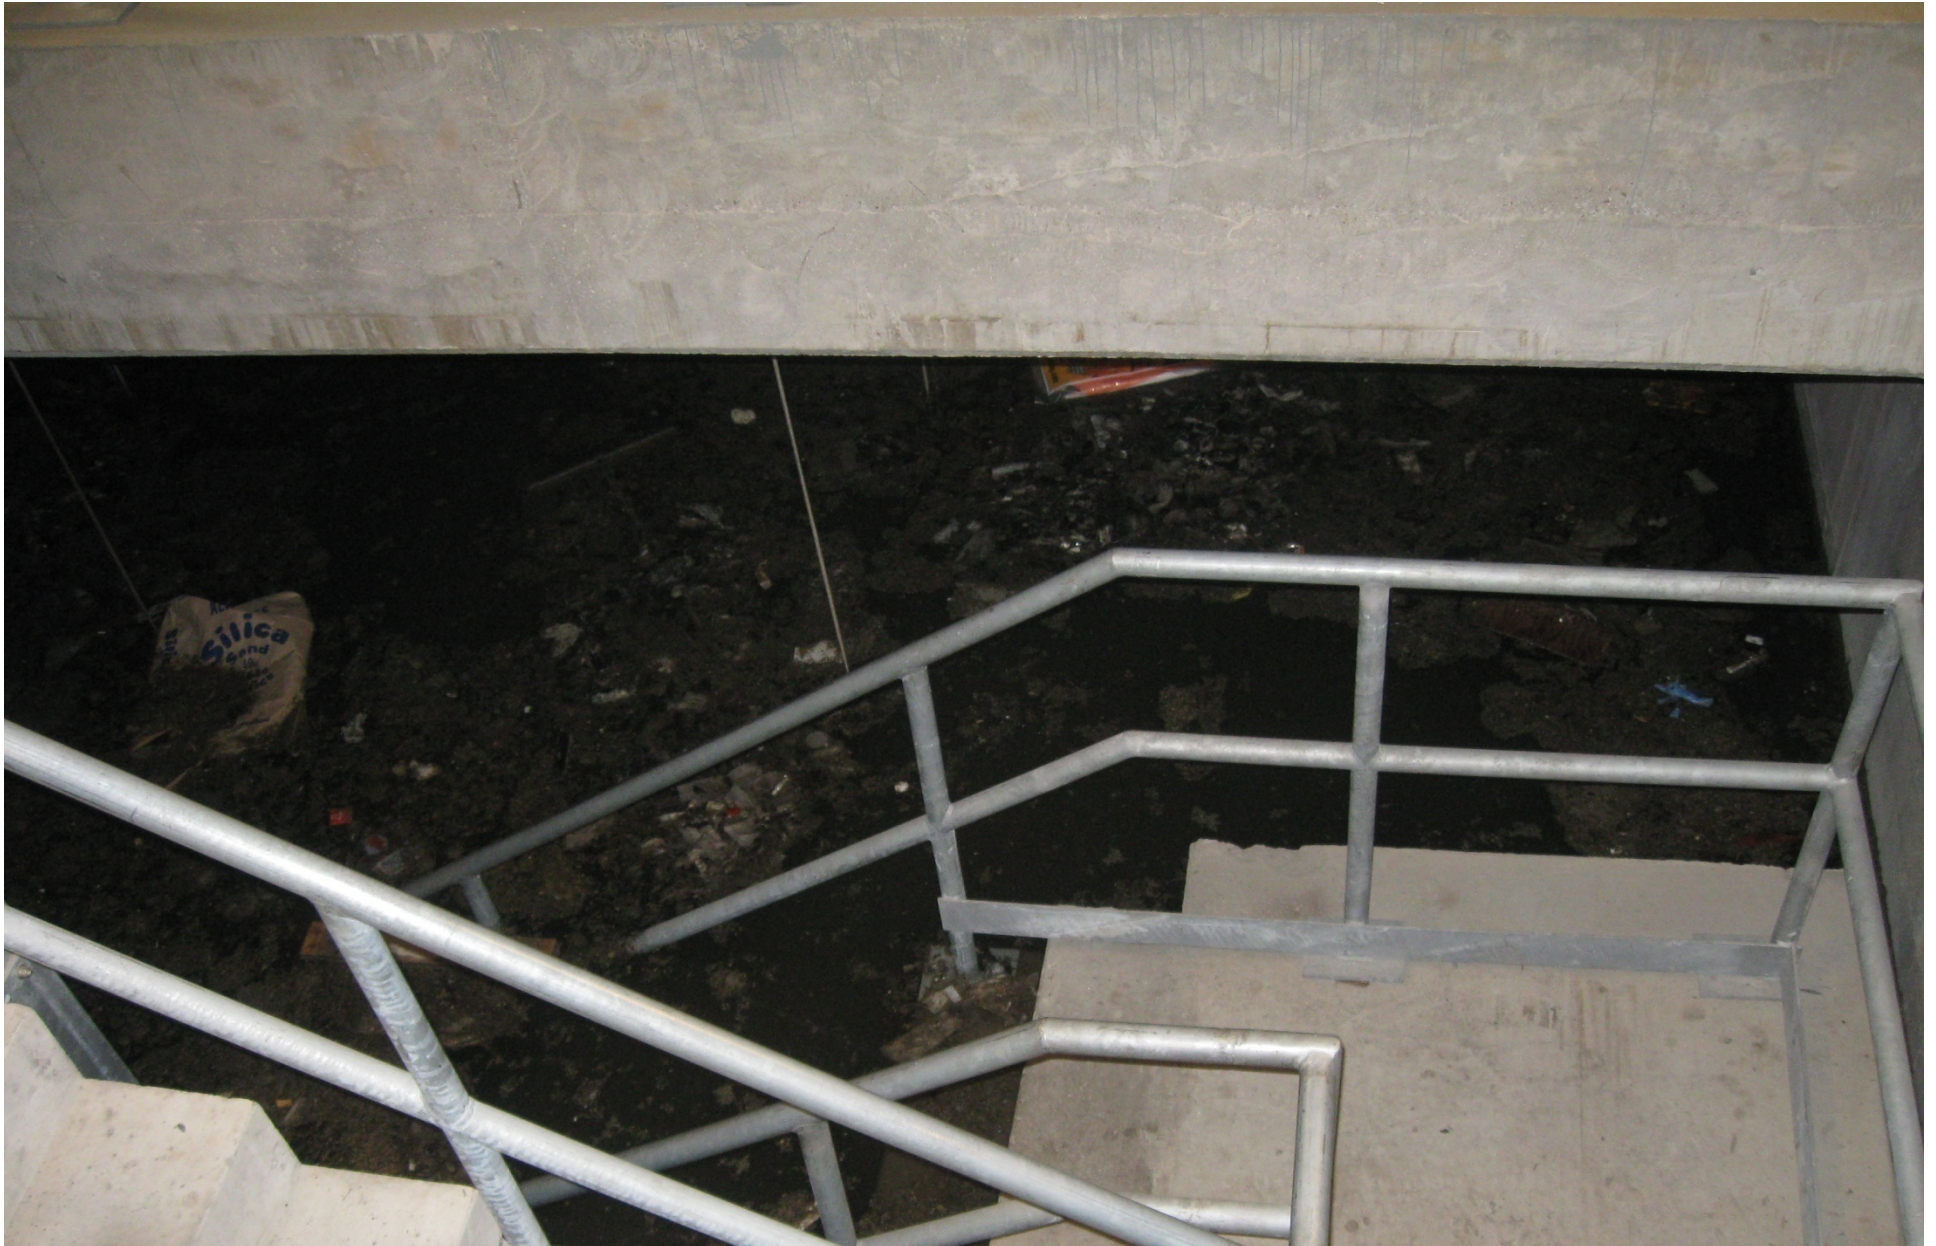
Flooded wet well area – Jan.14th

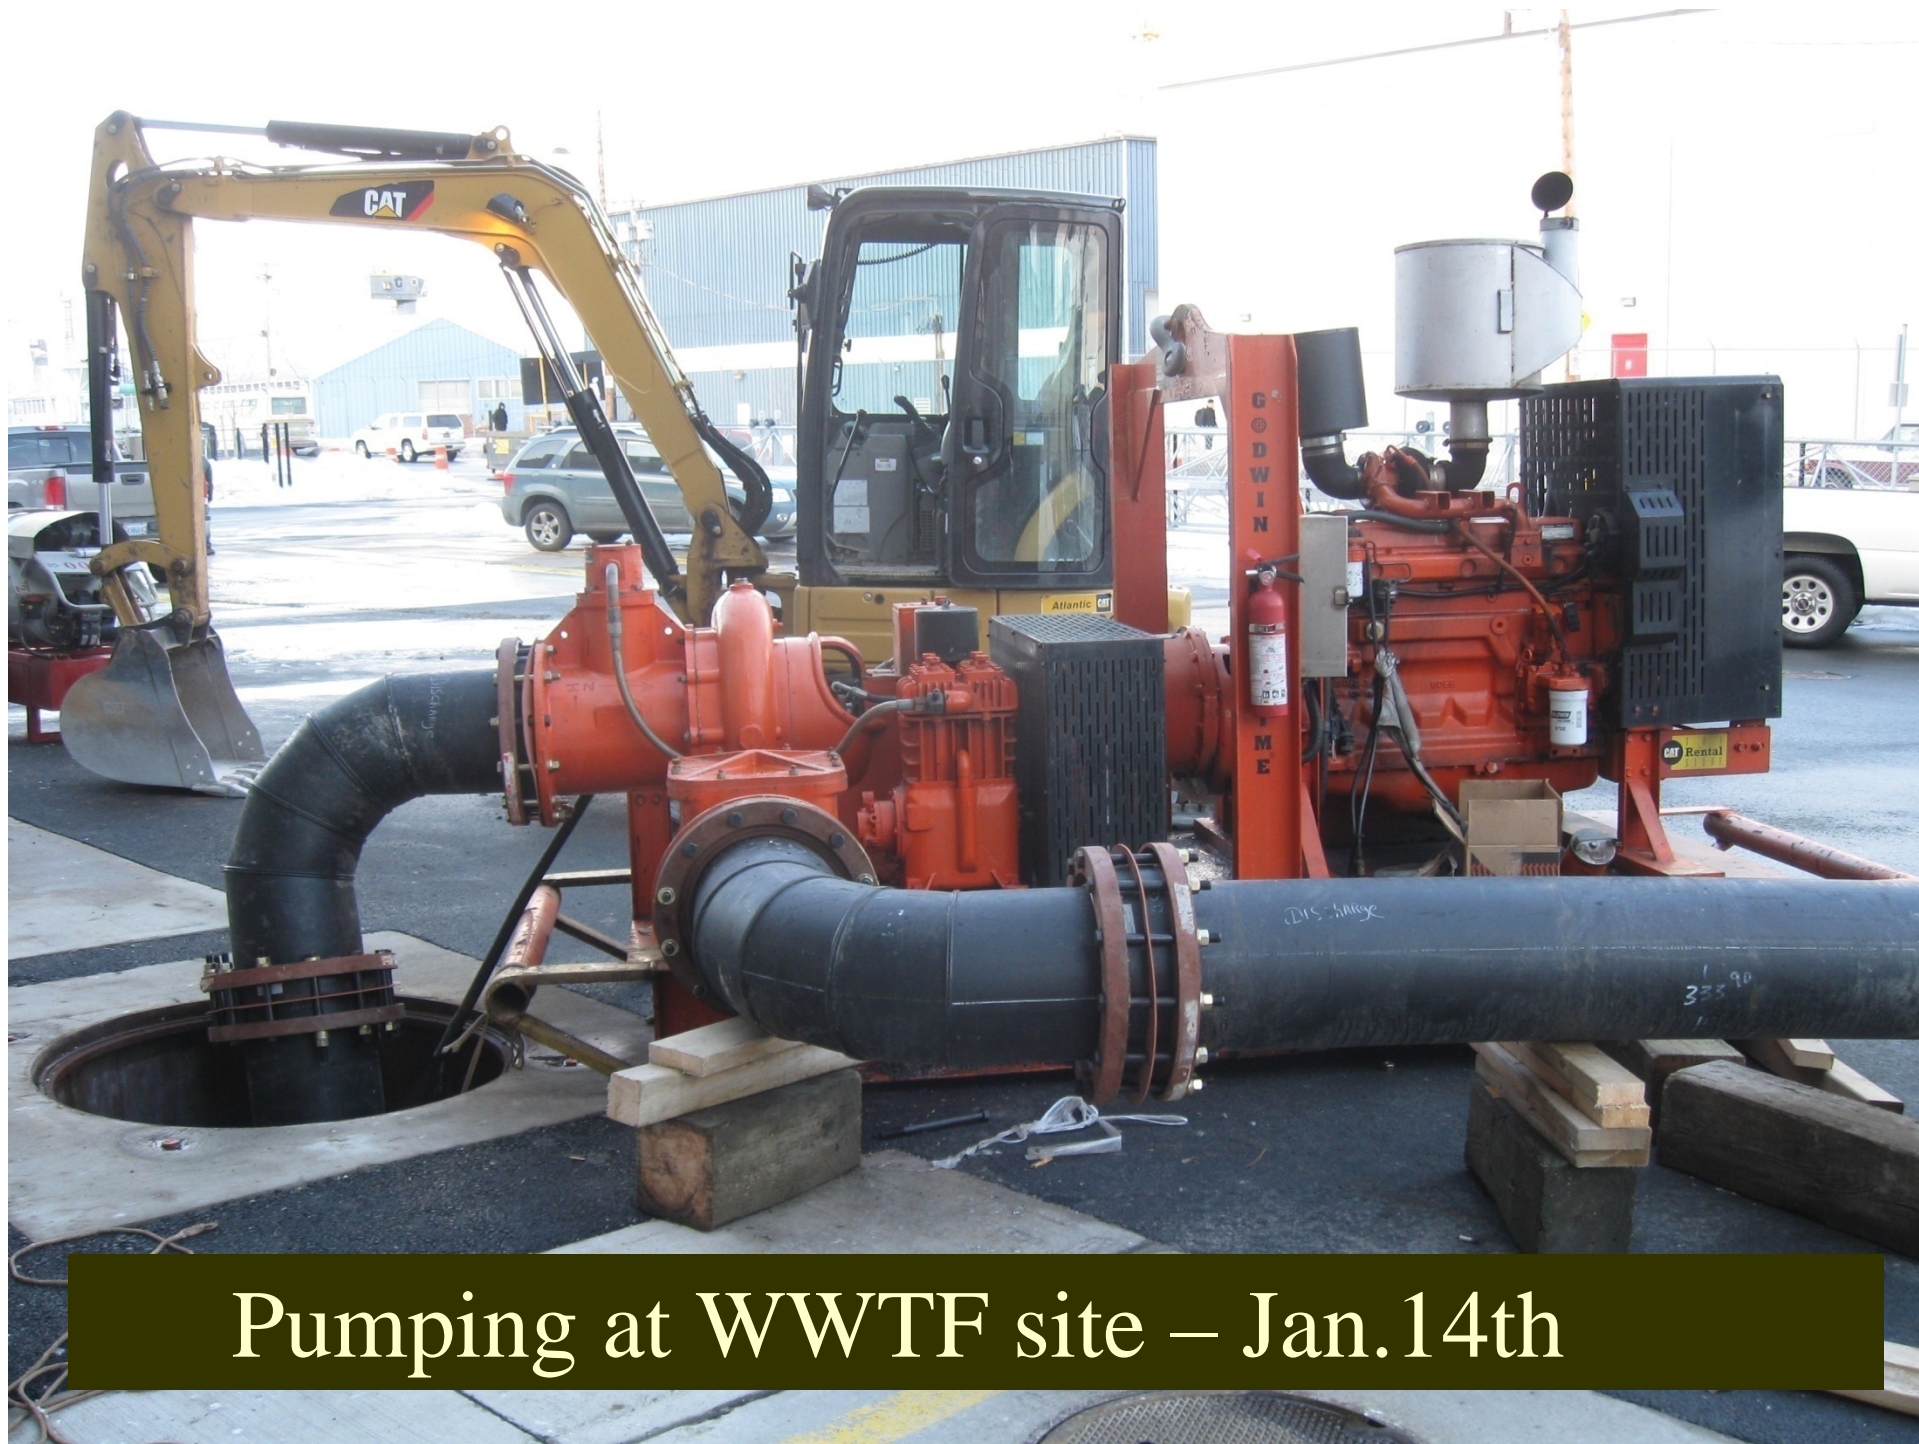
Pumping at WWTF site – Jan.14th

- ❖ Pump out of plant commenced on Jan 14 (valve still open to collection system)
- ❖ Temporary heating rigged immediately and in safe manner to protect plant and personnel from freezing temperatures
- ❖ Valve closed manually on Jan 18 to protect plant from wet weather
- ❖ Facility cleanup and insurance investigations commenced
- ❖ No safety incidents
