Halifax Harbour Solutions Project

Halifax Wastewater Treatment Facility - Update

Regional Council, April 14, 2009

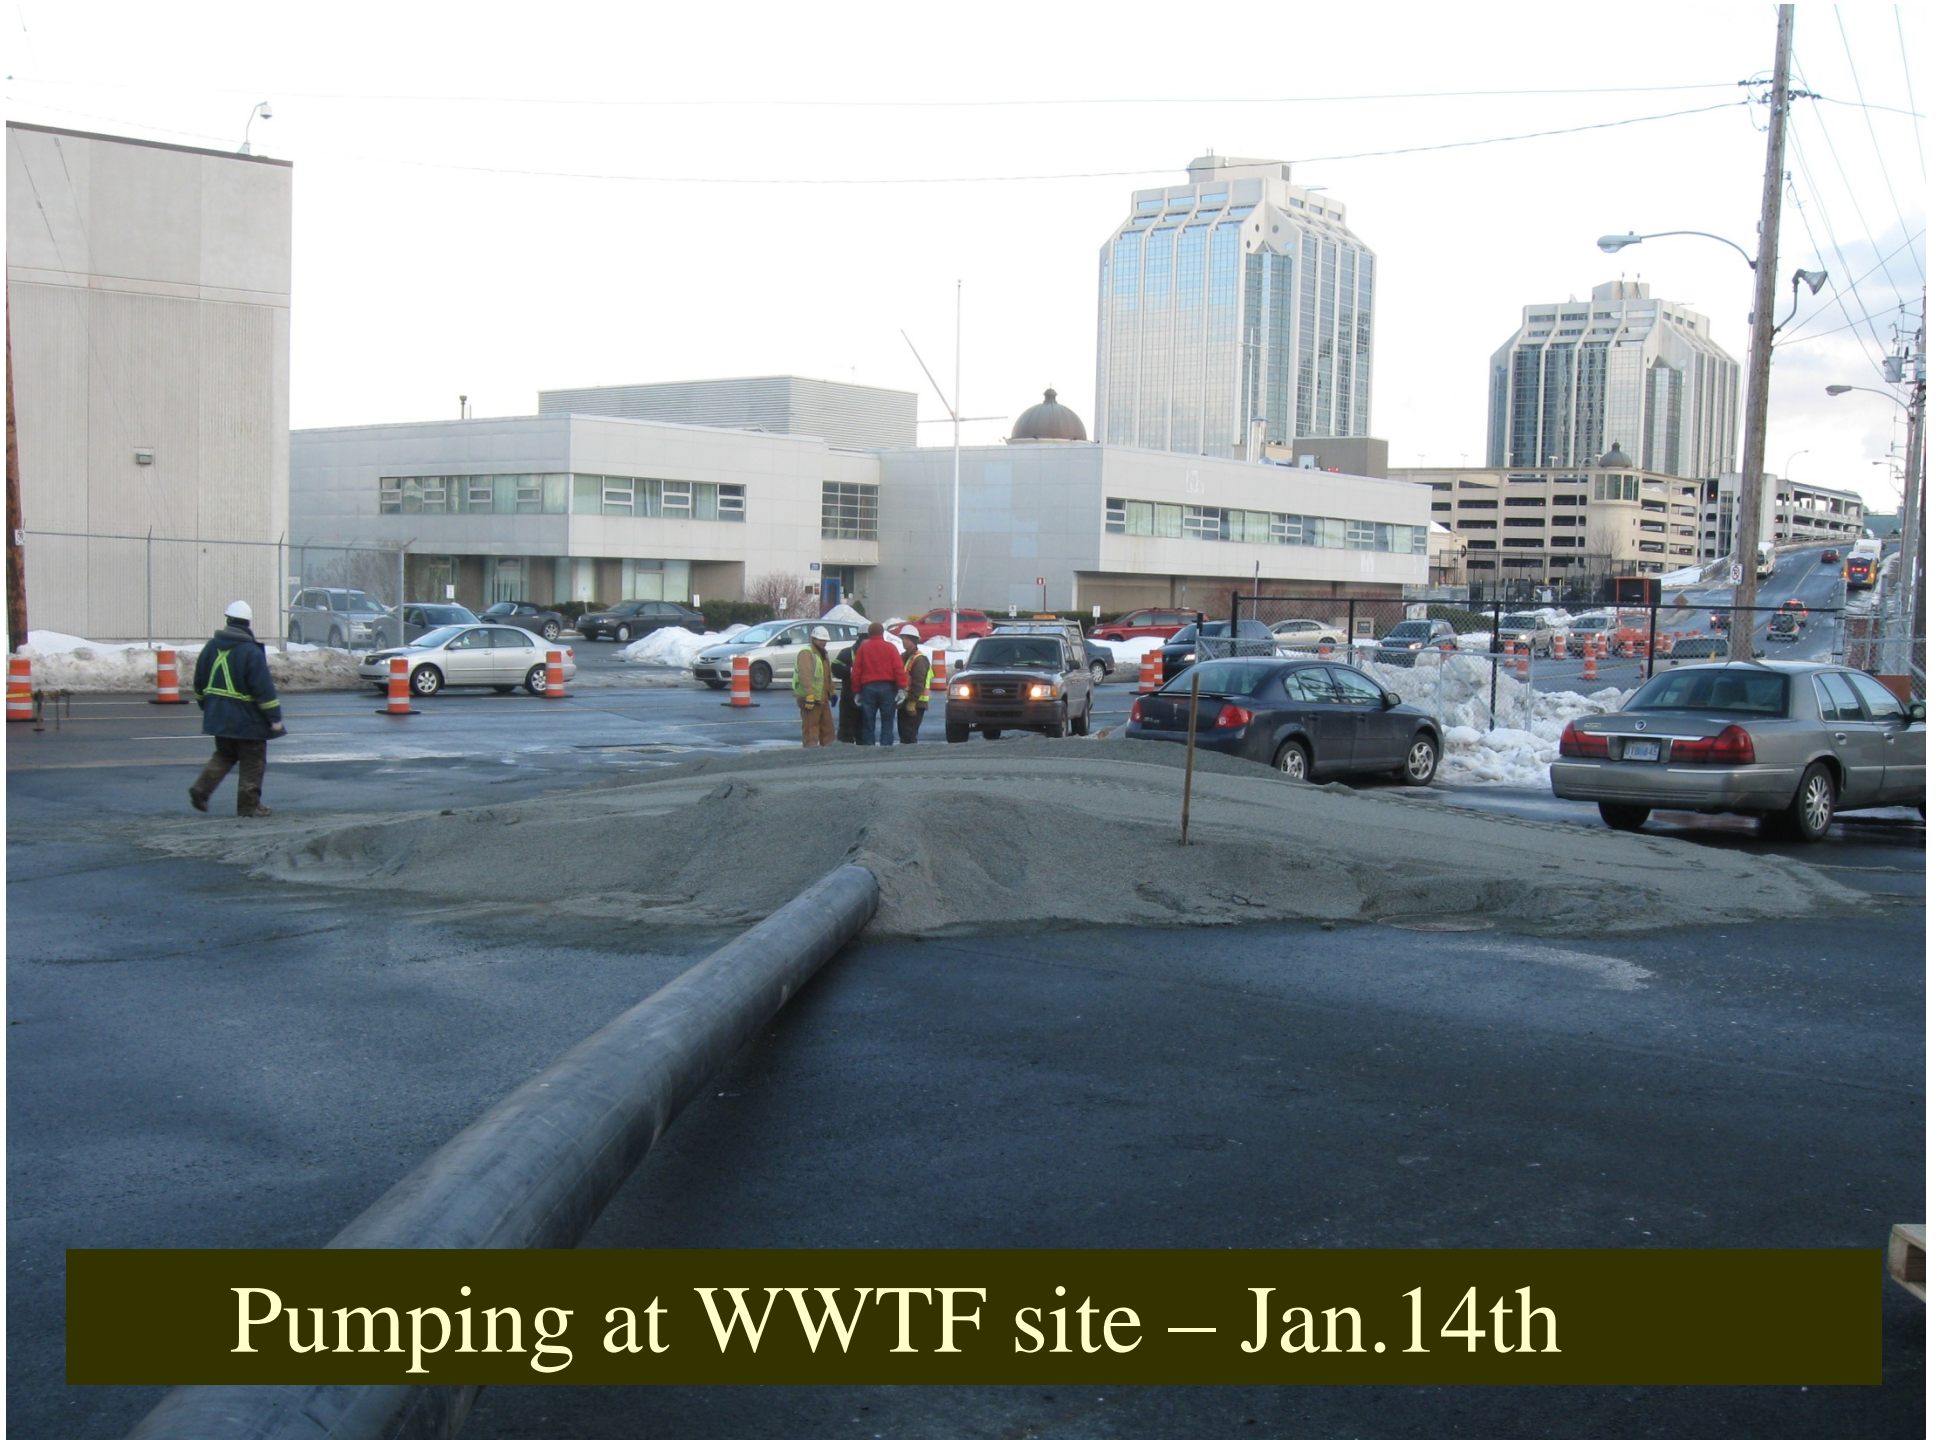
Pumping at WWTF site – Jan.14th

- ❖ Pump out of plant commenced on Jan 14 (valve still open to collection system)
- ❖ Temporary heating rigged immediately and in safe manner to protect plant and personnel from freezing temperatures
- ❖ Valve closed manually on Jan 18 to protect plant from wet weather
- ❖ Facility cleanup and insurance investigations commenced
- ❖ No safety incidents

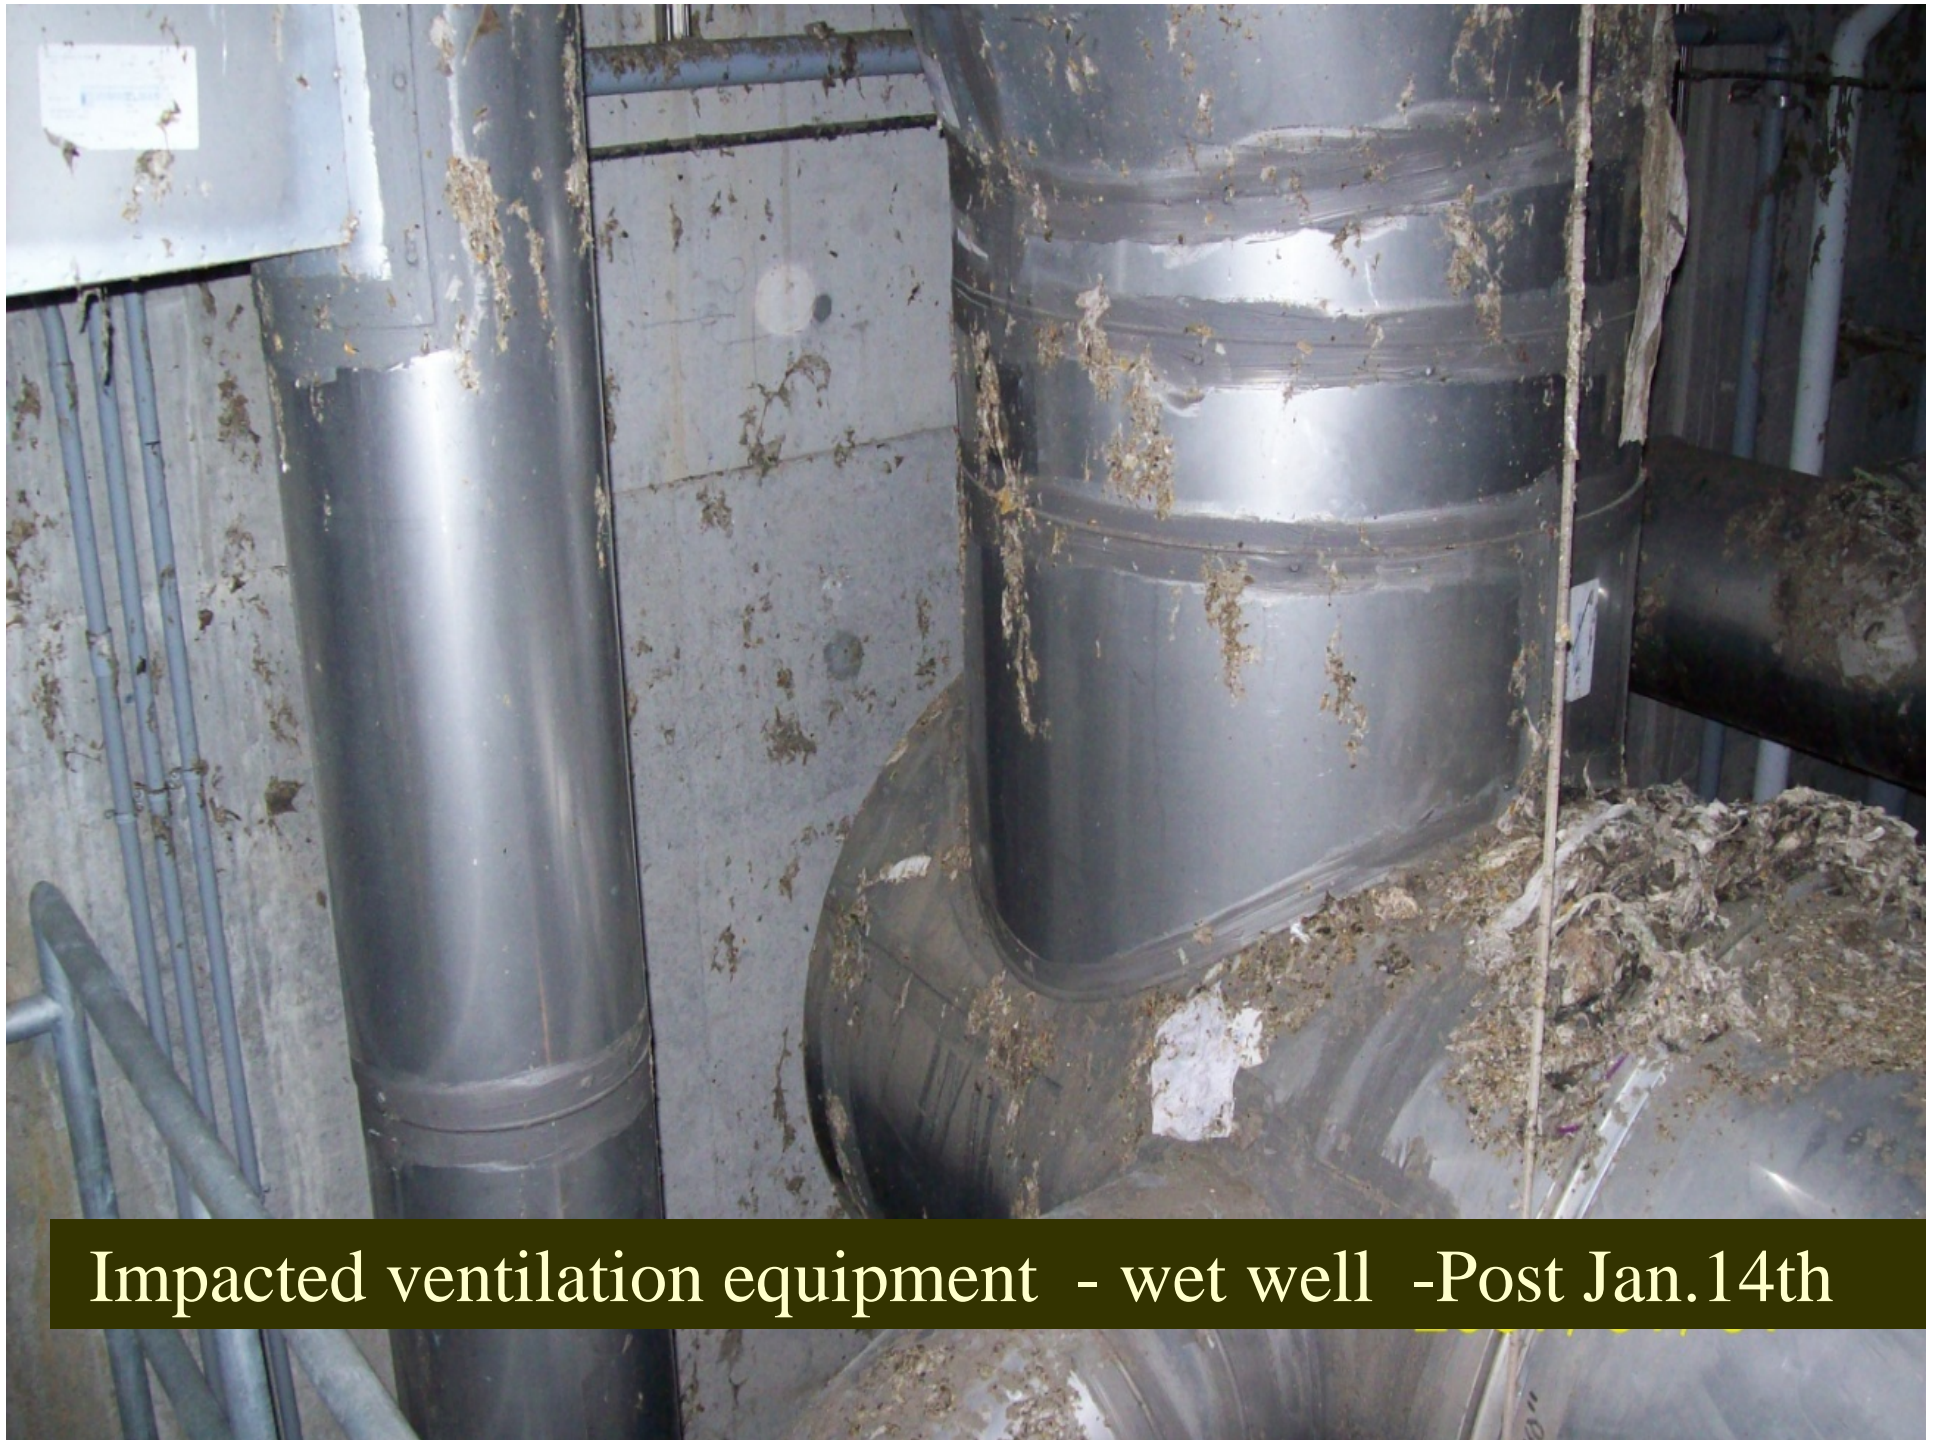
Impacted ventilation equipment - wet well -Post Jan.14th

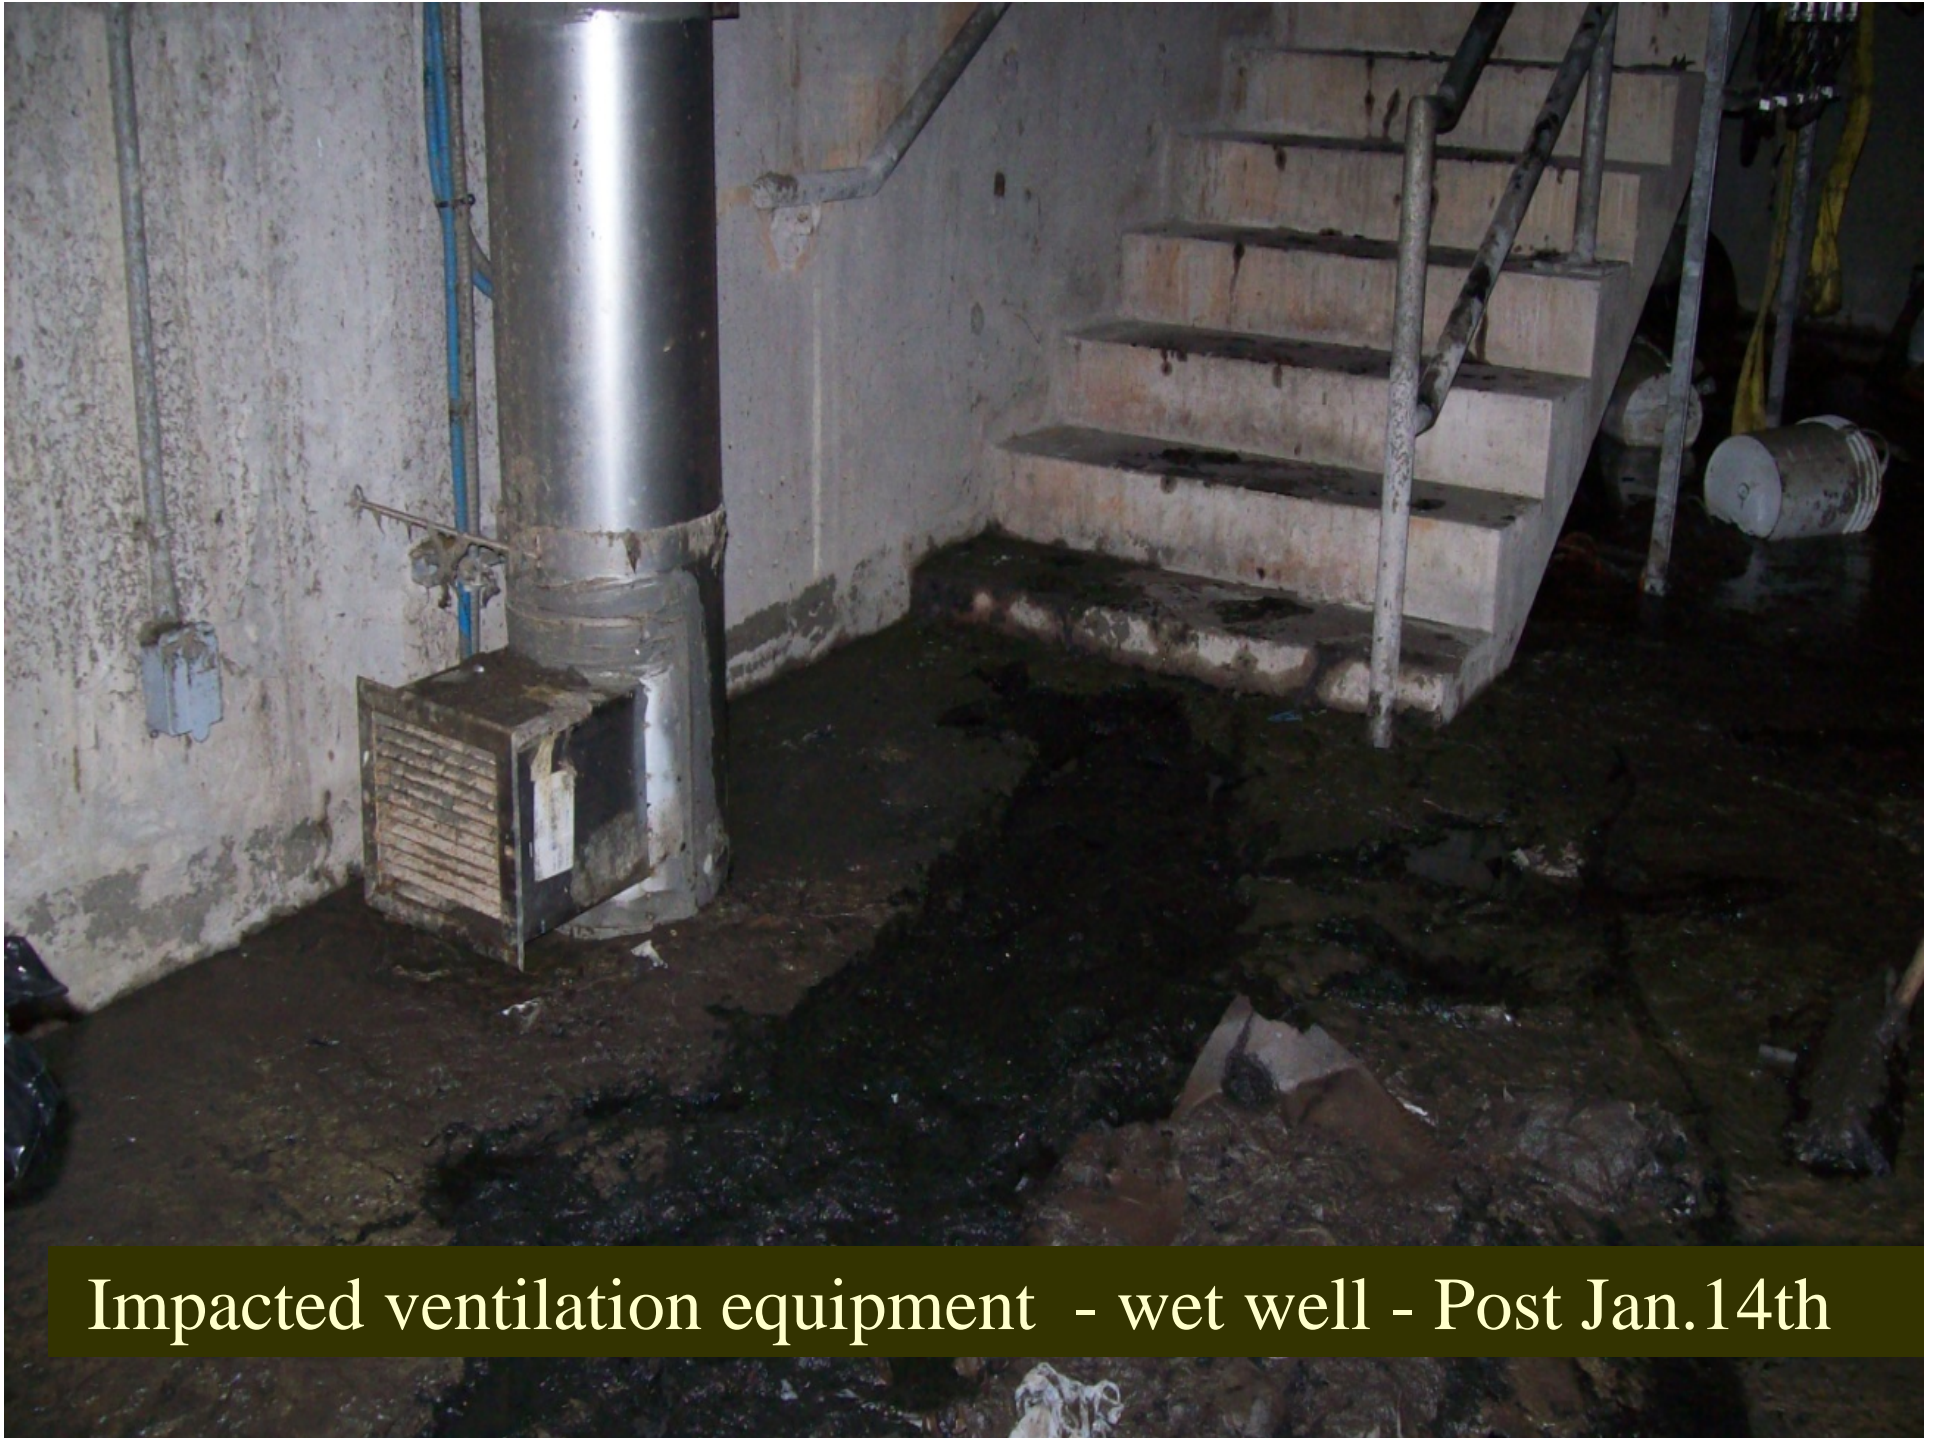
Impacted ventilation equipment - wet well - Post Jan.14th

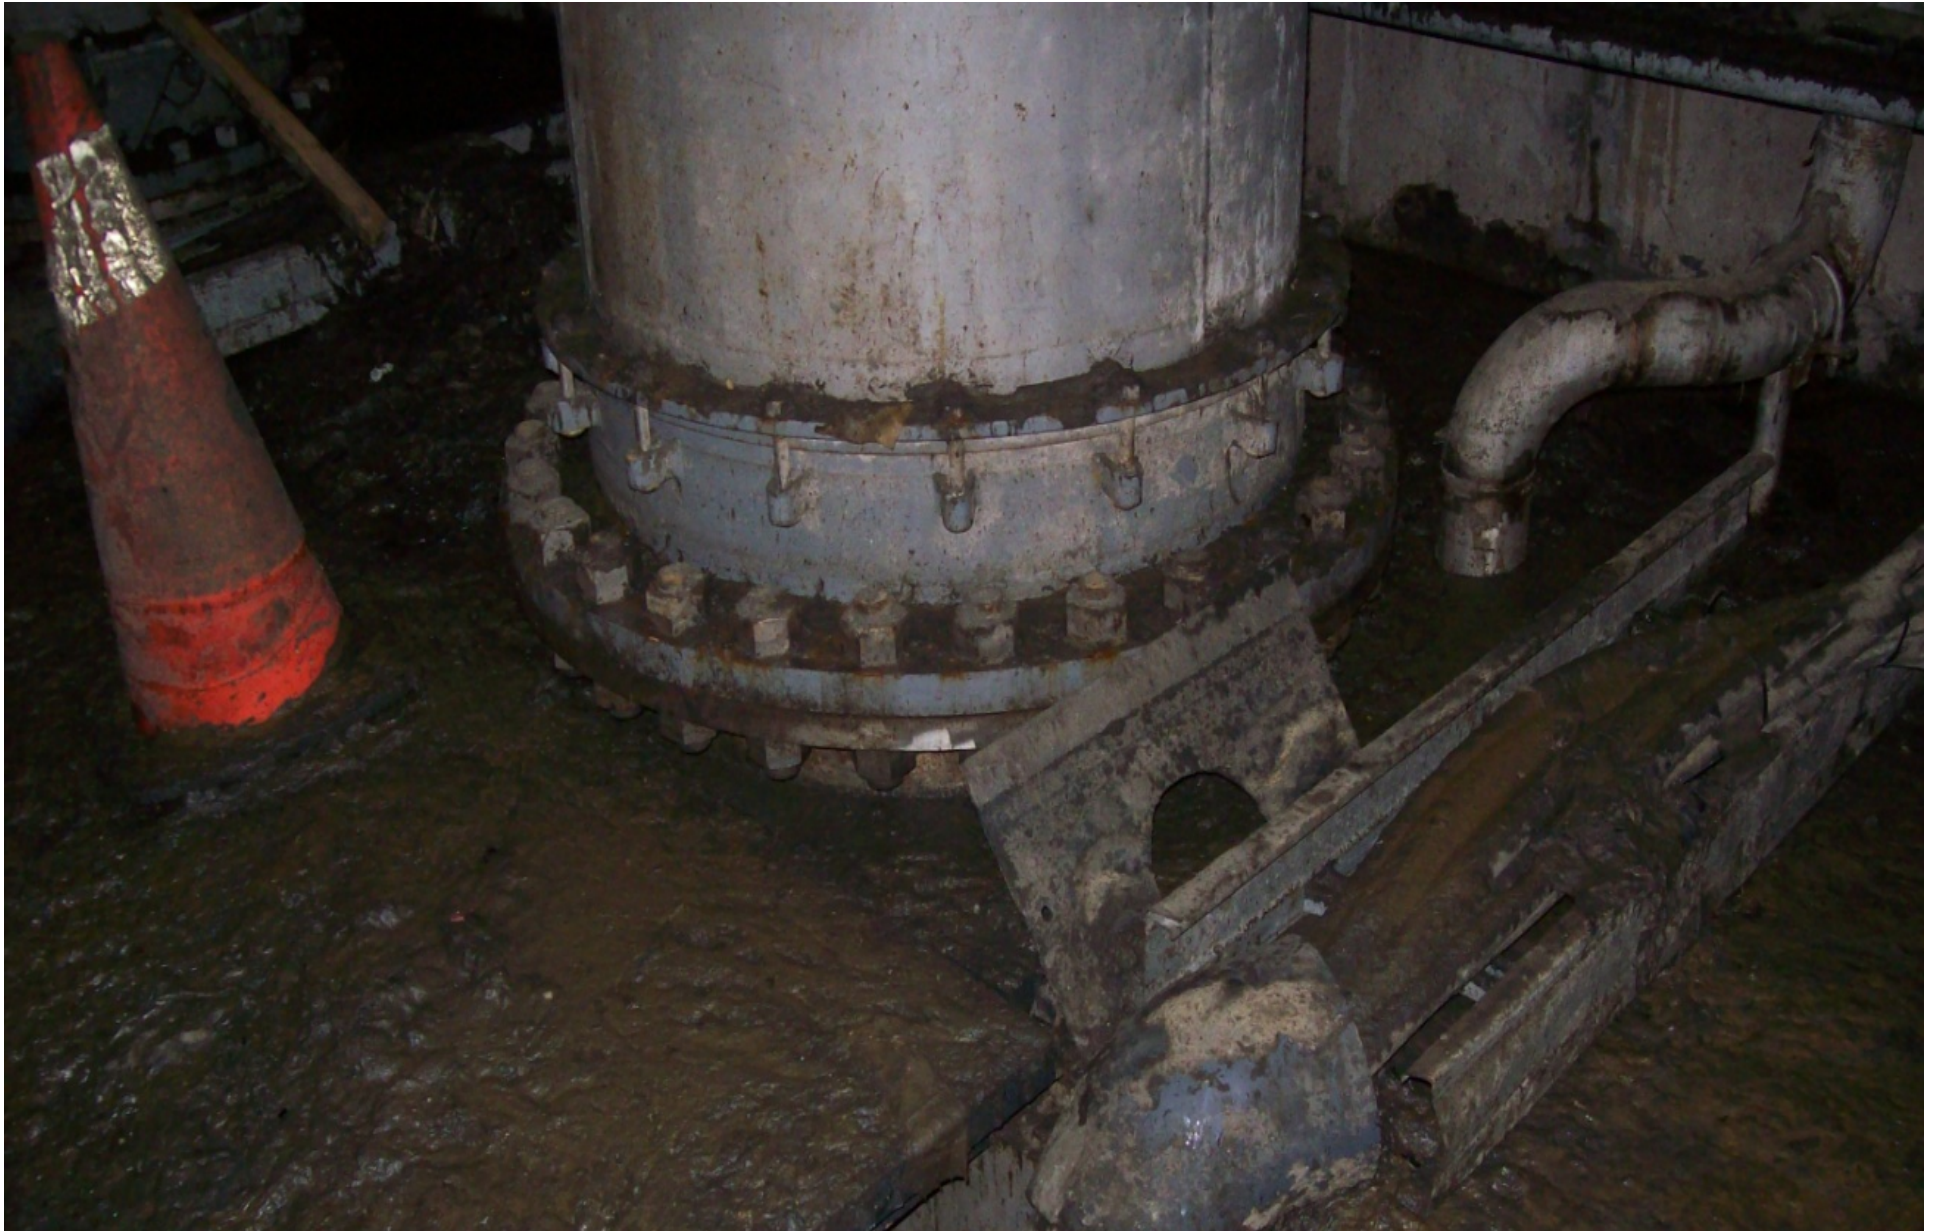
Floor - wet well -Post Jan.14th

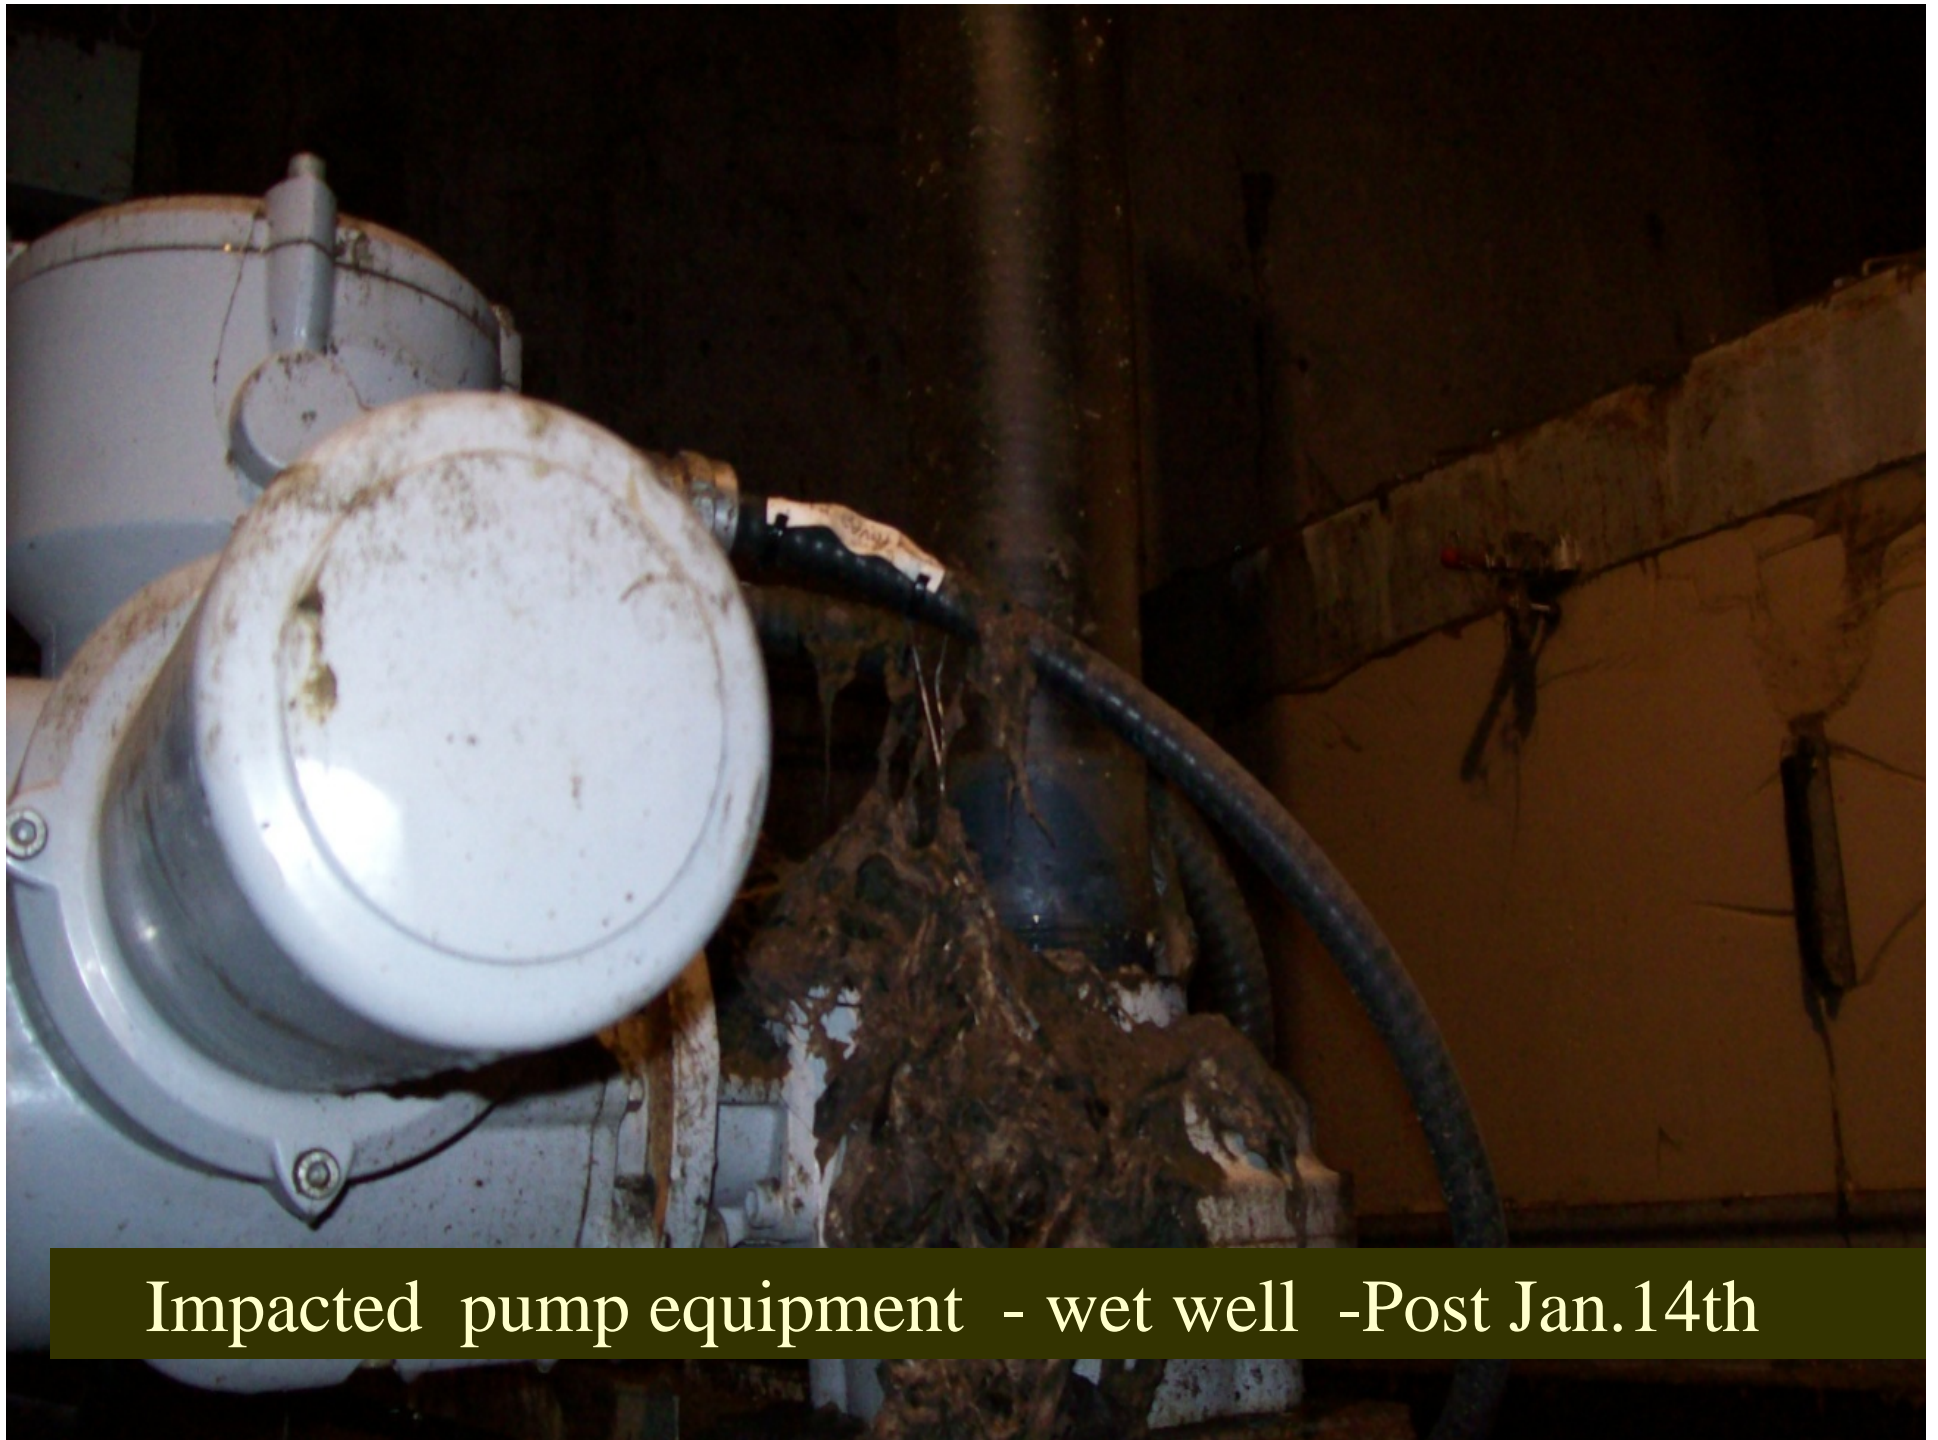
Impacted pump equipment - wet well -Post Jan.14th

- ❖ Continue to Protect the Asset
- ❖ Complete inspection of the large raw water submersible pumps; if motors damaged, place an order as the delivery time is long [in the order of 6 to 7 months]
- ❖ Complete inspection of Sluice Gate Actuator
- ❖ Clean the Wet Well such that workers can replace equipment in a safe work environment
- ❖ Take an image of the SCADA software on the control system hardware

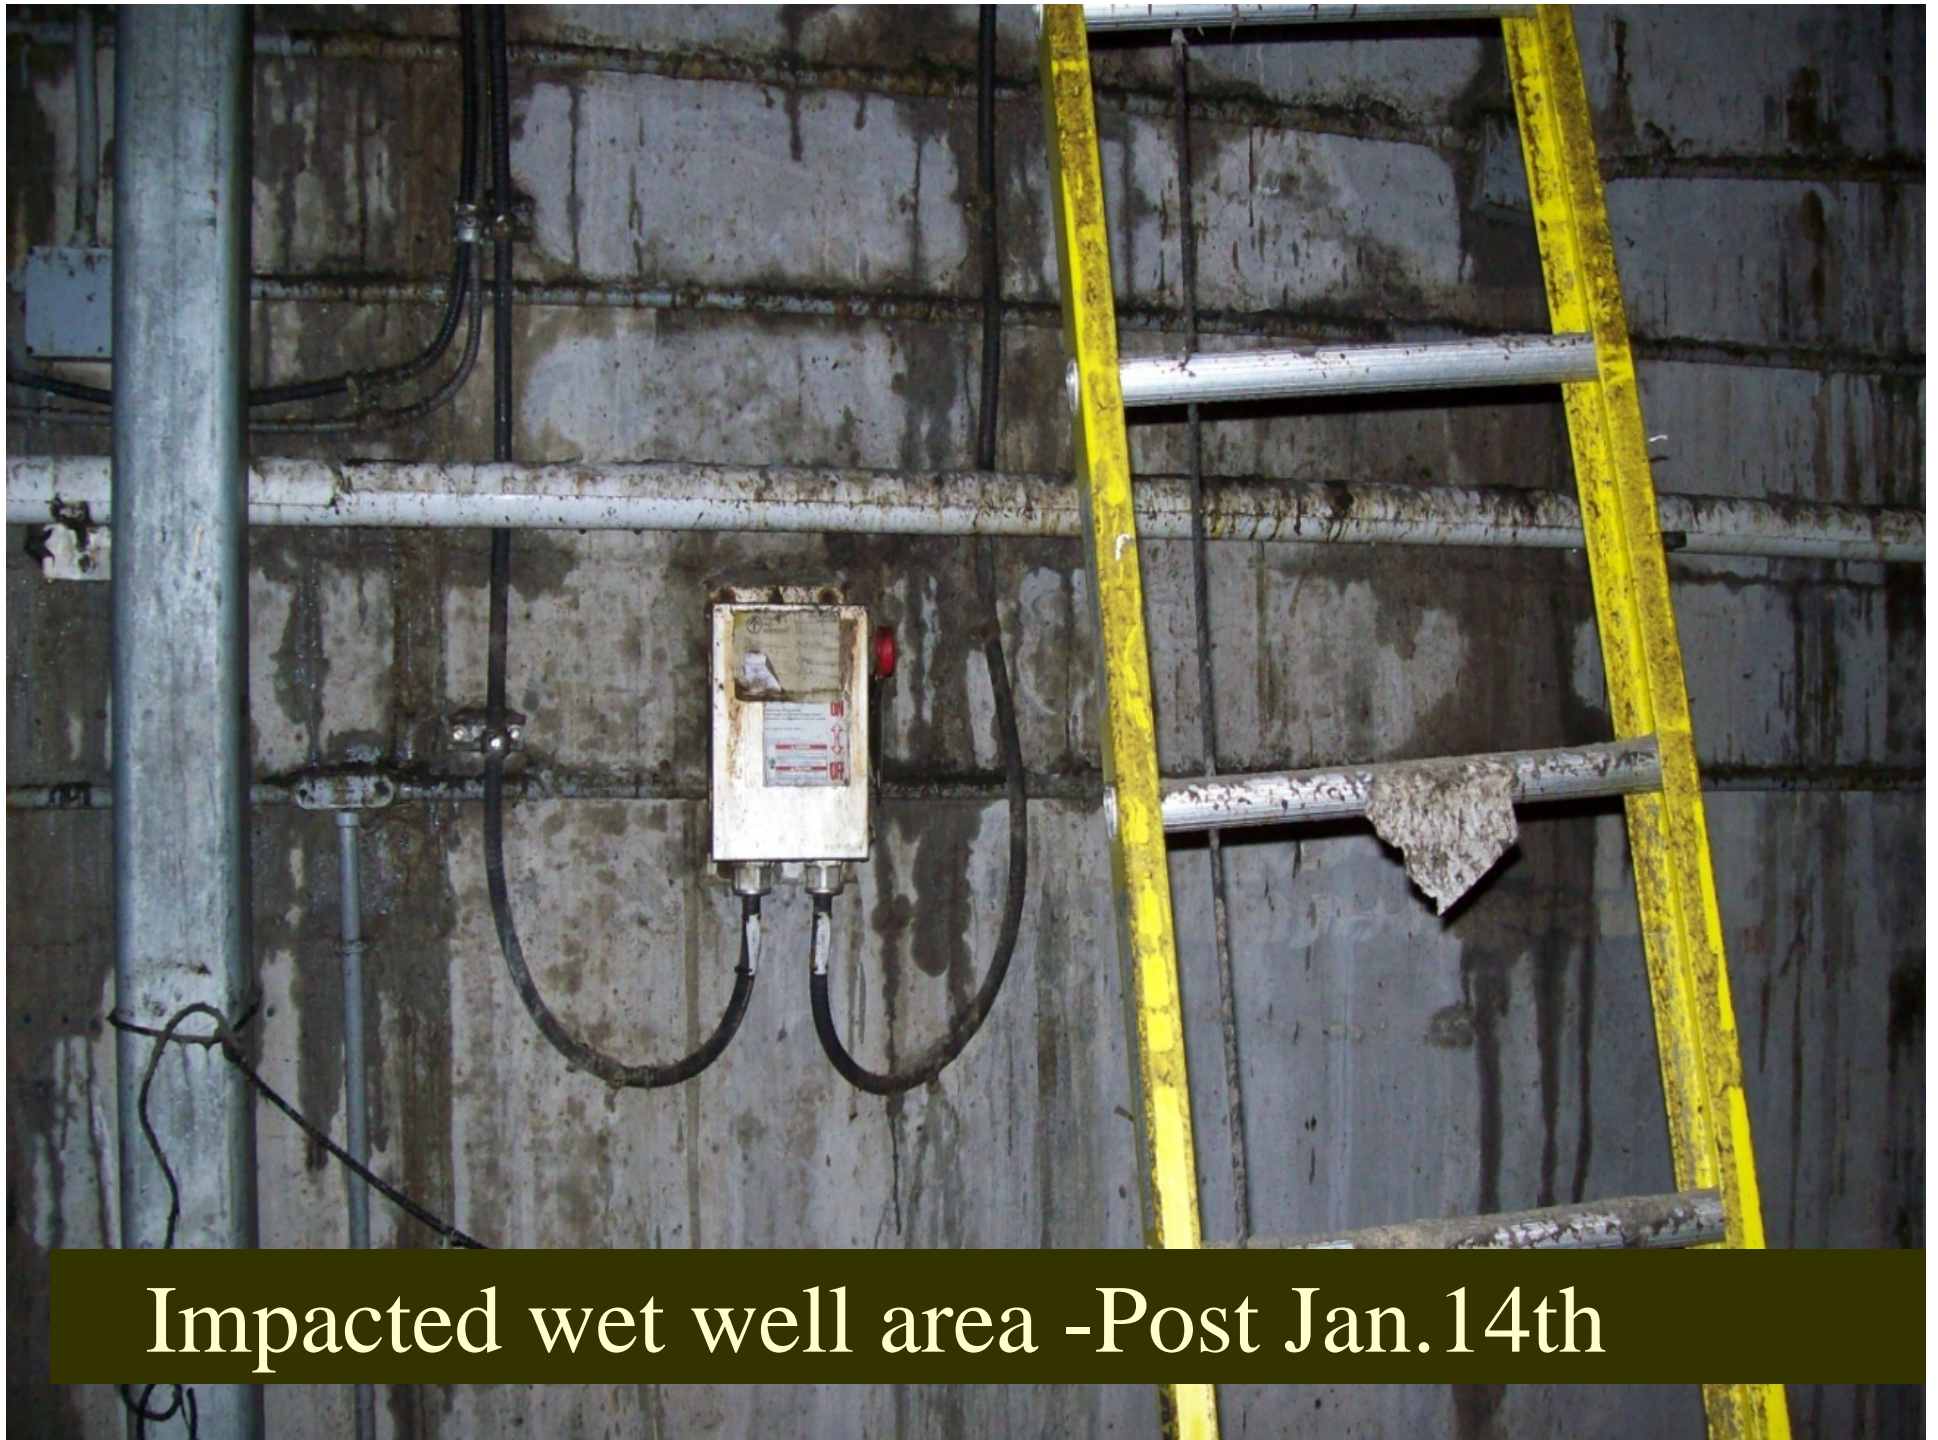
Impacted wet well area -Post Jan.14th

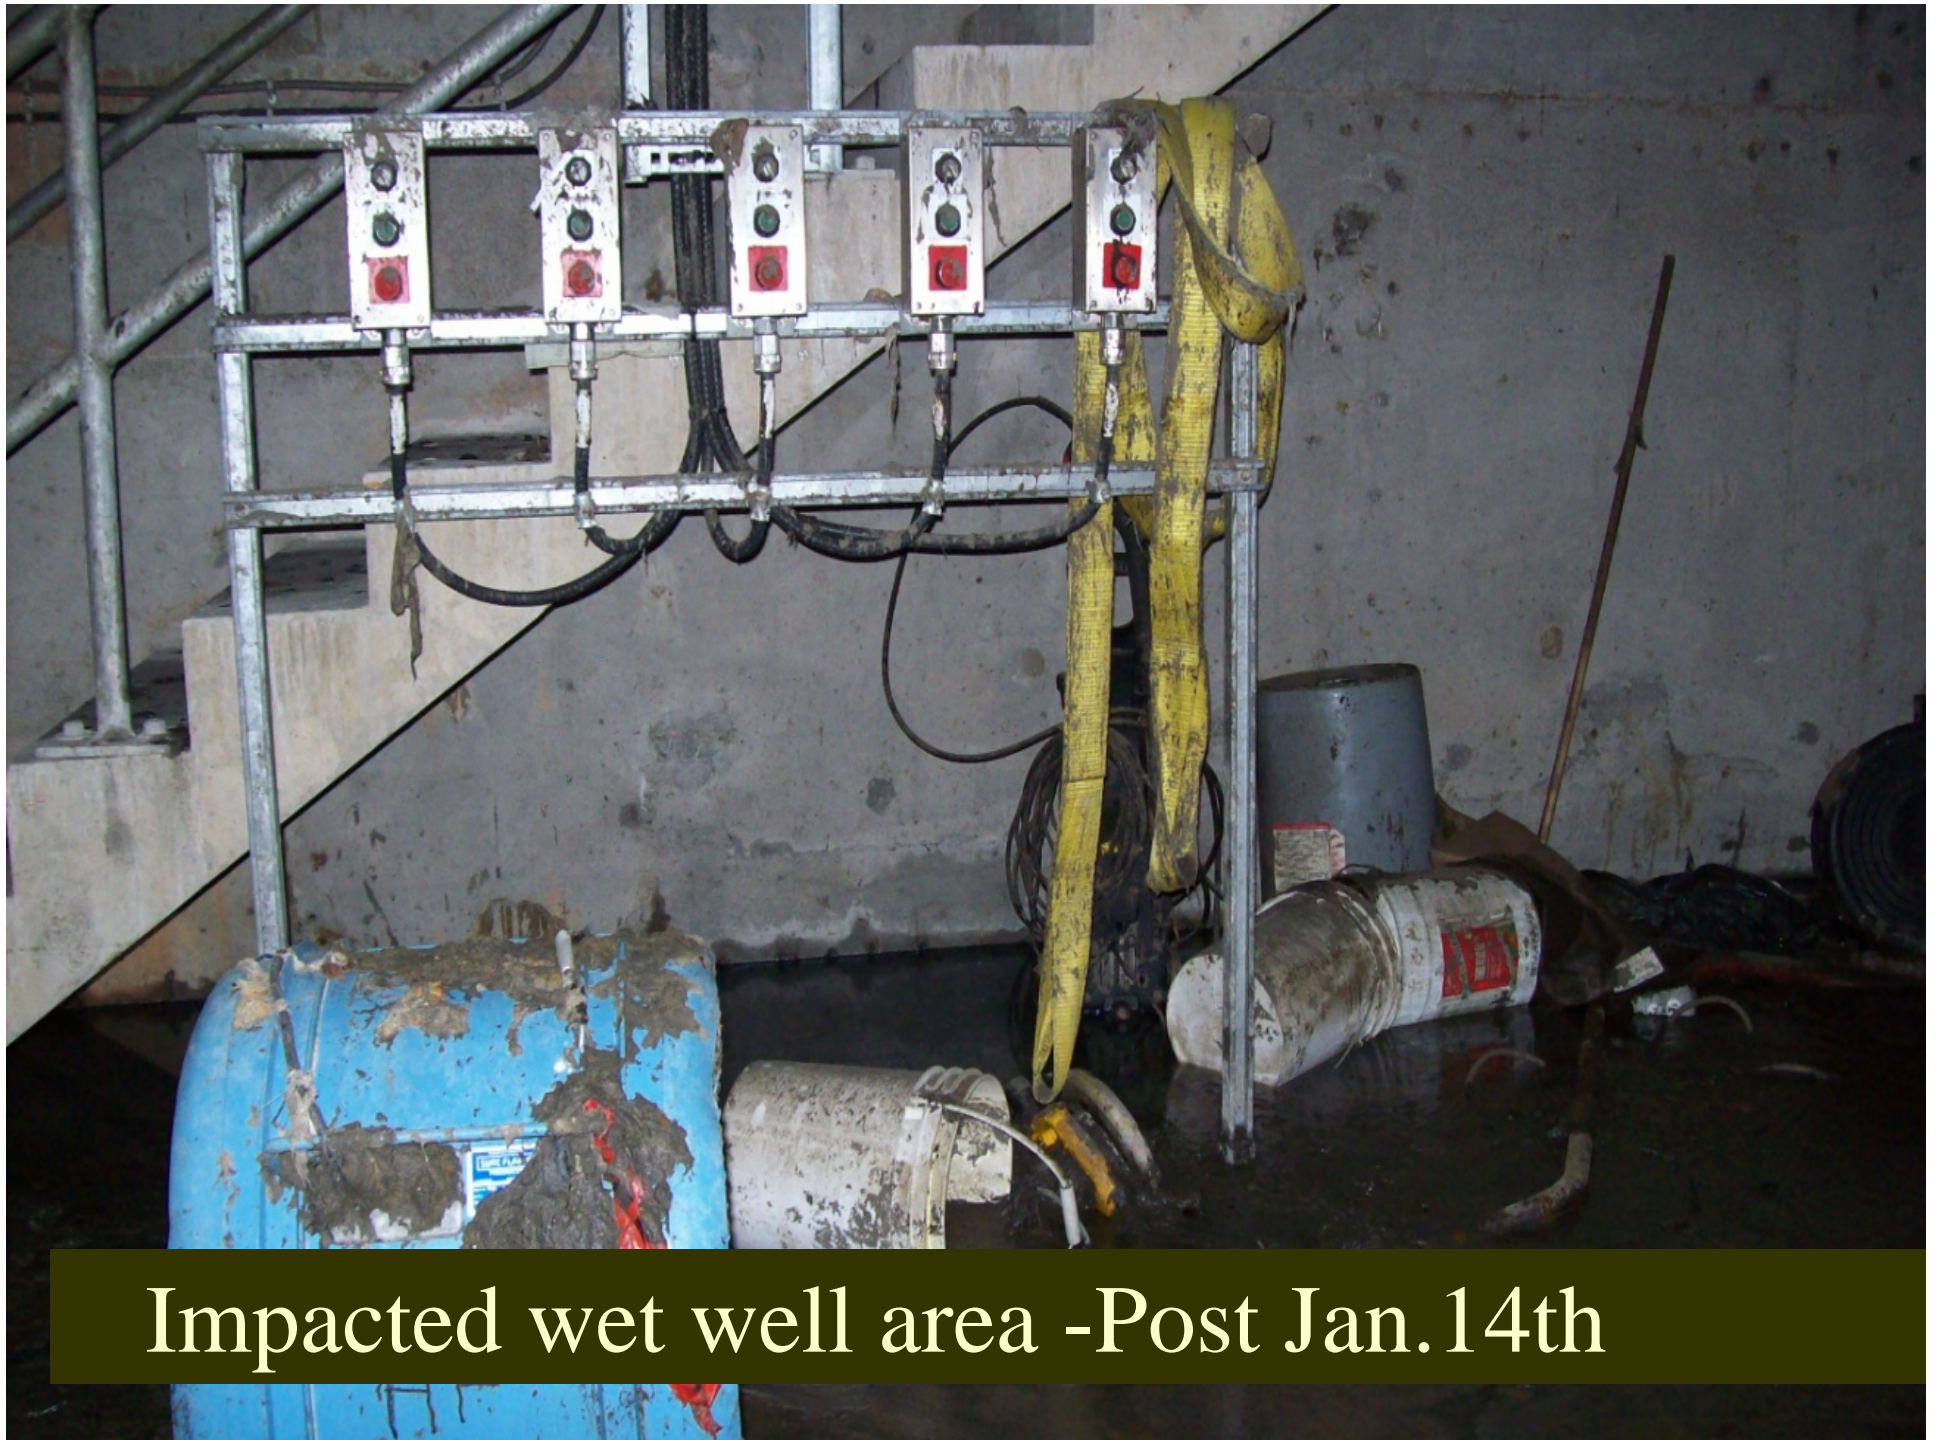
Impacted wet well area -Post Jan.14th

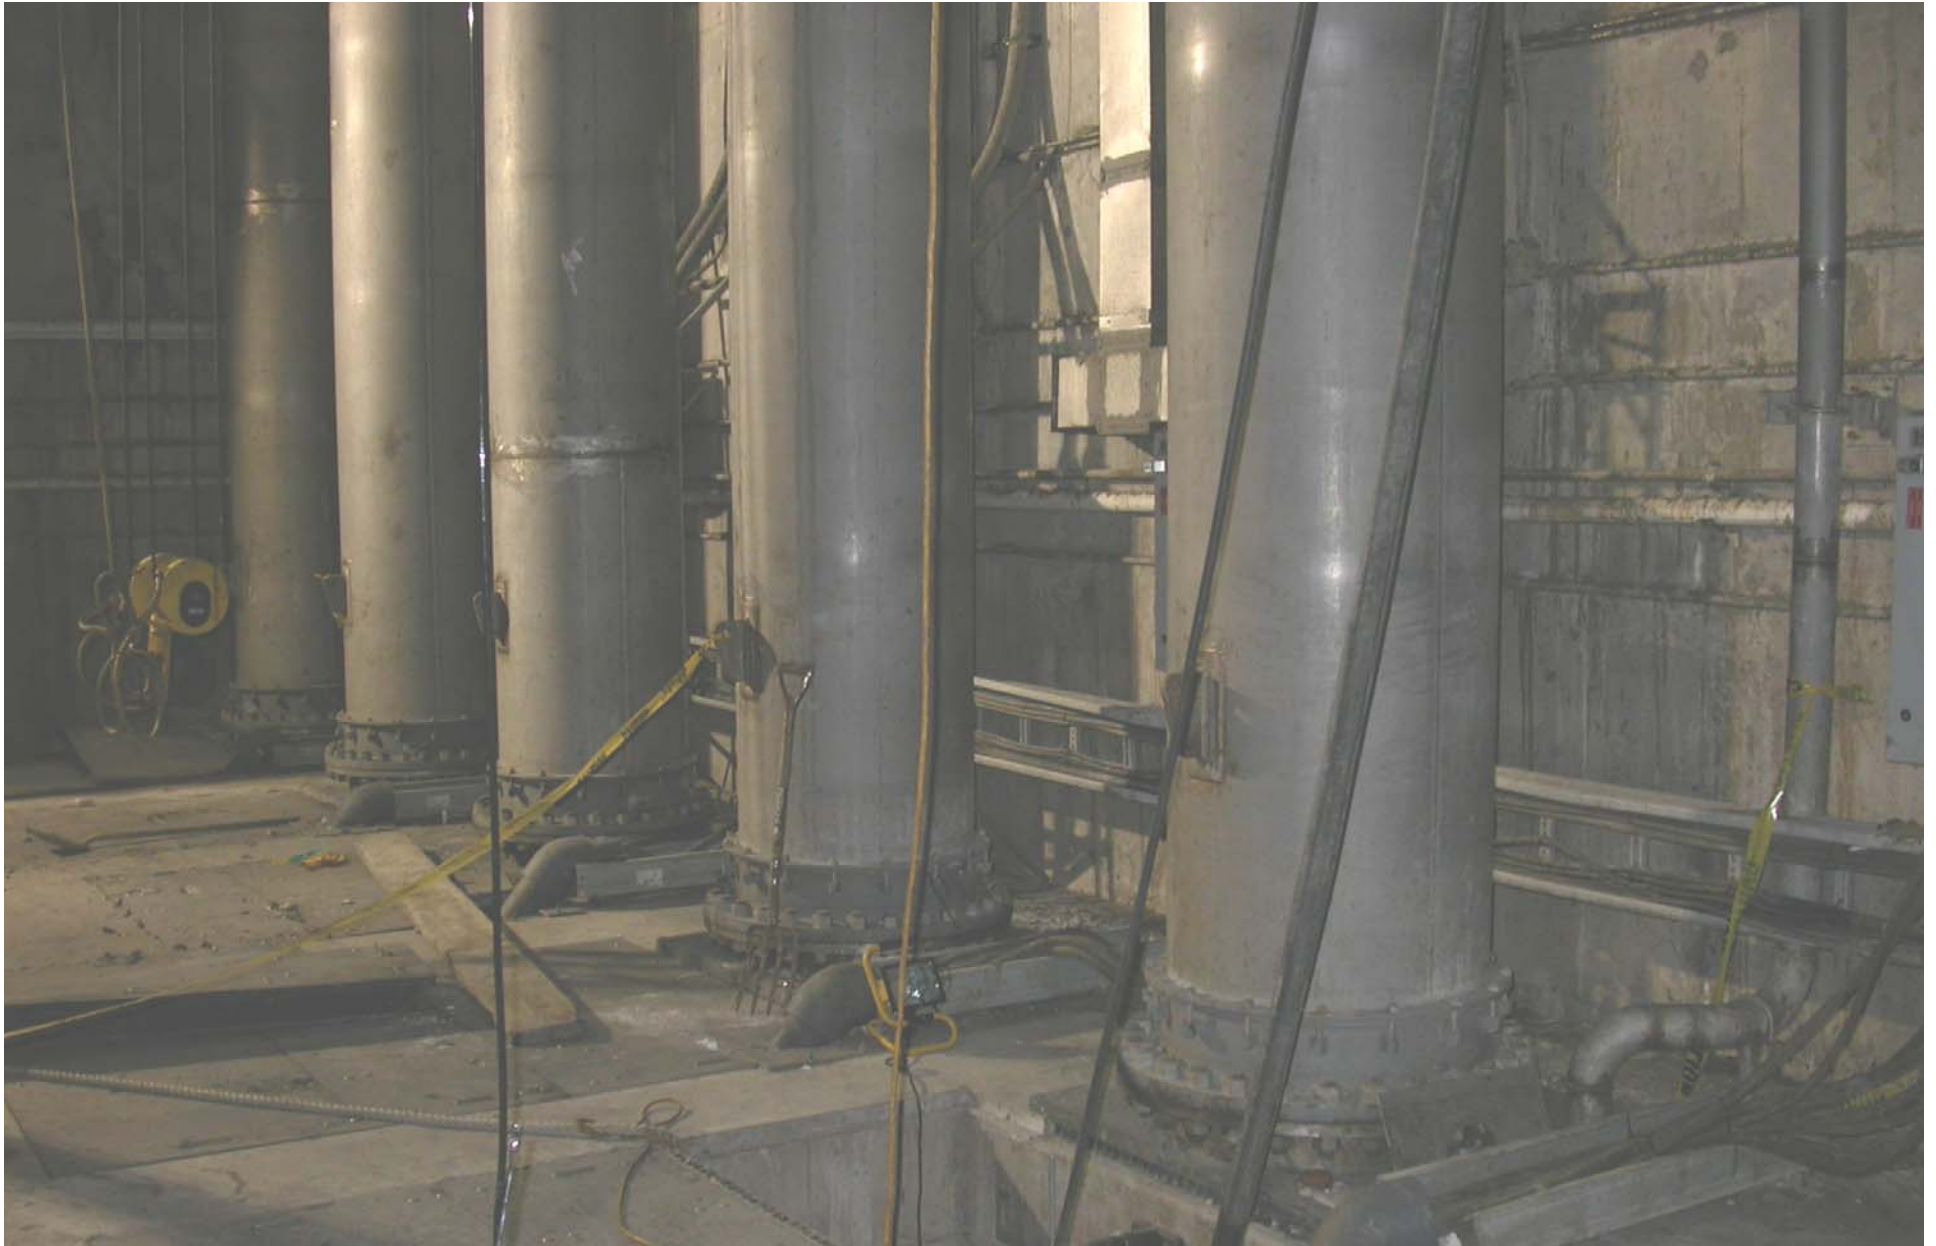
Discharge Piping for 5 Raw Water Pumps – Post Jan.14th
