Halifax Harbour Solutions Project

Halifax Wastewater Treatment Facility - Update

Regional Council, April 14, 2009

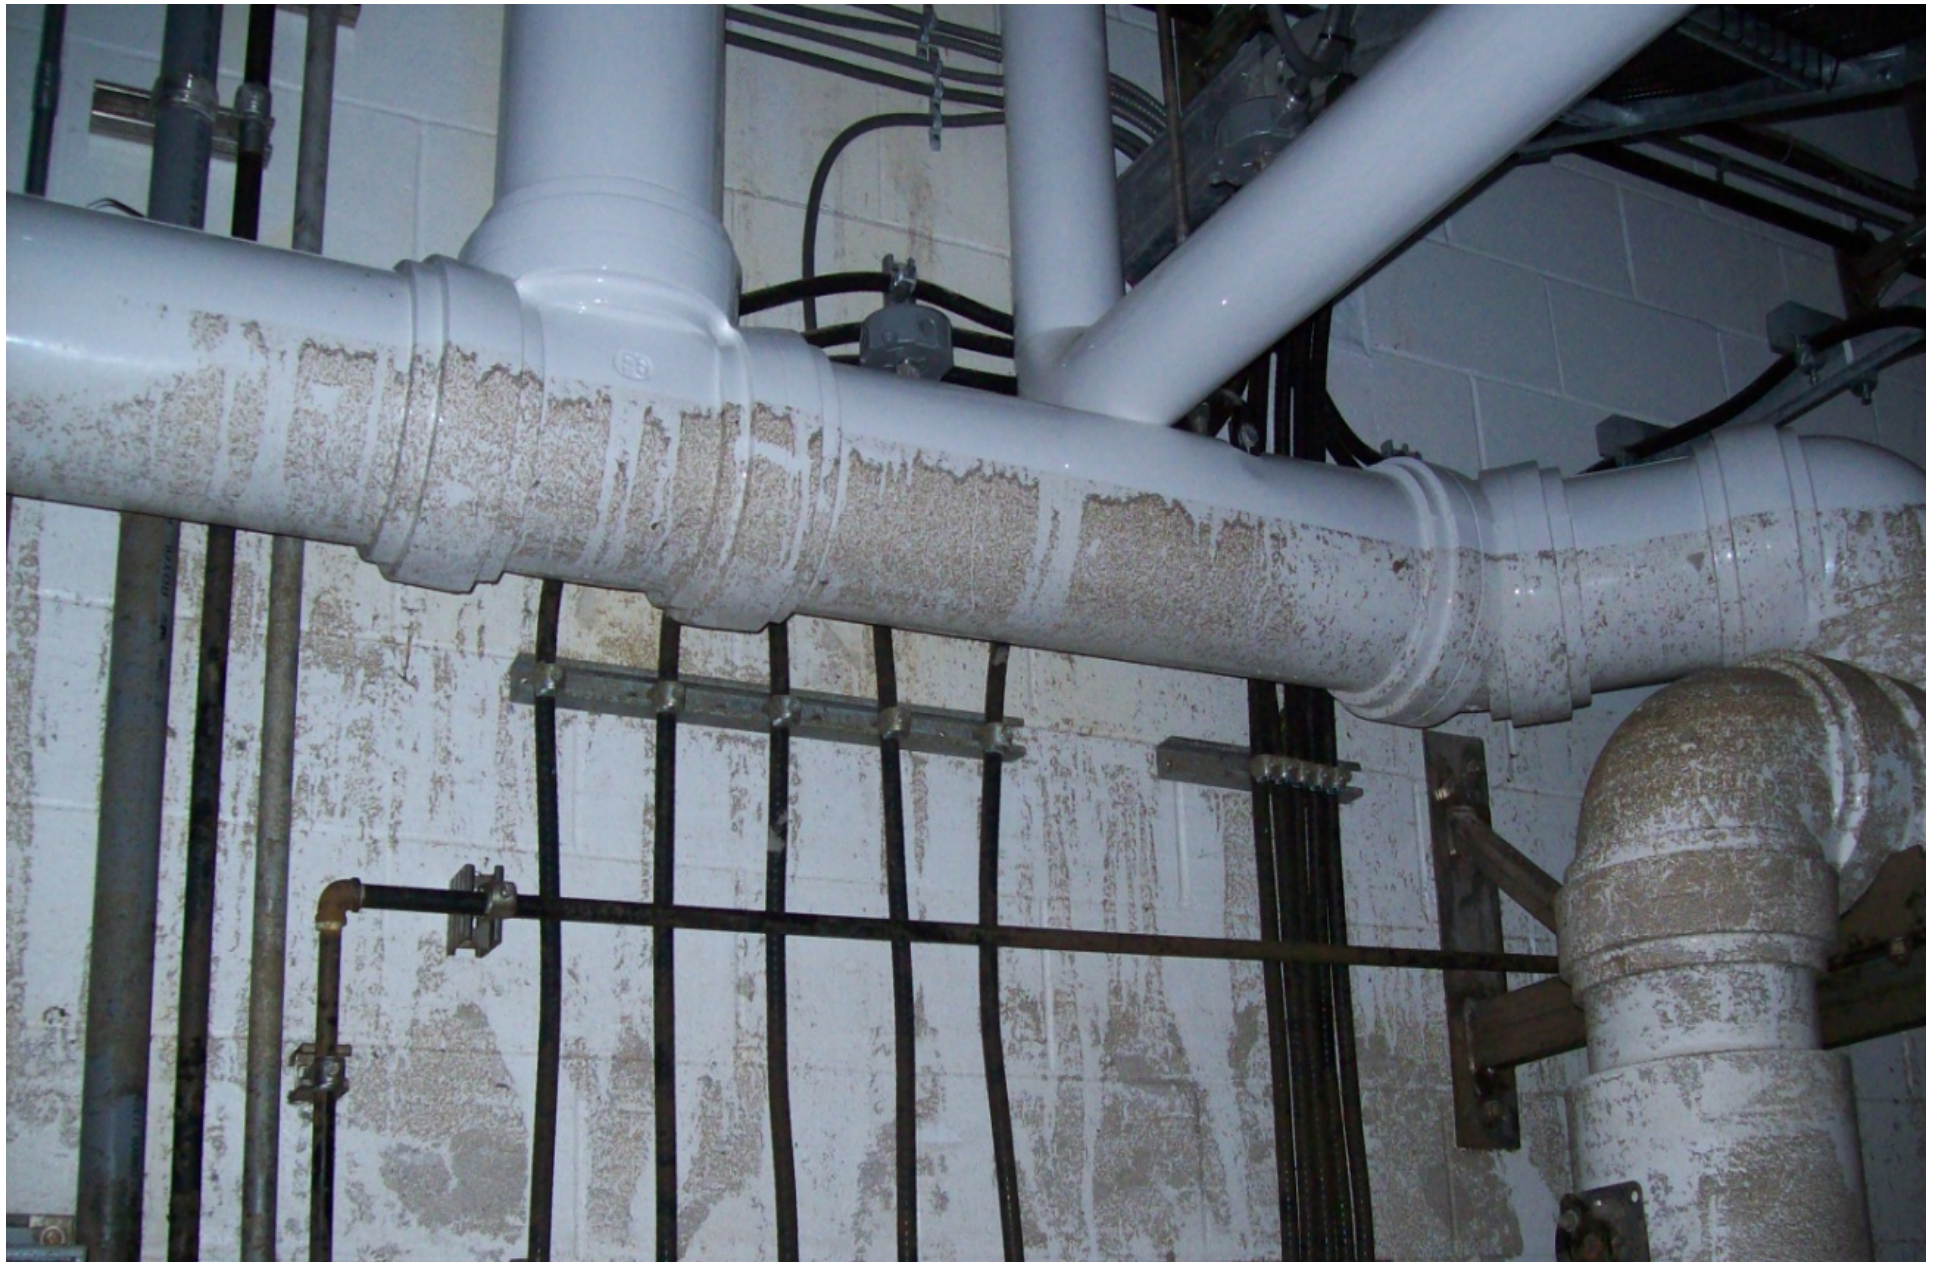
Wall in basement showing flood waterline – Post Jan.14th

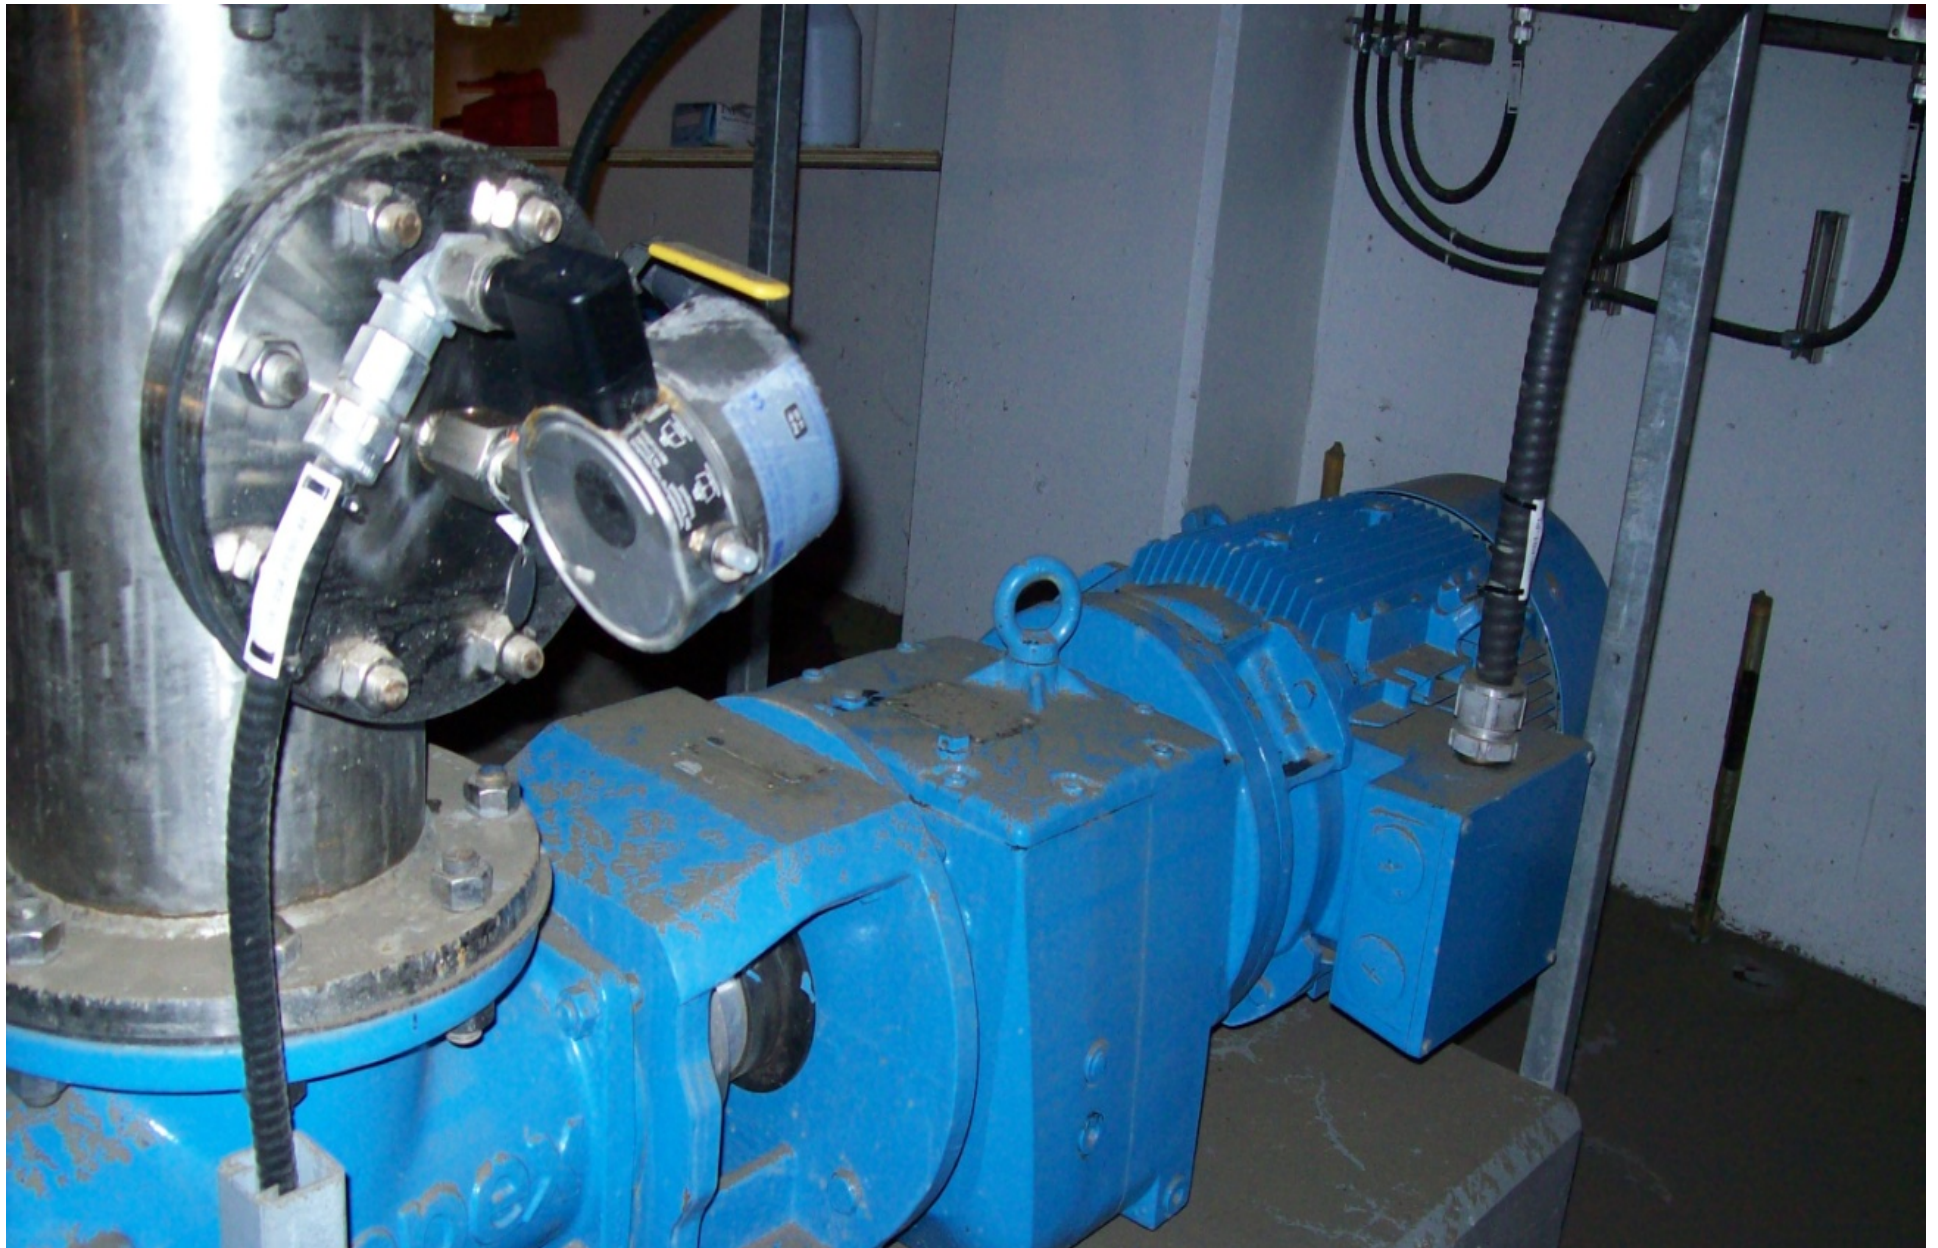
Process pumps in Basement– Post Jan.14th

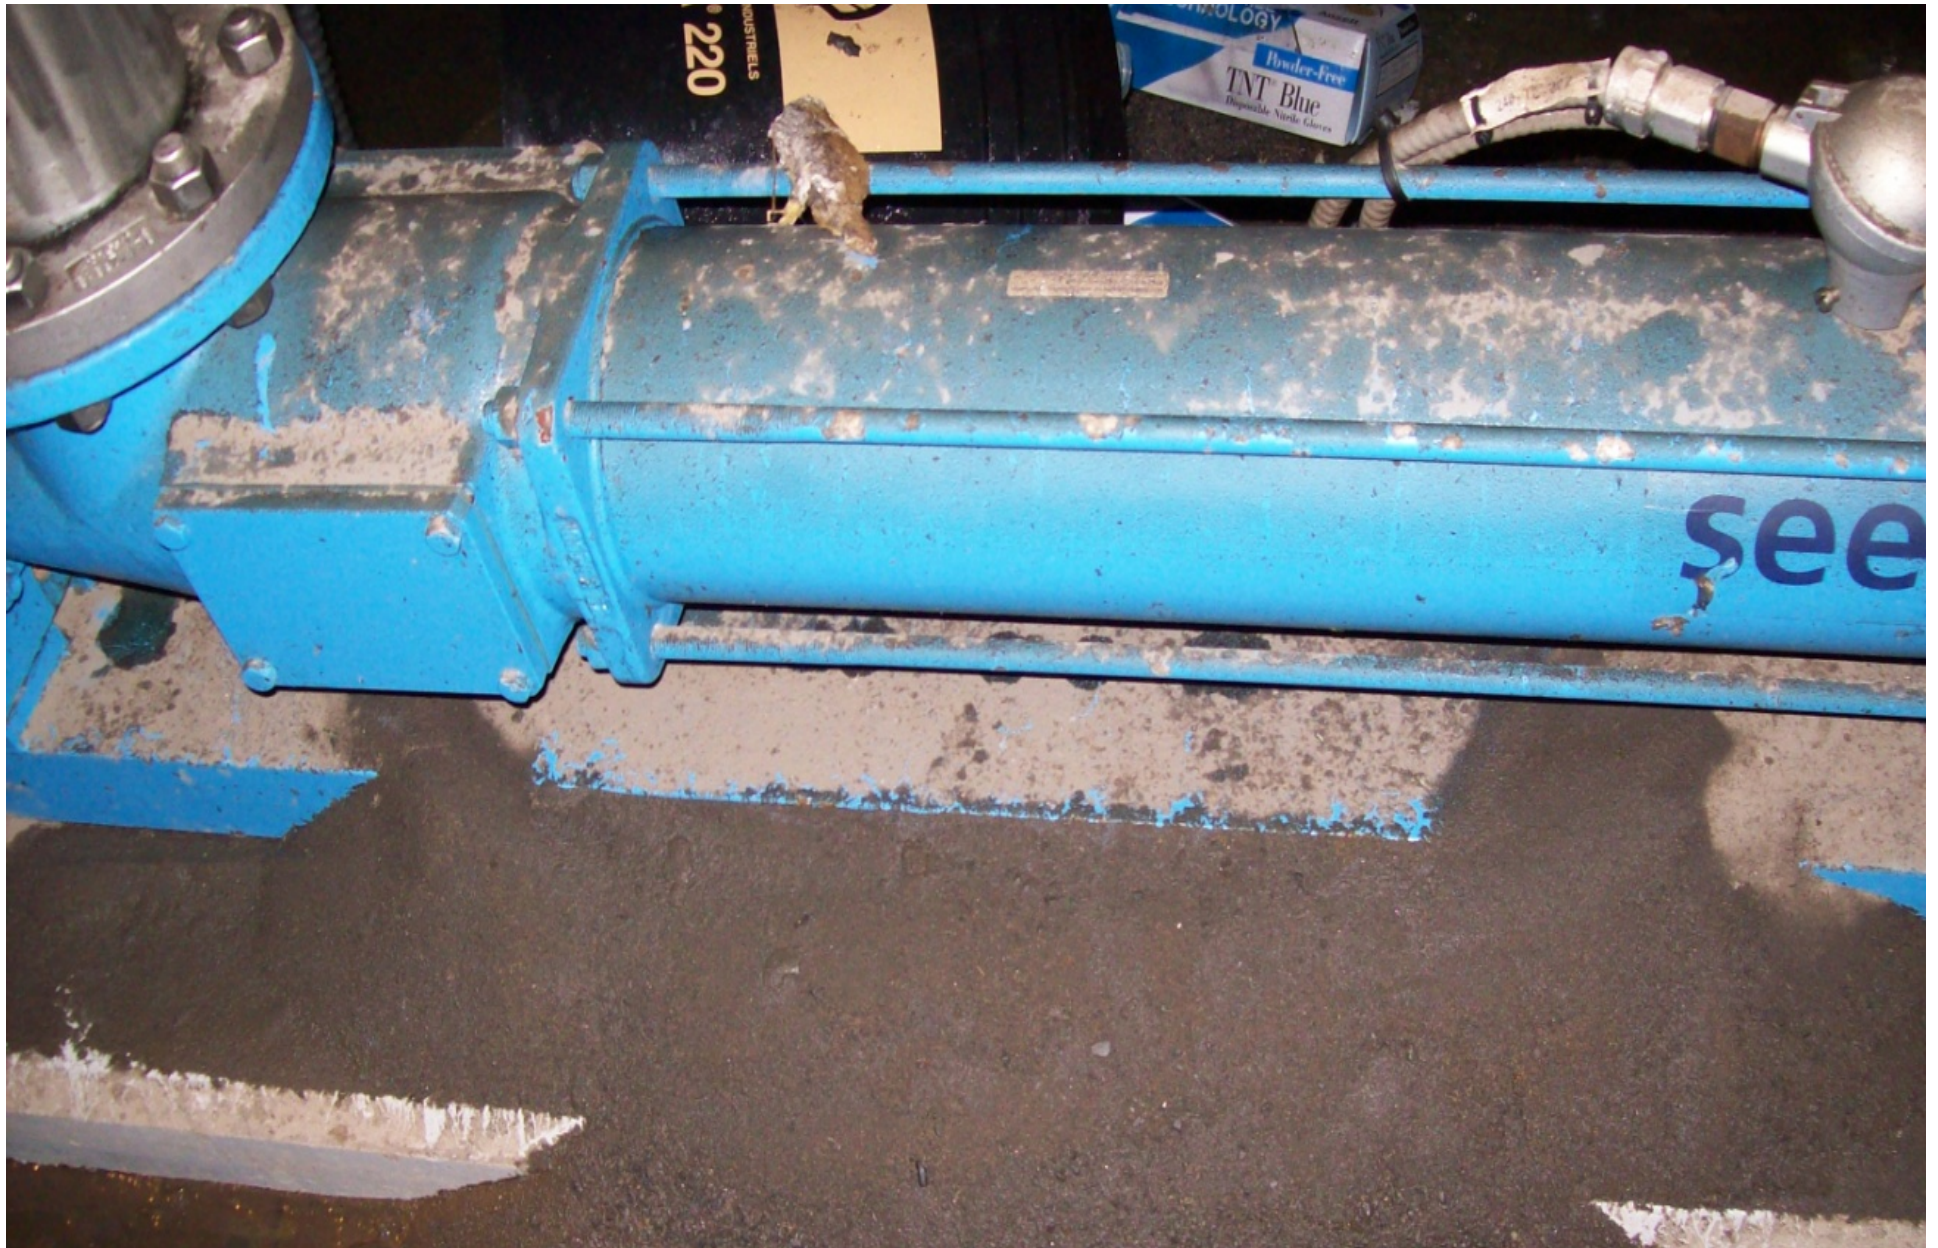
Process pumps in Basement– Post Jan.14th

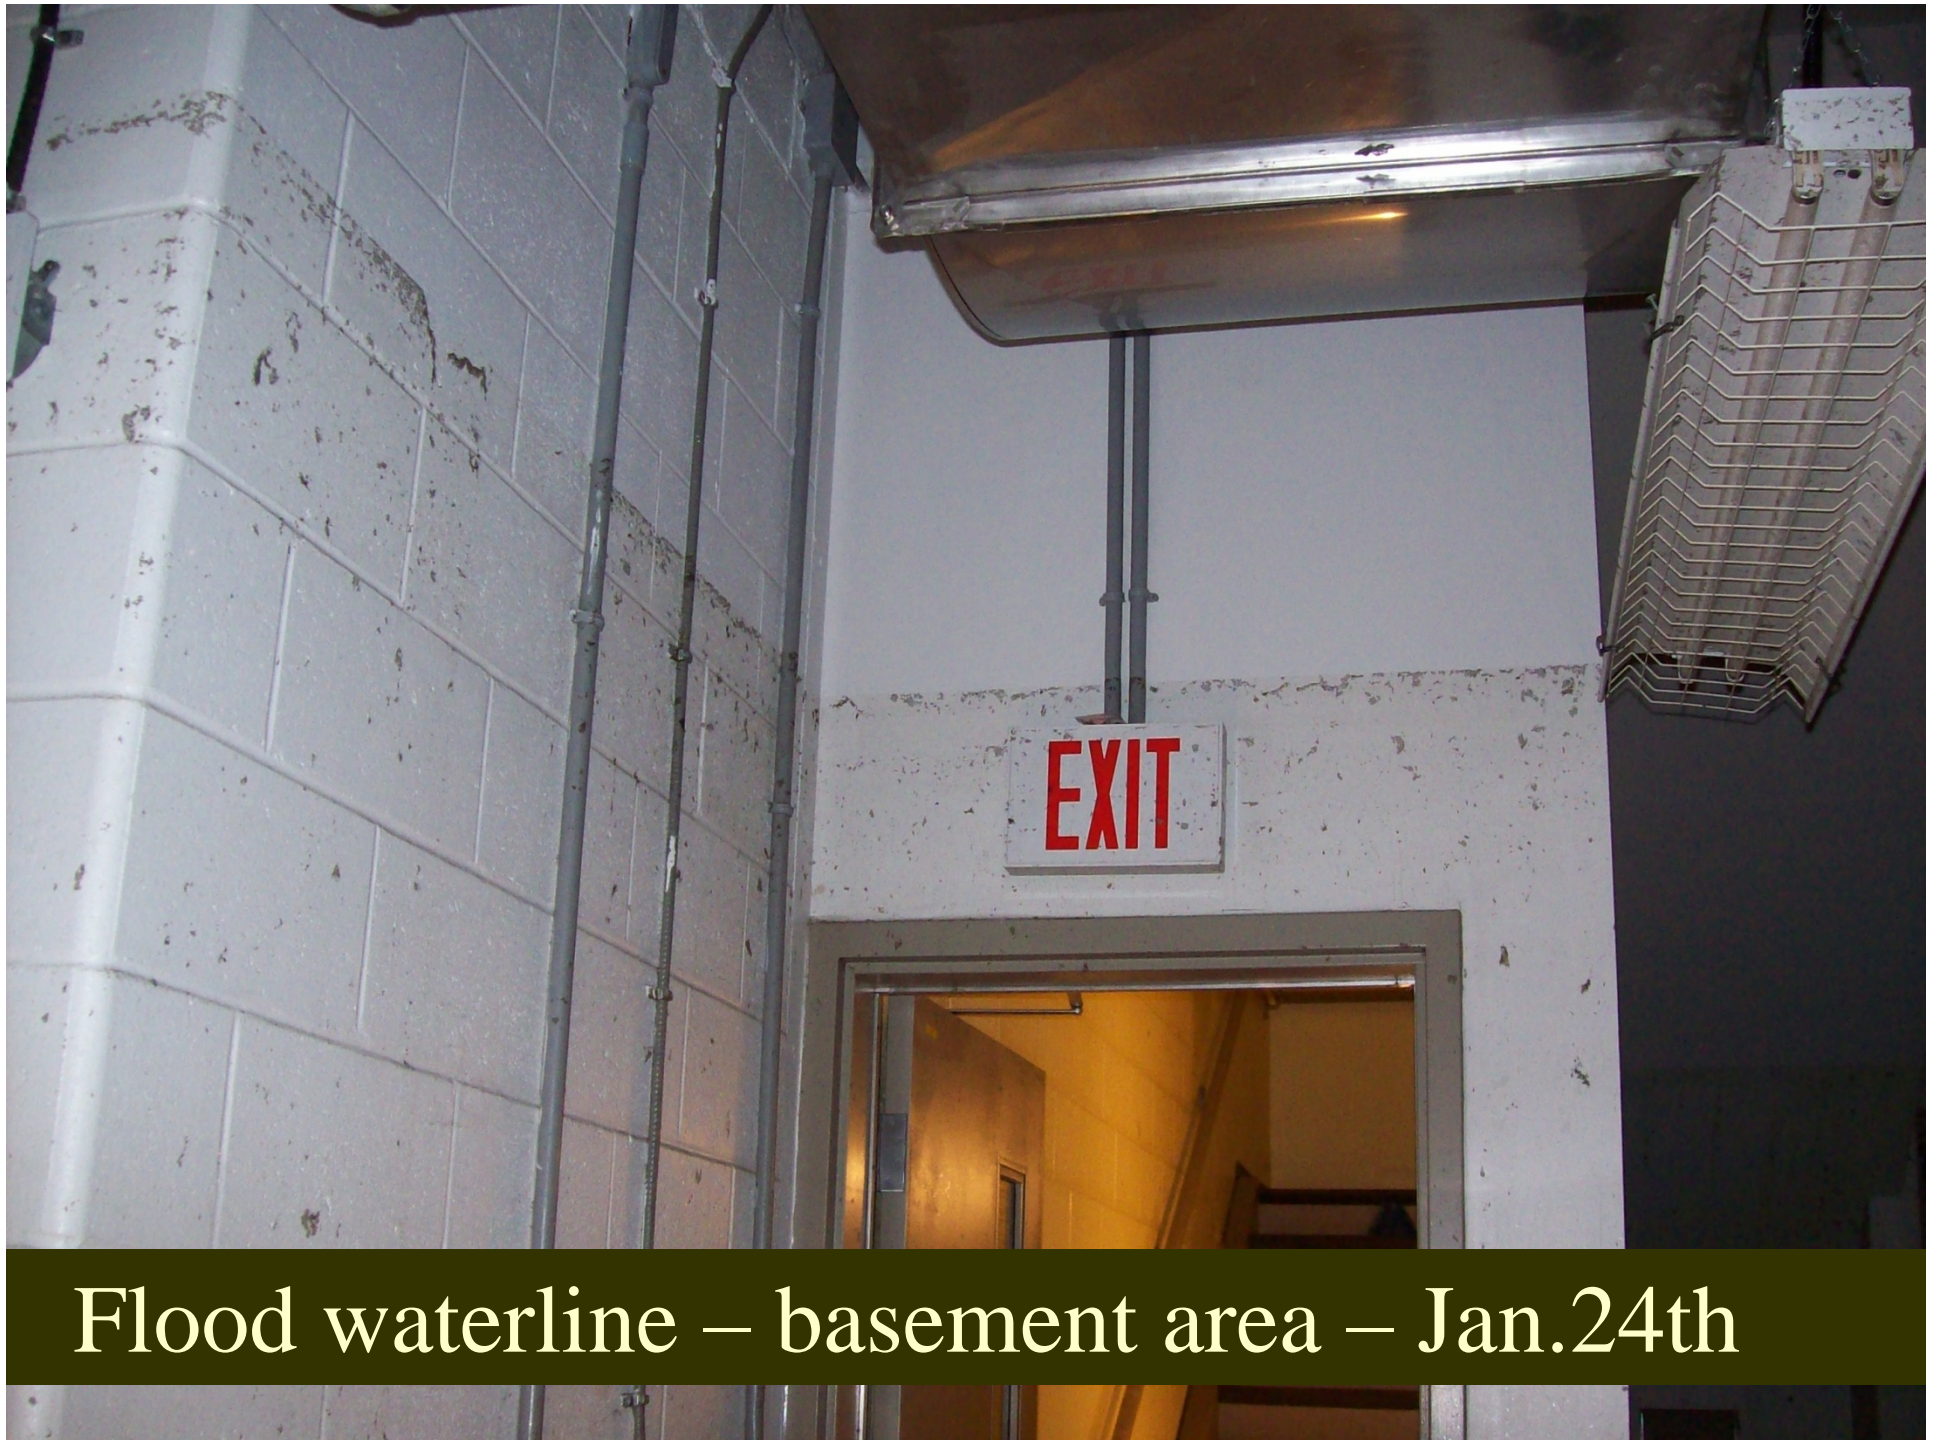
Flood waterline – basement area – Jan.24th

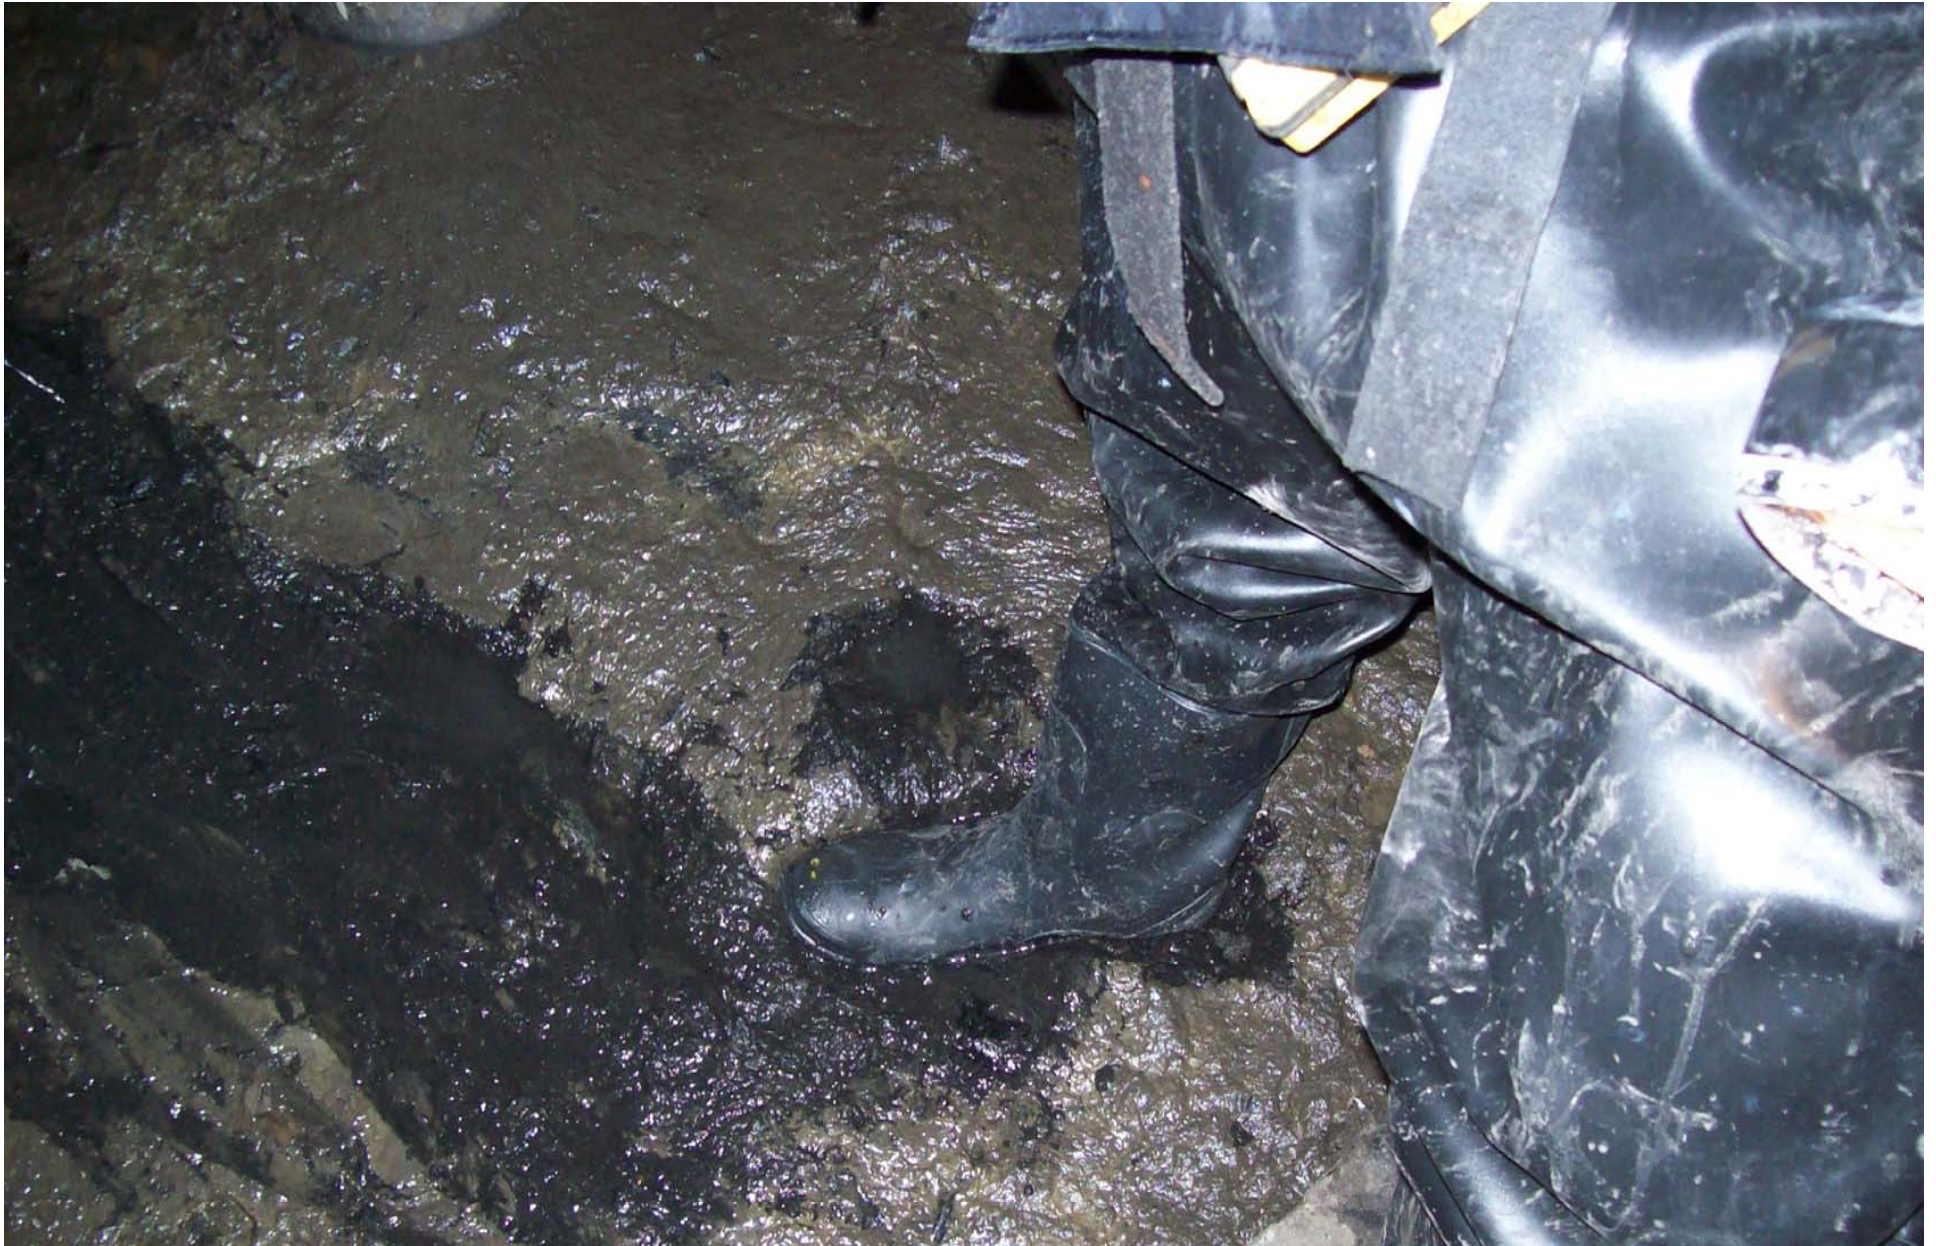
Floor of wet well prior to initial clean up – Jan.24th

- ❖ Continue to Protect the Asset
- ❖ Complete inspection of the large raw water submersible pumps; if motors damaged, place an order as the delivery time is long [in the order of 6 to 7 months]
- ❖ Complete inspection of Sluice Gate Actuator
- ❖ Clean the Wet Well such that workers can replace equipment in a safe work environment
- ❖ Take an image of the SCADA software on the control system hardware

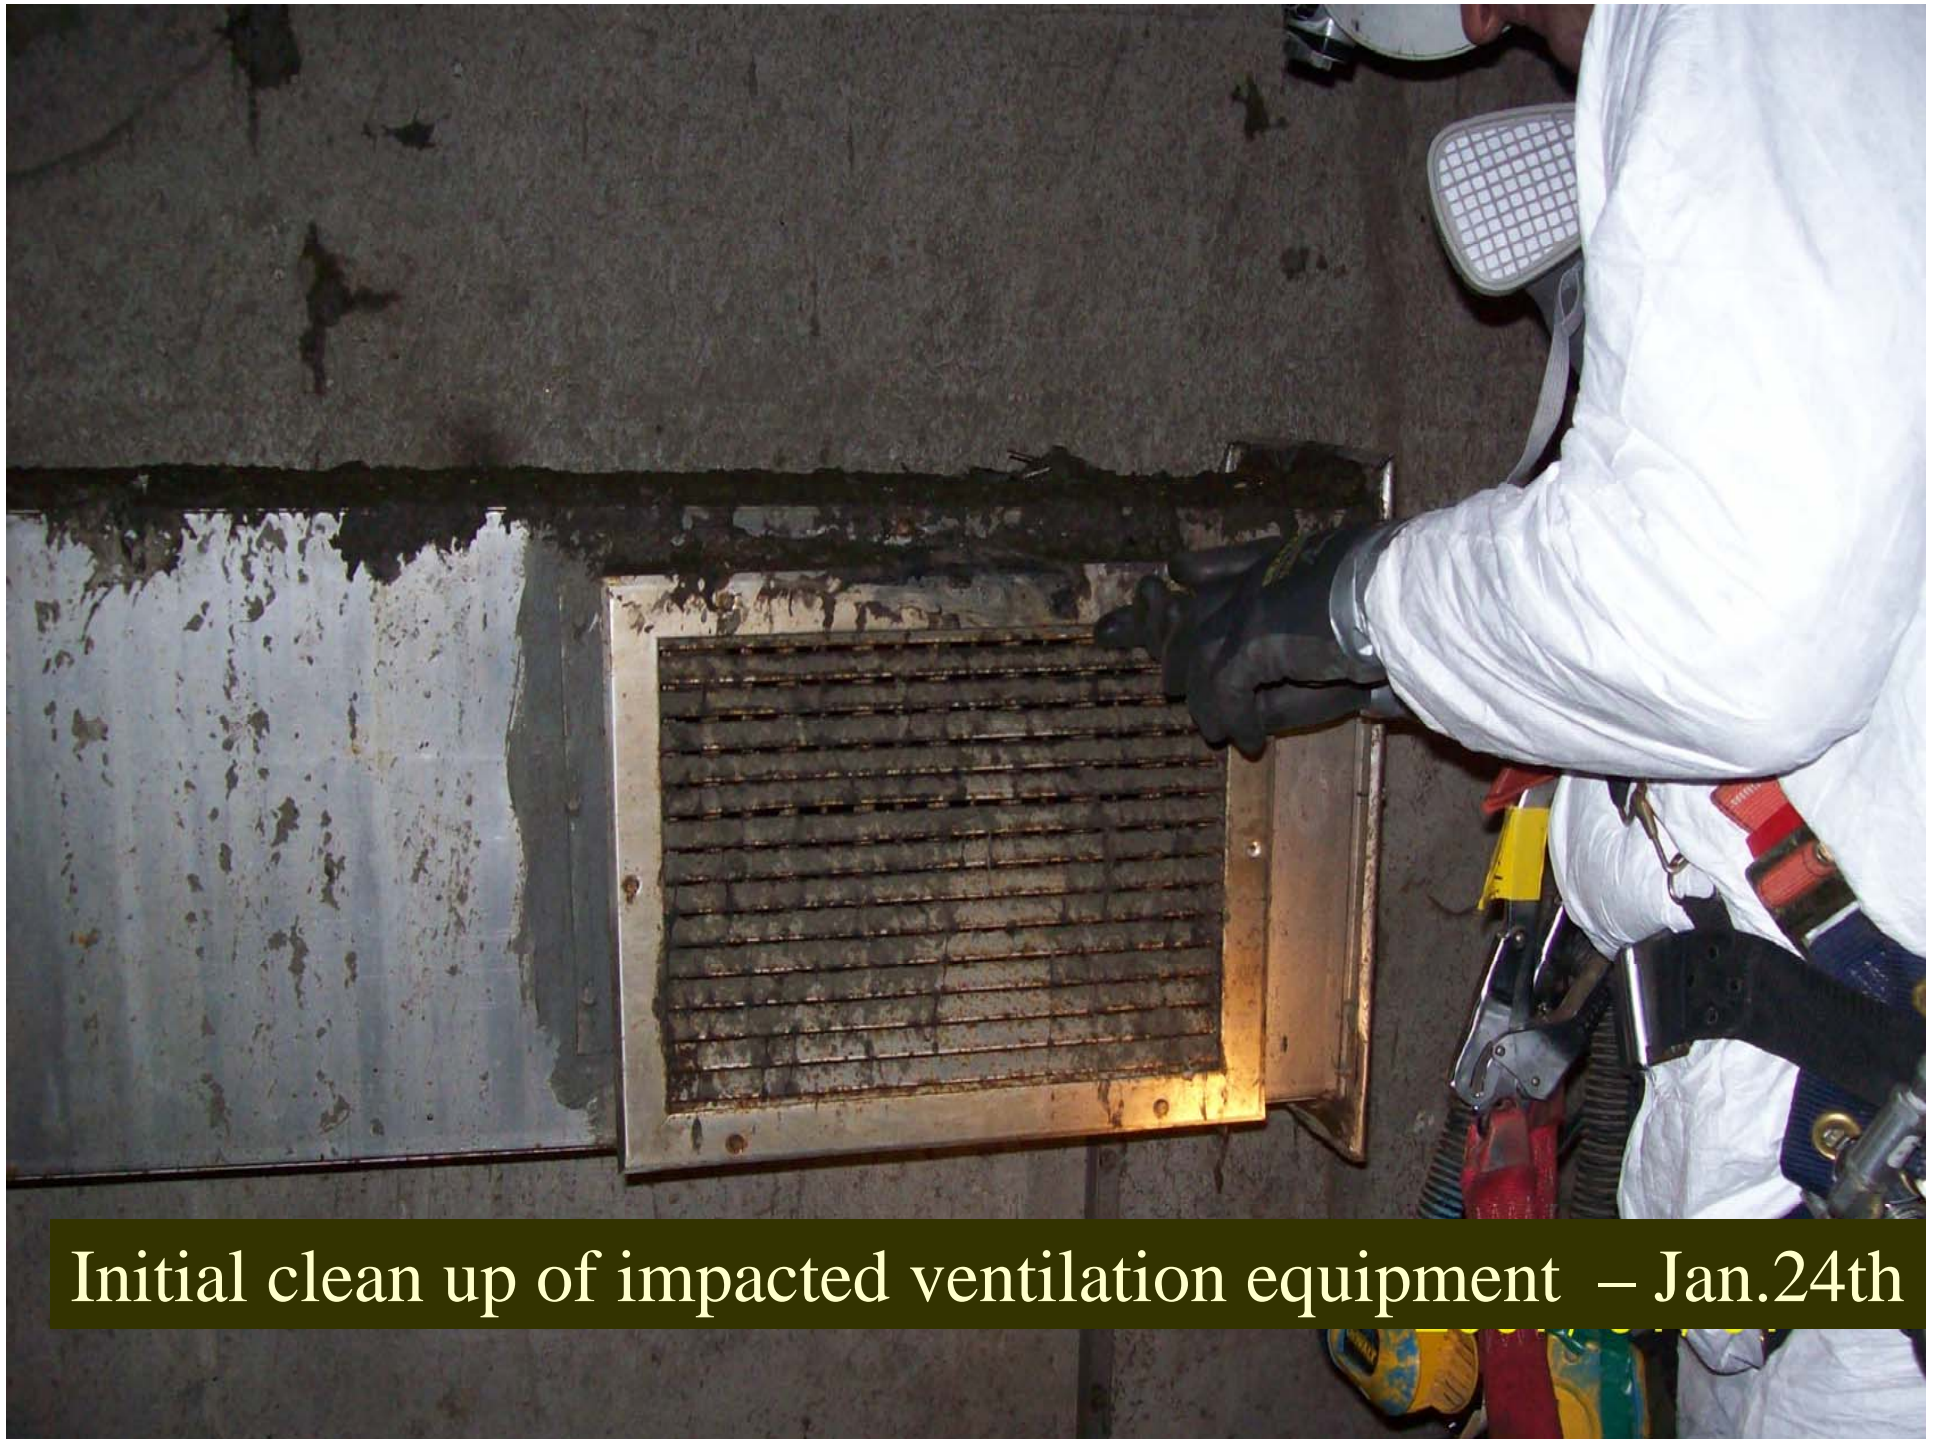
Initial clean up of impacted ventilation equipment – Jan.24th

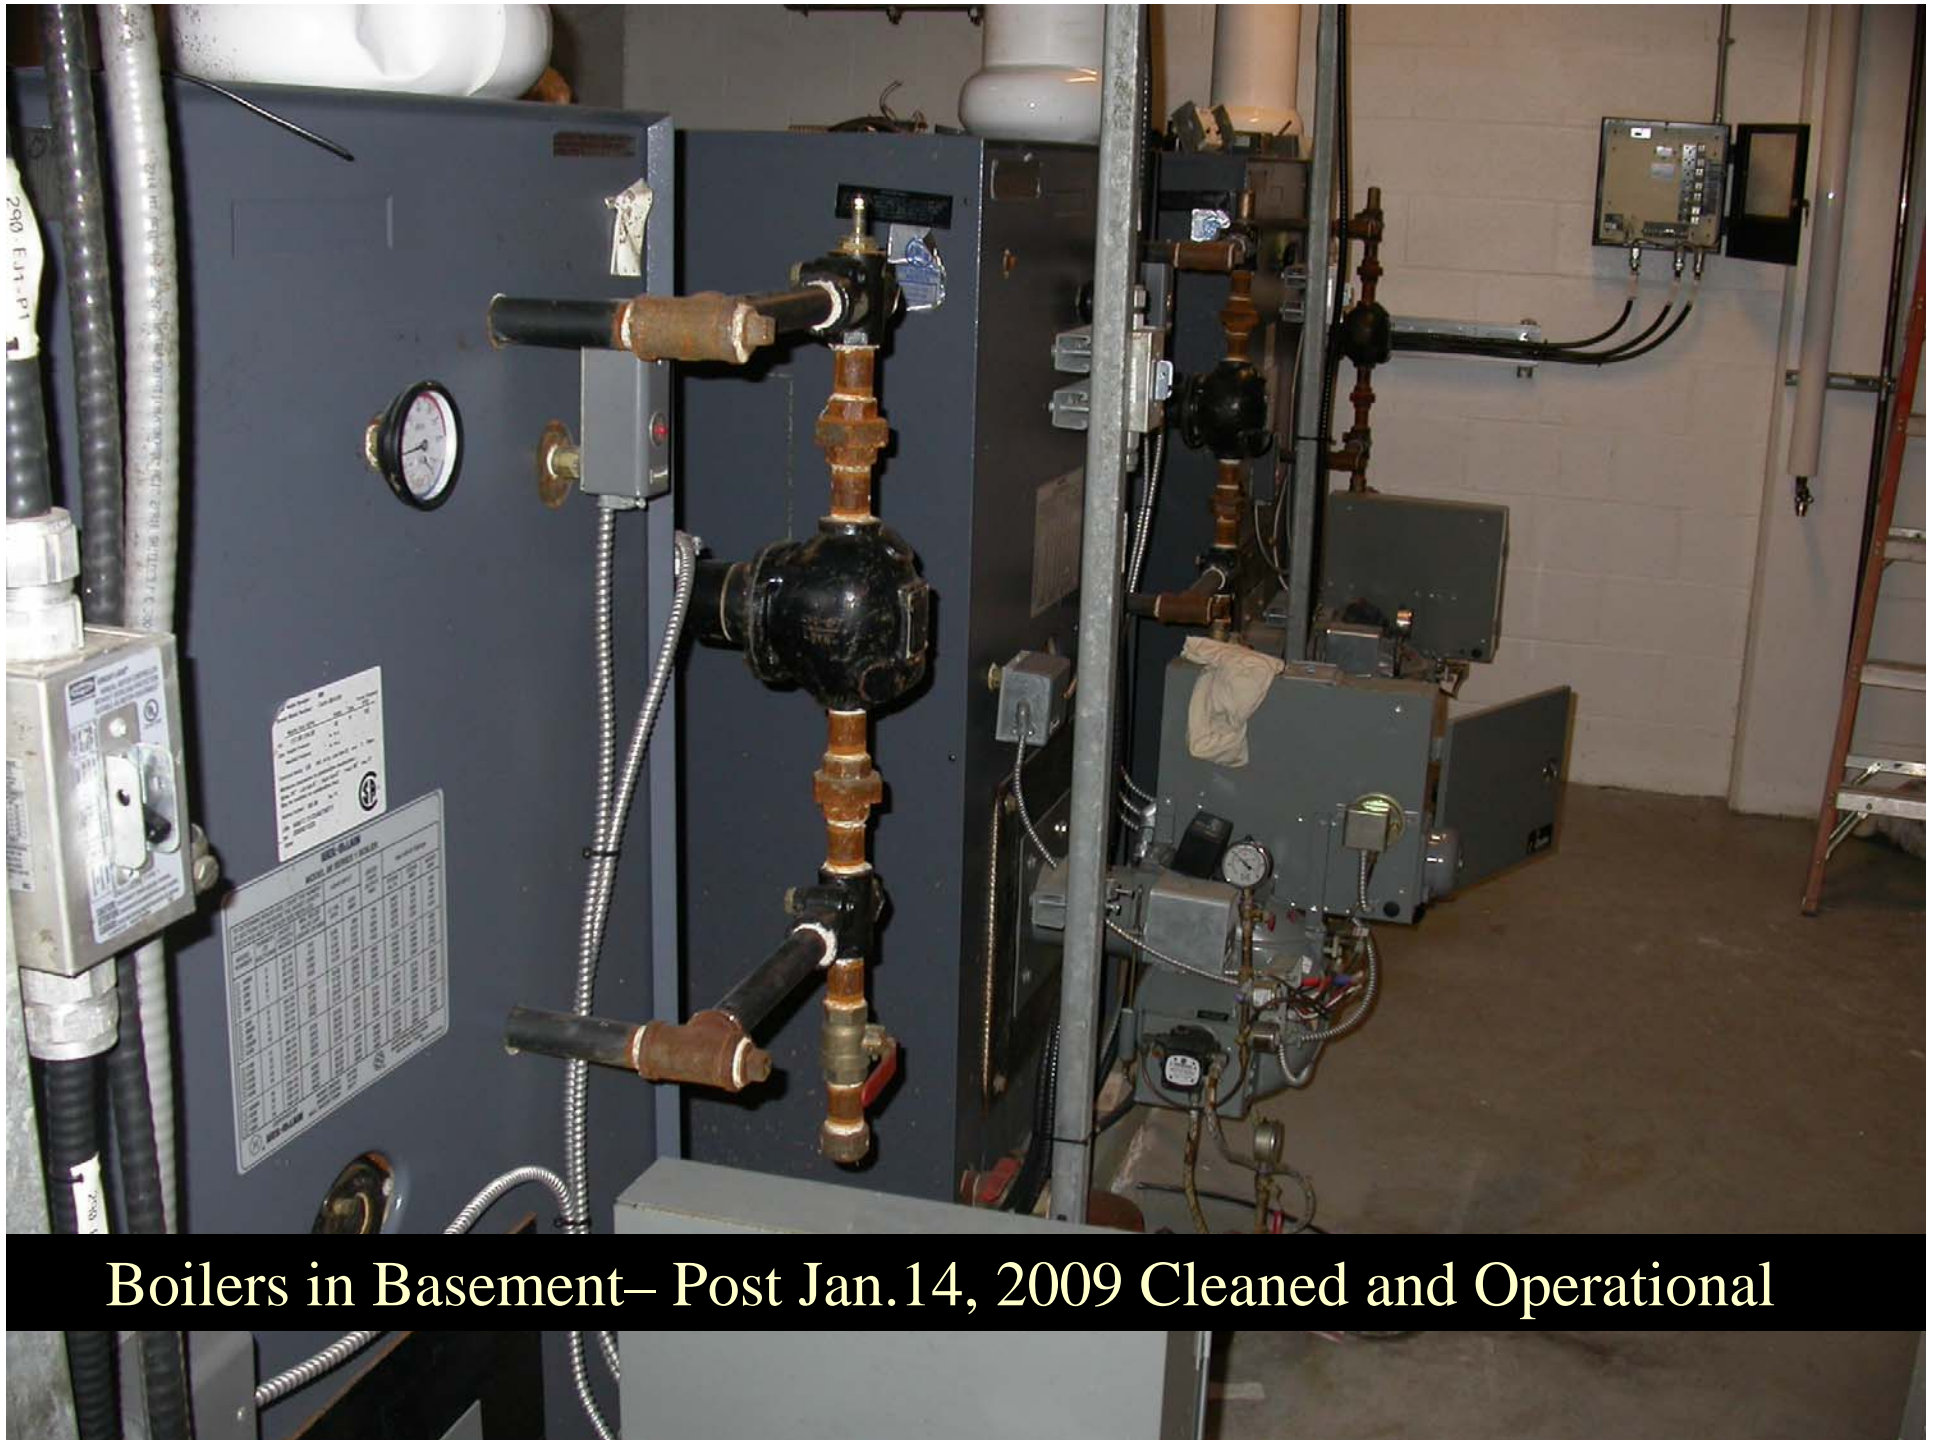
Boilers in Basement— Post Jan.14, 2009 Cleaned and Operational

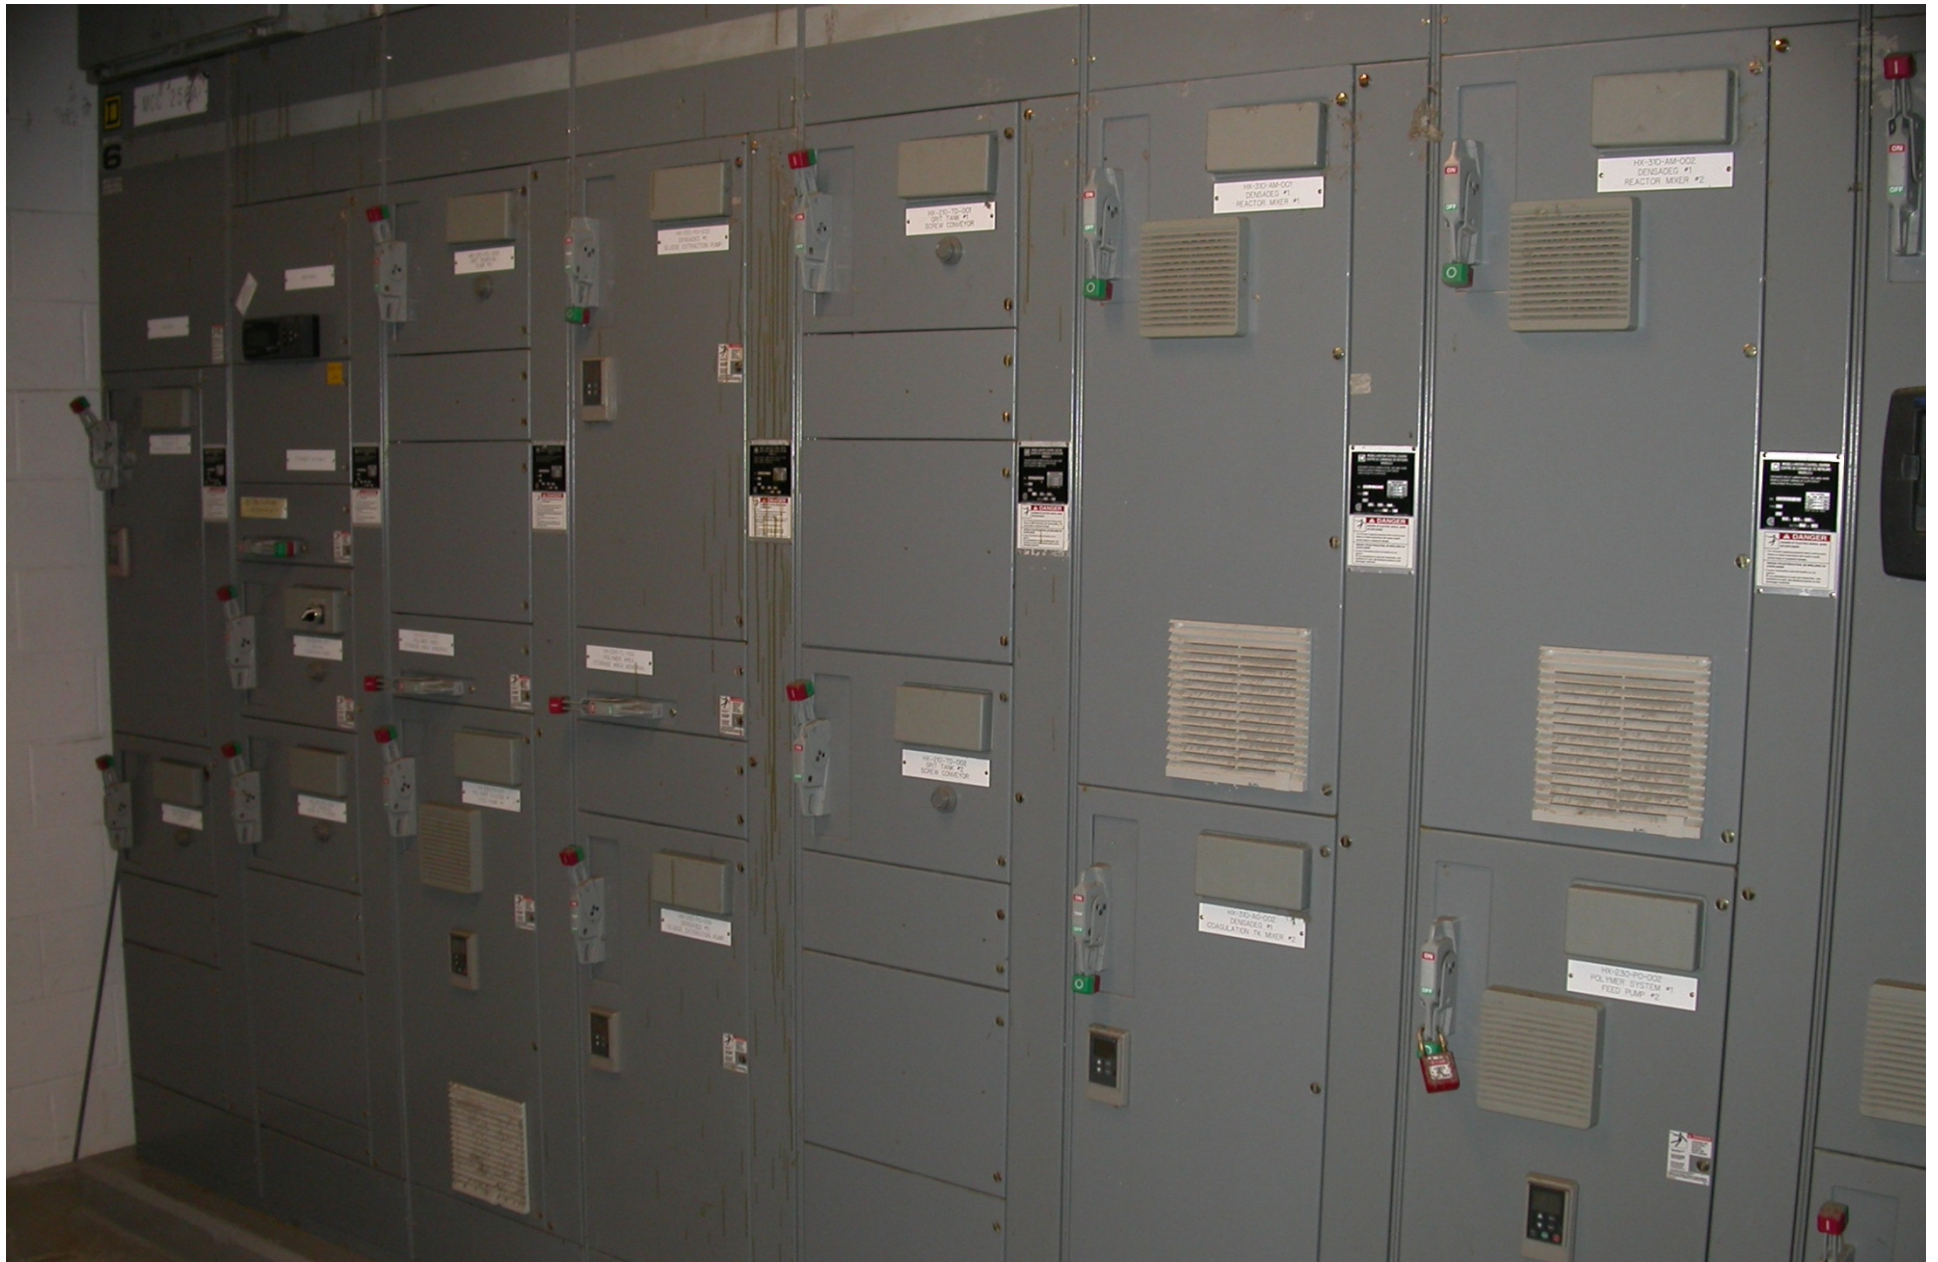
MCC Room in Basement– Post Jan.14th Cleaned/Not Operational

- ❖ Submerged electrical cables, instrumentation & electrical equipment to be repaired or replaced [NSPI electrical standard] including the MCC in the Basement [6 month delivery]
- ❖ Develop schedule for recovery & order the critical equipment. Who installs can be decided later
- ❖ Halifax Water has hired specialist consultants to perform more in depth forensics and make recommendations for improvements [work to be complete by May 09]

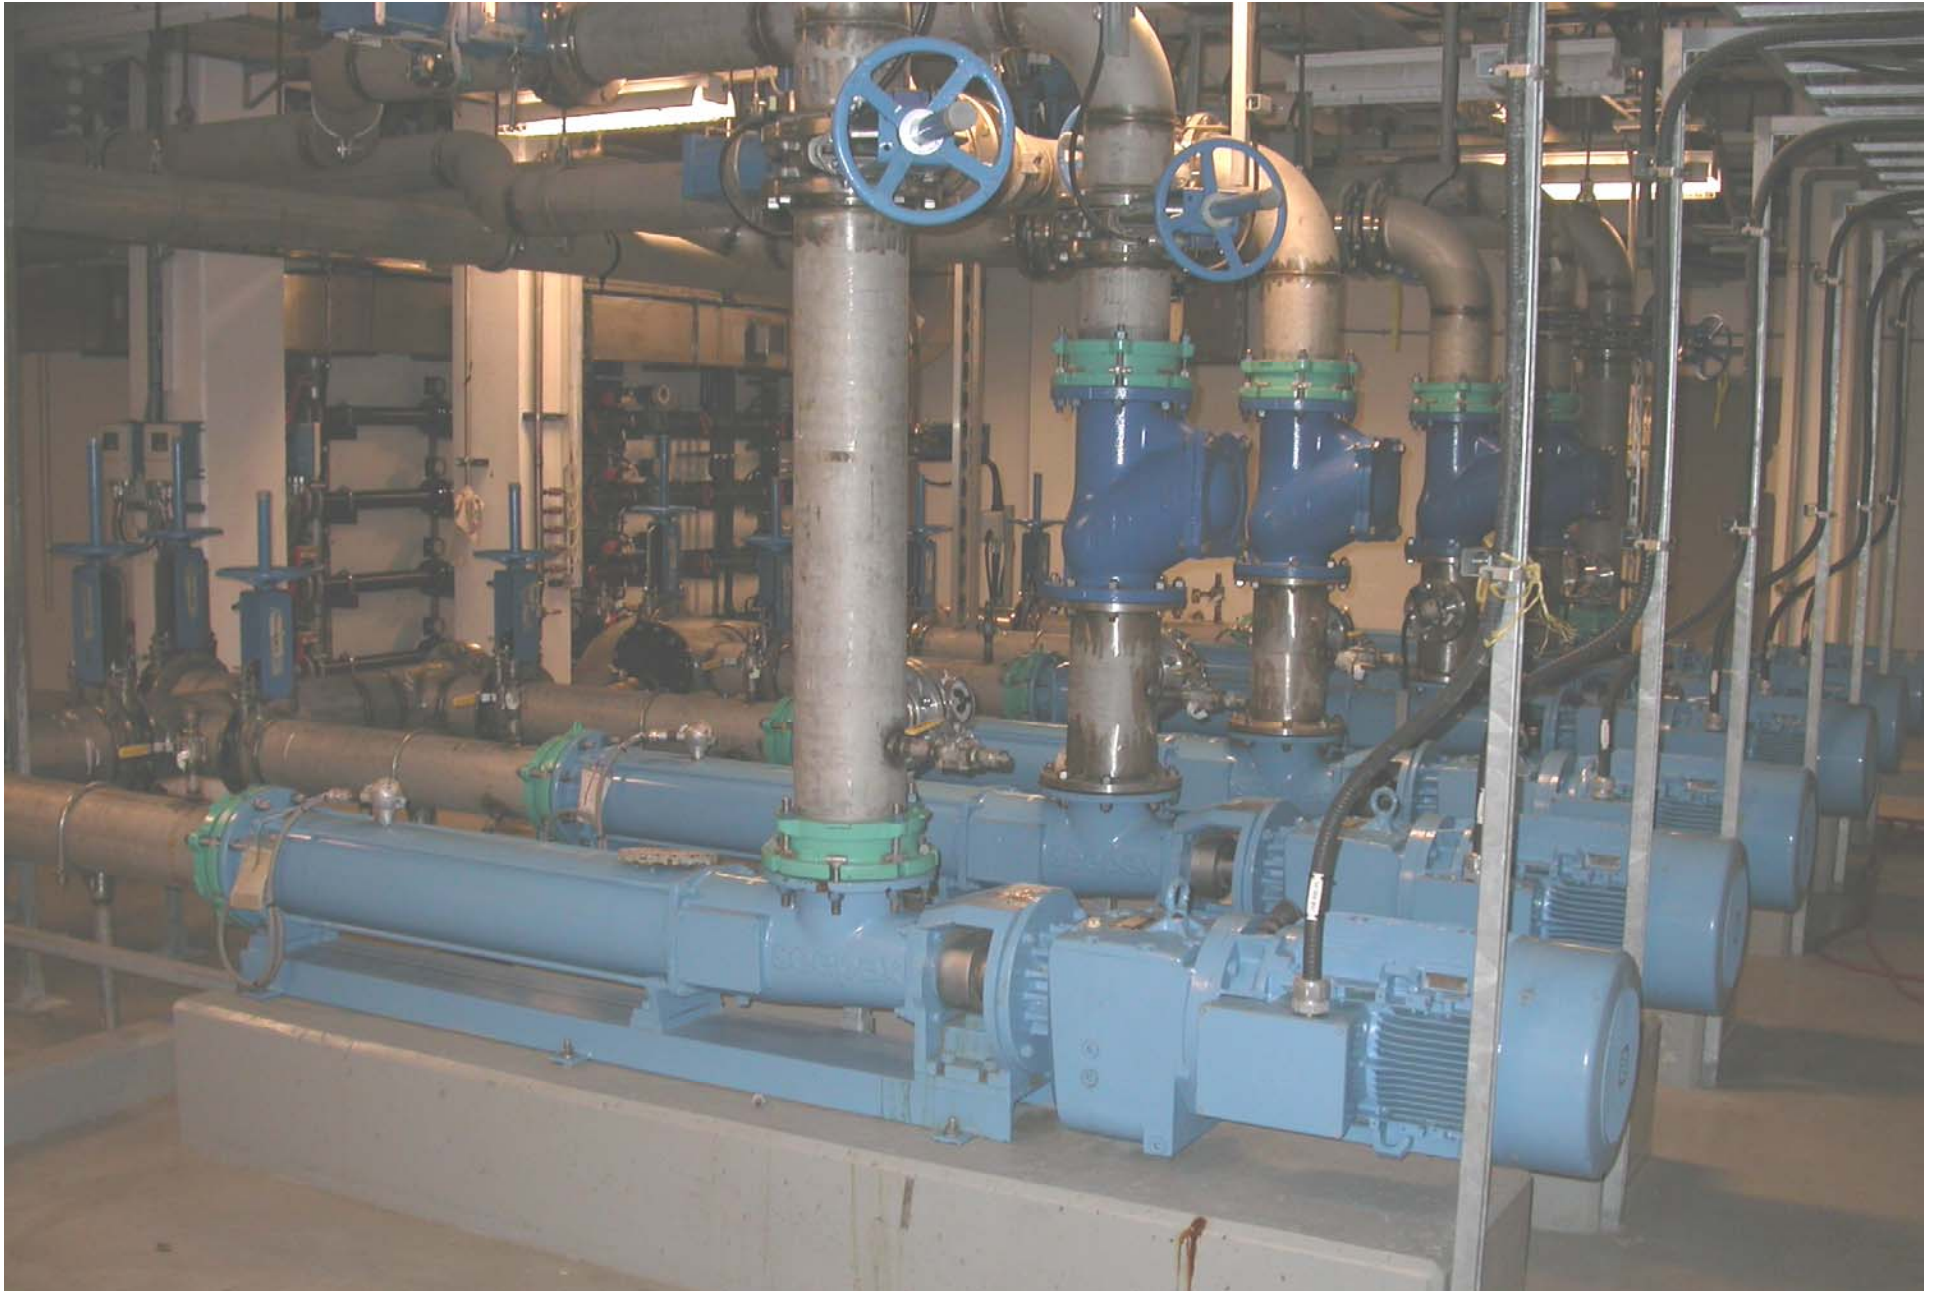
Process pumps in Basement– Post Jan.14th - Cleaned/ Not Operational
