Halifax Harbour Solutions Project

Halifax Wastewater Treatment Facility - Update

Regional Council, April 14, 2009

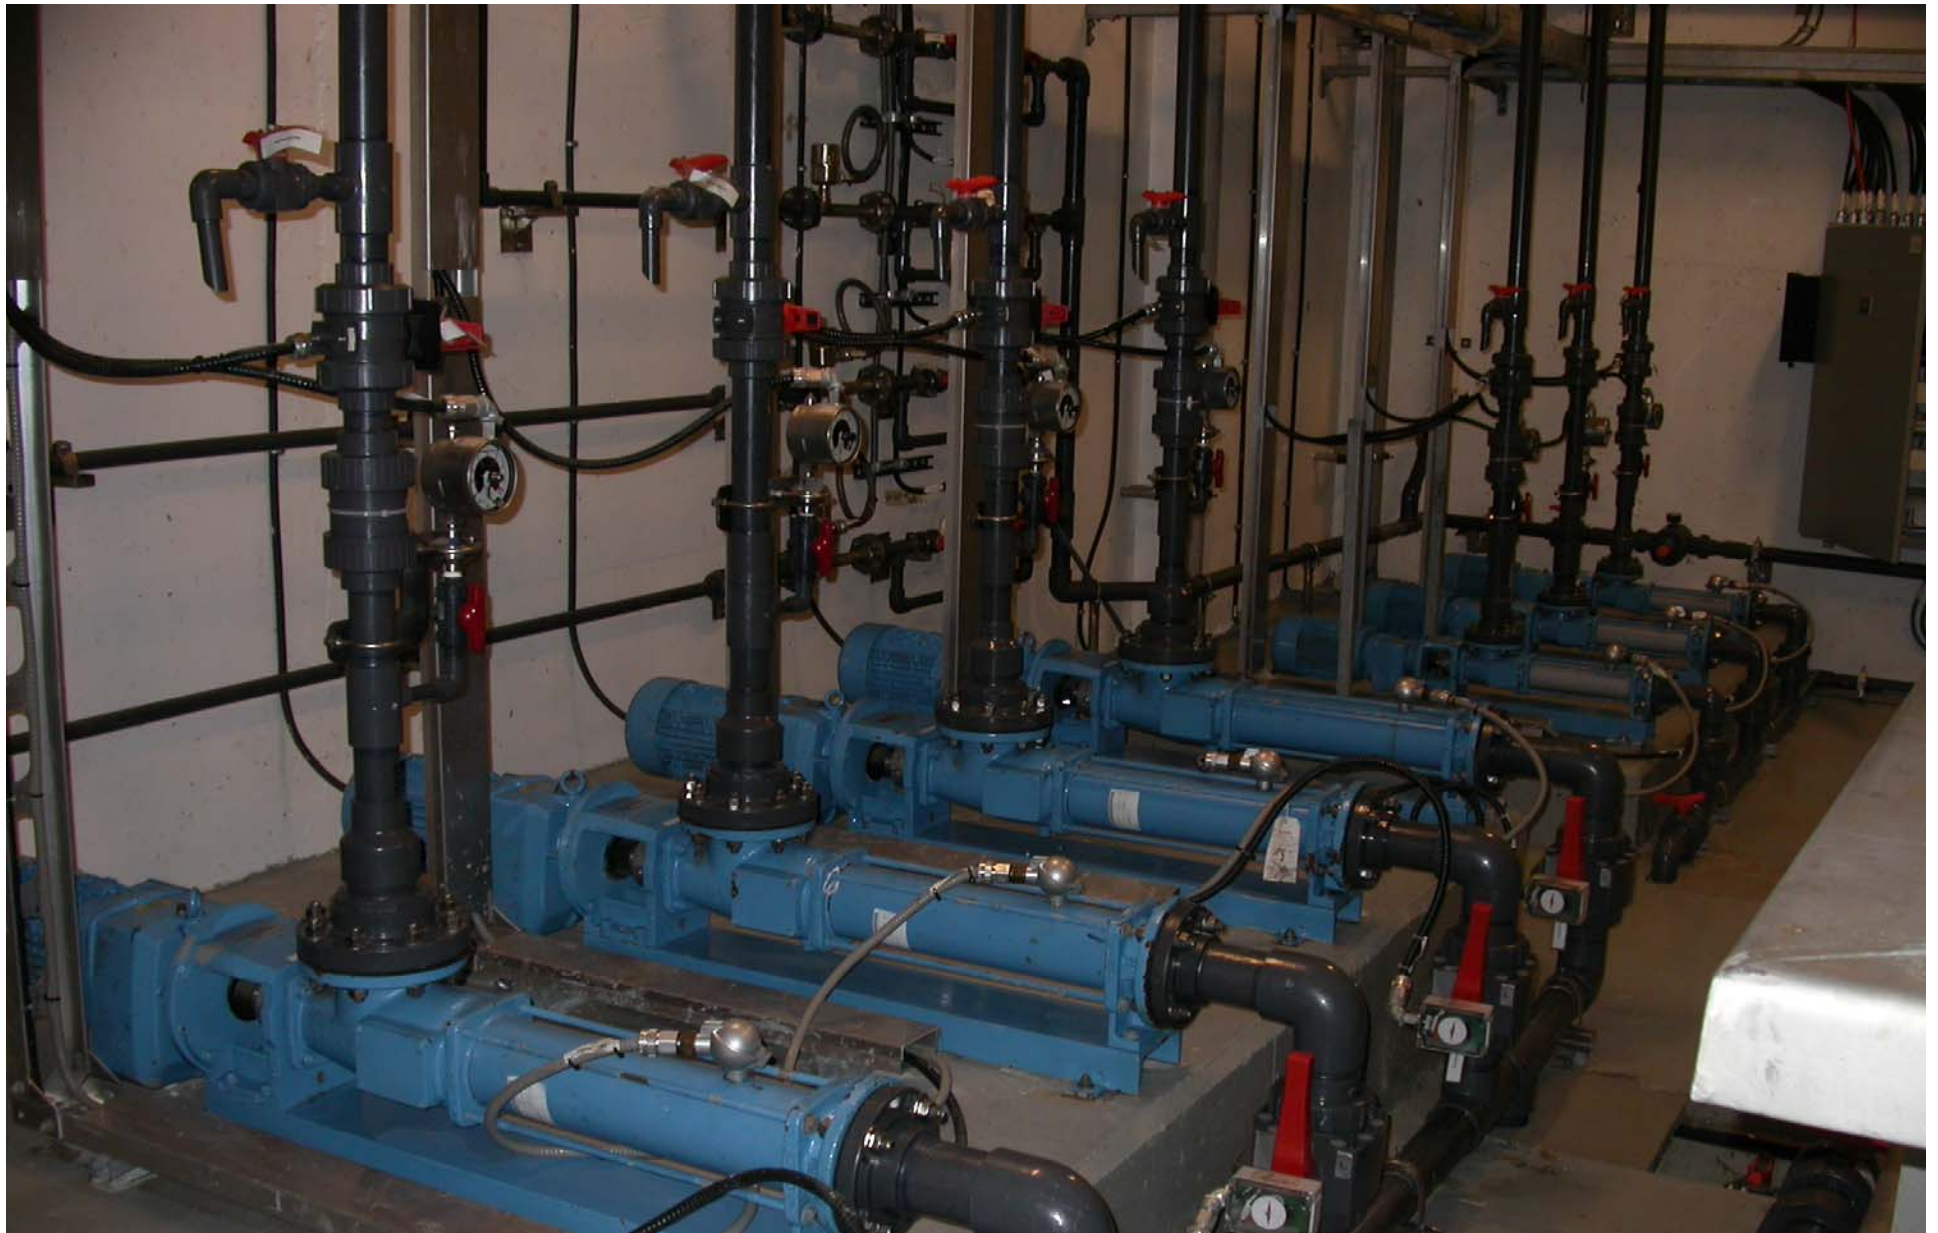
Process pumps in Basement— Post Jan.14th - Cleaned/ Not Operational

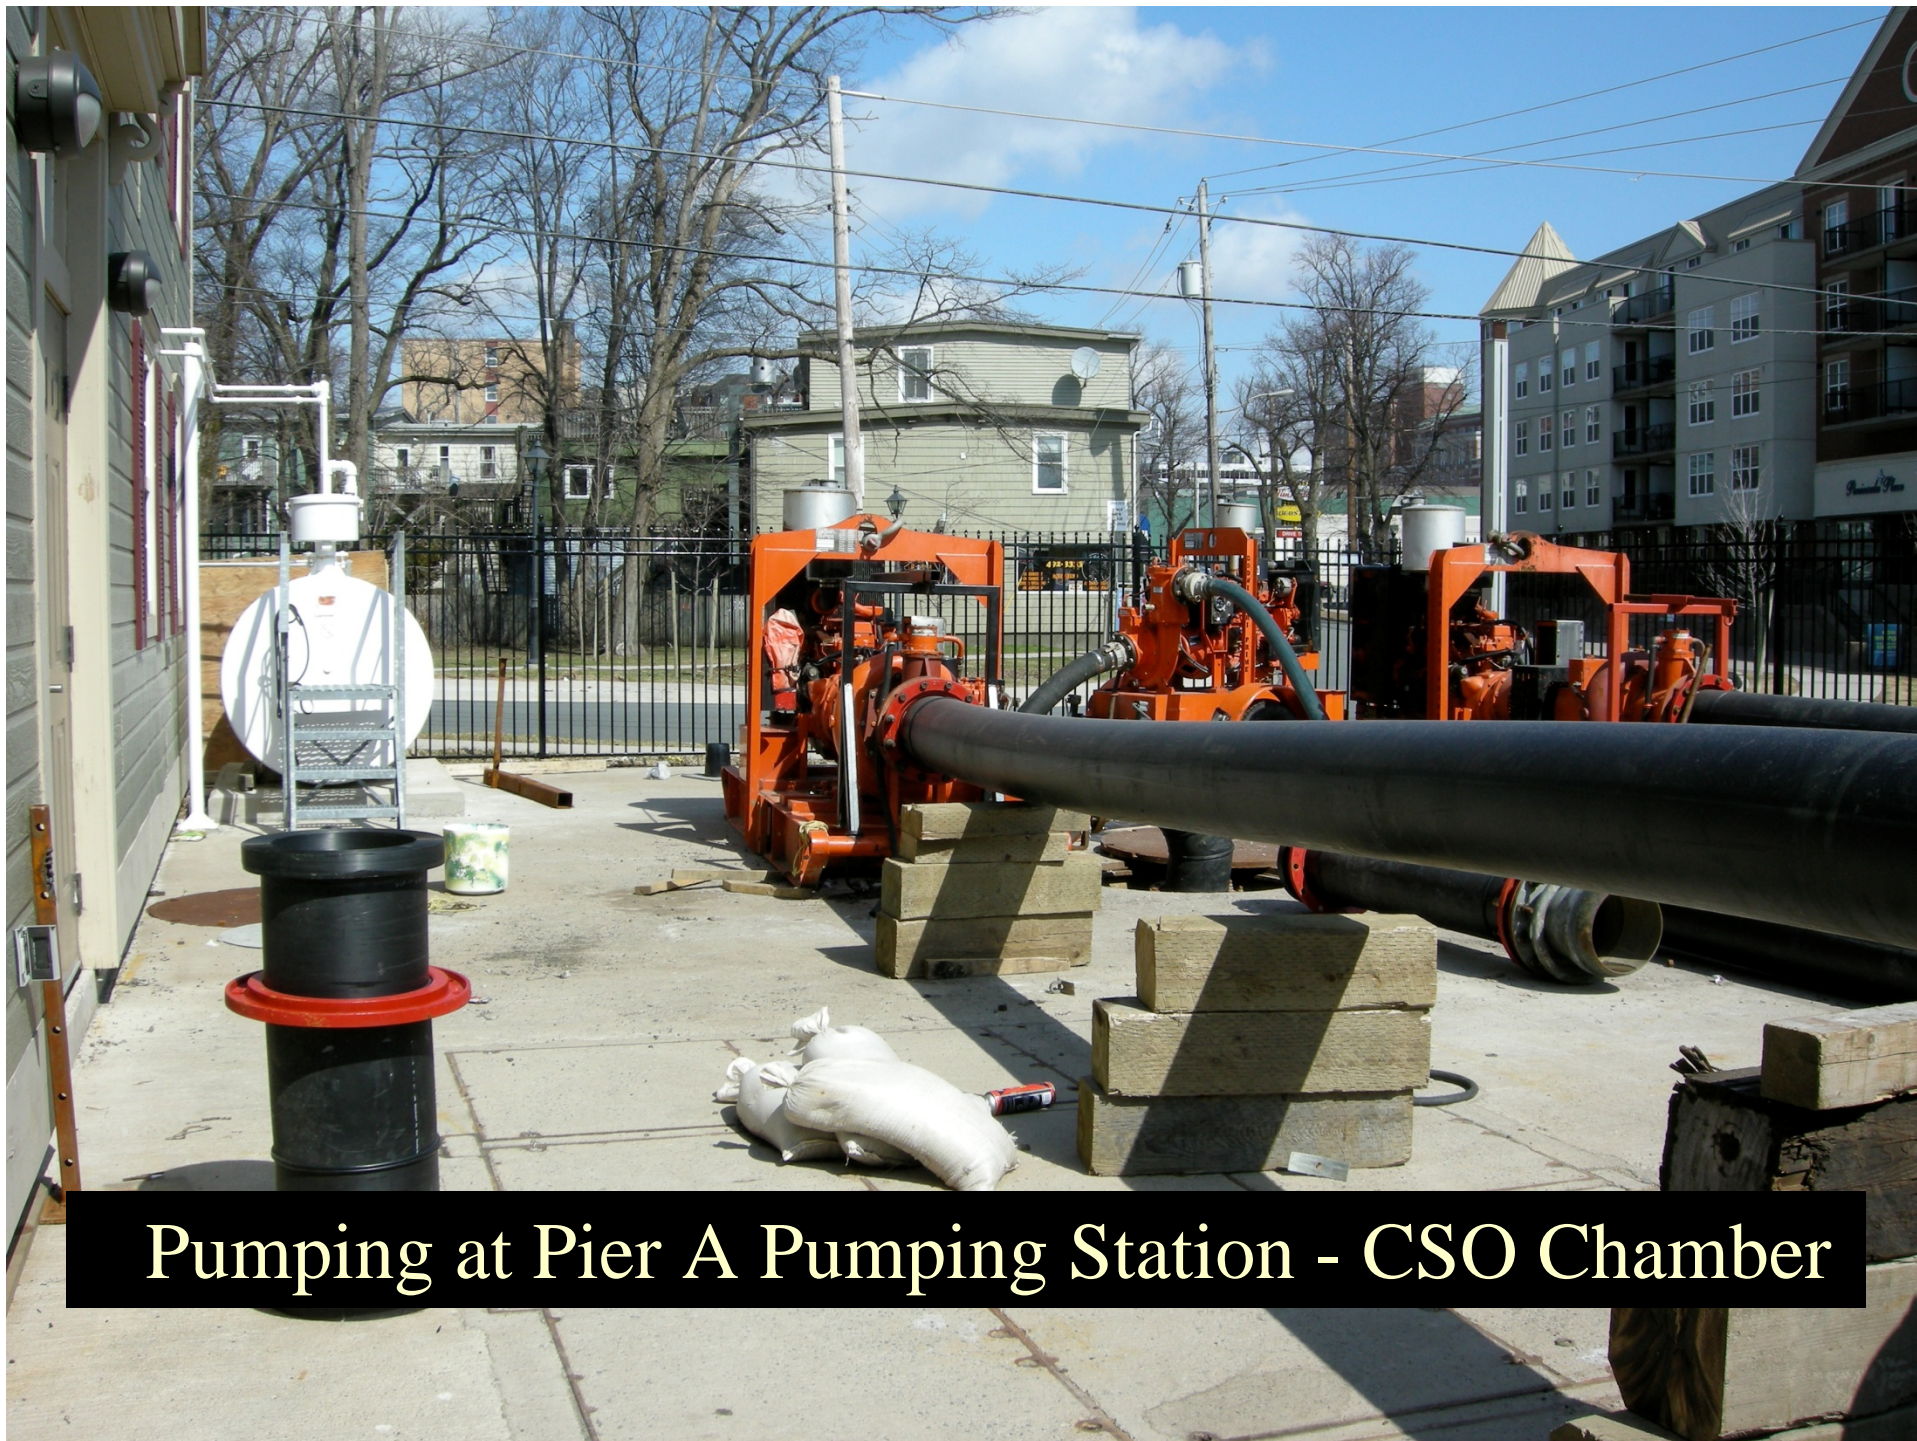
Pumping at Pier A Pumping Station - CSO Chamber

- ❖ Vigilance around the Pier A Pumping Station/CSO
- ❖ Pump out grit/debris in waterfront CSOs on an as required basis [Effluent continues to be screened before discharge to Harbour]
- ❖ Keep watch for wet weather events and co-ordinate pumping of tunnel in downtown Halifax to minimize street flooding
