Item No. 11.5.1
Halifax Regional Council
May 13, 2014

DATE: February 24, 2014

SUBJECT: Case H00395: Substantial alterations to 5171 George Street (Bank of Commerce Building); 1813 Granville Street (Hayes Insurance Building); 1819 Granville Street (Merchants Bank of Canada Building); 1824 Hollis Street (Champlain Building); and 1820 Hollis Street (Flinn Building) – 5 municipally registered heritage properties.

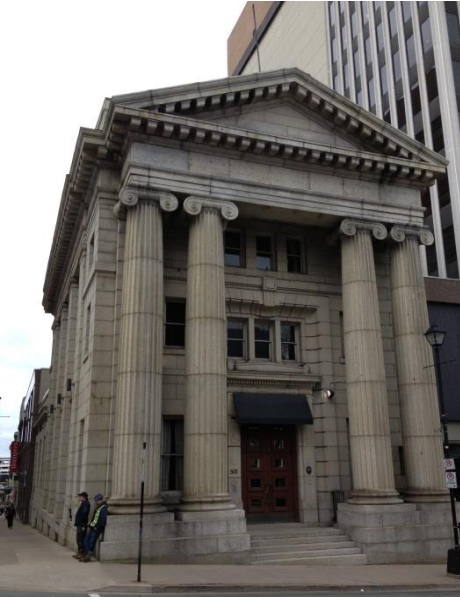
Bank of Commerce Building – 5171 George Street (1906)

<p>Character Defining Elements:</p> <ul style="list-style-type: none"> • Prominent position as a corner building facing Province House; • Three-storey, granite block constructed building designed in the Classic Greek Revival style with a ‘Temple front’ with substantial entablature and pediment carried by paired Ionic columns on massive granite plinths; • Flat roof with over hanging eaves and a stone bracketed cornice, and rooftop balustrade/parapet; • Granite steps leading to the main entry which has massive wooden doors framed by pilasters and a narrow frieze with relief carvings and a dentilled cornice. Main entry is set within a two-storey, recessed centre bay framed by chamfered pilasters and a voussoir lintel with keystone; • Windows on the front elevation flank the central bay, with central ganged windows at the second and third floors; • The side elevation is five bays wide with three center bays recessed and framed by engaged columns and pilasters; • First floor windows on the side elevation are large, recessed hung windows with decorative hood mouldings; • Second floor windows smaller and paired, while the third floor windows triplicate and smaller again; • String course between the second and third floors; • Temple front entablature is carried around side elevation; • Rear addition: 1storey, granite addition with large recessed hung windows with a flush sill and flat arch above. The addition has a flat roof with a simple cornice and parapet.

With its prominent position as a corner building and impressive Classic Greek Revival architecture, the Bank of Commerce building is valued for both its architecture and its historical associations. This purpose-built bank building is composed entirely of granite and the impressive building design represents the stability of the bank institution, and the rich banking history in Halifax. The building is in excellent condition and is highly unaltered (Attachment K).

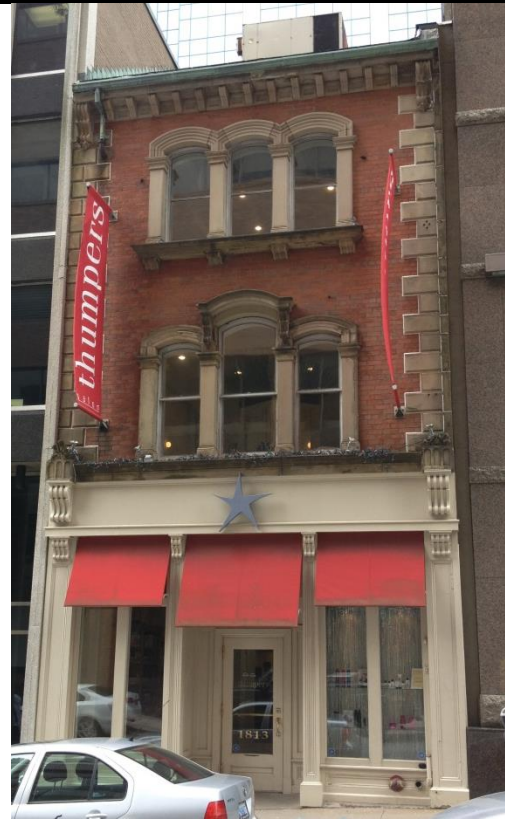
Hayes Insurance Building – 1813 Granville Street (c. 1863)

- Three storey red brick and sandstone building with sandstone quoins at the second and third floors;
- Truncated pitched roof with moderate overhang supported by a deep bracketed cornice;

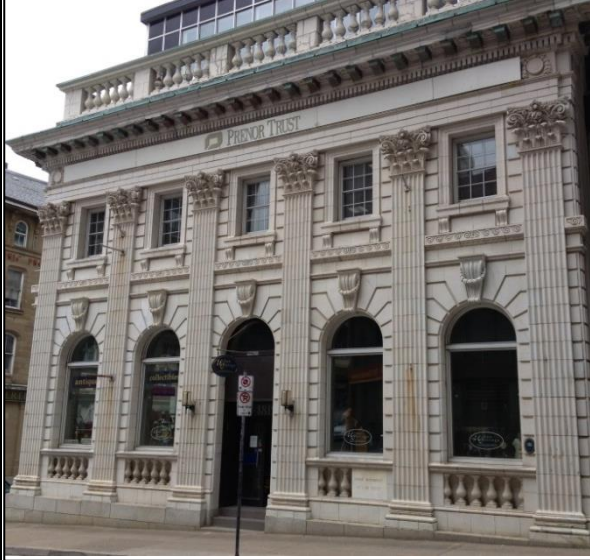
Merchants Bank of Canada Building – 1819 Granville Street (1911)

- Prominent position as a corner building;
- Two storey building on a granite base with a modern, one-storey, stepped-back, rooftop addition;
- Highly ornamented white glazed terra cotta exterior;
- Flat roof with a balustrade parapet and a wide eaves cornice with dentils and modillions;
- Symmetrical facades with bays articulated by fluted pilasters with Corinthian capitals, the second floor level articulated by a decorative string course,
- Central recessed door on Granville Street in an arched opening;
- Tall arched window and door openings on the ground floor, with voussoirs and large keystones above and balustrade sills below;
- Square 6-over-6 windows on the second storey, with moulded surrounds and bracketed sills.

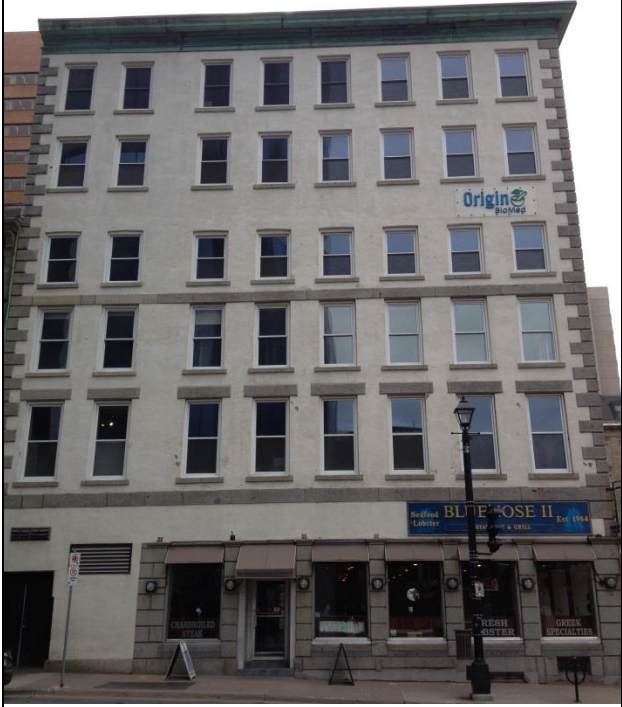
Champlain Building 1824 Hollis Street/5124 Duke Street – c 1860

<p>Character Defining Elements:</p> <ul style="list-style-type: none"> • Prominent position as a corner building; • Six storey building with a simple parapet, a flat roof with a modest overhang and a moulded copper cornice which is returned on both Hollis and Duke Street; • Simple proportions and minimal ornamentation; • Granite quoins, granite stringcourses at the second and fourth floors; • Granite window sills; prominent granite lintels above second floor windows; • Change in vertical floor separation between the fourth and fifth floors; • Change in horizontal bay separation on the southern bay on Hollis Street; • Stucco/parge exterior finish over brick; • Regular arrangement of vertically proportioned windows with a high void to solid ratio; • Windows on the second and third floor are proportionately larger than those on the fourth, fifth and sixth floors; • Dressed granite storefront with beveled granite pillars topped by simple capitals, and a regular arrangement of fixed plate glass windows; • A wide frieze/sign band between the lower string course and storefront windows.

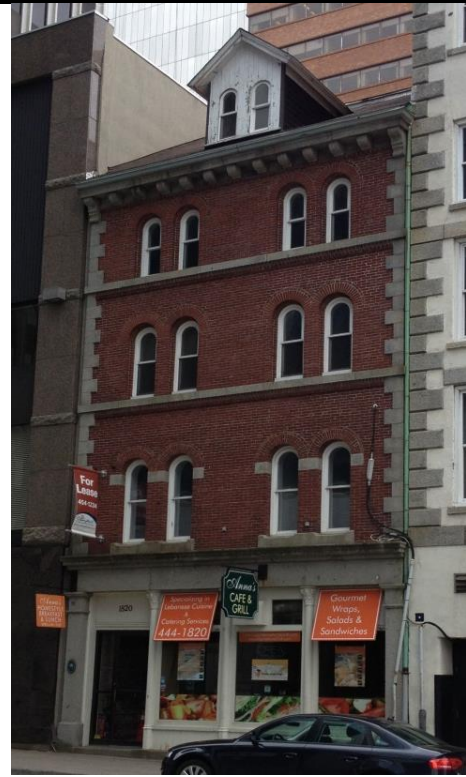
Flinn Building – 1820 Hollis Street (c. 1863)

- Four and ½ storey brick and stone building designed in a two bay arrangement;
- Truncated pitched roof with a central wooden dormer on the front and rear elevation, and a modest roof overhang with granite cornice supported by solid stone brackets.

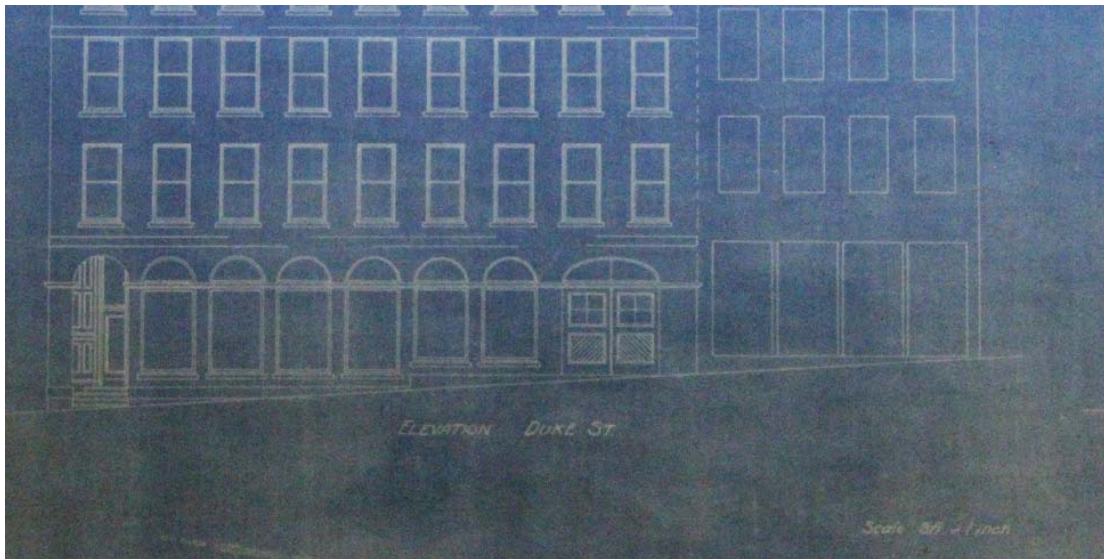
Partial 1911 Drawing showing proposed corner entrance at lower left

As previously noted in this report, the upper 2 levels of the façade will be removed while the lower 4 levels will be retained and restored. While this solves the logistical challenges during construction, it also offers an opportunity to restore the facades in a manner that will more closely resemble their original and intended appearance. Most noticeably, this will re-introduce the ground floor arched windows, which were arguably the character-defining elements with the greatest impact to the streetscapes. In addition, a new corner entrance will be created at the intersection of Duke and Hollis Street as was intended in a 1911 architectural drawing

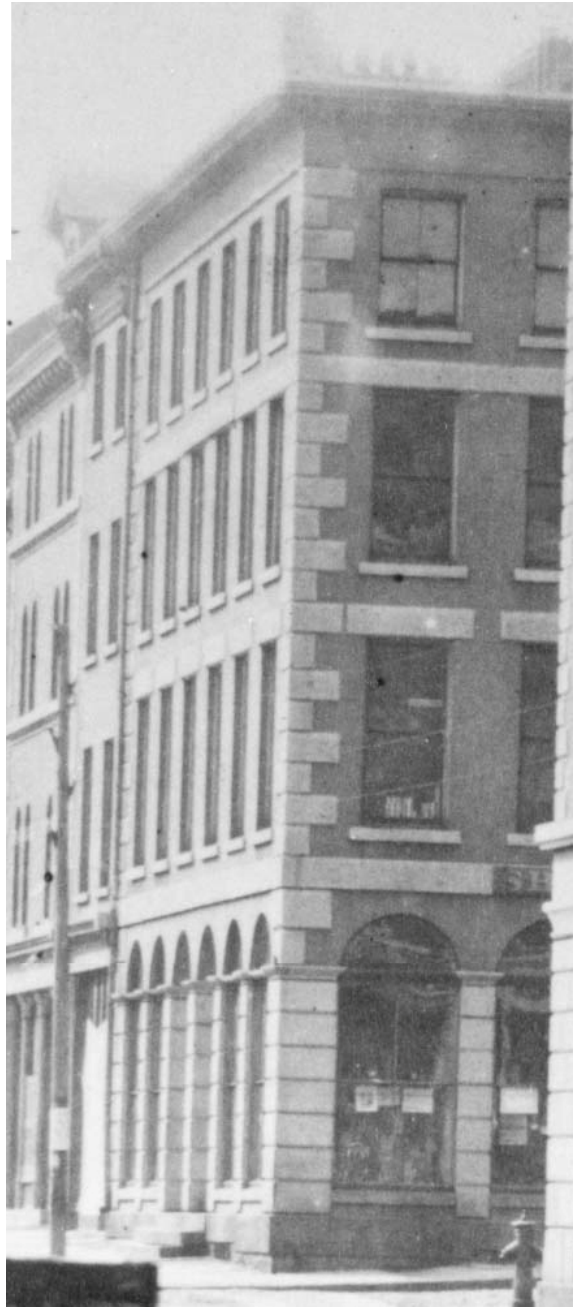
Photo taken in 1871 showing original building including arched windows and frieze/cornice condition

A new frieze and cornice will be constructed along the top of the 4-storey façade which will resemble the original design to the extent that it can be determined from archival photographs (see photo below). The entire façade will have new wood windows installed in keeping with its original appearance. Overall, a restored 4 storey façade of the Champlain Building will recapture much of its original character-defining elements including its ground floor arched windows and its original scale within the block.

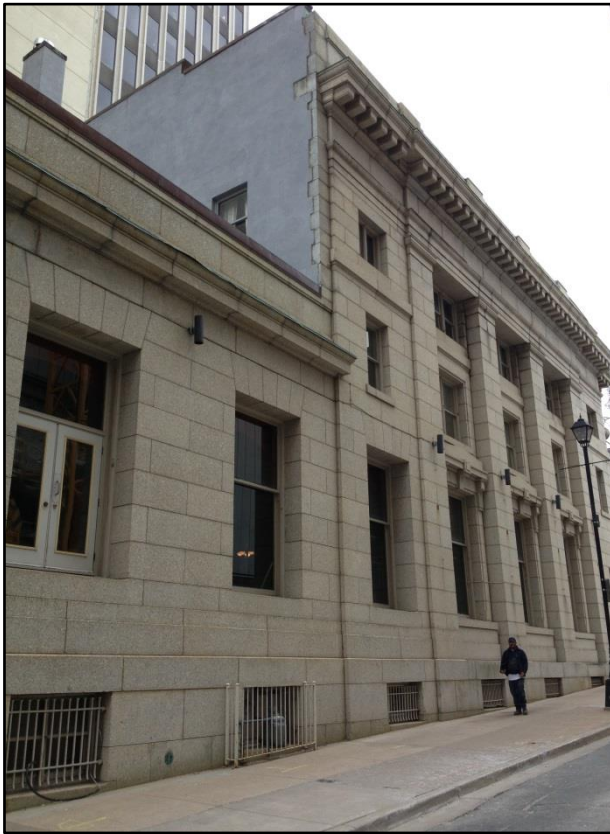
Photograph 3: Side elevation, showing main and rear addition of the Bank of Commerce building.

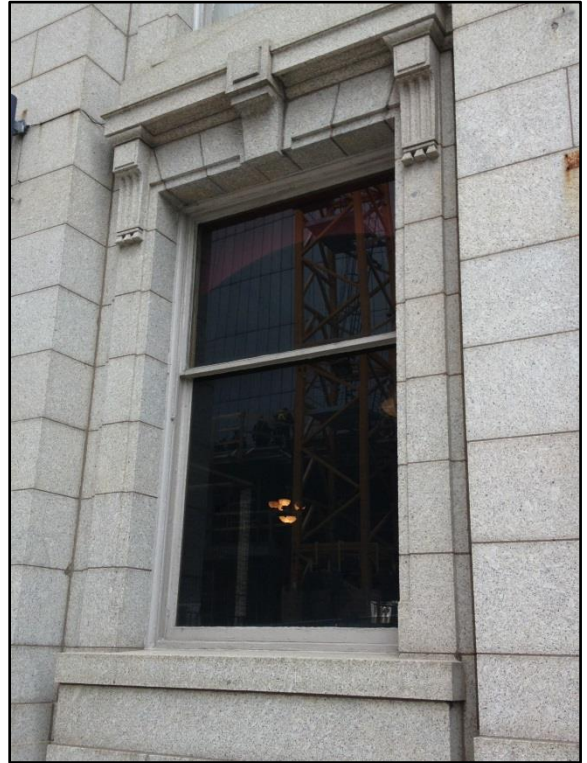
Photograph 4: Window detail - main building, Bank of Commerce building.

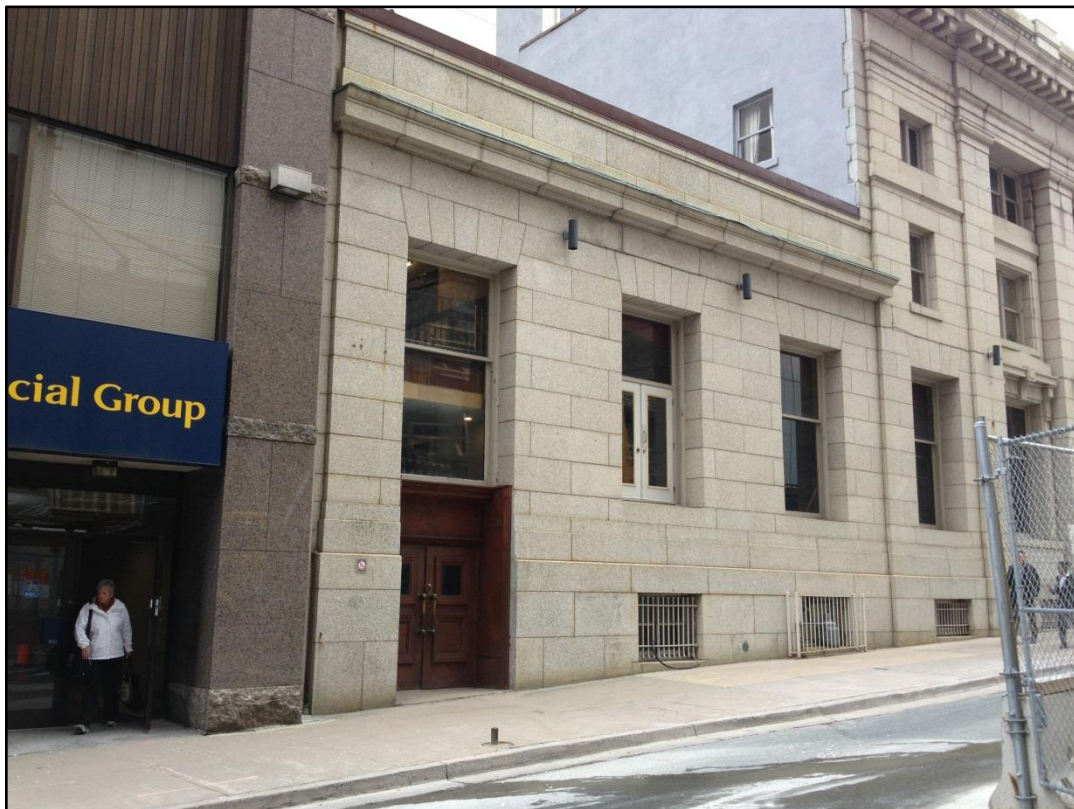
Photograph 5: Bank of Commerce rear addition.

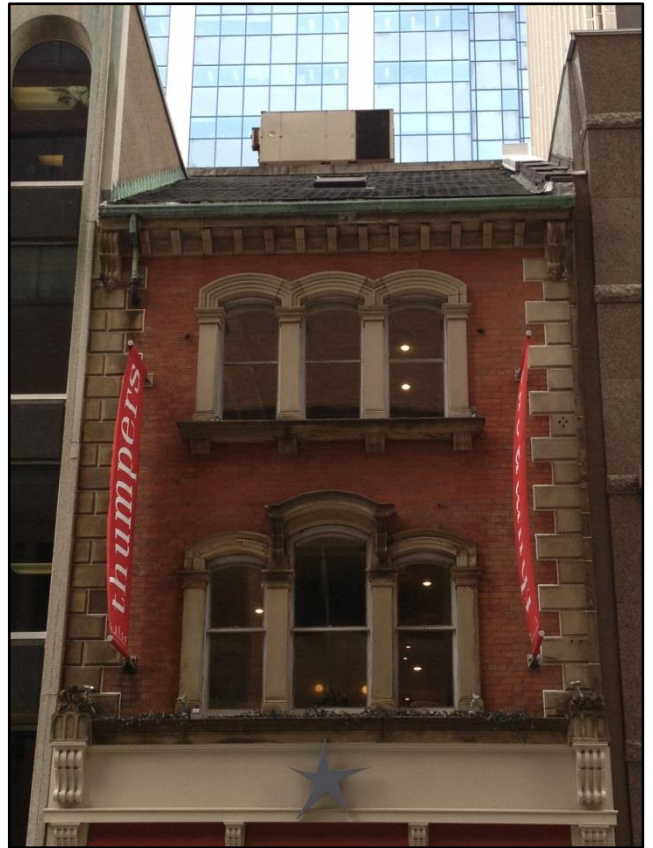
Photograph 2: Upper storeys of the Hayes Insurance building.

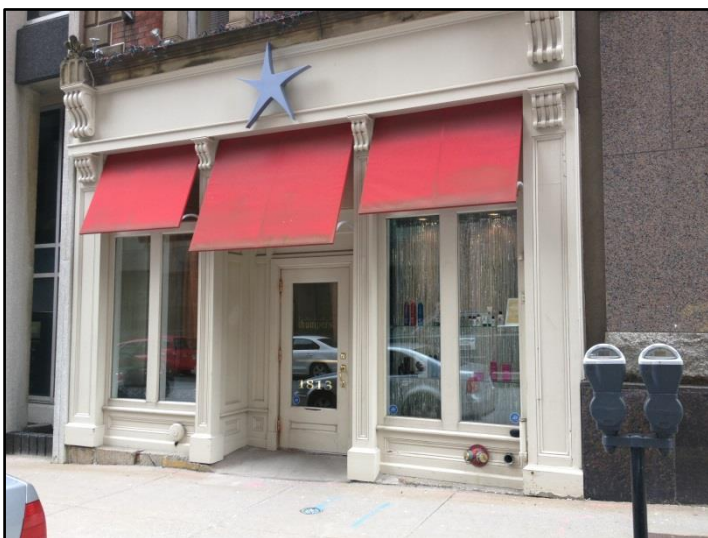
Photograph 3: Storefront of the Hayes Insurance building.

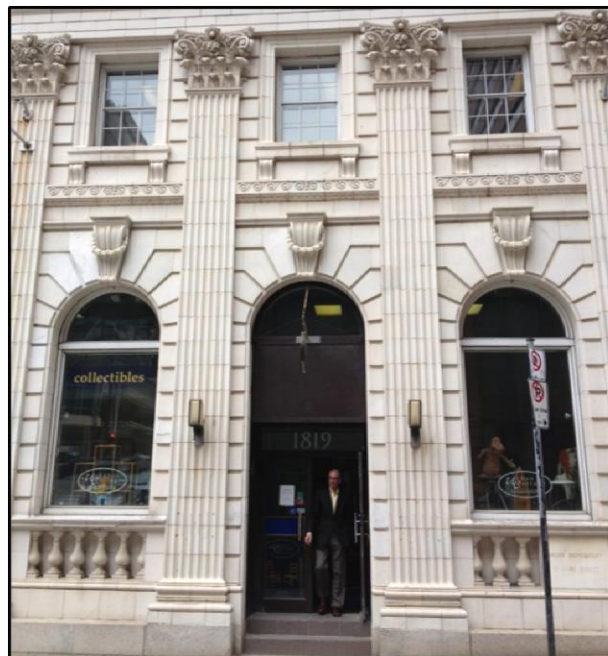
Photograph 2: Main entrance of the Merchants Bank of Canada building.

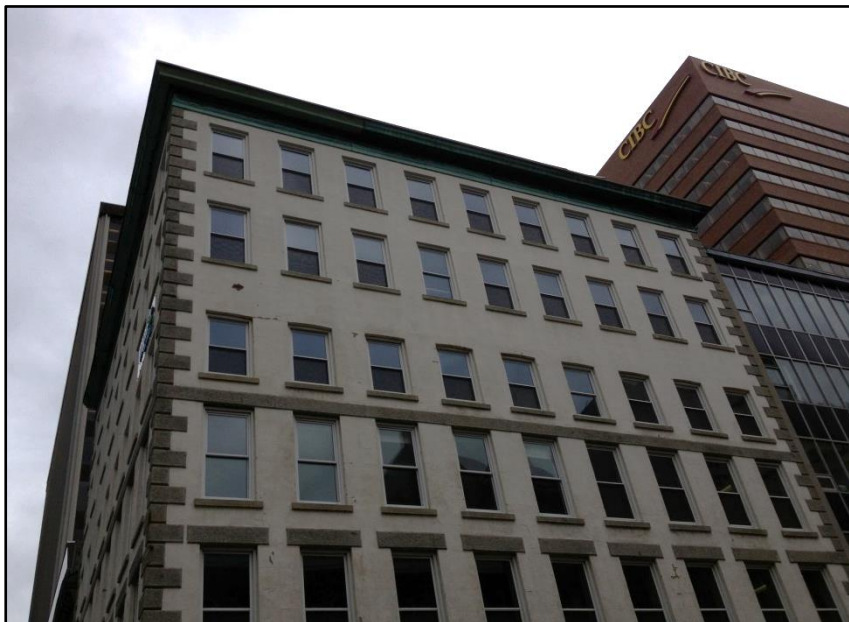
Photograph 4: Upper storeys of the Champlain building.

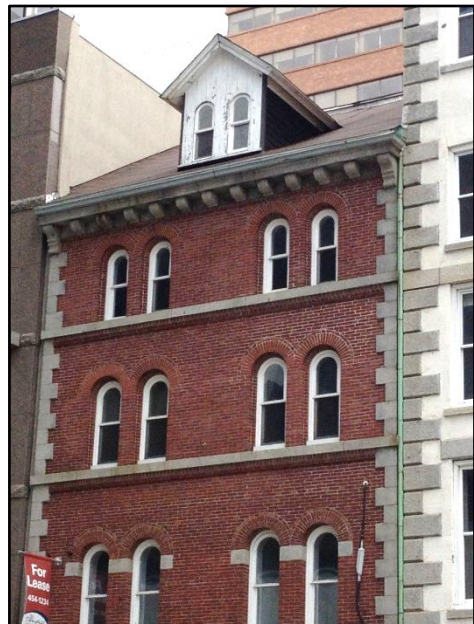
Photograph 2: Upper storeys of the Flinn building.

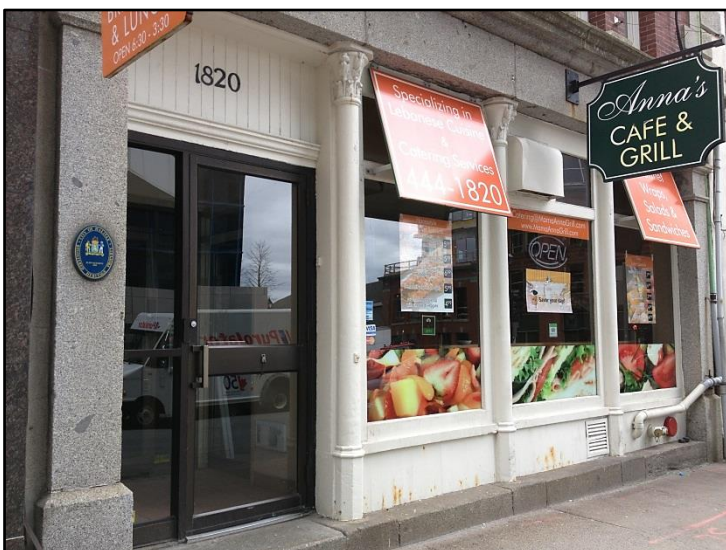
Photograph 2: Storefront of the Flinn building.
