Halifax Harbour Water Quality Monitoring Project

Survey Summary #150

Survey Date: 26 February 2008
Nature of Survey: Complete Survey
Report File (this document): HHWQMP_report150_080226.doc
Data File: HHWQMP_data150_080226.xls

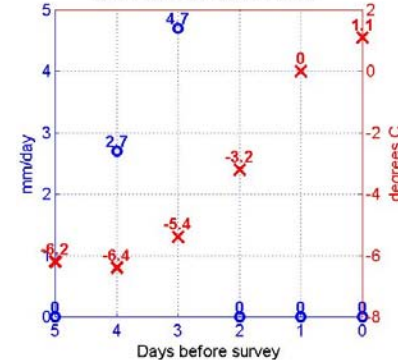
RAINFALL AND MEAN TEMP

Rainfall and temperature data collected at Shearwater Autoport.

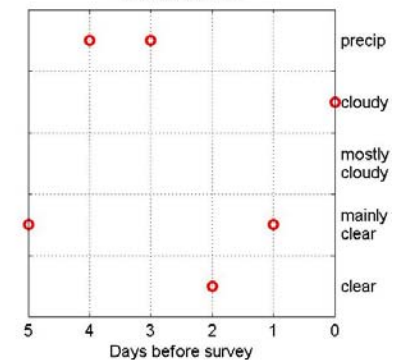
CLOUD COVER

Cloud cover data collected at Shearwater Airport

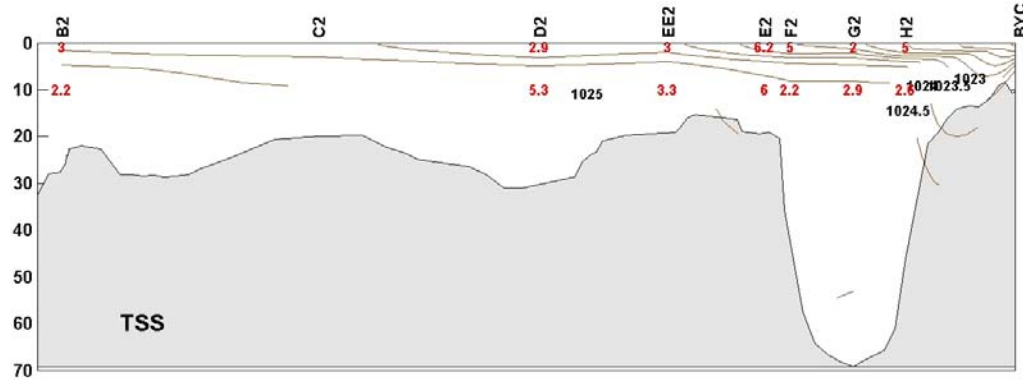
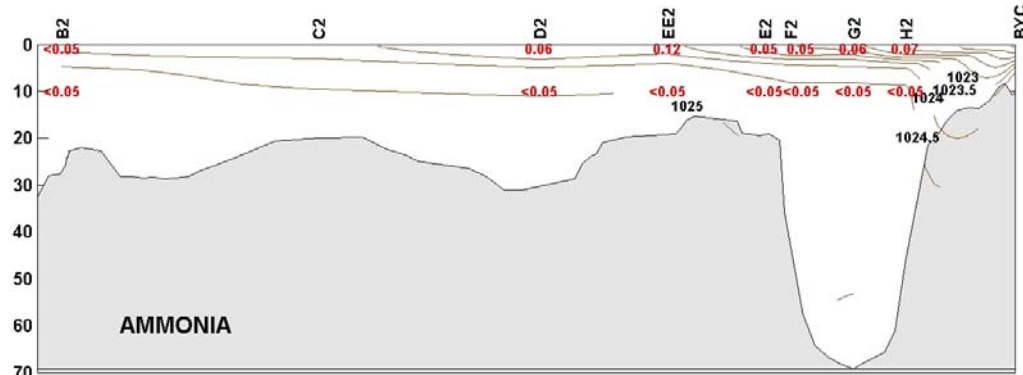
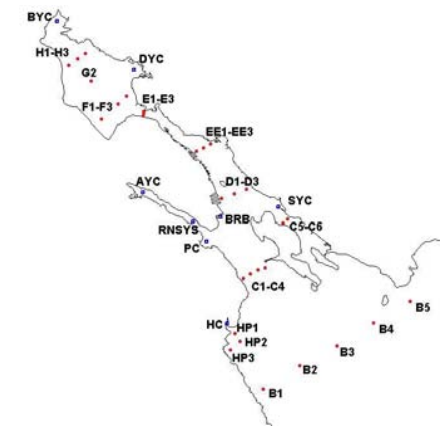
CHEMISTRY

TSS: TSS values are low (mean 3.7 mg/L) without an obvious coherent distribution.

Ammonia: Eight of fourteen samples were below the detection limit (0.05 mg/L) and the overall mean value is 0.4 mg/L. The detectable values were all in the 1 m samples in the Inner Harbour and Basin.

Metals: The mercury guideline of 0.025 ug/L is exceeded in two samples (B2-1 m and D2-10 m). Remarkably, 13 of 14 samples had detectable levels (> 0.01 ug/L) of mercury. There is also a copper guideline exceedence at B2-10 m.
