# Halifax Harbour Water Quality Monitoring Project Survey Summary #155

**Survey Date:** 06 May 2008  
**Nature of Survey:** Complete Survey  
**Report File (this document):** HHWQMP\_report155\_080506.doc  
**Data File:** HHWQMP\_data155\_080506.xls

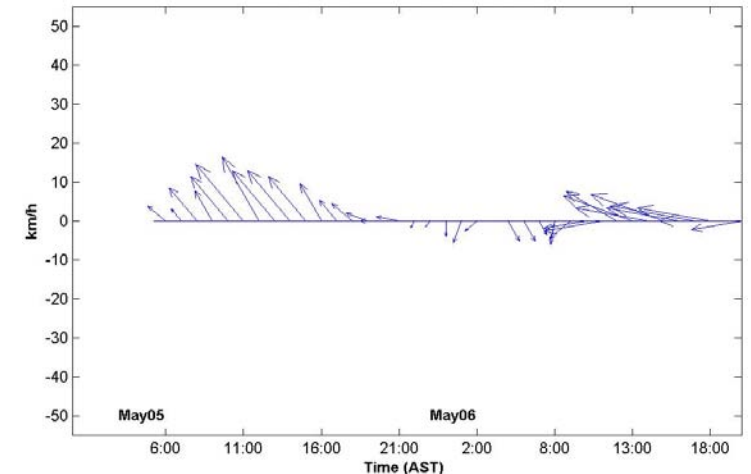
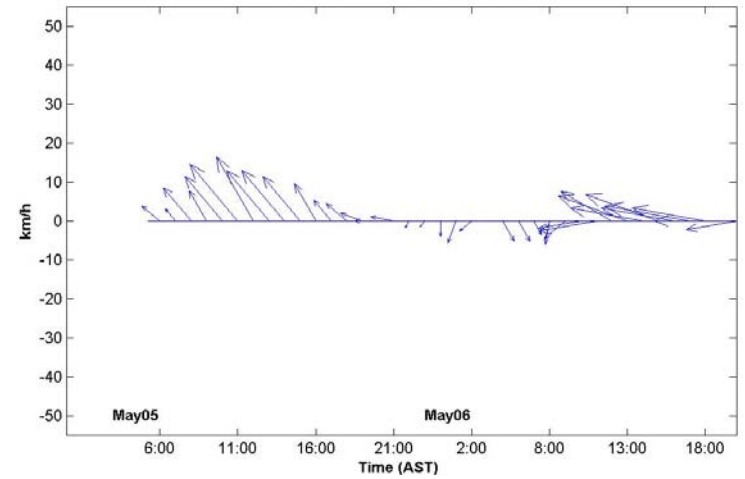
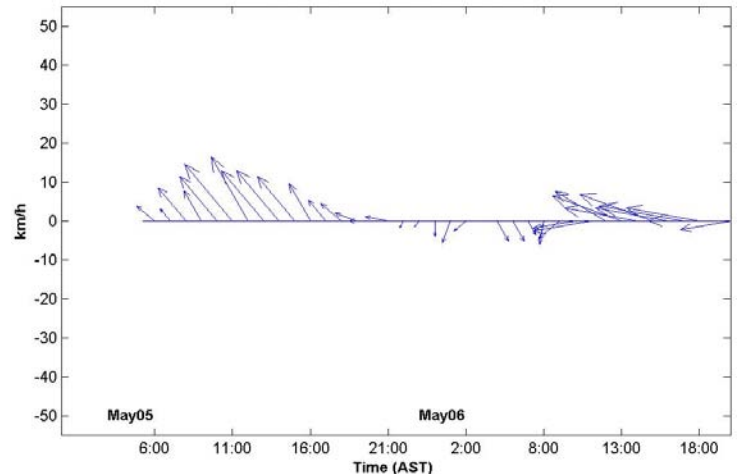
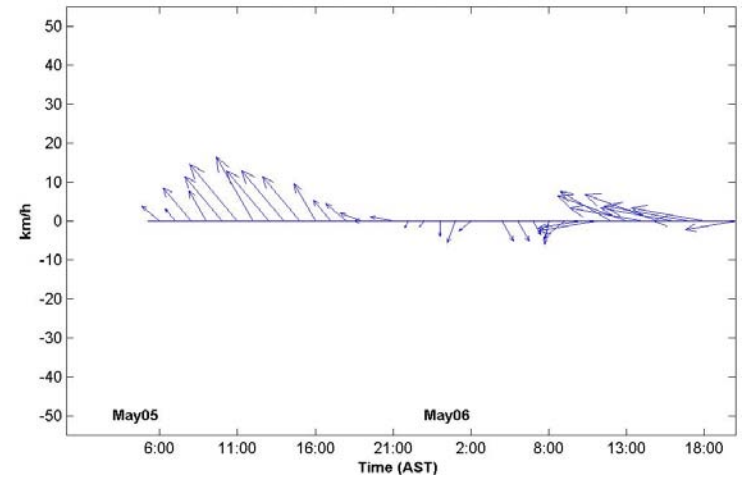
Wind Speed and Direction at Shearwater Jetty

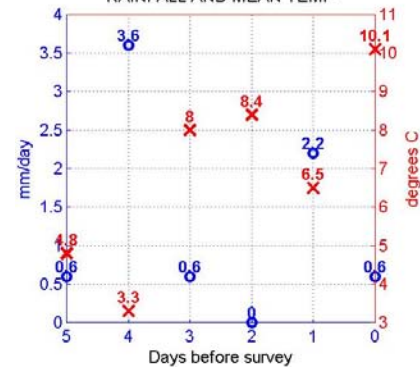
RAINFALL AND MEAN TEMP

Rainfall and temperature data collected at Shearwater Autoport.  
Cloud cover data collected at Shearwater Airport

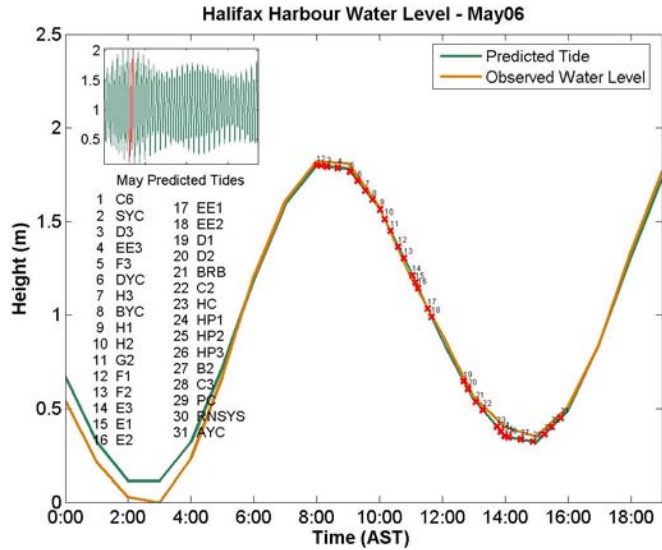
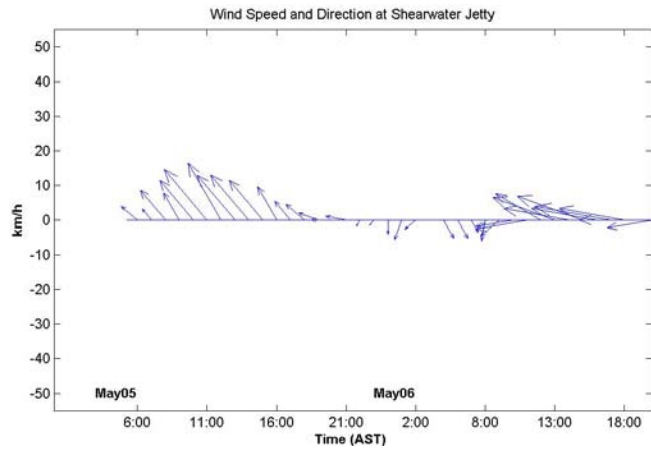
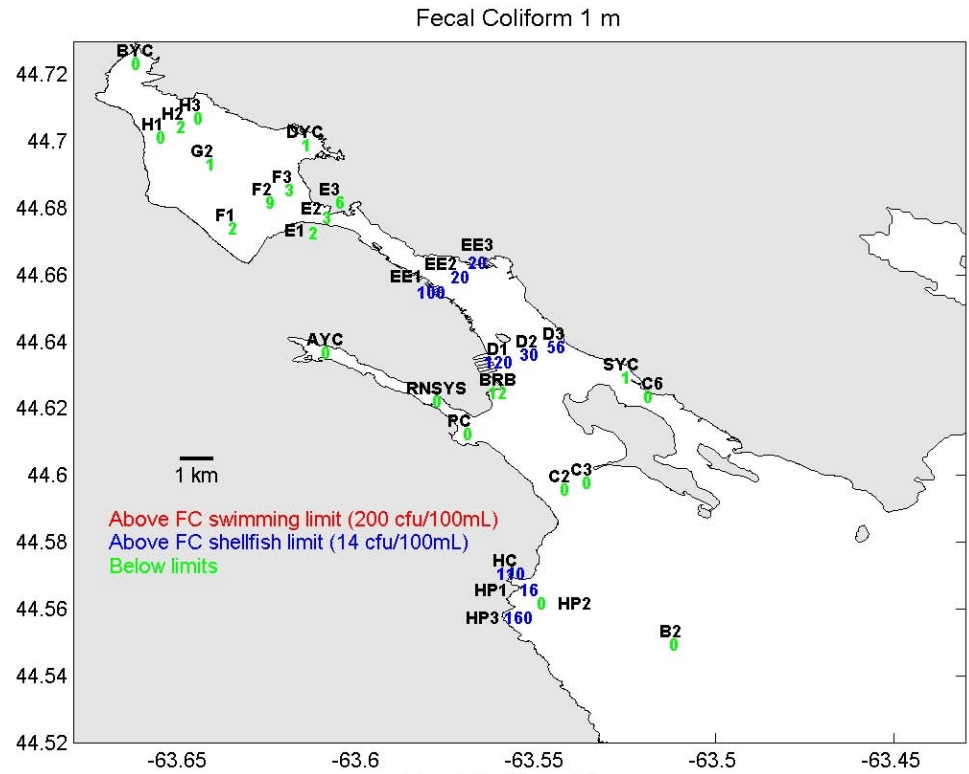
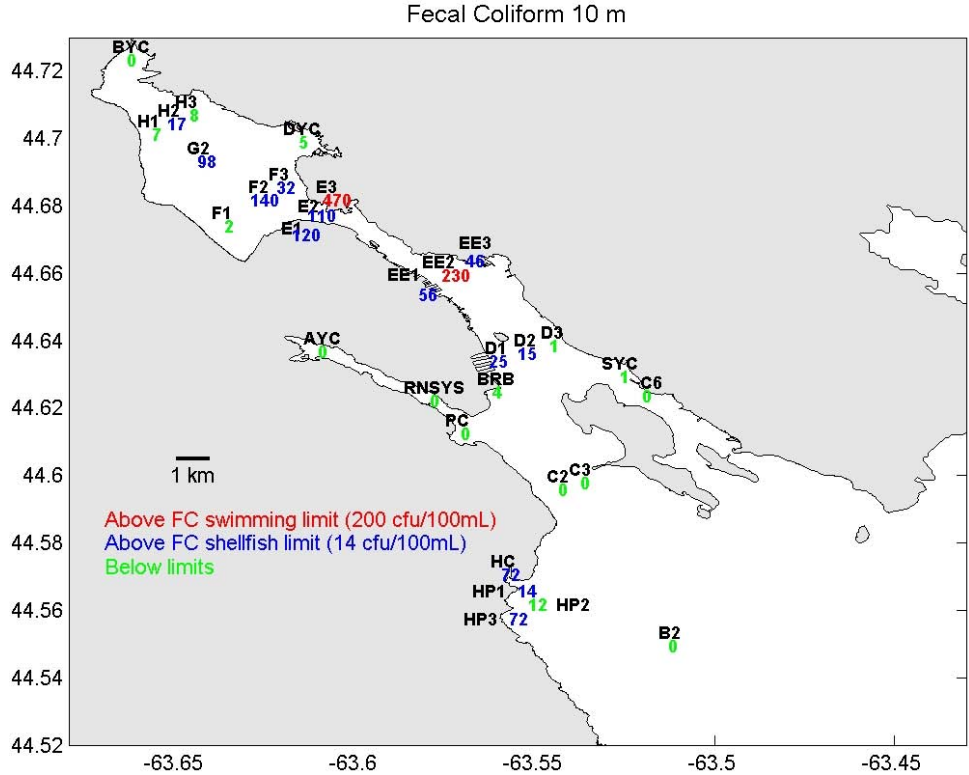
## Fecal Coliform Summary – May 06, 2008

Fecal coliform: above swimming limit (200 cfu/100mL)  
above shellfish limit (14 cfu/100mL)  
below limits
