**TD BUILDING REDEVELOPMENT
HRM SITE PLAN APPROVAL: SUPPORTING INFORMATION**

SITE PLAN APPROVAL APPLICATION

TD CENTRE REDEVELOPMENT

2011.07.25

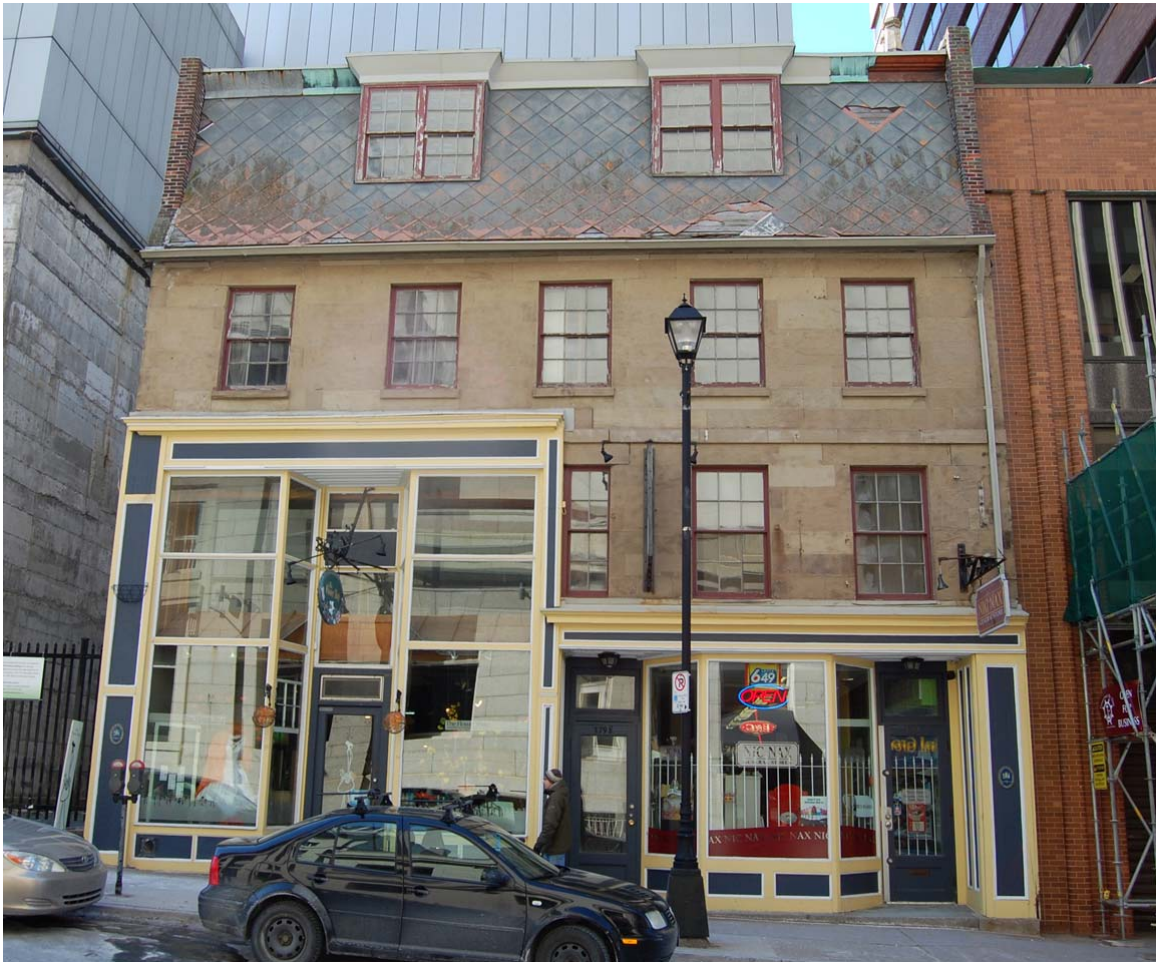
Macara-Barnstead Building, Granville Street façade, 2011

Since originally built in 1825, the Macara-Barnstead building has gone through an evolution which has seen its street façade altered in the 1850s, 1906 and finally during the 1920/30s. These alterations largely consisted of modifications to create larger storefront windows and the replacement of the original gable roof with a mansard roof. While Mr. Penny states that these alterations have resulted in a building which is “ugly” and “disfigured”, it is our opinion that they have become an integral part of the building’s history and therefore part of its heritage value.

The larger of the two storefront windows has become an important component of the building’s identity. While it may not follow strict architectural protocol for integration with the lines and patterns of the original façade, it provides a charm to the street by way of its large glass windows, recessed entrance, wood paneling, and opportunity for retail display. Such features provide a sense of urban engagement allowing pedestrians to visually interact with the shop and provide a covered entry threshold at the streetwall. Its quirkiness has ironically become part of its charm and arguably part of its redeeming value.

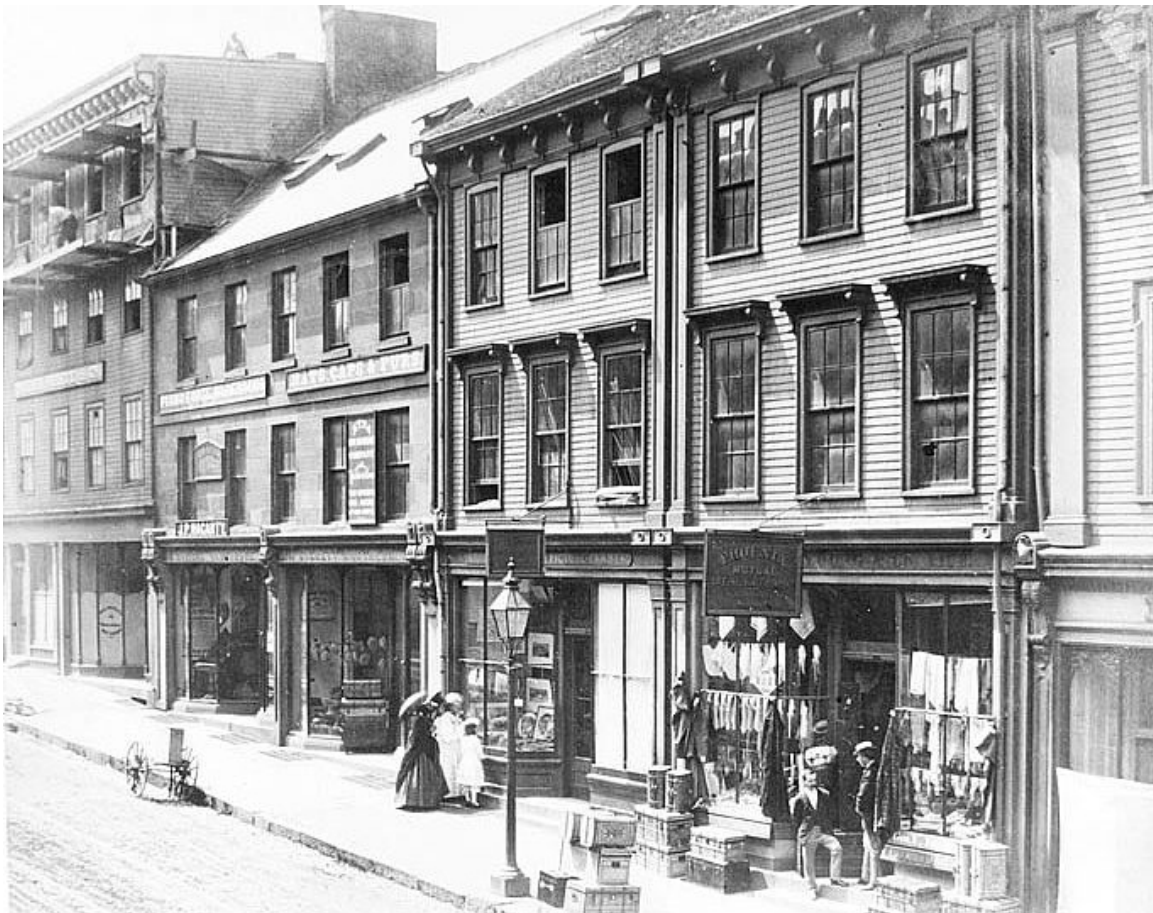
Granville Street, 1871, Nova Scotia Archives, depicting Macara-Barnstead Building with original storefronts and gable roof (2nd building from left)

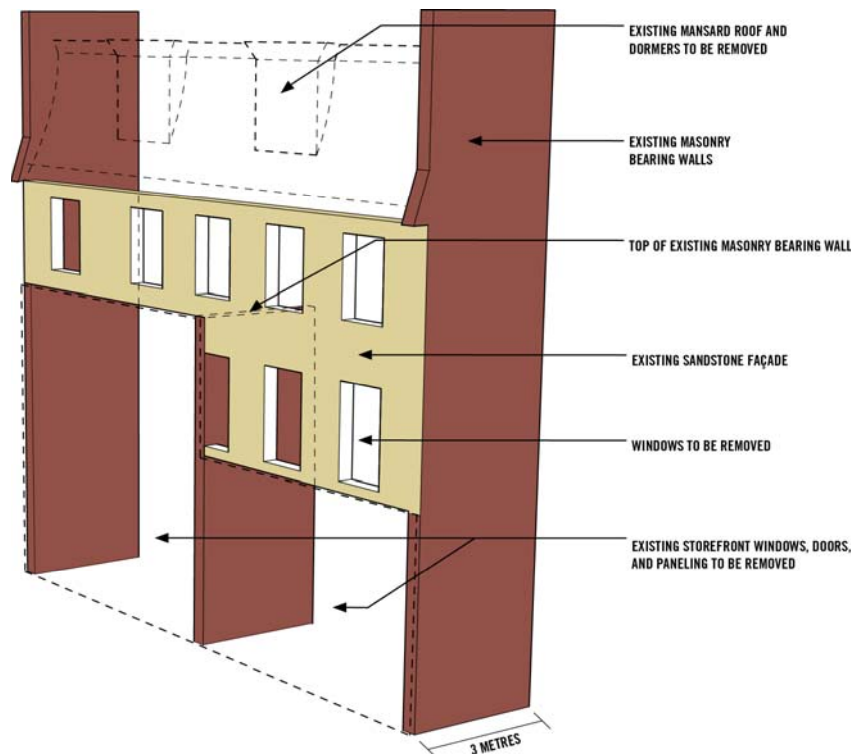
With regards to the ability of physically maintaining the existing building within a redevelopment of the overall property, we are proposing to retain the stone façade as well as portions of the masonry bearing walls situated along the ends and at the centre. These walls would extend to a depth of 3 metres from the property line to coincide with the stepback of new the office tower above. The masonry walls currently support steel beams which carry the stone facades directly above – it is therefore critical to maintain these as they are integral to the support of the façade. The remainder of the existing building will be demolished, which is necessary in order for the new development to proceed. The building as it exists behind the façade has never been visible from the street and only recently has been partially exposed due to the demolition of the Kelly Building. Therefore its demolition will not diminish the historic presence along Granville Street.

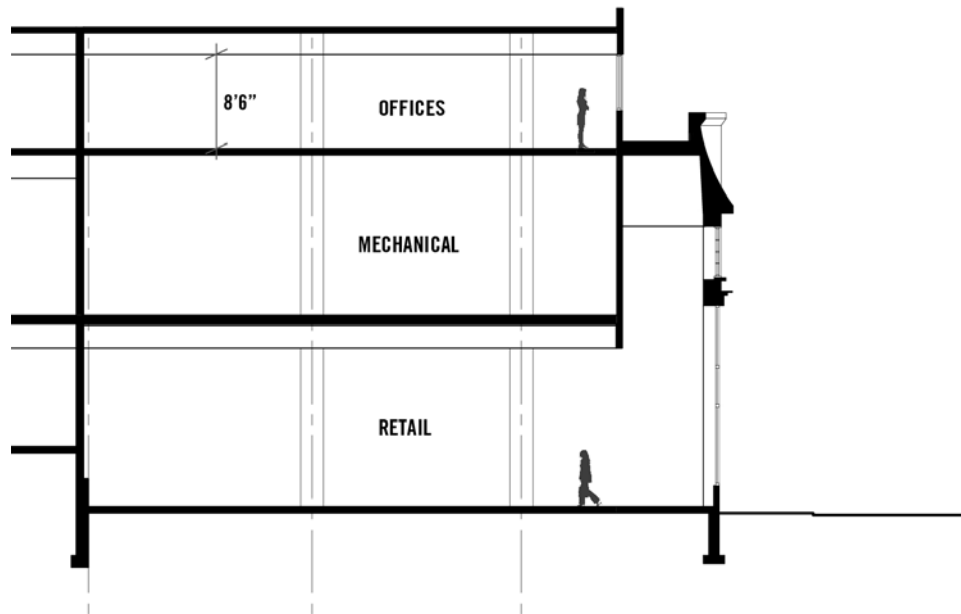
will be created directly behind the storefronts which will prevent the adjacent new floor from impeding the open space or abutting the original façade. This will create a dramatic entry experience into these retail spaces. The office floor above the double height space will extend towards the street and become the new roof directly in behind the mansard. The window sills at this floor will align with the top of the mansard parapet, approximately 3 feet above the floor level, which is appropriate for office space and will allow unimpeded views from the office windows. The mansard then becomes an extended parapet wall and as a result, the dormer windows will contain opaque glass which from the street will be indiscernible when compared to a regular window.

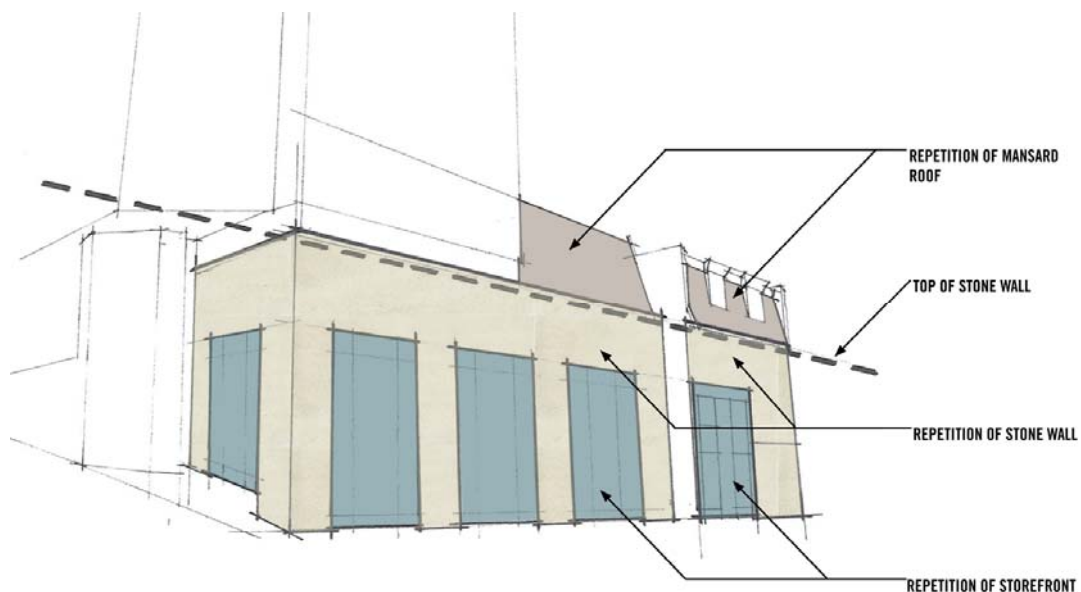
Our design process begins with an analysis of the primary architectural features of the Macara-Barnstead building in order to establish its essential qualities. We suggest there are three fundamental attributes which may characterize the façade and provide clues for the new Granville streetwall. First, is the strong horizontal line which is established by the top of the sandstone wall, further enhanced by the cornice. This creates a strong datum which leads the eye across the façade of the building. Second, is the large, double height storefront window situated within the southern half of the façade. While arguably the building's most quirky moment, it is nonetheless one of its strongest visual features and has resulted in a wonderful storefront experience along Granville Street. Third, is the mansard roof which acts as the top of the building. While similar to the large storefront window in that it is not an original component of the building, it has become part of its heritage value and an important characteristic of its street presence. Collectively, these three attributes establish the basic architectural 'order' of the façade and provide an opportunity to extrapolate such features into the redevelopment of Granville Street.

The proposed design extrapolates these basic characteristics of the Macara-Barnstead façade and creates a new architectural rhythm to the streetwall. The existing cornice line is extended across the new addition to create a top of wall height for the overall streetwall. The basic proportion of the large existing storefront window is repeated to create new storefronts complete with recessed entrances and canopies. A new copper shingled mansard roof caps the top of the new wall and extends as a wall down to grade, creating a recessed niche between the Macara-Barnstead façade and the new addition. This niche provides a visual break between new and old while also exposing the existing quoins on the corner of the Macara-Barnstead façade. Finally, new punched windows are added to enhance the existing window patterns.

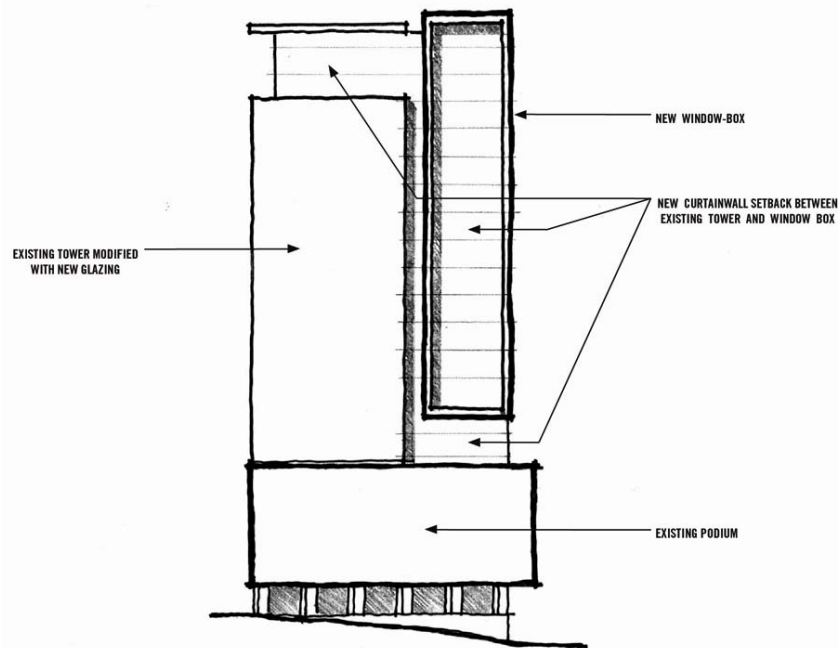
Within the addition, the proposed design creates a distinct architectural element within the overall tower design. At the southeast corner, a new 14 storey 'window-box' is created which visually breaks the tower into two basic components, thus reinforcing the vertical proportions of the tower. As the window-box turns the corner and extends along the west façade, it incorporates a vertical window pattern which reinforces the new proportions of the tower. The incorporation of this new design vocabulary provides an opportunity to create elegant, vertical proportions to the tower which is in keeping with the original tower's intentions. In order to create a sense of separation between the window-box and the remainder of the tower, a new curtainwall design is setback from the adjoining facades, starting at the new upper floors, extending vertically down between the window box and main tower, and then continuing under the window box. This separation creates distinct components to the tower that collectively provide a visually cohesive composition.

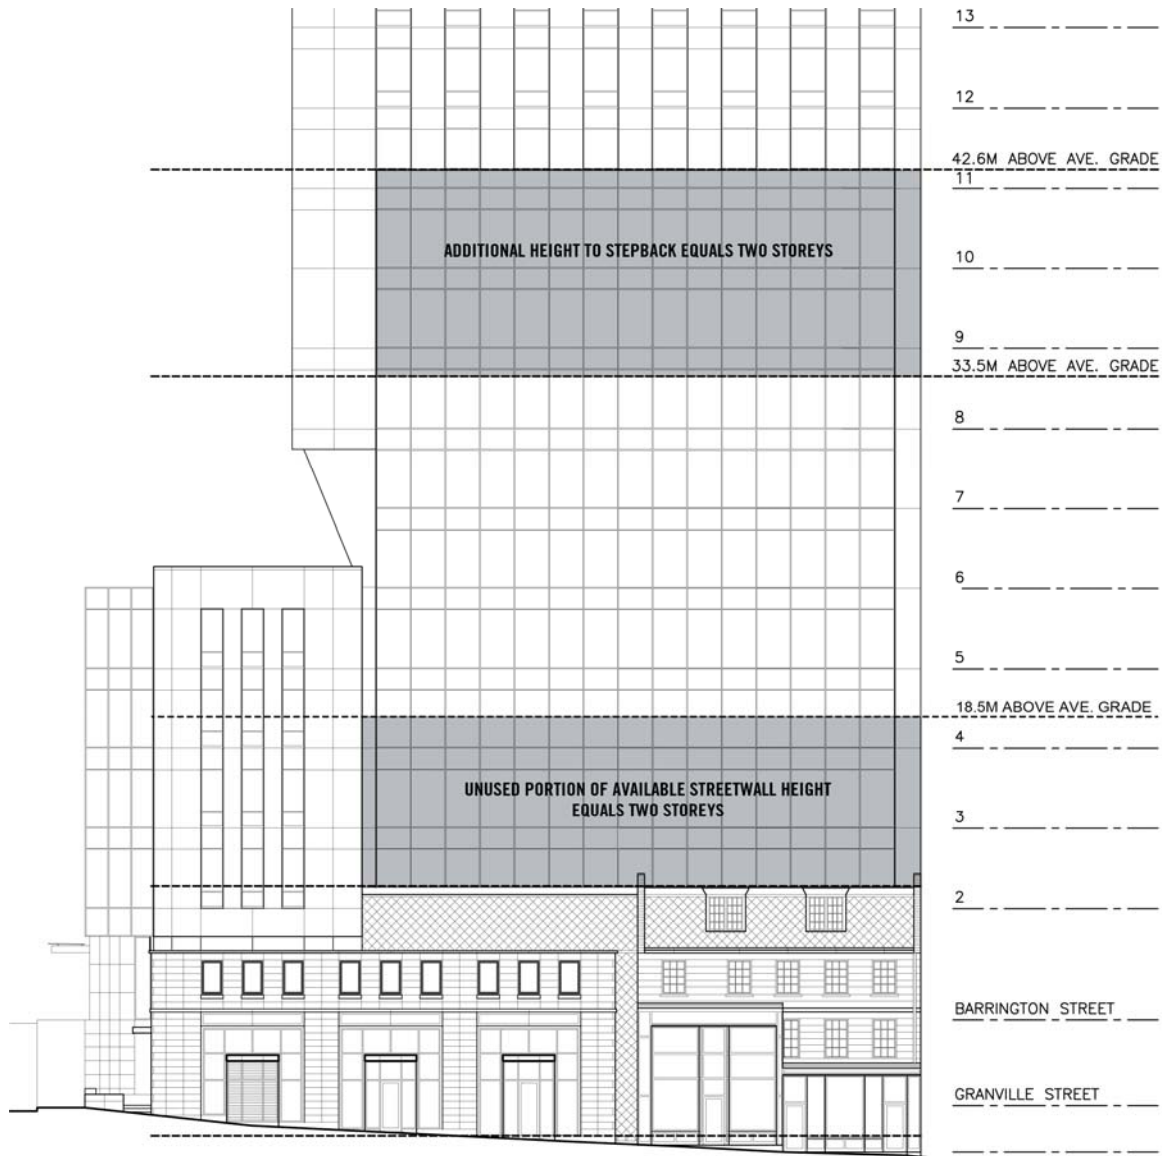
It is therefore proposed that the tower be provided the opportunity to offset that portion of un-used streetwall height. The proposed tower design extends the 33.5 metre height setback requirement by adding the two un-used floors from the streetwall allowance. This establishes a height of approximately 42.6 metres, which is a direct result of the floor locations within the existing tower. Refer to illustrative diagram provided herein.

Diagram illustrating offset of allowable streetwall height to tower

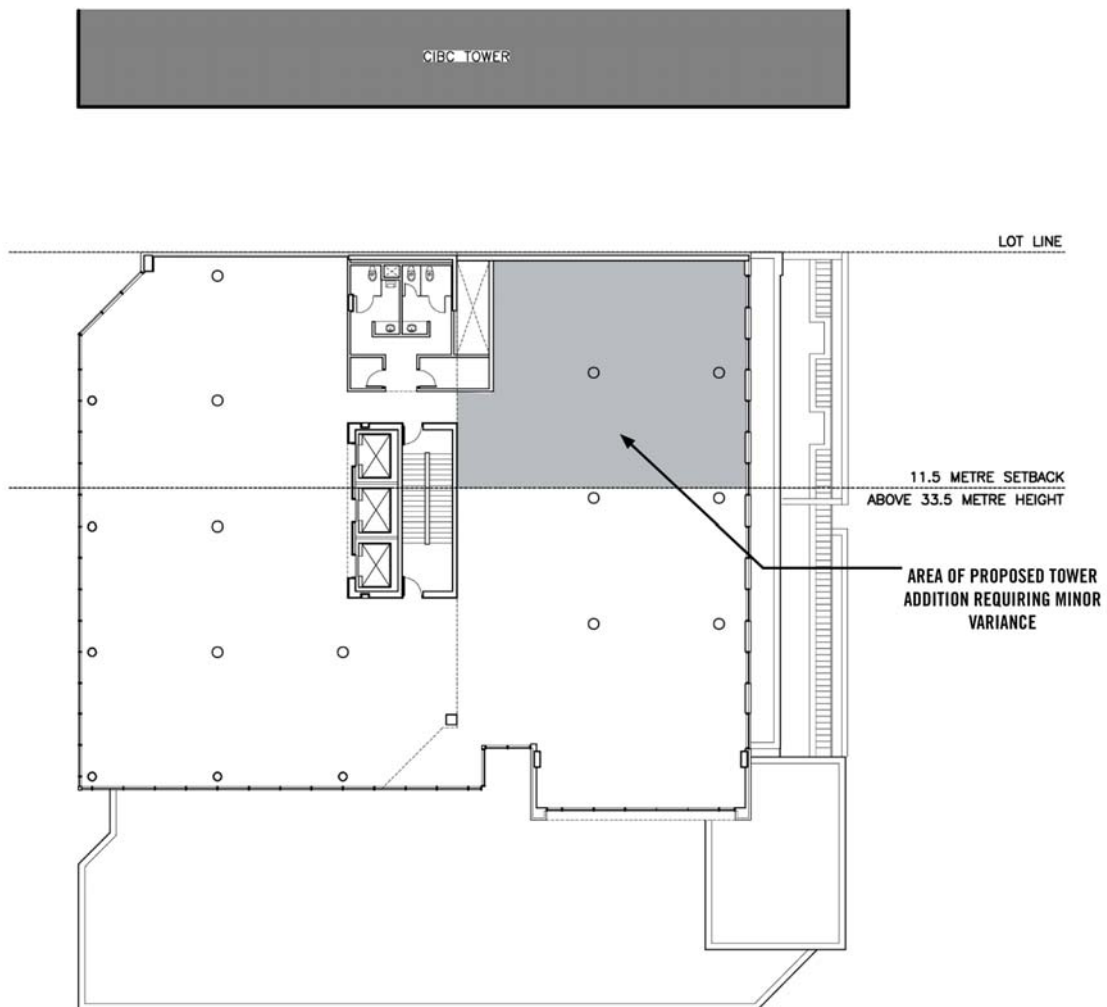
PROPOSAL: The proposed design is an extension of existing building conditions and will not create any new situations which are inconsistent with what currently exists. The existing TD tower is positioned on the lot line for its full height. The proposed addition to the existing tower generally extends the footprint of the tower along its eastern portion up to the setback distances as required from Granville Street. As a result, the addition maintains the tower's relationship to the interior lot line, which is necessary to provide an overall tower configuration that is viable. By doing so, the addition eliminates the existing blank façade on the east side in its entirety and replaces it with a new façade comprised of mostly glass with aluminum panels.

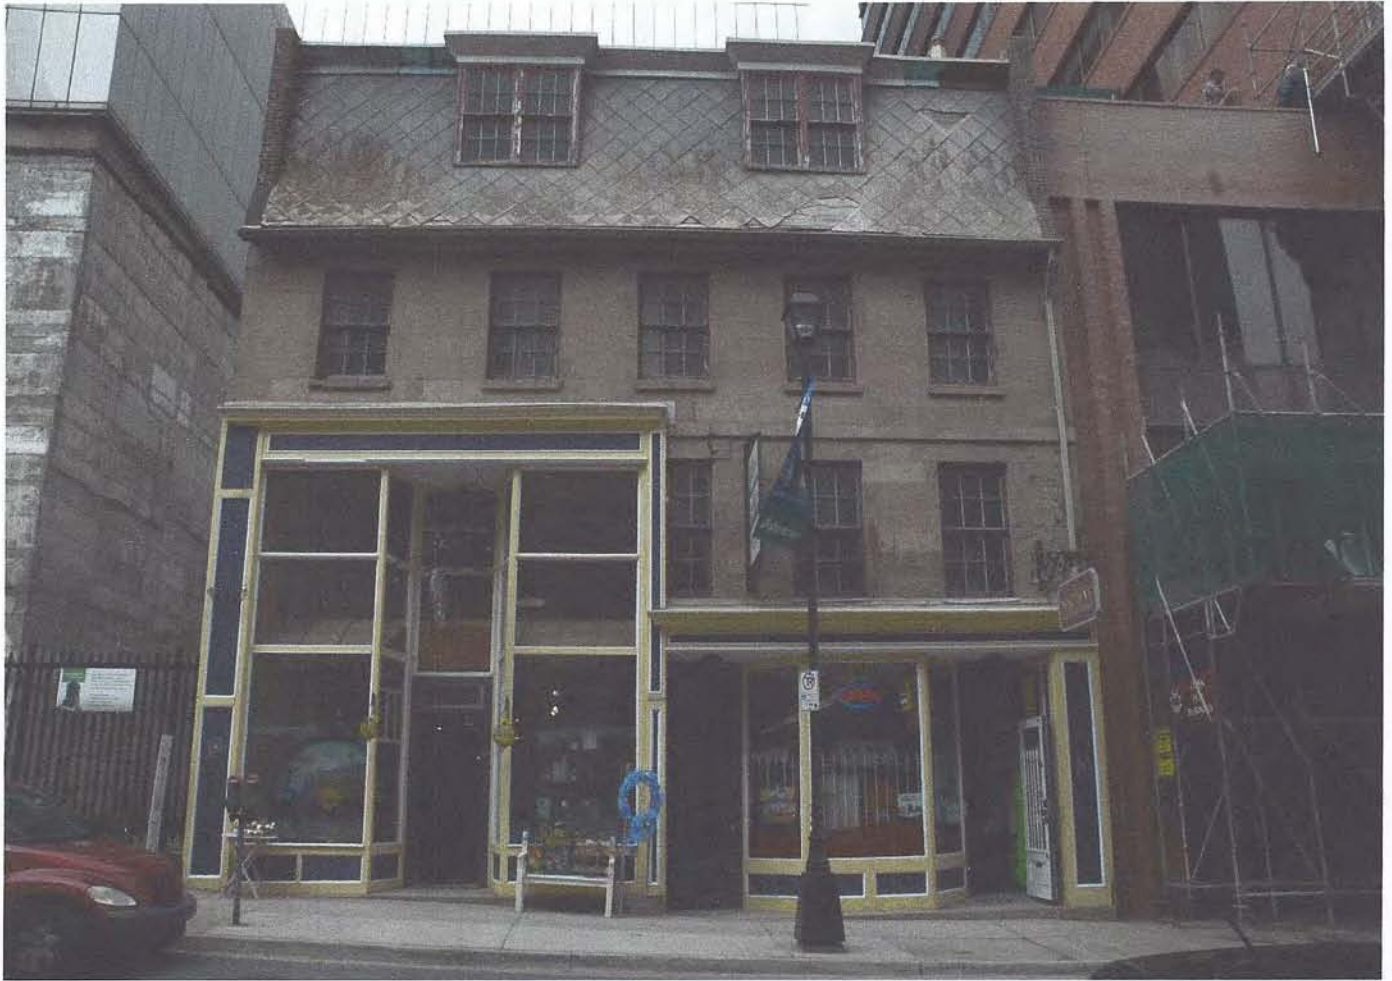
Photo No. 1 - East Elevation

We have noted during a site visit that the exterior facade of the masonry wall currently displays some open mortar joints and deteriorated stone. It can be anticipated that parts of this wall will require deconstruction to enable repairs to the stone and reinstate masonry bonding ties to the backup wall. This work would be carried out after the removal of the temporary shoring frames and once the existing facade is secured to the new concrete structure.

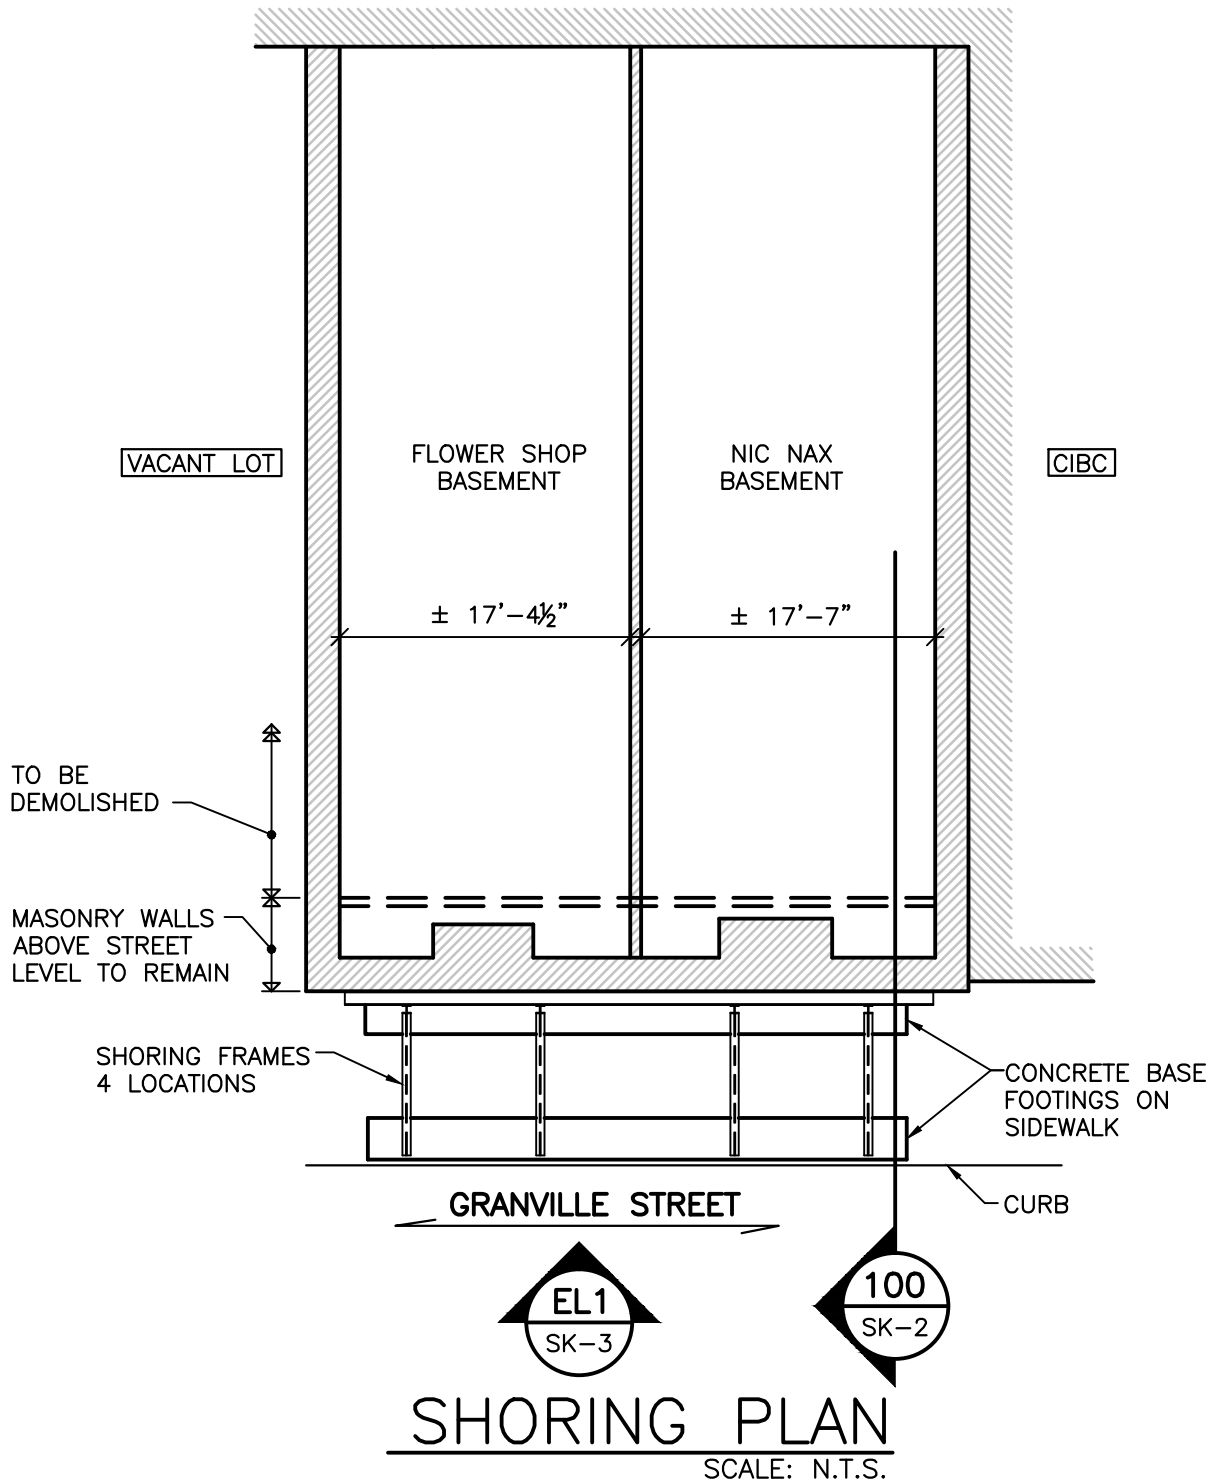
title: SHORING PLAN

The temporary steel shoring frames proposed for the lateral support of the Granville Street facade are shown in accompanying sketches. The Shoring Plan indicates the layout of the existing building foundation and also shows that the front 10 feet of the stone masonry north and south side walls will be retained above the sidewalk level elevation. These sections of the existing stone wall will assist the temporary steel frames in bracing the facade.

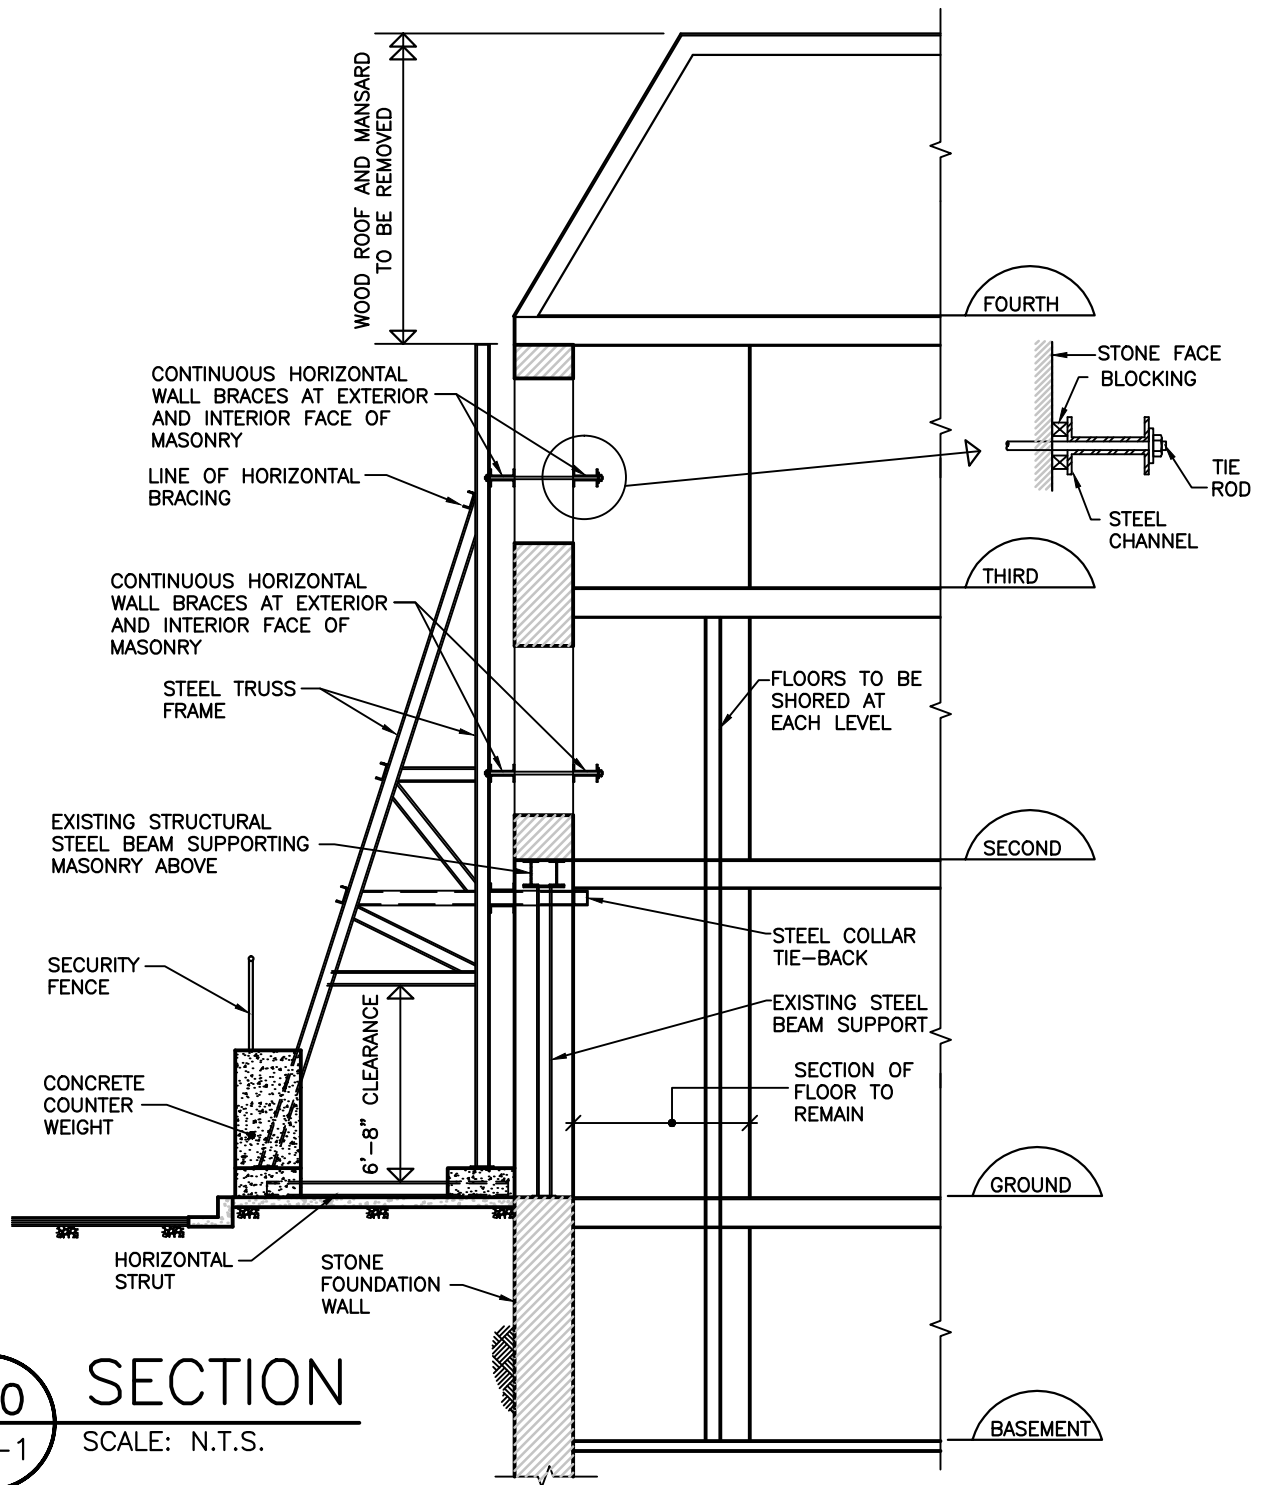
100 SECTION
 SK-1 SCALE: N.T.S.

WOOD ROOF AND
MANSARD TO BE
REMOVED

FACADE TO BE
MAINTAINED IN
POSITION

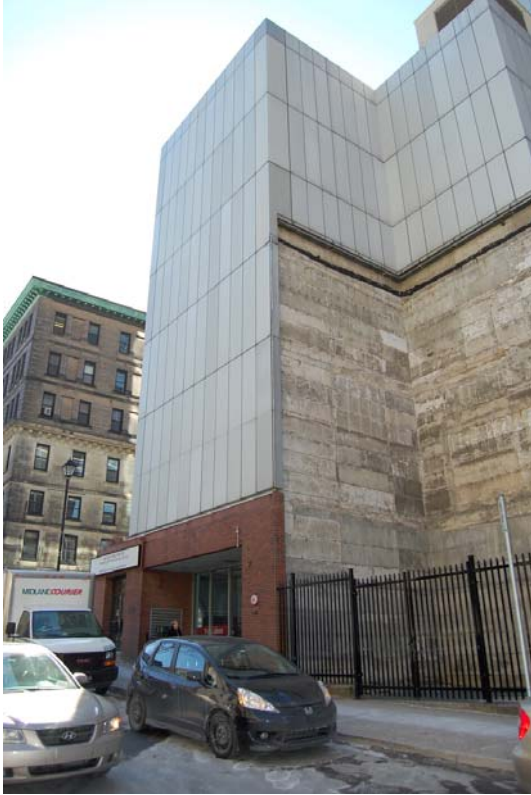
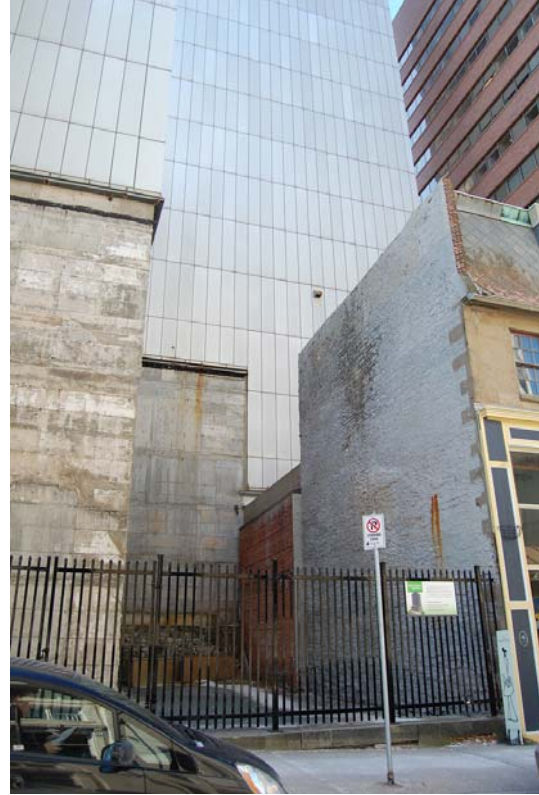
Views of vacant lot and blank walls along Granville Street

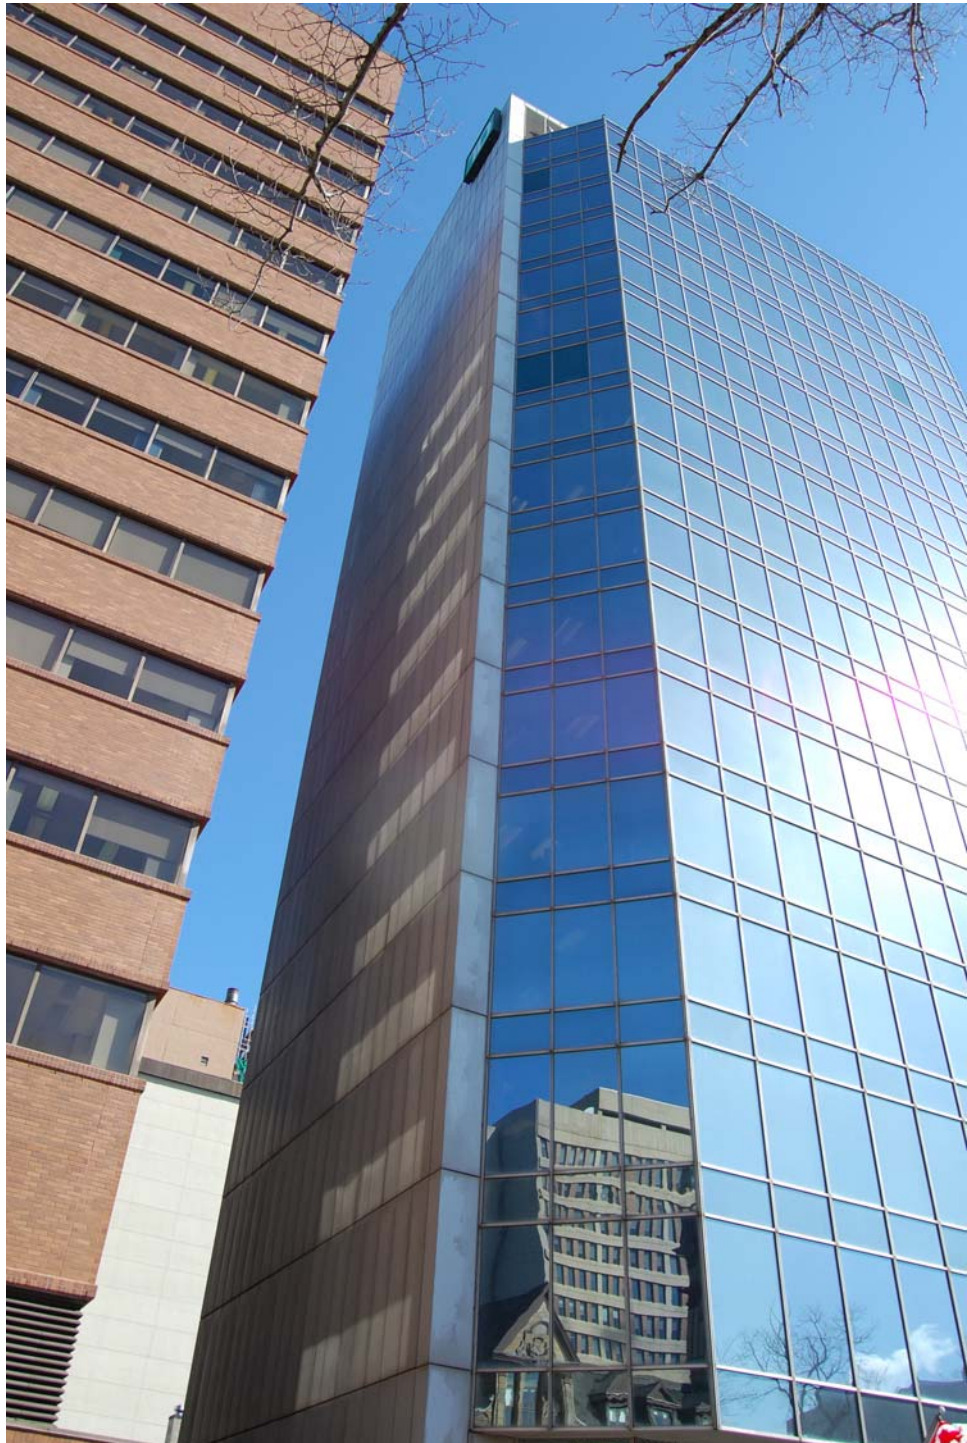
View of northwest corner of tower showing blank wall facing CIBC building
