TD Centre Redevelopment
Macara Barnstead Building

**TD BUILDING REDEVELOPMENT
HRM SITE PLAN APPROVAL
25-07-2011**

Downtown Halifax Site Plan Approval Process Substantive Applications

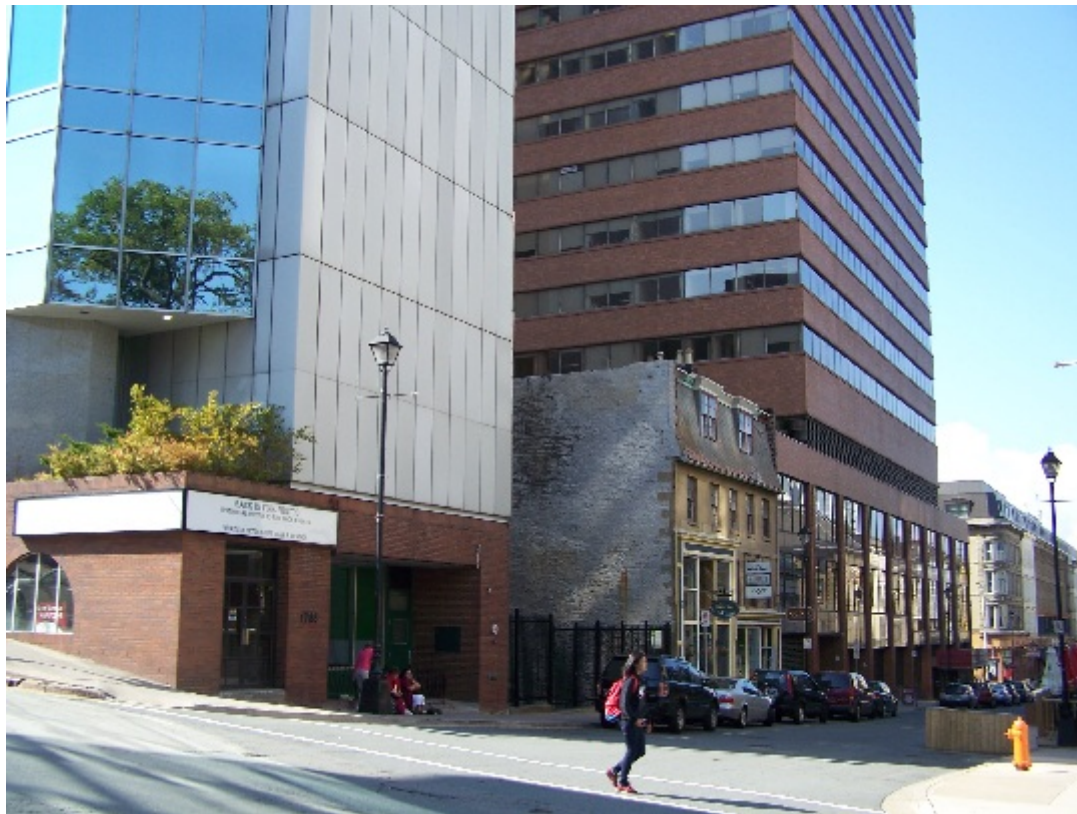
Existing Macara Barnstead building and vacant former Kelly Luggage site between rear of TD and CIBC buildings. George & Granville Streets.

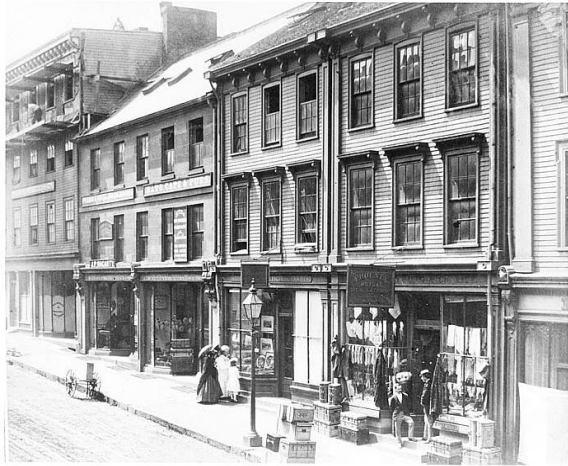
Earliest photo of Macara-Barnstead building, from Roger's Photographic Advertising Album, 1871. Kelly building is on the extreme left. Macara-Barnstead second from left, showing storefronts renovated in 1860s and occupied by Hagarty's Musical Instruments on the left and Everette's Hats & Furs on the right.

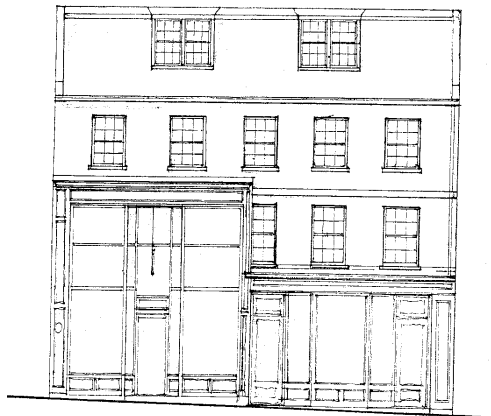
Sketch from Appendix A of Attachment G, showing 1906 enlargement of the old Hagarty storefront to create a two-storey display window for Barnstead's Drug Store. Enlarged storefront cuts through centre window on 2nd floor. Windows changed to 6-over-6. Mansard roof and dormers were added in 1922.

made to this building cutting through a window is an unbelievable eye-sore, which has been in place for over a century. It should not be given celebrity status, but modified or removed. It was a crude and expedient solution that lacked any sense of propriety or taste. By this crude insertion of a very large window as apart of the 1906 alterations, the whole wall has become unbalanced, with over 70% of the 1825 wall now destroyed. The vertical cut, exactly on the centre line of the façade, ignored the asymmetrical layout of the Georgian windows of 1825, and thus caused the unacceptable reduction of a sliding sash window by one third of its width. Replacing the shop window to the north and extending vertically, the shop window to the south, fundamentally ignored all basic rules of architectural composition. The windows again fail to recognise the original façade's grid, and go much further in introducing five different dimensions of wood panelled margin, thus abrogating all the composure of the original simple stone wall with an overwhelming, oversized opening with no clear indication that the stone wall above is supported by anything other than a wooden signboard. To make matters worse, the different dimensions of wooden margins to the plate glass windows, make each of the 1906 interventions a different horizontal dimension, with different approaches to the openings previously in place in the 1870 photograph. Further to this is the extraordinary breaking of all architectural composition rules to establish a major division of the façade, precisely at the centre line. This makes the façade a duality, but a lop-sided one, a very different attitude from the Georgian grid, established over two hundred years, and so crudely simple as measuring for the centre line and sawing up through whatever was found to be in the way.

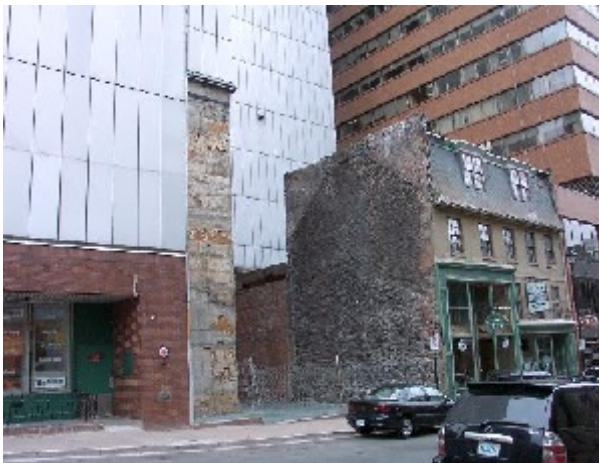
Original truncated gable-roofed form of Macara-Barnstead Building revealed in stone side-wall after demolition of Kelly Building in 2006. The 1880s rear addition can also be seen. Original chimney pots can also be seen above the roof line on the north side (there are fireplaces in each of the upper floor rooms).

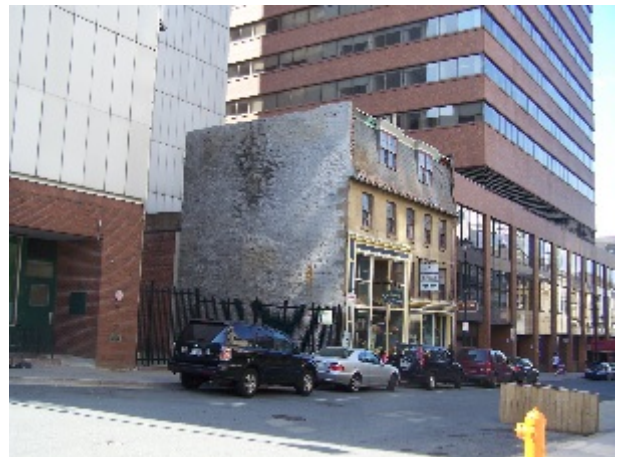
Macara-Barnstead building 2011. Whitewashed side wall highlights sandstone corner quoins.

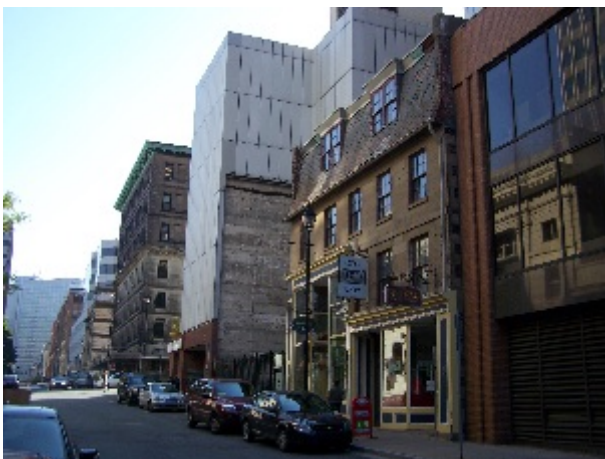
Macara-Barnstead building is slightly "proud" of adjacent CIBC building, revealing sandstone corner quoins.

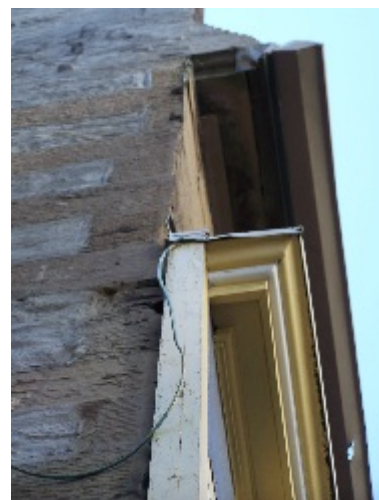
Gaps between masonry corners and storefront trim

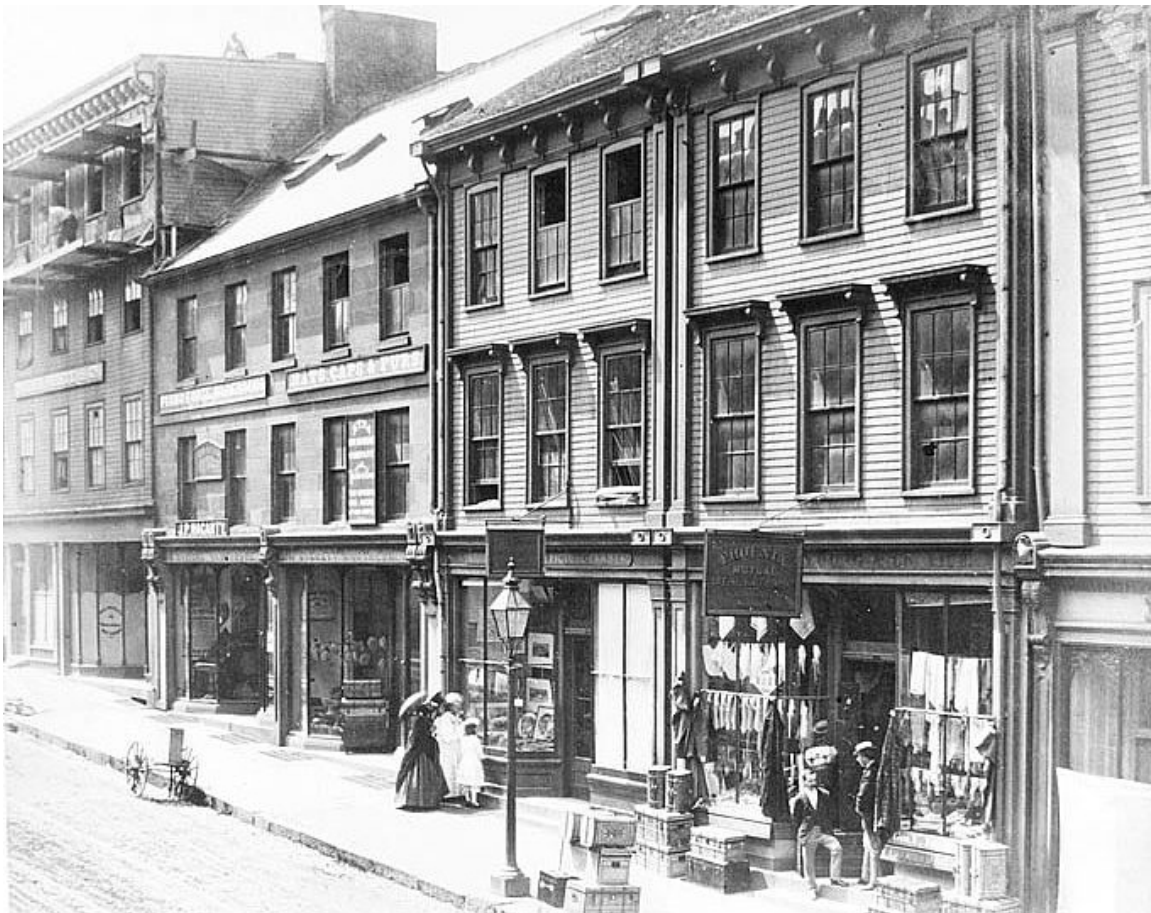
Granville Street, 1871, Nova Scotia Archives, depicting Macara-Barnstead Building with original storefronts and gable roof (2nd building from left)

The utilitarian attitude towards openings was still visible in the building at the corner of George and Granville streets in the 1870 photo Fig. 1. This was the commercial low-grade end of the Georgian style, with little to commend it but its quiet and effective grid, providing order and a sense of composure. The sole decorative features of these buildings were the cornice at the top of the wall with possibly delicate classical mouldings, and the horizontal plain string courses dividing the wall into horizontal bands. A generation earlier, in Edinburgh, or Bath, the string course would have been

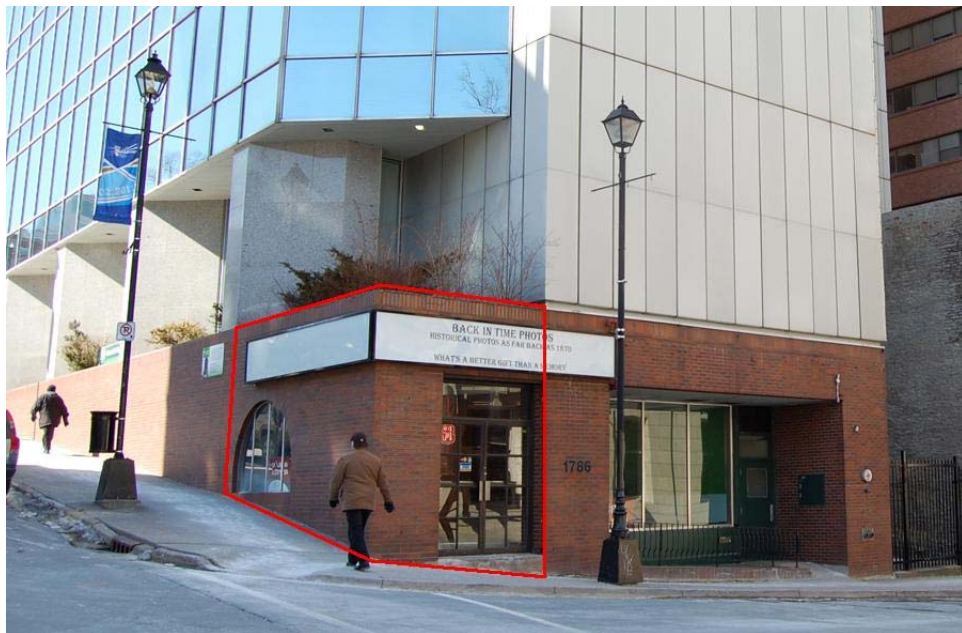
The one storey portion at the corner of Granville and George Streets will be demolished to provide an open corner condition which will provide a new storefront and small public plaza. This will also allow the new Granville streetwall to 'turn the corner' and become a three-dimensional building form rather than a two-dimensional façade.

The brick base along George Street will be removed and replaced with new granite panels to match the existing granite on the piers directly above. This will create a cohesive appearance to the podium base.

The four storey blank wall along Granville Street will be modified to allow the new streetwall to extend below it. The addition of new windows and aluminum panels in the remaining three storeys above will eliminate the blank wall and thus lessen its visual impact on the street.

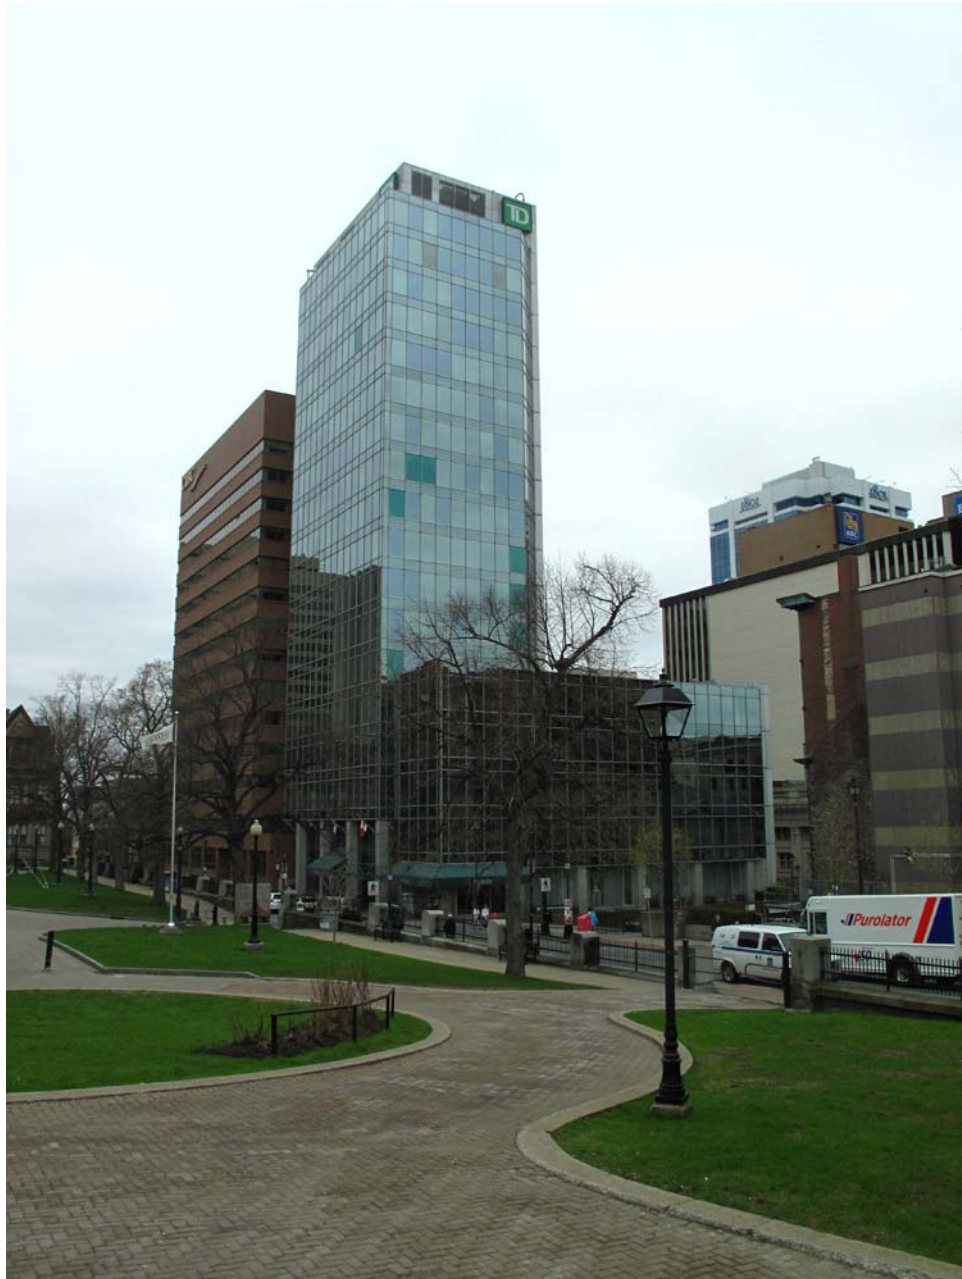
View from Grand Parade

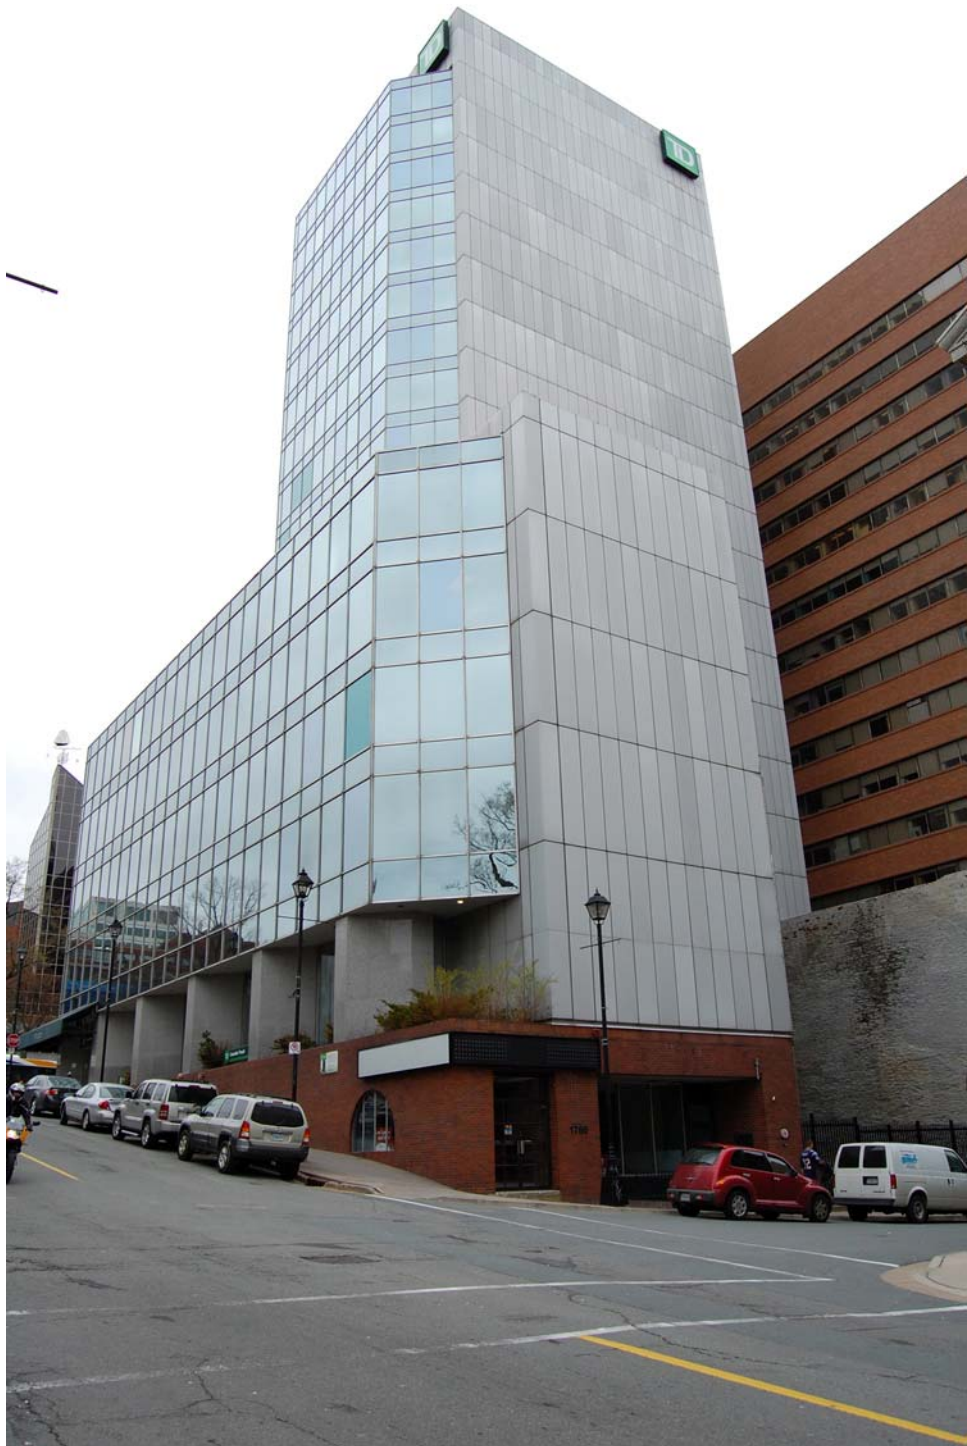
View from southeast corner of George and Granville Streets

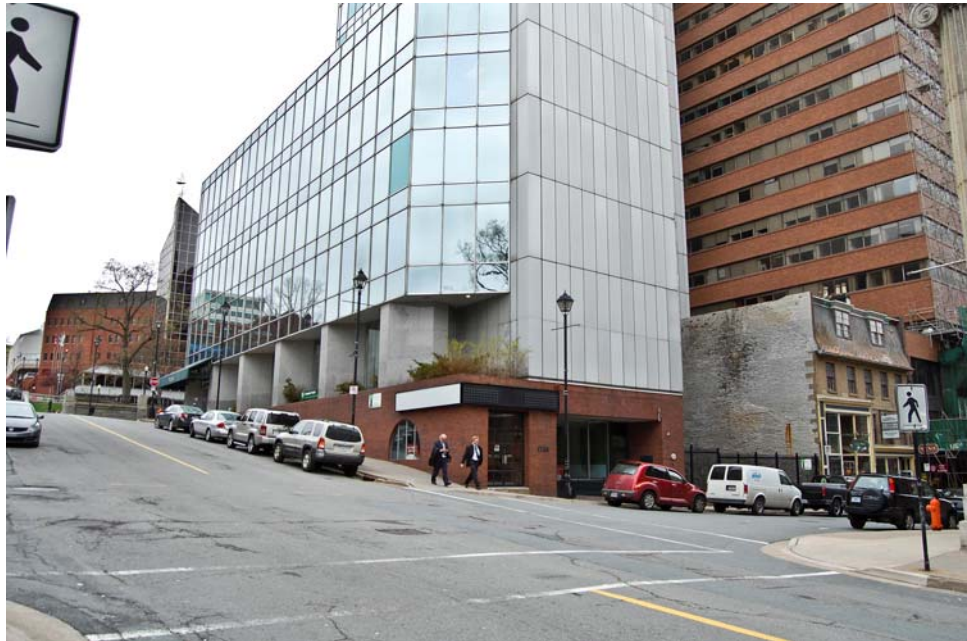
View of existing podium, vacant lot and Macara-Barnstead building along George and Granville Streets

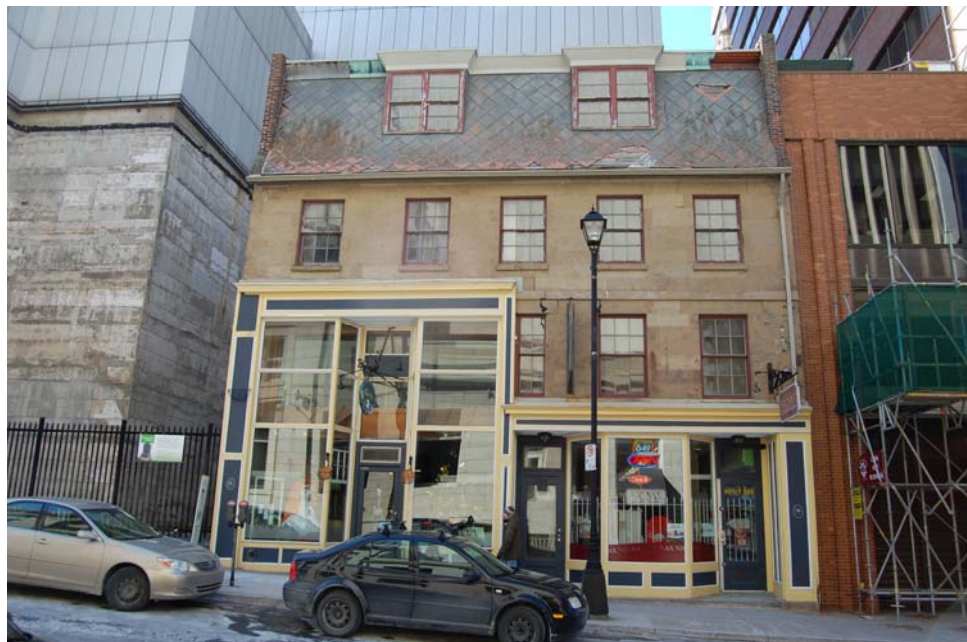
View of Macara-Barnstead façade along Granville Street

We have noted during a site visit that the exterior facade of the masonry wall currently displays some open mortar joints and deteriorated stone. It can be anticipated that parts of this wall will require deconstruction to enable repairs to the stone and reinstate masonry bonding ties to the backup wall. This work would be carried out after the removal of the temporary shoring frames and once the existing facade is secured to the new concrete structure.

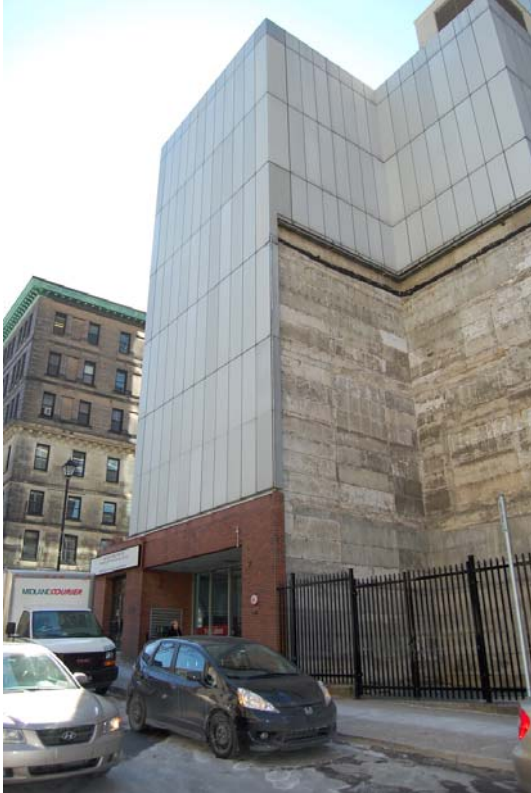
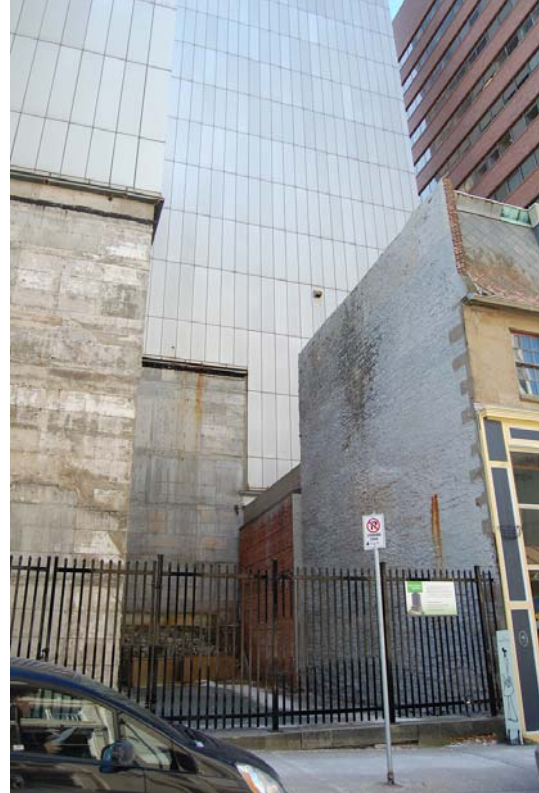
Views of vacant lot and blank walls along Granville Street

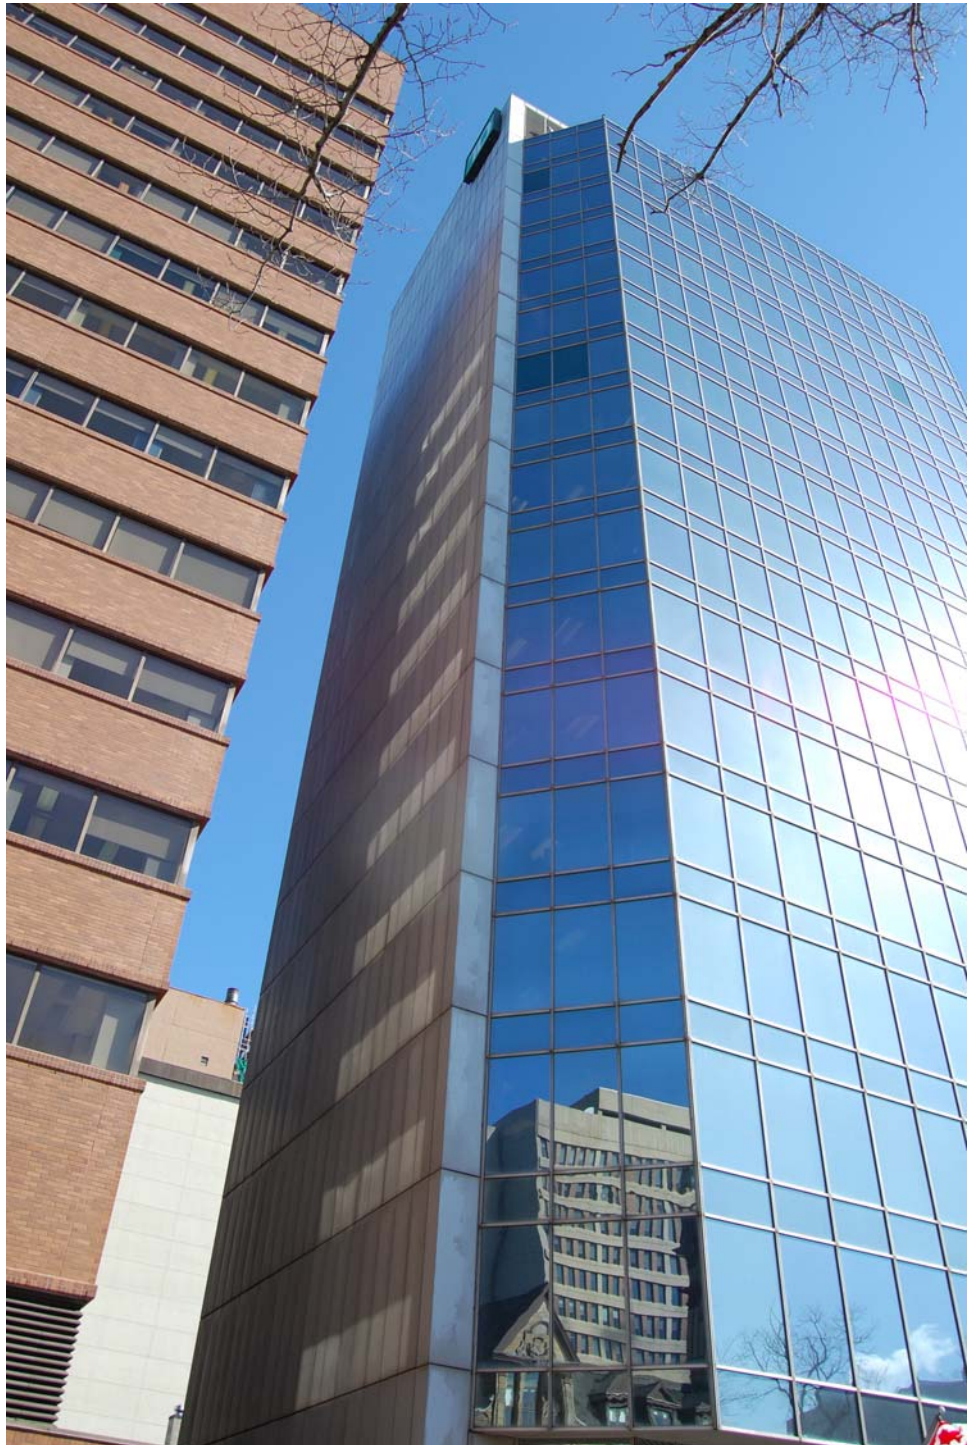
View of northwest corner of tower showing blank wall facing CIBC building
