Halifax Regional Council  
March 23, 2004

SUBJECT: Case H00108 - Application to Demolish 1790 Granville Street, Halifax,  
NS (A Registered Heritage Property)

**INSPECTION REPORT  
KELLY BUILDING  
1790 GRANVILLE STREET  
HALIFAX, NS**

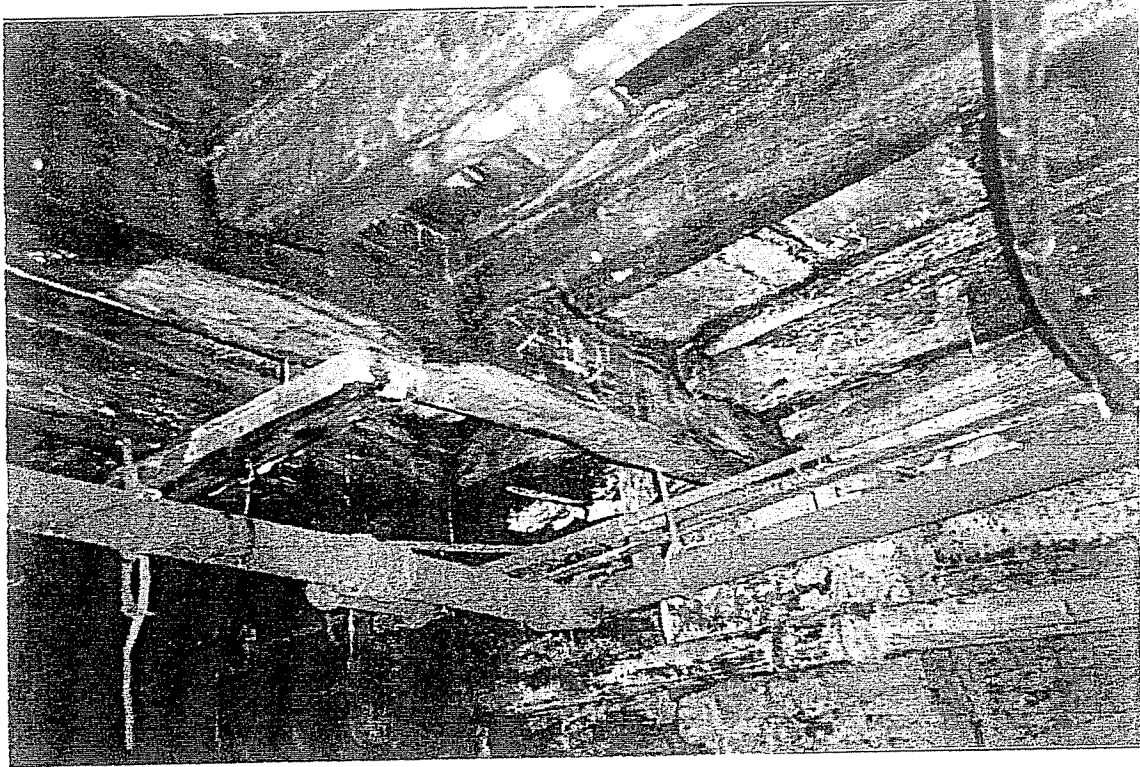
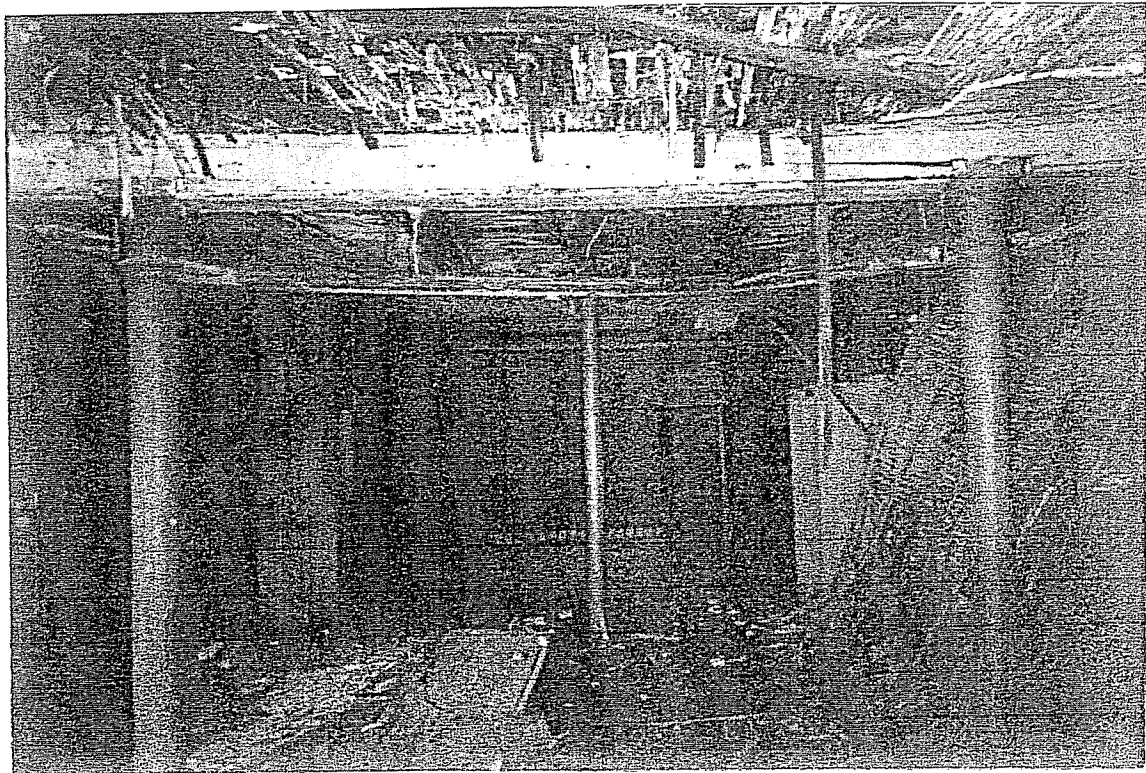
Photos 7 and 8 show the deflections in the second floor. The floor has sagged in excess of three inches (3") across the width of the building. Photo 9 shows moss growing on the second floor. The ceiling finishes have fallen in most areas due to water movement down through the building and rot of both the finishes and support structure. Photos 10, 11, 12, 14, 18, 19, 20, 21, 27, 28, 29, 30 and 31 were taken at various locations in the building and indicate the condition of the ceilings and floor framing. Photo 10 shows the underside of the second floor. The main beam is completely saturated with water present on the surface. Part of the metal ceiling finish was removed to gain access to this beam. The white growth on the beam is a fungus. This beam

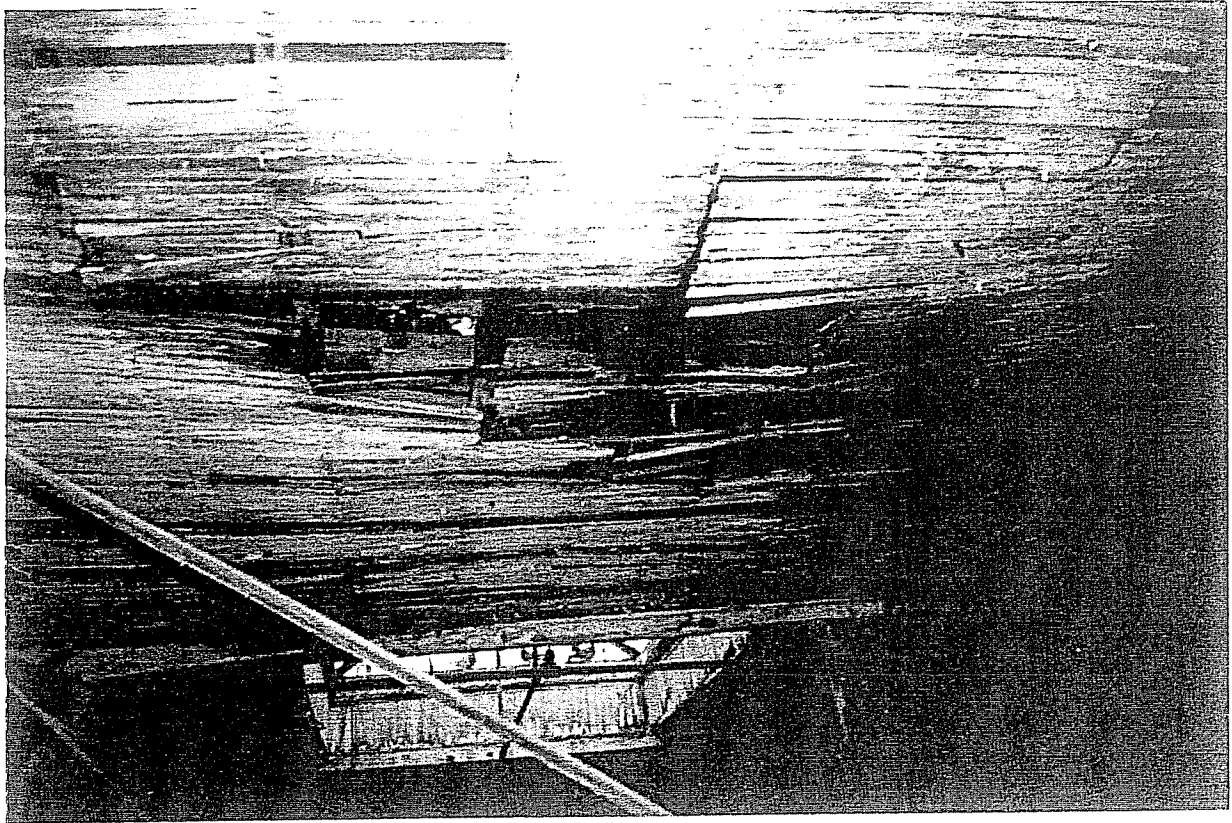
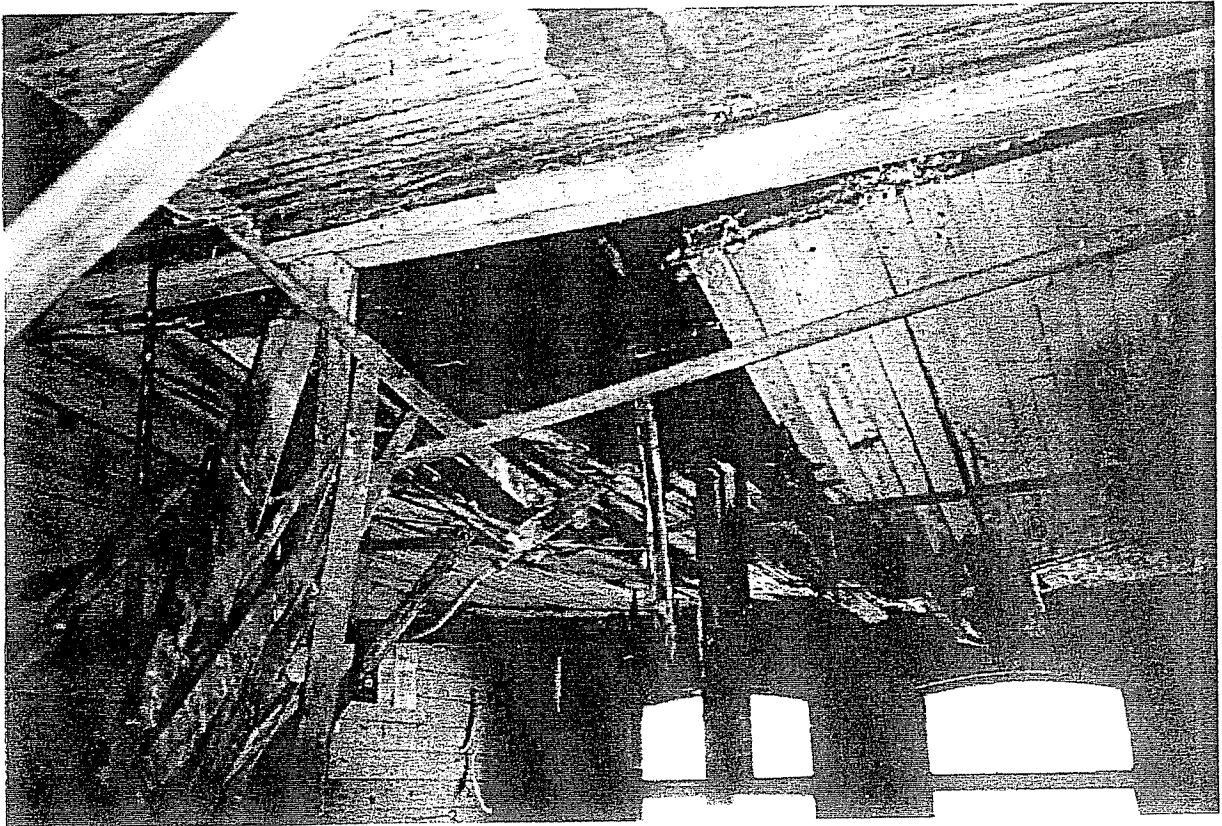
has very little capacity remaining due to the advanced state of rot. Photo 13 shows the underside of the third floor framing (one floor above Photo 10, similar location). Again, once the ceiling finishes were removed, the same conditions of fungus growth and rot existed as were recorded on the lower floors. Photos 19 and 20 were taken at the underside of the fourth floor. The sag of the main support beam is very evident in Photo 19. These large movements are beyond the useful capacity of the beam and it is considered to have failed. Again the framing is completely saturated. In Photo 20 the large movements have resulted in the fascia board splitting at the column on the right in the photo. Again, from a structural capacity perspective, it is considered this beam has failed. Photo 23 shows the wood framing at the back of the street elevation masonry wall. The wood column and diagonal brace are in poor condition due to deterioration from water. The masonry facade does not exhibit signs of major movements or cracking. It is felt the front wall could be saved for its historical significance and used in a redevelopment of the property. This would require great care in demolition of the wood framing behind the masonry wall with temporary supports provided until a permanent structure is in place.
