**SUBJECT: Case 17070, Pre-application, TD Bank Building Expansion
(Barrington/George/Granville streets)**

TD BUILDING REDEVELOPMENT
HRM SITE PLAN APPROVAL: DRAWINGS

**TD BUILDING REDEVELOPMENT
HRM SITE PLAN APPROVAL: SUPPORTING INFORMATION**

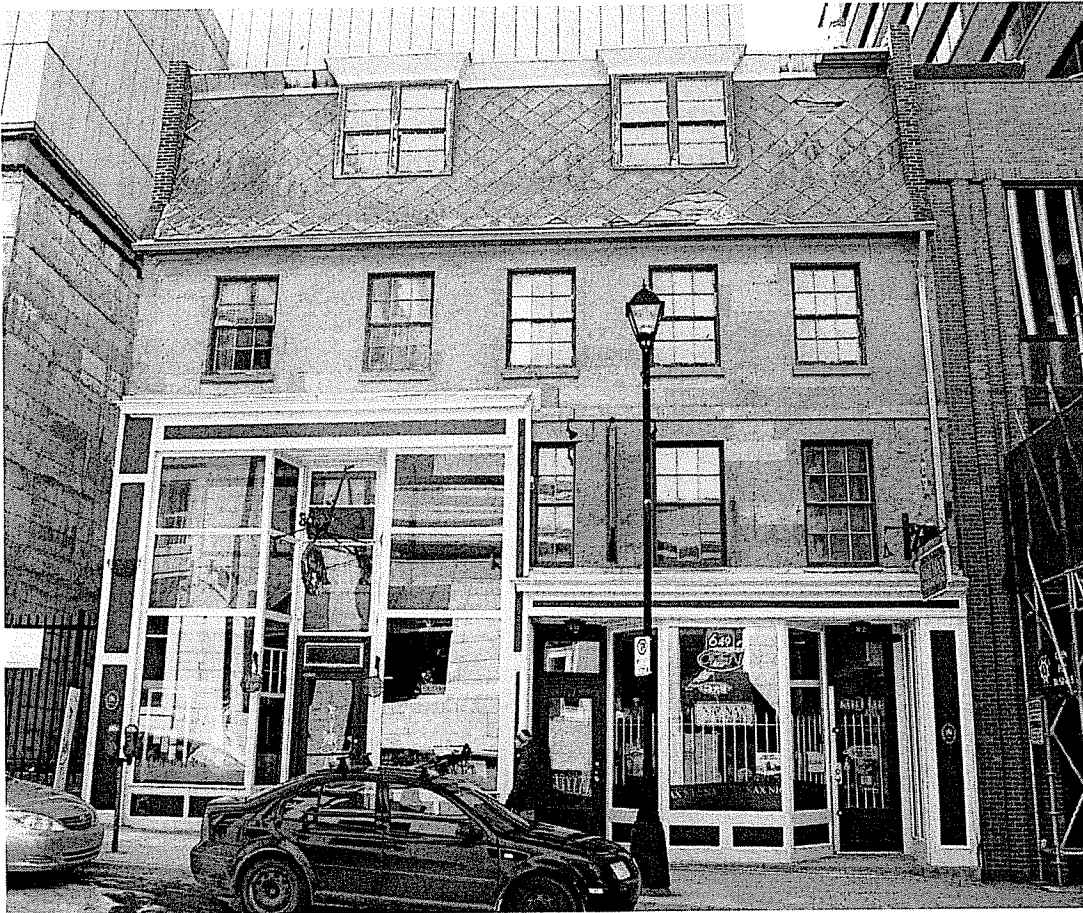
Macara-Barnstead Building, Granville Street façade, 2011

The larger of the two storefront windows has become an important component of the building’s identity. While it may not follow strict architectural protocol for integration with the lines and patterns of the original façade, it provides a charm to the street by way of its large glass windows, recessed entrance, wood paneling, and opportunity for retail display. Such features provide a sense of urban engagement allowing pedestrians to visually interact with the shop and provide a covered entry threshold at the streetwall. Its quiriness has ironically become part of its charm and arguably part of its redeeming value.

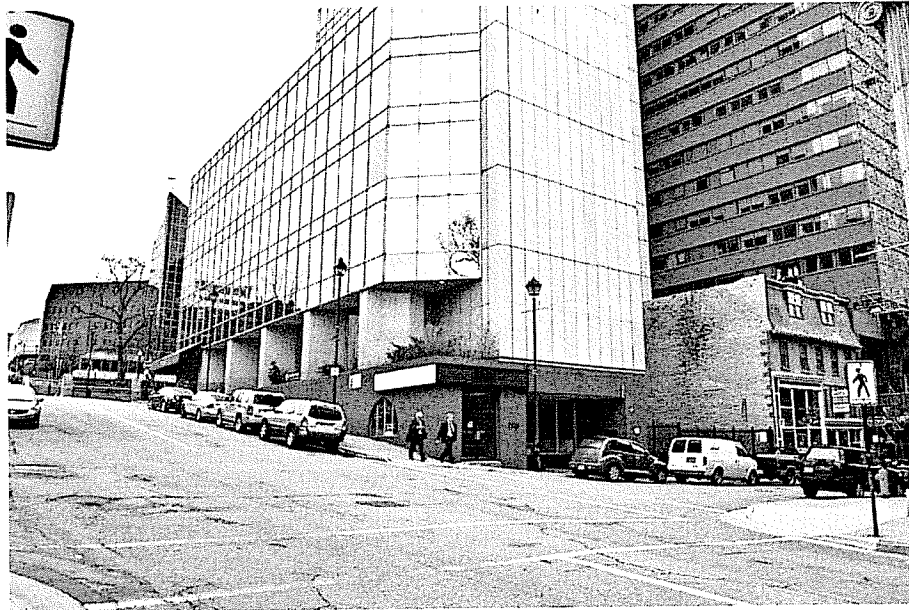
View of existing podium, vacant lot and Macara-Barnstead building along George and Granville Streets

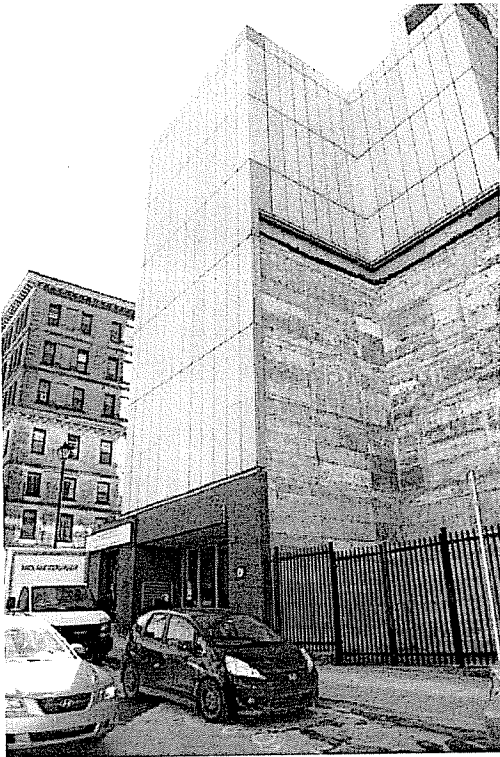
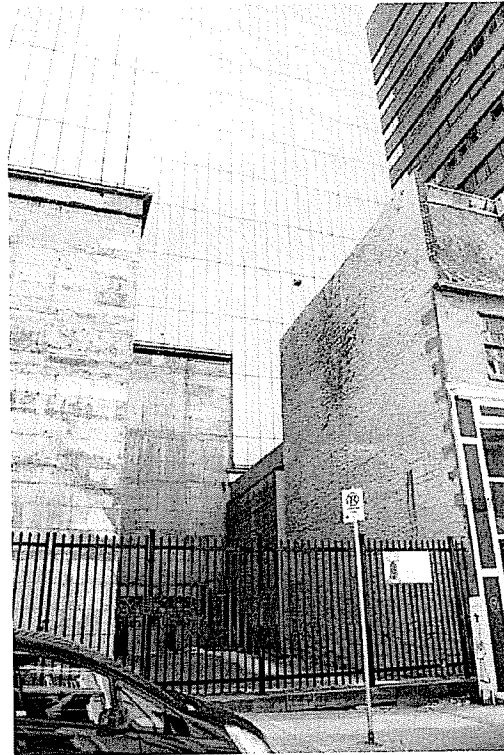
Views of vacant lot and blank walls along Granville Street

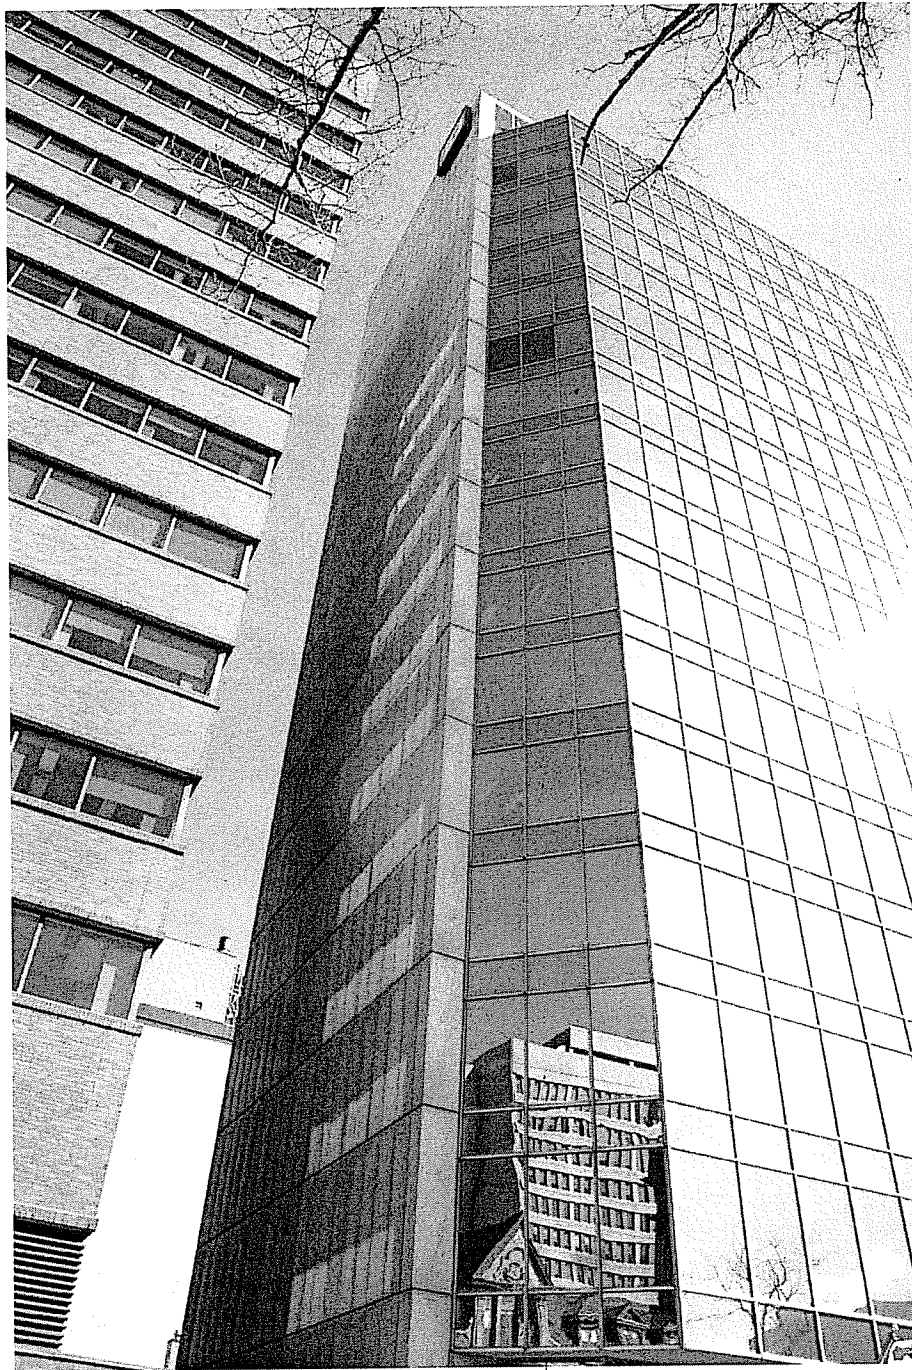
View of northwest corner of tower showing blank wall facing CIBC building
