## **Attachment H**

### **HALIFAX REGIONAL MUNICIPALITY BY-LAW H-502**

**Schedule “B-1”**  
**CONSERVATION STANDARDS**  
**The Standards for the Conservation of Historic Places in Canada**

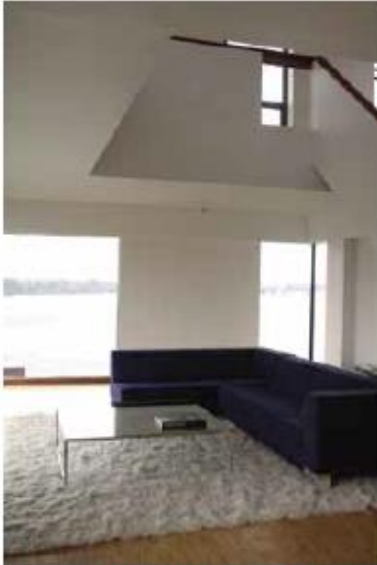
The character-defining interior features and finishes, such as the birch floors, window frames and views of the city at Habitat 67 in Montreal, have been carefully maintained, repaired and retained.

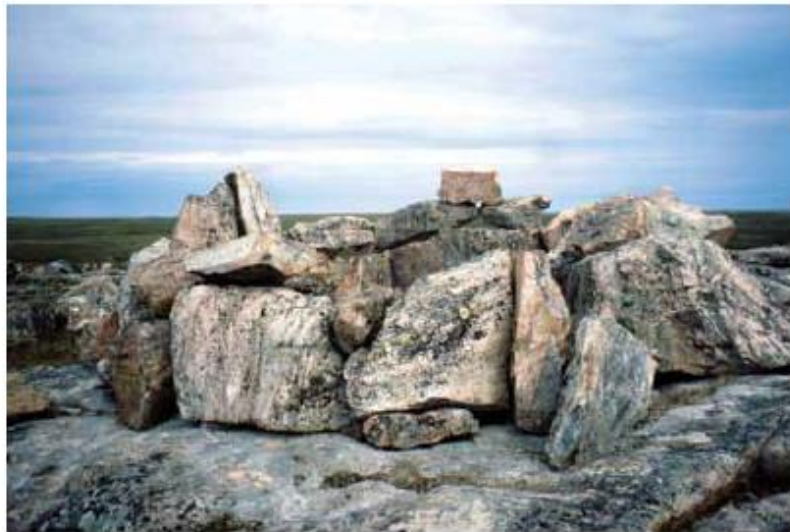
Centuries ago, the inland Inuit, or Kivallirmiut, recognized the hunting potential of the annual fall crossing of massive herds of caribou and began establishing seasonal camps along the Kazan River. Today Fall Caribou Crossing NHSC in Nunavut, is noted not only for its archaeological remains and former importance to the Kivallirmiut, but also for its natural landscape, continued use as a hunting area and the vitality of the oral history and traditions of the people who know it best. Moving any of these stones would impair heritage value.

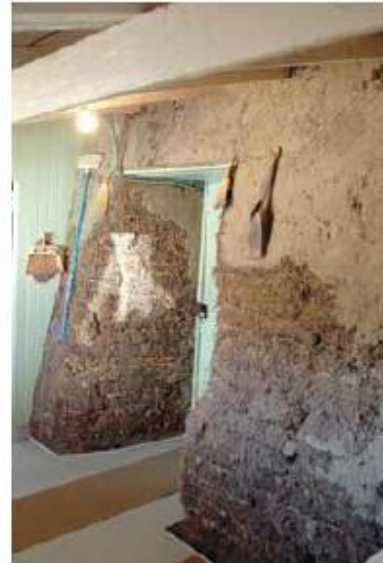
The lean-to is a character-defining element that shows the evolution of the Addison Sod House in Saskatchewan from a rustic sod dwelling to a comfortable home. Removing the later changes to restore the house to an earlier period would not be appropriate because it would remove elements that have heritage value.

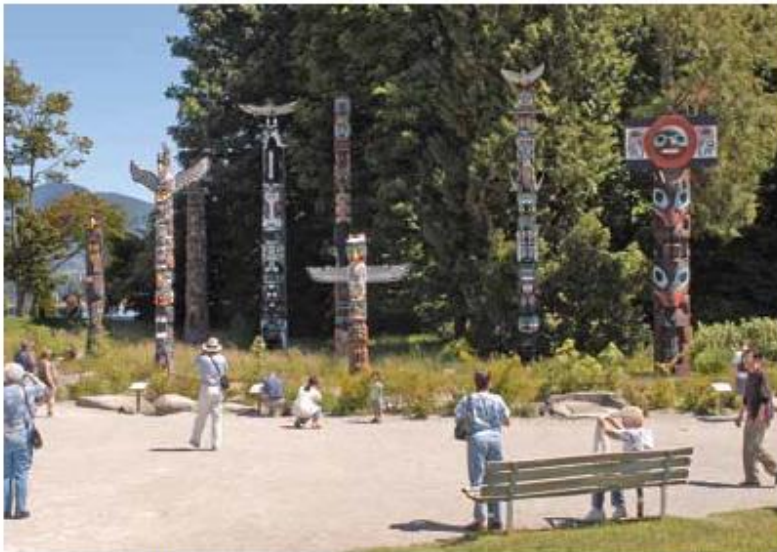
Over the years, several landscape architects and architects have made specific contributions to the evolving functions of Vancouver's Stanley Park. These include the play areas, totem groupings and aquarium that are now integral to the park's heritage value.

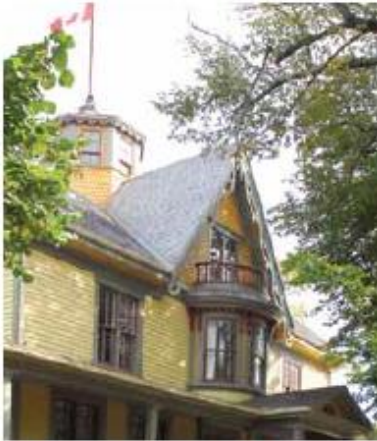
When the windows of Lefurgey House in Summerside, PEI were damaged in a fire, instead of replacing the entire windows, only the broken glass was replaced. The replacement glass, salvaged from a nearby house that was replacing its windows, had similar properties and wavy appearance.

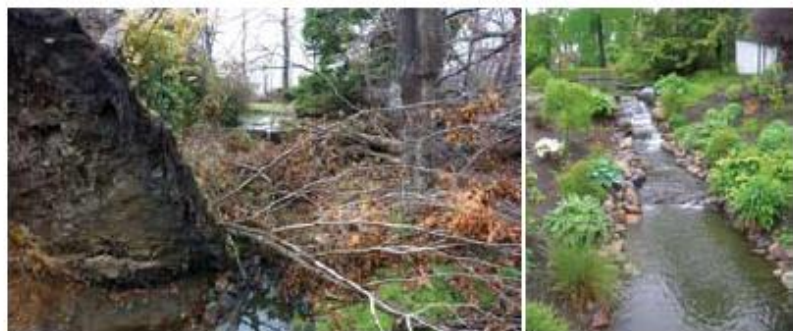
The extensive damage caused by Hurricane Juan to the Halifax Public Gardens required substantial replanting. The large scope of work is still considered a minimal intervention because any less work would have negatively affected the heritage value of the place.

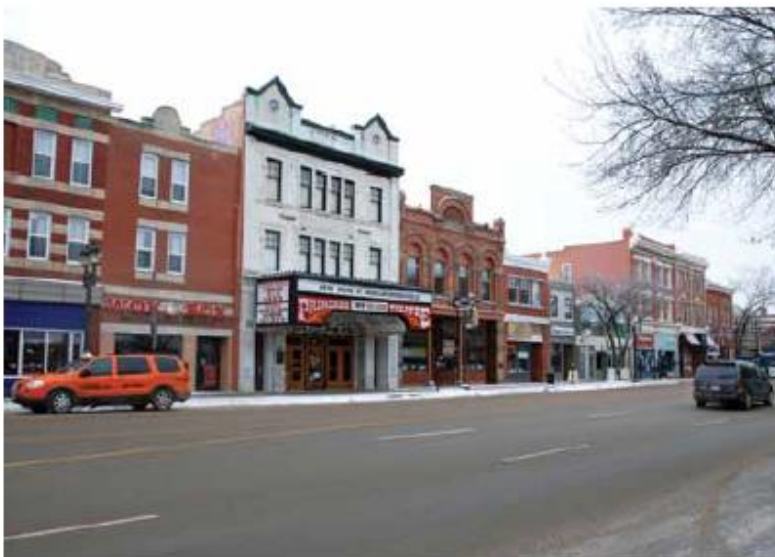
The Old Strathcona Provincial Historic Area in Edmonton is a diverse historic district. The individuality of each building and evidence of the era of its construction has been maintained. Earlier simply constructed wood buildings stand alongside later more sophisticated masonry buildings and modern infill structures.

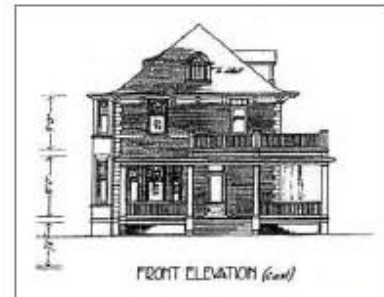
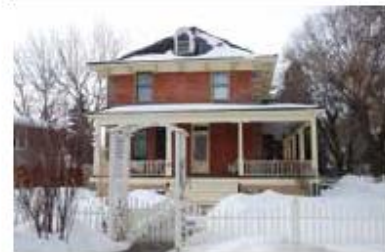
The original plans for the Margaret Marin Residence in Edmonton indicate a decorative upper balcony that was never built. During recent renovations, it was decided not to construct this balcony because it would have conveyed a false sense of historical development.

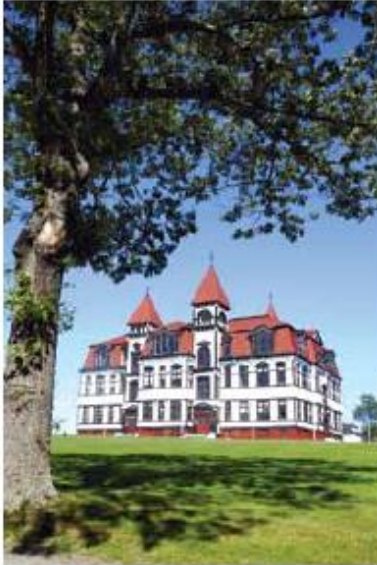
Despite changing requirements in education, the Lunenburg Academy in Nova Scotia remains in its original building and setting. The Academy was designed using green space, natural lighting and ventilation in a way that is still valid for school use today.

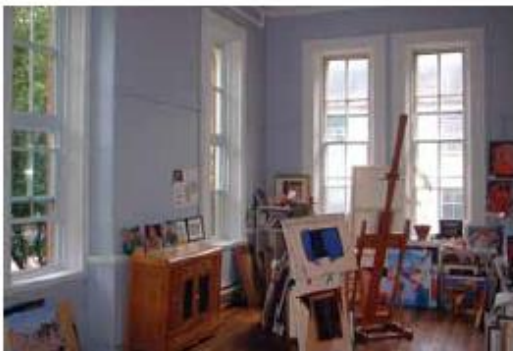
After serving the community for many years as a primary school, the Charlotte Street School in Fredericton now has a new community use as the Charlotte Street Arts Centre. This use required little change to the building's layout and character. Classrooms were maintained to serve as open art studios, dance and music studios and an art gallery. The existing wide corridors and staircases, as well as the classrooms and other spaces, fit the new needs well.

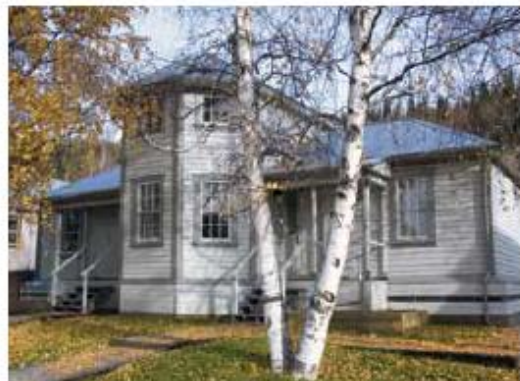
This Dawson City building, originally built to be the temporary location for the government telegraph office, was rehabilitated into housing units.

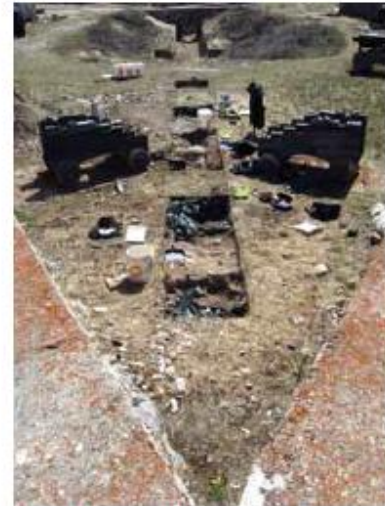
Nearby archaeological resources were protected when stabilizing the Prince of Wales Fort in Manitoba. Strategically placed archaeological investigations on the surface of the ramparts established the extent of artifacts, including their depth below the surface.

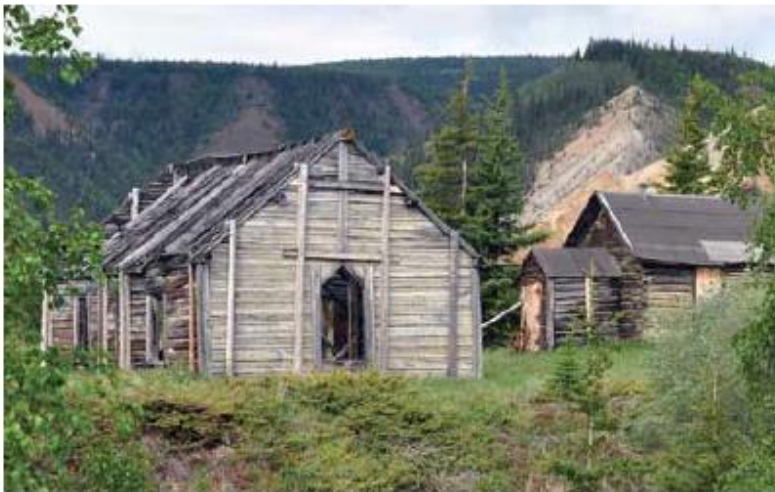
These buildings, along with others at St. Luke's Anglican Rectory and Church in the Yukon, were temporarily stabilized using a variety of measures including adding sandwich bracing, cable bracing, heavy frames, roll roofing, and covering door and window openings in order to keep out snow and rain. Stabilization allows the structures to be adequately researched and their eventual restoration to be planned.

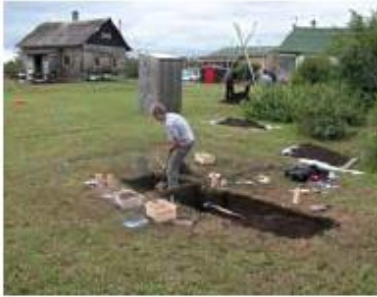
Ground-penetrating radar was used at McPherson House in Fort Simpson, NT; this guided archaeological excavations limiting the impact on the site.

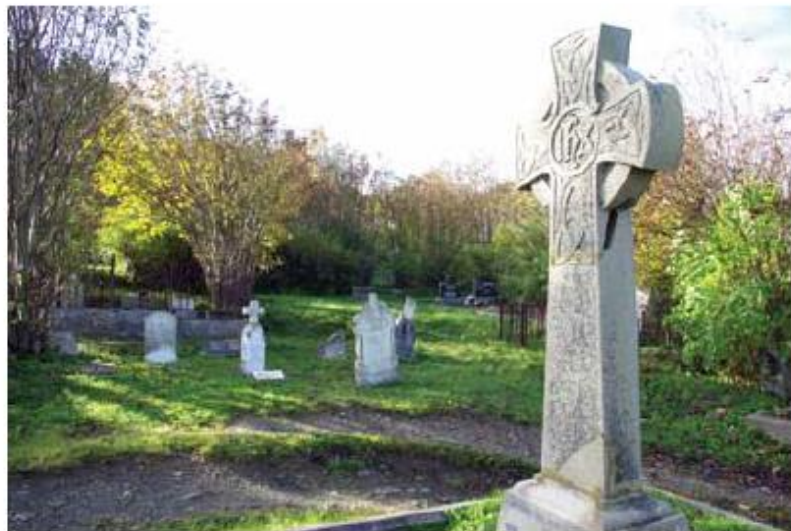
A condition assessment and evaluation undertaken before an intervention at Belvedere Cemetery in St John's Ecclesiastical District, would reveal that the well-aged and weathered patina found on the grave markers is not damaging. It is in fact a character-defining element of this historic place and should be preserved.

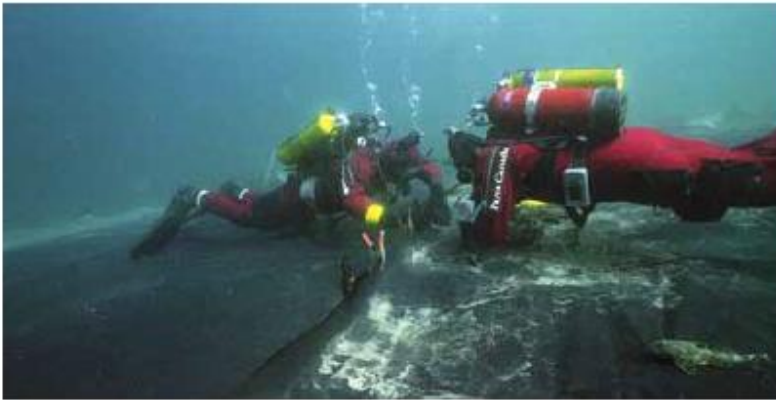
Wrecks at Red Bay NHSC, NL, such as this Basque Period wreck, are reburied using sand and tarp to ensure their long-term preservation. Their condition is periodically assessed through monitoring.

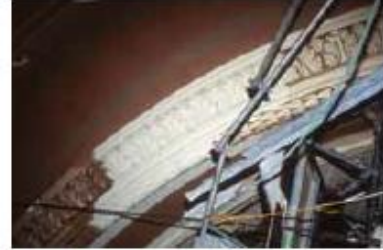
When restoring decorative plaster in the Walker Theatre in Winnipeg, moulds were made of existing plaster elements. The deteriorated plaster was then patched and repaired using the moulds to match the original.

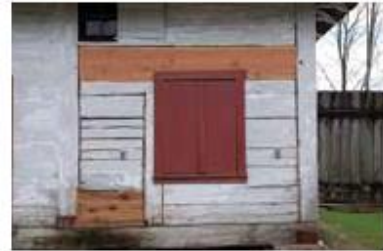
A condition assessment of the exterior walls and frame of this Storehouse at Fort Langley, BC found extensive deterioration of some timbers, which required replacement in kind. The dimensions, hewn finish and species of wood used in the repairs matched those replaced. The photograph shows part of one storehouse wall after the repairs were completed, but before the new timbers were whitewashed.

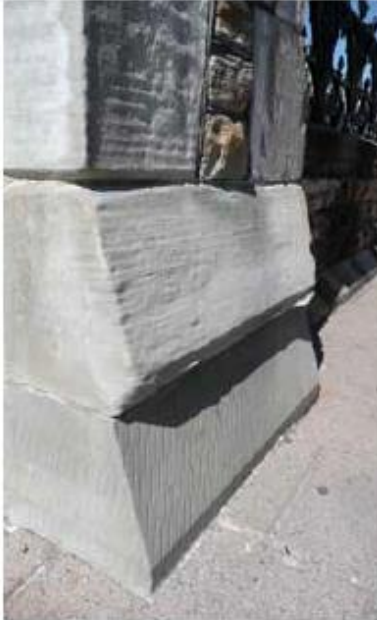
The new pieces of stone on the Wellington Wall at the Parliament Grounds in Ottawa are clearly visible on close inspection due to a different tooling technique.

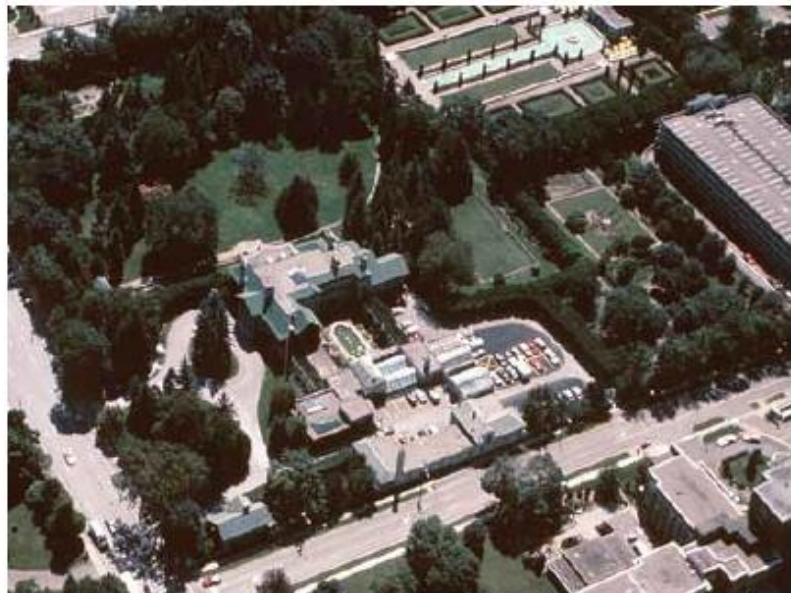
The grand residential estate at Parkwood in Oshawa is a cultural landscape that covers 4.8 hectares. Aerial photography was used to document the large-scale site during the conservation process.

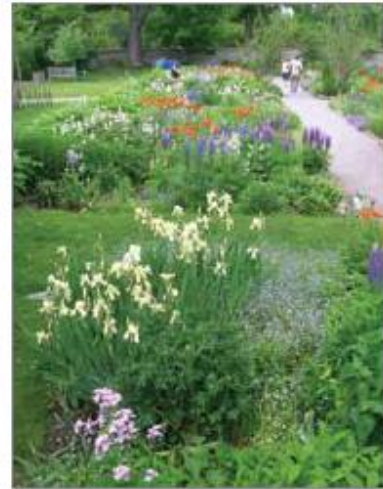
In areas of Maplelawn and Gardens NHSC in Ottawa where insufficient historical evidence existed, a Rehabilitation approach was taken. New perennial beds were designed using adjacent layouts and historical information from other parts of the garden as inspiration. This approach resulted in compatible new beds that completed the garden and strengthened its overall heritage value.

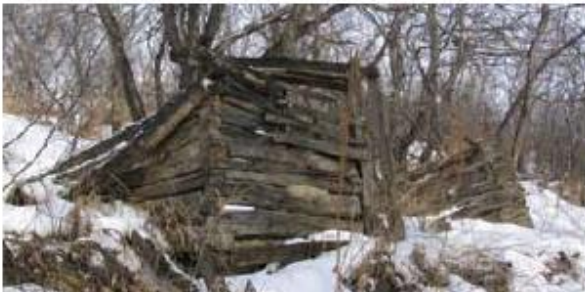
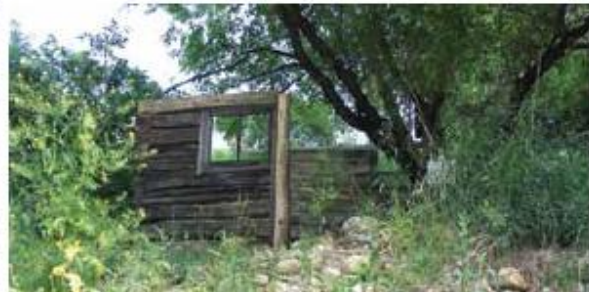
The character-defining elements of Doukhobor Dugout House NHSC in Saskatchewan, such as the window frames, had suffered visible deterioration from exposure to the elements. A long-term repair solution was necessary to prevent further decay and to preserve the site's heritage value.

Following the reinforcement treatment of treating the logs with preservatives, collapsed character-defining elements were reassembled based on records from previous interventions and existing traces on the site.

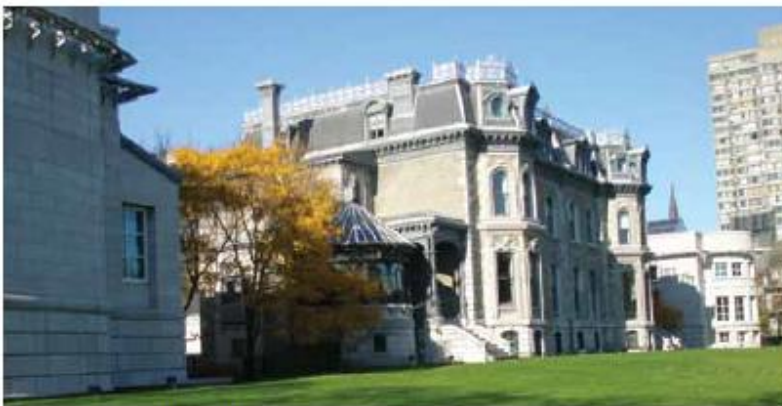
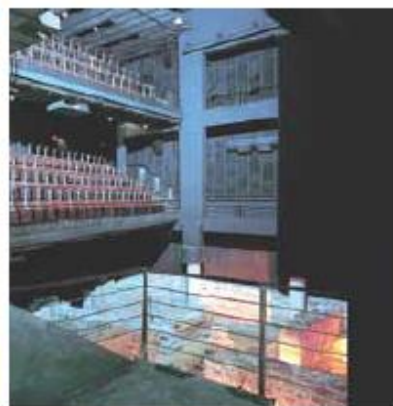
These two additions in Montreal show the range of possibilities for successful additions to historic places. Although the addition to Shaughnessy House by the Canadian Centre for Architecture has a larger footprint than the original building, it demonstrates a subtle approach, using compatible scale, proportions of openings, materials and details, which acknowledges the original building. Pointe-à-Callière Museum of Archaeology and History illustrates a contrasting contemporary approach where an archaeological site has been successfully integrated into a new design in ways that communicate the site's heritage value.

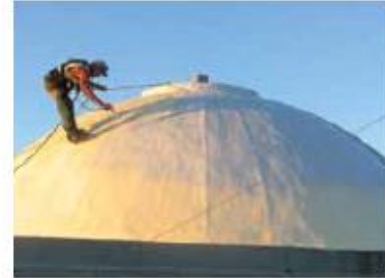
The dome of Melville City Hall was originally an uninsulated, painted-metal covering that caused persistent condensation problems. Applying insulating polyurethane foam with aluminized coating was a cost-effective solution that was compatible with the historic metallic look of the dome. If a more elaborate solution is contemplated in the future, the polyurethane could be removed.

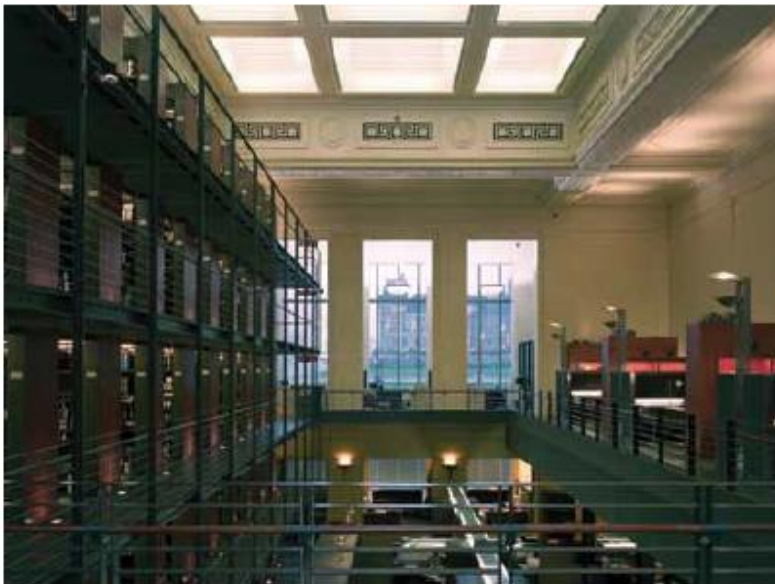
Space to temporarily house the Library of Parliament in the former Bank of Nova Scotia Building on Sparks Street in Ottawa. The entire intervention was designed to be reversible.

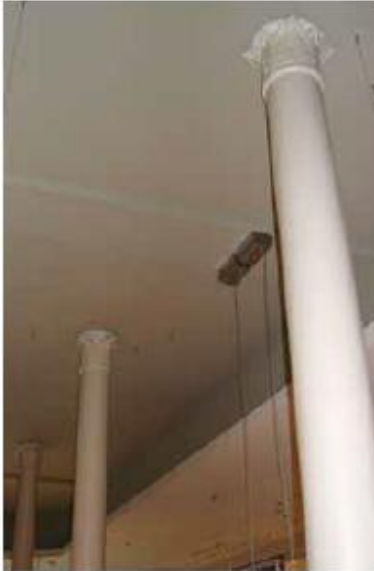
These cast iron columns were uncovered and restored when CentreBeam Place, in St. John, was rehabilitated.

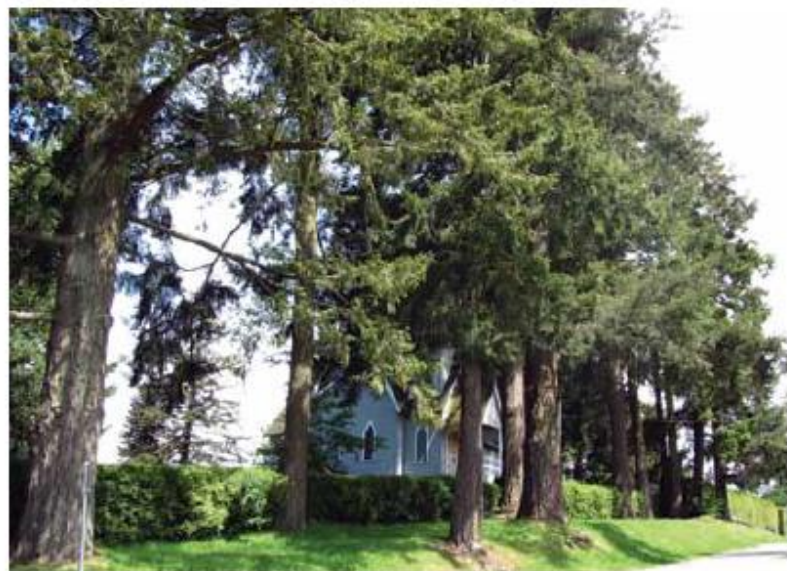
The rhythmic pattern created by the regular spacing of trees along the street is a character-defining element of the Avenue of Trees in Surrey, BC that can be used as evidence to restore the row if a gap develops.

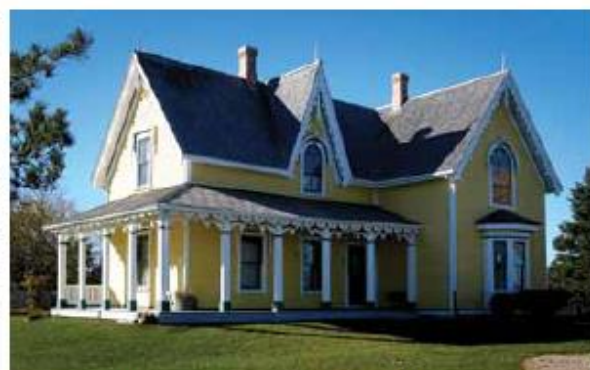
Based on documentary evidence, including an 1880 engraving, the original fenestration of the Biddeford Parsonage Museum in P.E.I. was restored and roof finials replaced.
