Item No. **9.1.1**
Environment and Sustainability Standing Committee
January 8, 2015

SUBJECT: Weed Growth in Lake Banook & MicMac

ASSESSMENT OF AQUATIC VEGETATION OVERGROWTH IN LAKE BANOOK

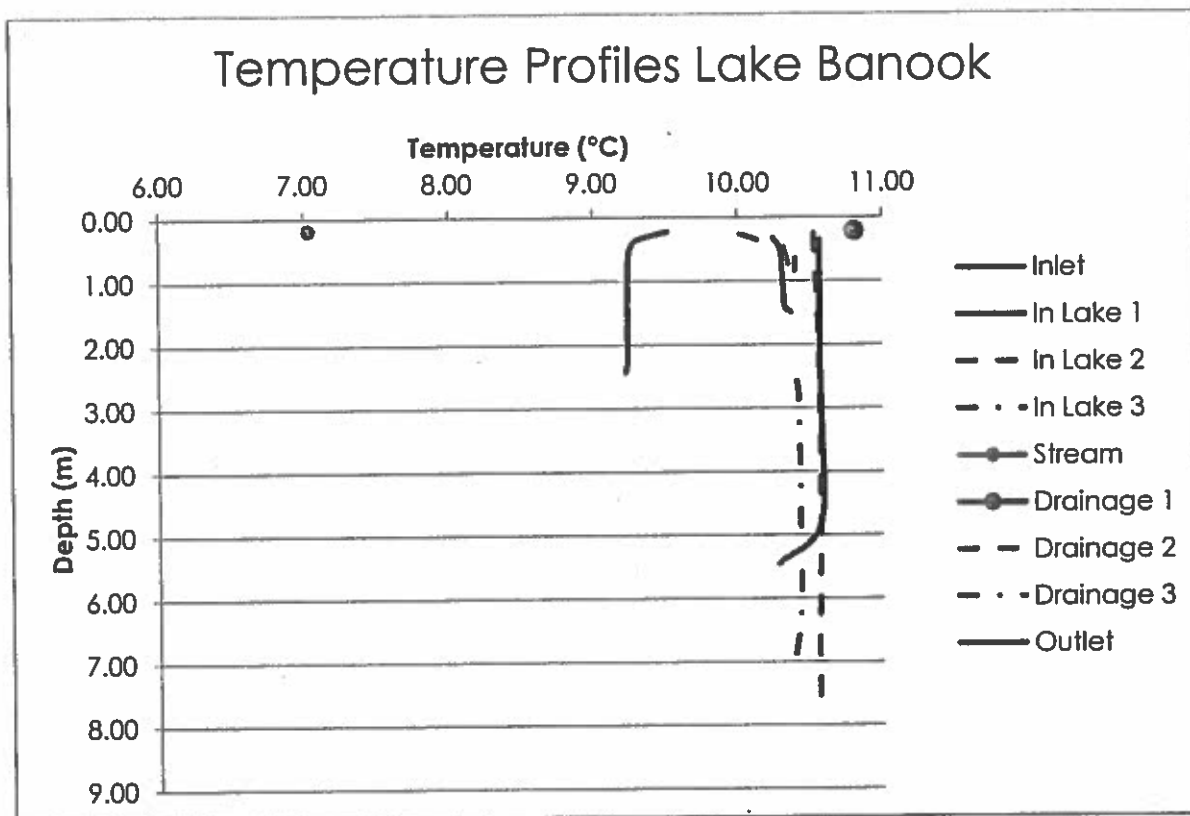
Figure 6 Temperature Profiles for Sampling Stations on Lake Banook.

The water column was well mixed on November 4, 2013. Temperature profiles were fairly uniform throughout the water column (Figure 6). Temperatures ranged from just over 7 °C to 10.8 °C. The coldest temperature was found in the Stream station, with the warmest temperature recorded at the Drainage 1 station. Overall, the In Lake stations had temperatures ranging from 10.2 to 10.58 °C. The Inlet station had slightly cooler temperatures ranging from 9.23 to 9.53 °C throughout the water column. The Drainage and Outlet sampling stations had temperatures in between the cooler Inlet Station and the warmer In Lake Stations, with the exception of Drainage Station 3. For full details on each of the temperature profiles refer to Appendix A.

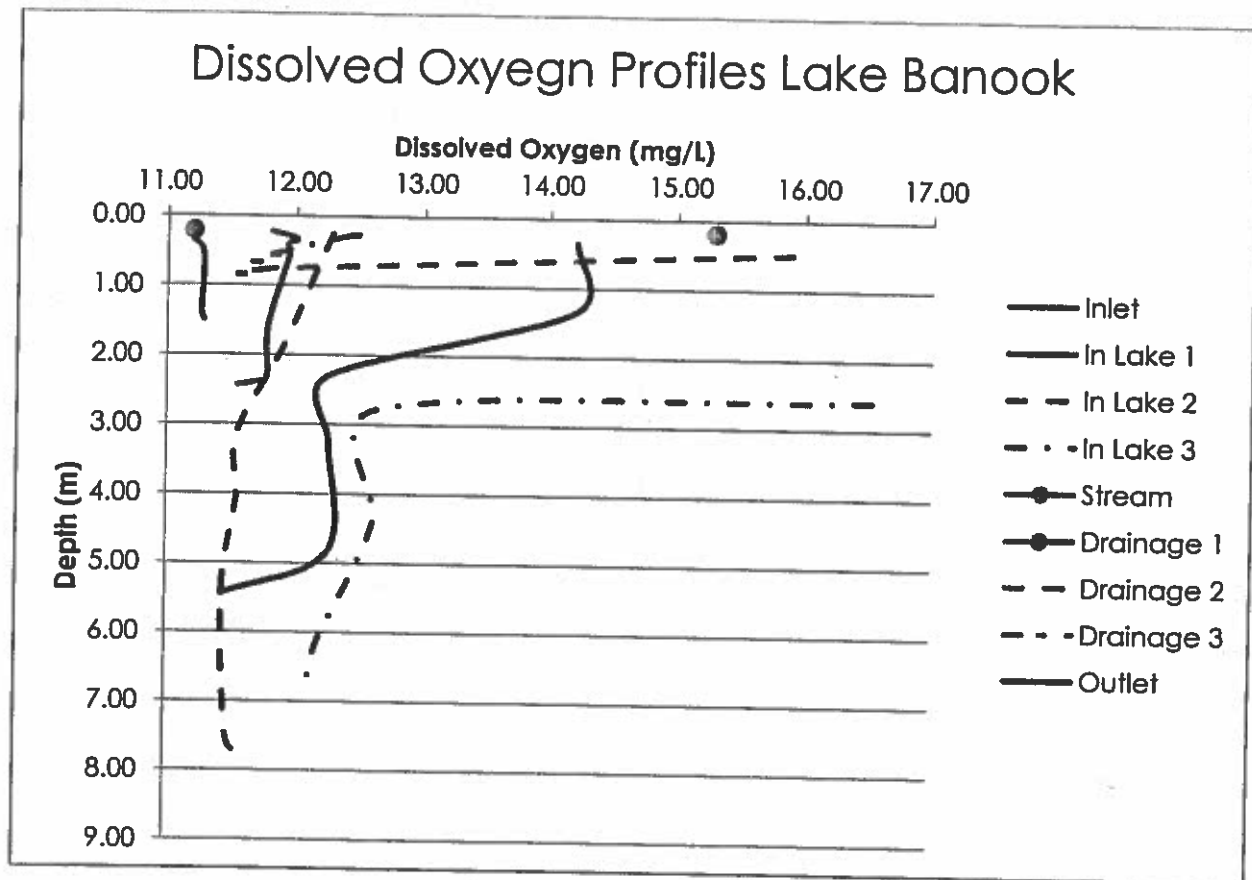
Figure 7 Dissolved Oxygen Profiles for Sampling Stations on Lake Banook.

The dissolved oxygen levels in Lake Banook and its various tributary and municipal inputs were high, ranging from just over 11 mg/L to 16.5 mg/L (Figure 7). Low temperatures and biotic activity late in the year may account for this. Dissolved oxygen levels were higher at the surface and declined with depth, which is fairly typical for oxygen levels in an aquatic environment. The lowest levels were observed in the outlet of the lake, with the highest levels being found at mid-depth at In Lake stations. For full details on each of the dissolved oxygen profiles refer to Appendix A.

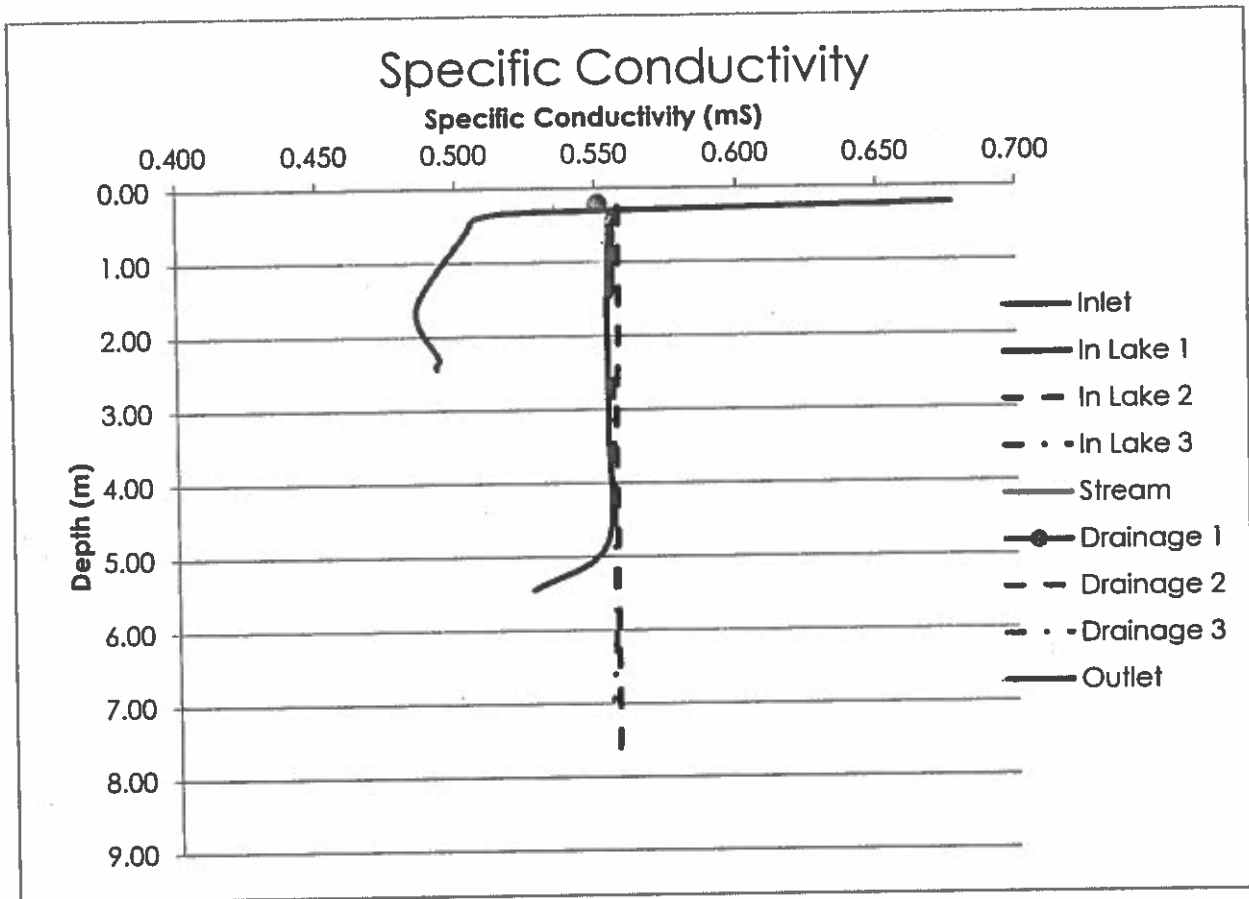
Figure 8 Specific Conductivity Profiles for Sampling Stations on Lake Banook.

Specific conductivity recorded in Lake Banook and its tributary and municipal inputs was relatively high (Figure 8). The levels observed are consistent with historical observations. Specific conductivity was recorded between 0.486 to 0.677 mS/cm. Samples were uniform with depth at approximately 0.550 mS/cm. The exception to this was in the Stream sample which was recorded to be 0.003 mS/cm. It is suspected that a mechanical error affected recording of specific conductivity in the Stream samples. The other exception was the Inlet station, which had a larger range of values throughout the depth profile. For full details on each of the specific conductivity profiles refer to Appendix A.

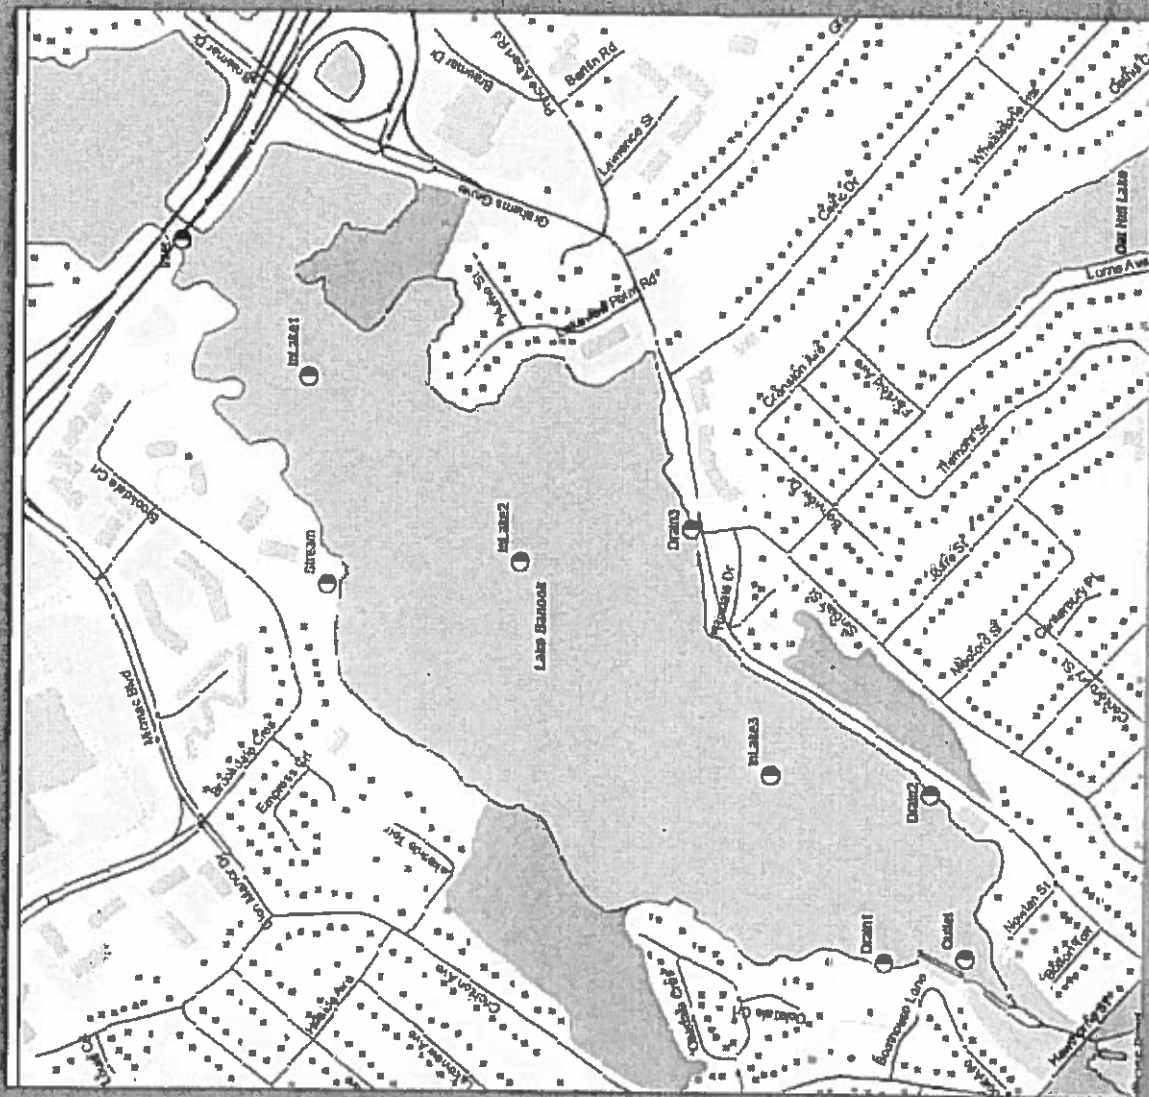
Water Quality – November 2013

- In Lake
 - Low nutrients
 - No total suspended solids detected
 - High specific conductance
- Lake inputs before rain
 - Higher nutrients than lake (specifically stream)
 - High TSS from Drain 1
- Lake inputs immediately after rain
 - Slightly higher nutrients than before rain
 - TSS similar to before rain

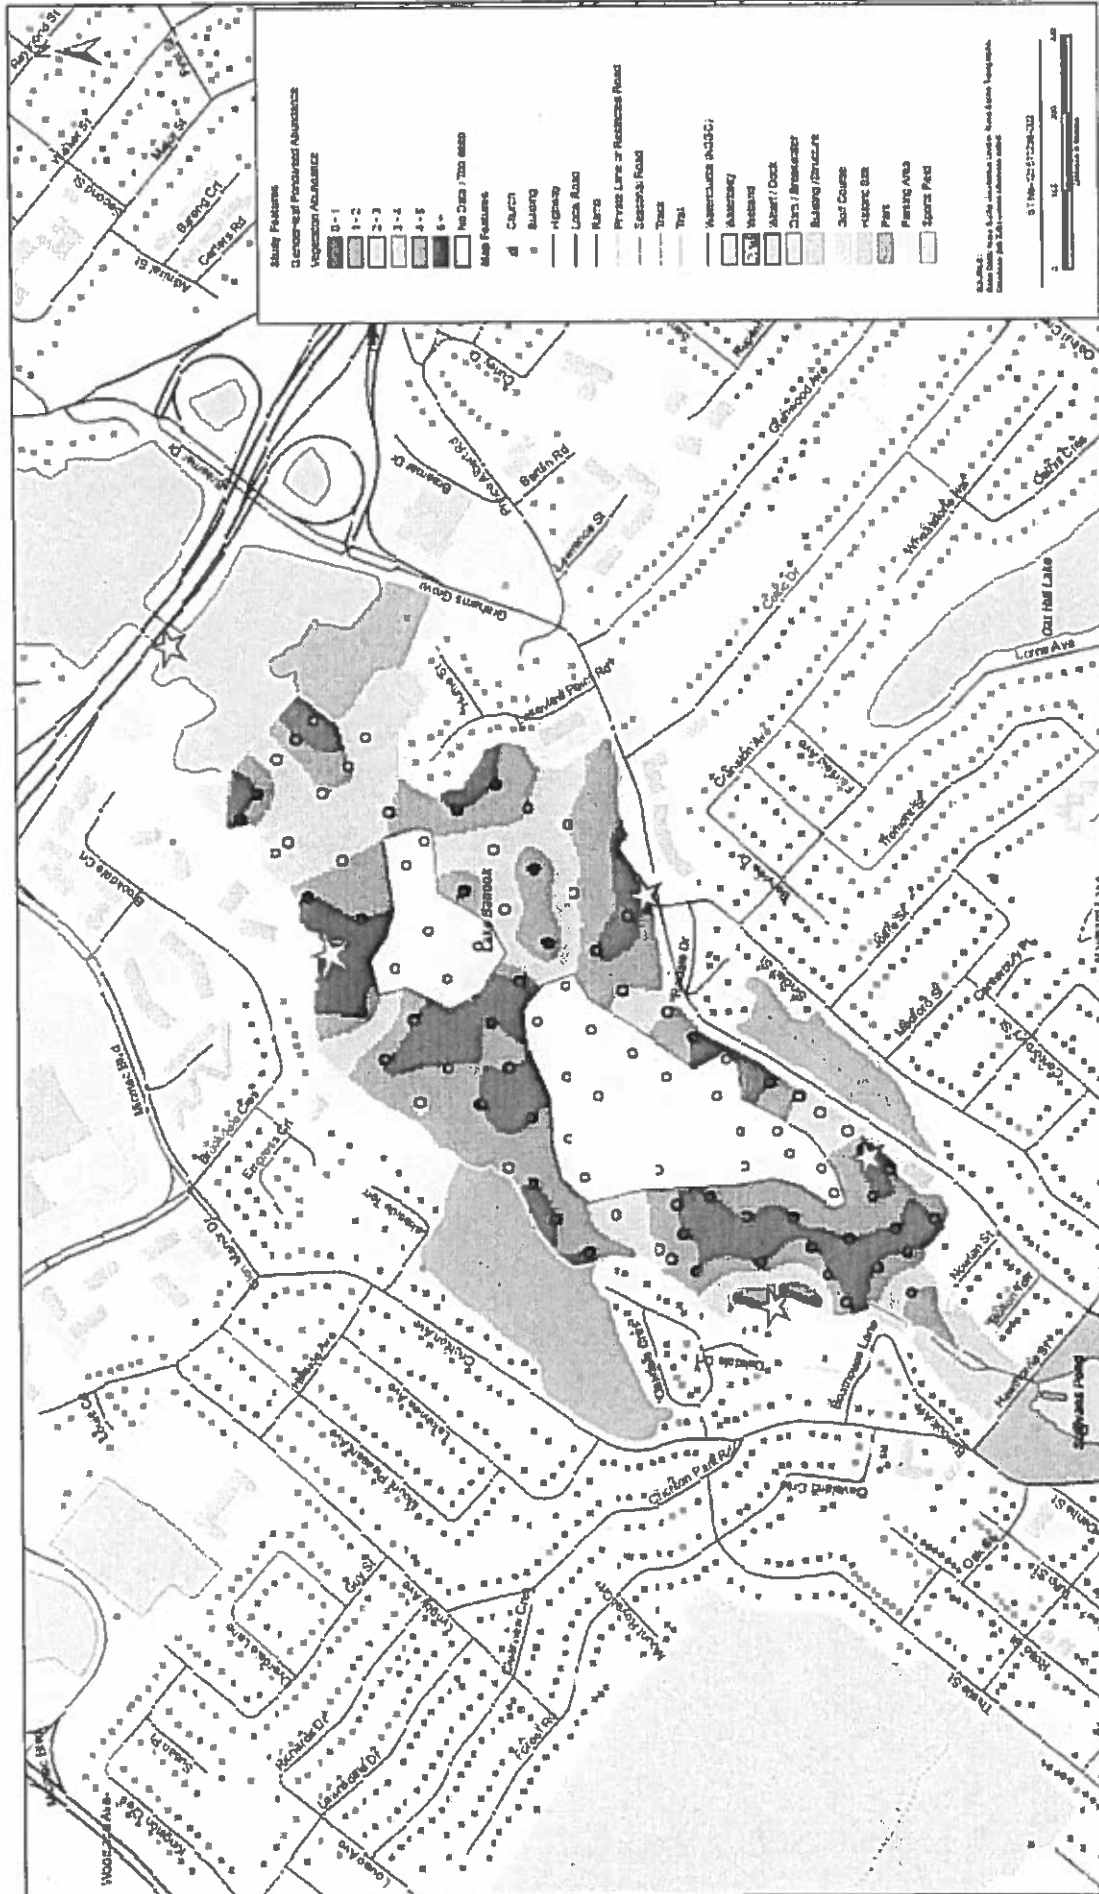
Vegetation Mapping

Transects run across Lake Banook in a small vessel and at intervals, submersed video was recorded to identify species and estimate abundance. A map of abundance for the two dominant species was produced

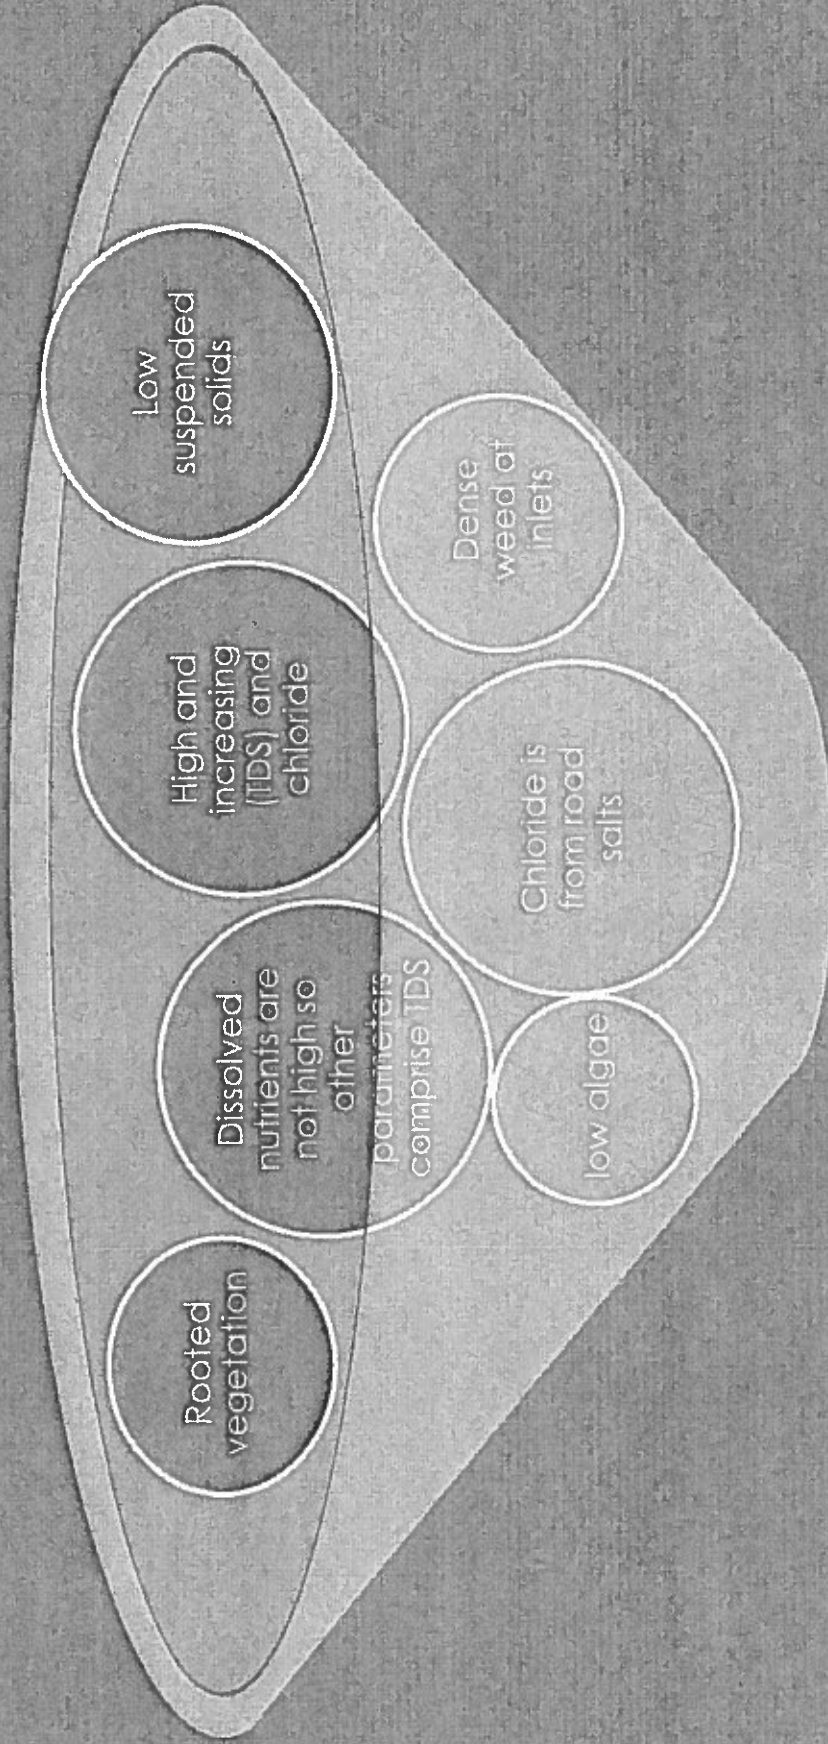
Suggests that there are urban non-point source contaminants getting to the lake but they are settling out, enriching sediments

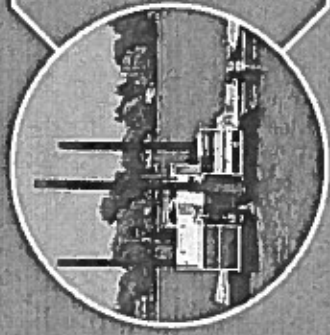
Physical removal of enriched sediment
and problem biomass

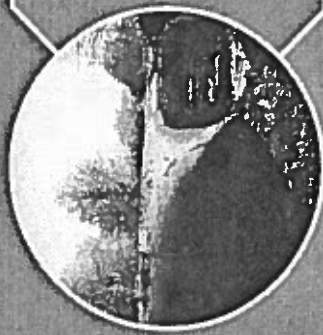
Dewatering of sediment
