SUBJECT: **Case 18120: MPS and LUB Amendments for 348 Purcell's Cove Road, Halifax**

SUPPLEMENTARY INFORMATION REPORT

Re: Property Development Review
348 Purcell's Cove Road

PROJECT:
 JENSEN PROPERTY INVESTIGATION

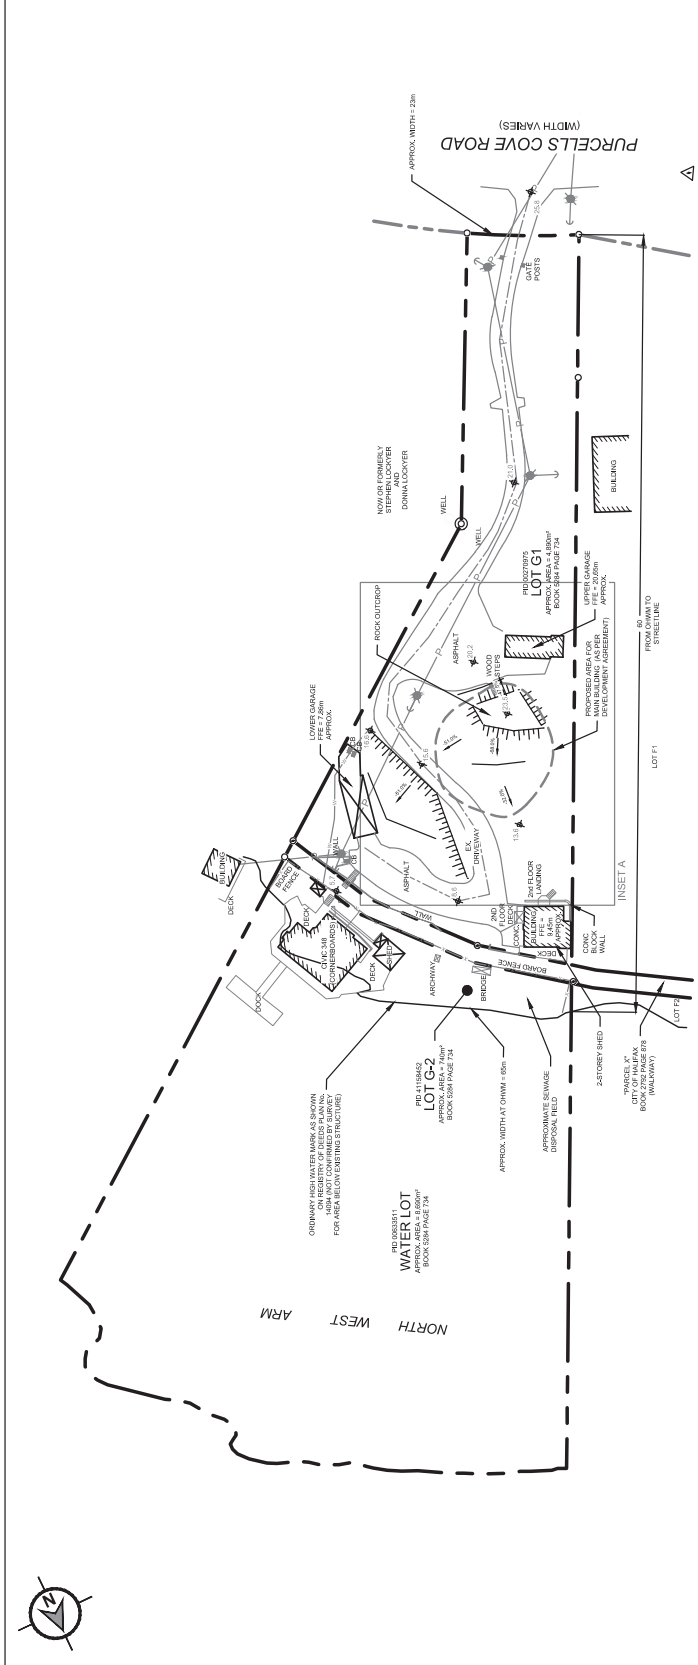
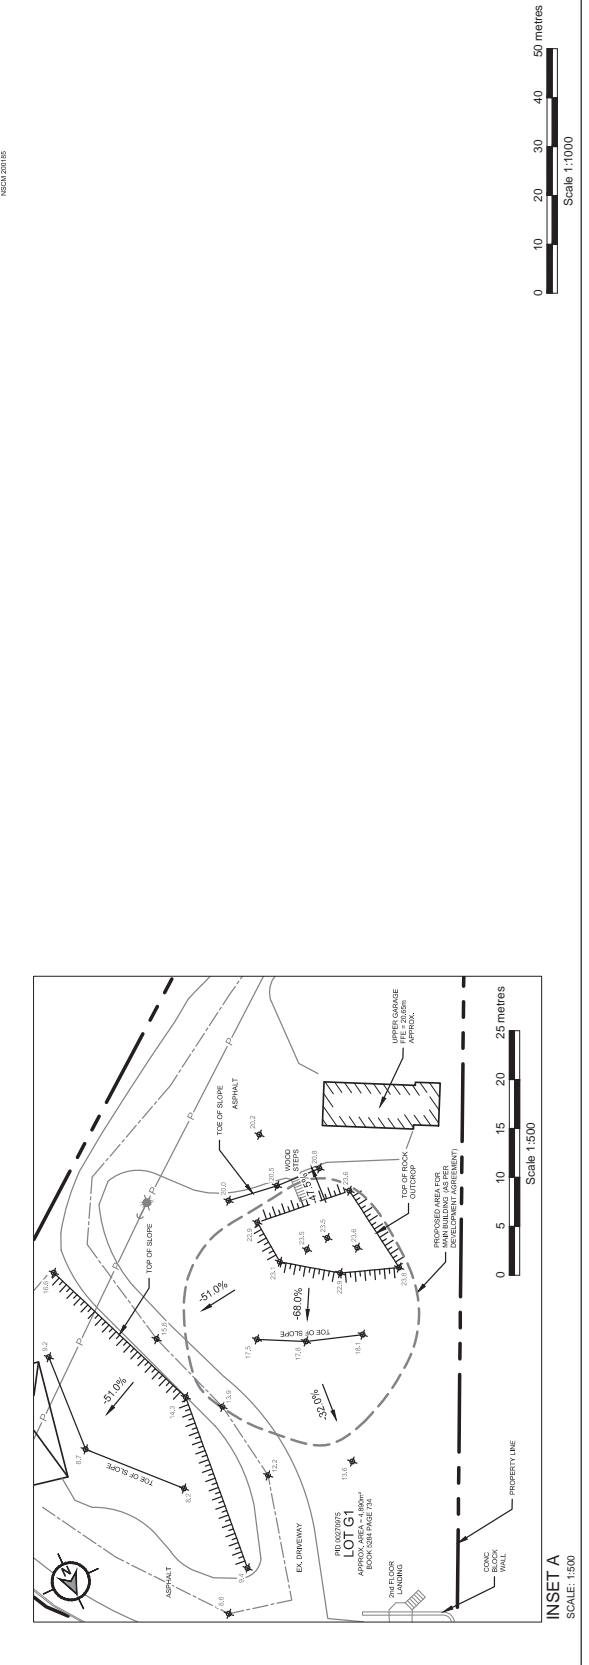
C-101

Shown on the attached Site Plan is a transposition of the *Proposed Area Main Building Location* from the 1982 development agreement. Strum has been asked by Sunrose Land Use Consulting to comment on the suitability of this location for constructing the main dwelling. Based on our review of the site as it exists today, the following issues have been identified as constraints that would have made this location difficult to construct within. Inset A on the attached Site Plan shows a greater level of detail for this area.

TITLE:
 SITE PLAN

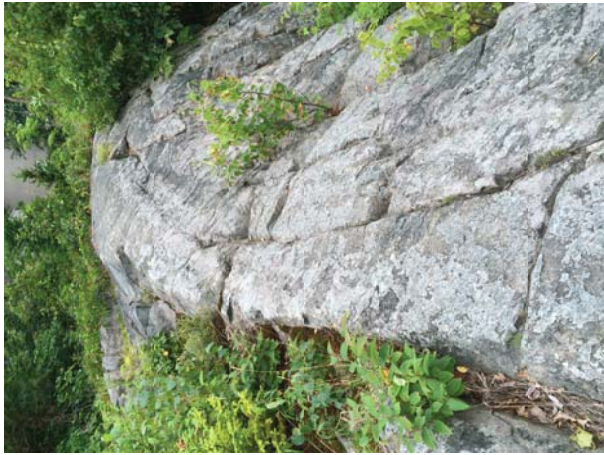
Photo 1: Bedding in downslope face of bedrock outcrop.

As indicated, this bedrock outcrop is a significant feature, located in the middle of the site. The bedding of the bedrock dips steeply down, away from the steep sloping face on the downward slope of the exposed rock outcrop. The orientation of the bedding, and the moderately close spacing of these discontinuities, would result in planes of weakness that would need to be addressed by engineering and construction measures in development of the site (attached Photo 1).

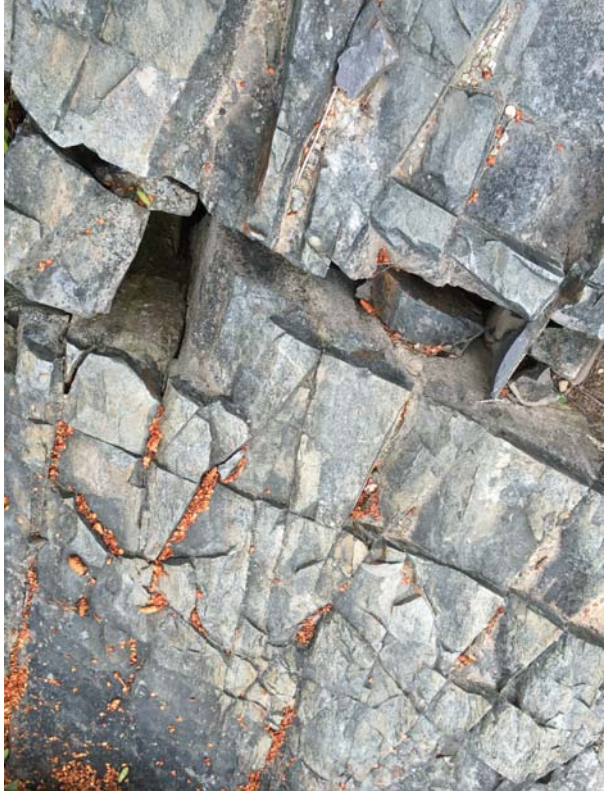
Photo 2: Blocky structure of rock in outcrop.

In addition to the bedding, fractures and joints are evident in the inspection of the outcrop surface resulting in a blocky structure further compromising the strength of the rock (Photo 2). This is supported by the owner's report of periodic rock falls that block the driveway from time to time. The necessity and uncertainty involved in addressing the in-situ rock outcrop could have led the designer to shift the location of site structures away from this area.

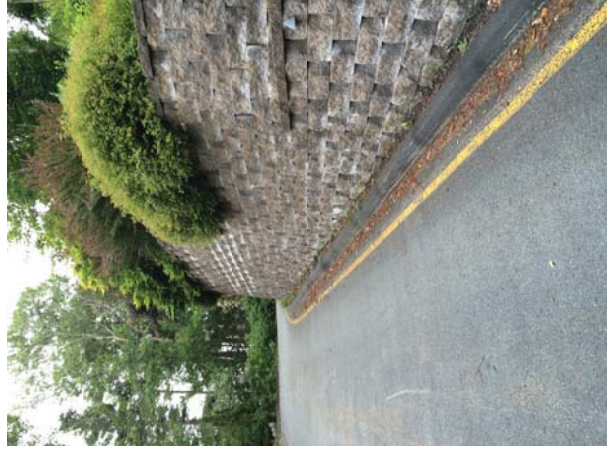
Photo 3: Retaining wall around bedrock outcrop.

A retaining wall was constructed in an attempt to prevent rock falls from the outcrop blocking the driveway. The contractor who constructed the wall, Jim Seaboyer, was contacted to review its construction. The wall is constructed of Rockwood retaining wall blocks manufactured by South Shore Ready Mix and is 1.8 m (6') to 2.4 m (8') high over much of its length (Photo 3). Mr. Seaboyer indicated that at points the wall was extended into the outcrop for support, bearing on the bedrock. As an indication of the weak structure of the bedrock, Mr. Seaboyer said after the wall was constructed he was using a jack hammer to cut some steps in the upslope face of the outcrop. Due to the vibration, sections of the bedrock settled causing damage to parts of the retaining wall that had to be repaired.
